## SPECIFICATION FOR ASBESTOS REMEDIATION WORKS

**PREMIER HOUSE, 22 DEANS\_GATE, MANCHESTER, M3 1PH**

| <b>Job number:</b> | <b>R05655</b> | |
| Version 3 | 25/03/2021 | Issued – addition of Retail Unit items to scope |

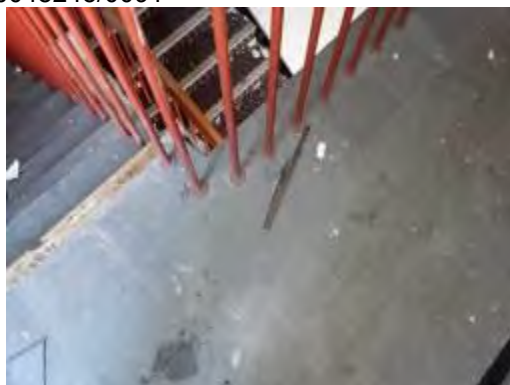
| Location 2 | | | | | | | | | | |
|---|---|---|---|---|---|---|---|---|---|---|
| Premier<br>house | External/E5 | J048245/0091 | Floor tiles and<br>bitumen to<br>floor | Vinyl floor<br>Tiles | Completely<br>Sealed | Low Damage | 12m <sup>2</sup> | Occasionally likely<br>to be disturbed | Identified | Chrysotile |

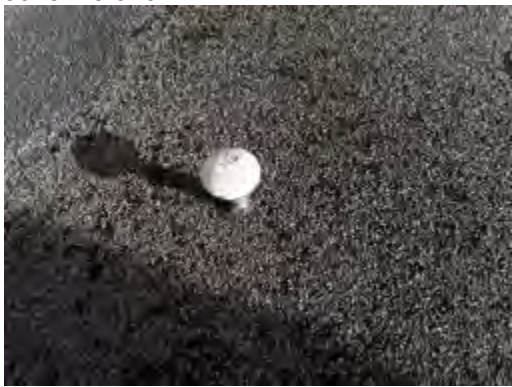
| Location 5 | | | | | | | | | | |
|---|---|---|---|---|---|---|---|---|---|---|
| Premier house | External/E8 | J048245/0102 | Composite cowles | Well bound Material | Surface Sealed | Low Damage | 26no. | Occasionally likely to be disturbed | Identified | Chrysotile |

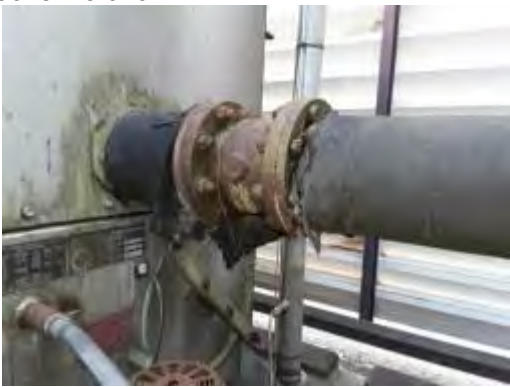
| Location 5 | | | | | | | | | | |
|---|---|---|---|---|---|---|---|---|---|---|
| Premier house | External/E8 | J048245/0107 | Gaskets to pipes | Gaskets | Surface Sealed | Low Damage | 6no. | Occasionally likely to be disturbed | Identified | Chrysotile |

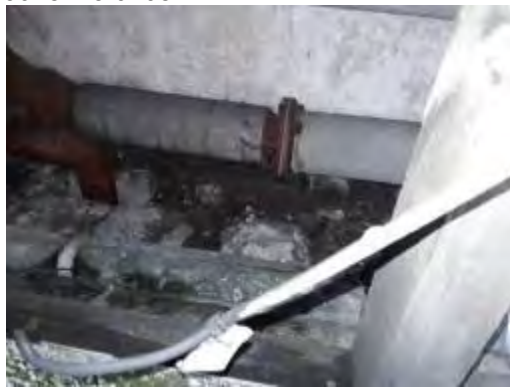
| Location 5 | | | | | | | | | | |
|---|---|---|---|---|---|---|---|---|---|---|
| Premier house | External/E8 | J048245/0108 | Gaskets to pipes in wall void | Gaskets | Surface Sealed | Low Damage | 38no. | Occasionally likely to be disturbed | Identified | Chrysotile |

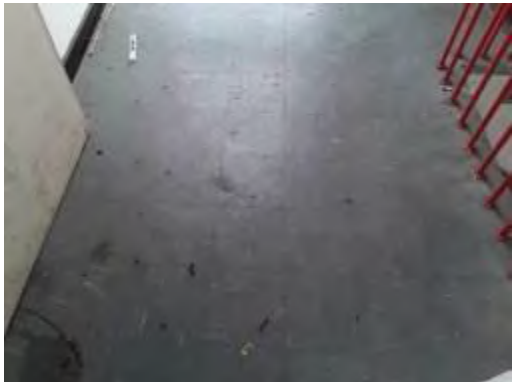
| Location 6 | | | | | | | | | | |
|---|---|---|---|---|---|---|---|---|---|---|
| Premier house | External/Stairs 1 | J048245/0109 | Floor tiles and bitumen to floor | Vinyl floor Tiles | Completely Sealed | Low Damage | 80m <sup>2</sup> | Occasionally likely to be disturbed | Strongly Presumed | Chrysotile |

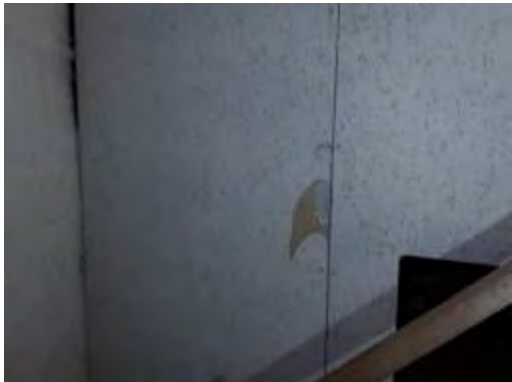
| Location 6 | | | | | | | | | | |
|---|---|---|---|---|---|---|---|---|---|---|
| Premier house | External/Stairs 1 | J048245/0112 | Board Panels | Board | Surface | Low Damage | 8m <sup>2</sup> | Occasionally likely to be disturbed | Identified | Amosite |

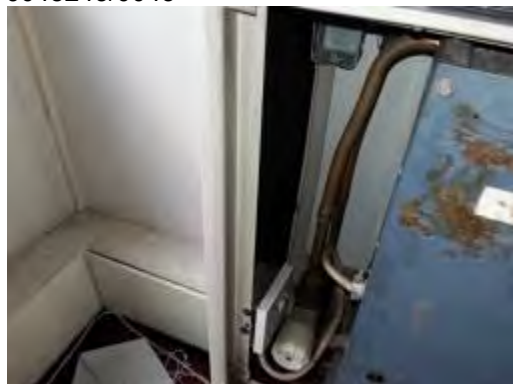
| Location 7 | | | | | | | | | | |
|---|---|---|---|---|---|---|---|---|---|---|
| Premier house | 1 <sup>st</sup> floor/1.0 | J048245/0043 | Board walls below windows and behind heaters | Board | Surface Sealed | Low Damage | 22m <sup>2</sup> | Occasionally likely to be disturbed | Identified | Amosite |

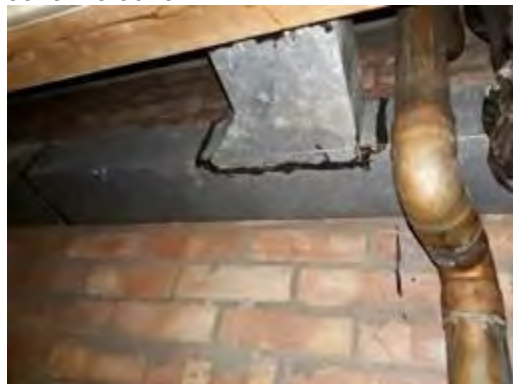
| Location 9 | | | | | | | | | | |
|---|---|---|---|---|---|---|---|---|---|---|
| Premier<br>house | 1 <sup>st</sup> floor/1.2 | J048245/0046 | Composite<br>putty to<br>ducting | Well<br>Bound<br>Material | Surface<br>Sealed | Low Damage | 3LM | Occasionally likely<br>to be disturbed | Strongly<br>Presumed | Chrysotile |

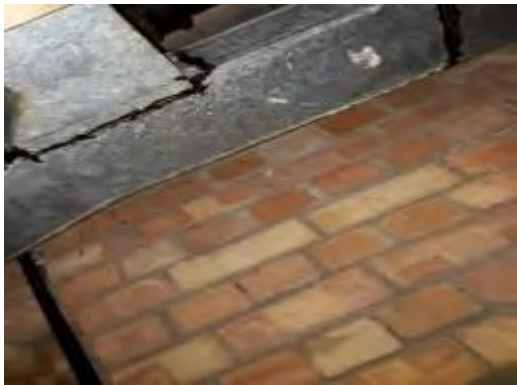
| Location 10 | | | | | | | | | | |
|---|---|---|---|---|---|---|---|---|---|---|
| Premier house | 1 <sup>st</sup> floor/1.4 | J048245/0048 | Composite putty to ducting | Well Bound Material | Surface Sealed | Low Damage | 3LM | Occasionally likely to be disturbed | Strongly Presumed | Chrysotile |

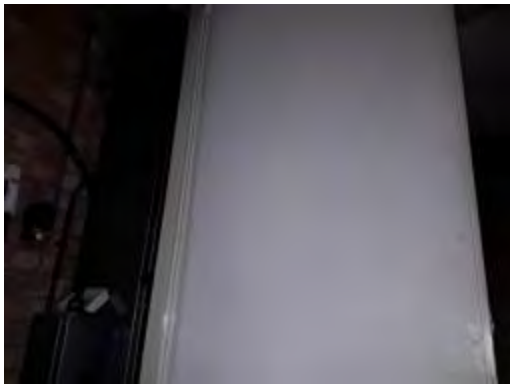
| Location 11 | | | | | | | | | | |
|---|---|---|---|---|---|---|---|---|---|---|
| Premier house | 1 <sup>st</sup> floor/1.5 | J048245/0050 | Board panel to doors | Board | Unsealed | Low Damage | 5no. | Occasionally likely to be disturbed | Strongly Presumed | Amosite |

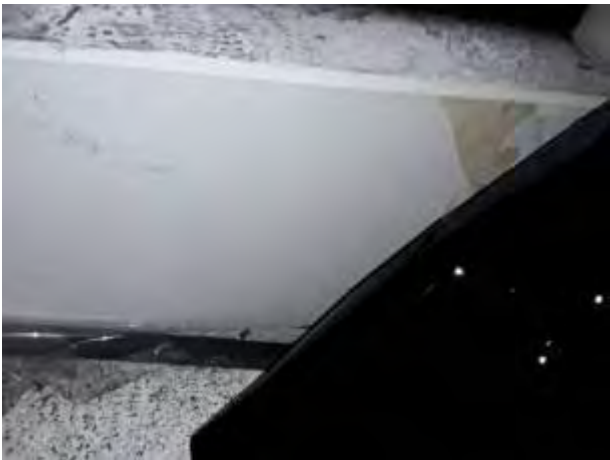
| Location 12 | | | | | | | | | | |
|---|---|---|---|---|---|---|---|---|---|---|
| Premier house | 1 <sup>st</sup> floor/1.6 | J048245/0051 | Board walls below windows and behind heaters | Board | Surface Sealed | Low Damage | 3m <sup>2</sup> | Occasionally likely to be disturbed | Strongly Presumed | Amosite |

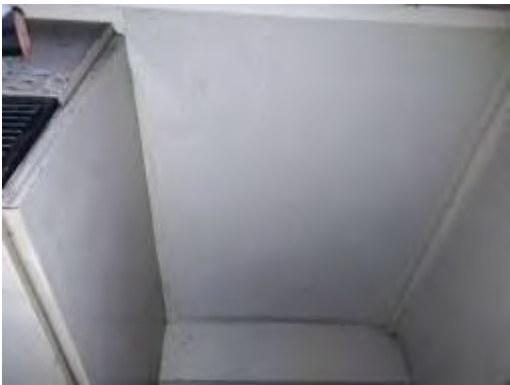
| Location 14 | | | | | | | | | | |
|---|---|---|---|---|---|---|---|---|---|---|
| Premier house | 1 <sup>st</sup> floor/1.8 | J048245/0054 | Board walls below windows and behind heaters | Board | Surface Sealed | Low Damage | 68m <sup>2</sup> | Occasionally likely to be disturbed | Strongly Presumed | Amosite |

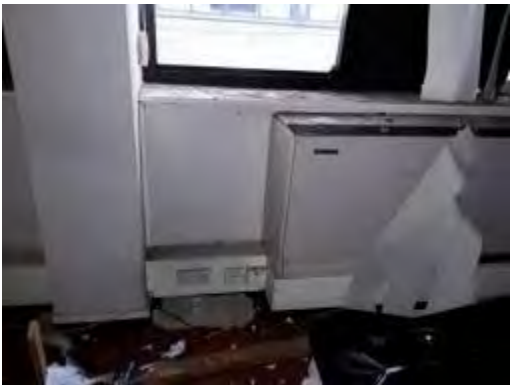
| Location 15 | | | | | | | | | | |
|---|---|---|---|---|---|---|---|---|---|---|
| Premier house | 1 <sup>st</sup> floor/1.11 | J048245/0055 | Board walls below windows and behind heaters | Board | Surface Sealed | Low Damage | 22m <sup>2</sup> | Occasionally likely to be disturbed | Strongly Presumed | Amosite |

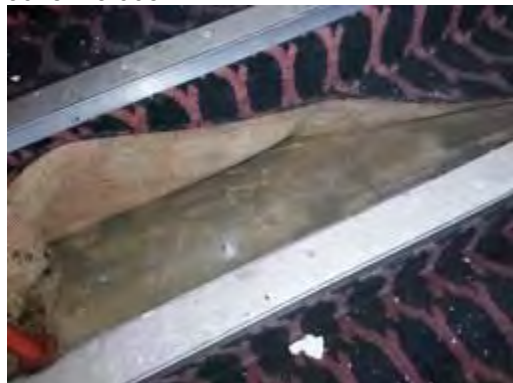
| Location 16 | | | | | | | | | | |
|---|---|---|---|---|---|---|---|---|---|---|
| Premier<br>house | 1 <sup>st</sup> floor/1.13 | J048245/0057 | Floor tiles and<br>bitumen to<br>floor | Vinyl floor<br>Tiles | Completely<br>Sealed | Low Damage | 12m <sup>2</sup> | Occasionally likely<br>to be disturbed | Identified | Chrysotile |

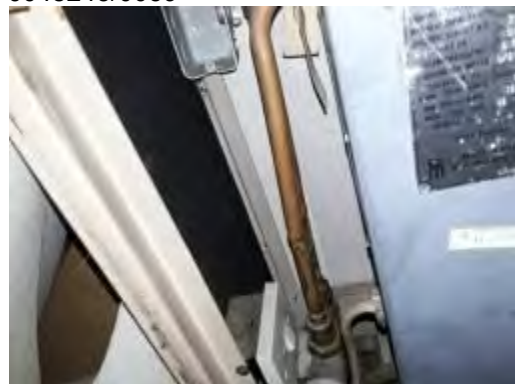
| Location 18 | | | | | | | | | | |
|---|---|---|---|---|---|---|---|---|---|---|
| Premier house | 1 <sup>st</sup> floor/1.15 | J048245/0059 | Board walls below windows and behind heaters | Board | Surface Sealed | Low Damage | 3m <sup>2</sup> | Occasionally likely to be disturbed | Strongly Presumed | Amosite |

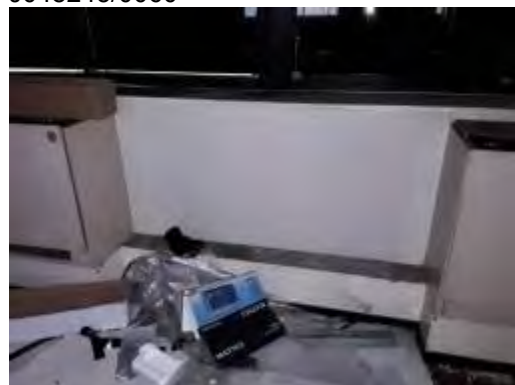
| Location 19 | | | | | | | | | | |
|---|---|---|---|---|---|---|---|---|---|---|
| Premier house | 1 <sup>st</sup> floor/1.16 | J048245/0060 | Board walls below windows and behind heaters | Board | Surface Sealed | Low Damage | 68m <sup>2</sup> | Occasionally likely to be disturbed | Strongly Presumed | Amosite |

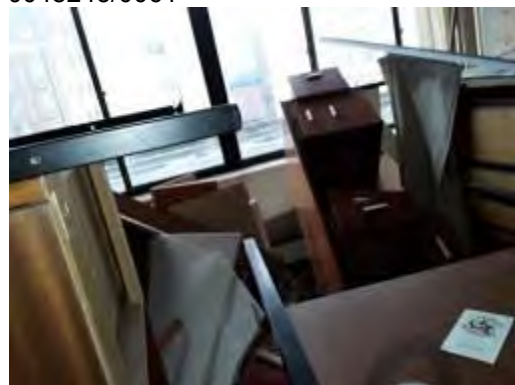
| Location 20 | | | | | | | | | | |
|---|---|---|---|---|---|---|---|---|---|---|
| Premier<br>house | 1 <sup>st</sup> floor/1.17 | J048245/0061 | Board walls<br>below windows<br>and behind<br>heaters | Board | Surface<br>Sealed | Low Damage | 12m <sup>2</sup> | Occasionally likely<br>to be disturbed | Strongly<br>Presumed | Amosite |

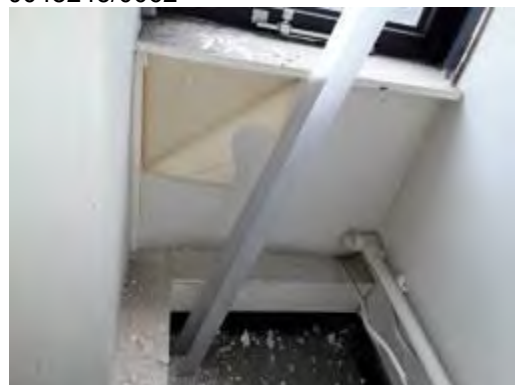
| Location 21 | | | | | | | | | | |
|---|---|---|---|---|---|---|---|---|---|---|
| Premier house | 1 <sup>st</sup> floor/1.18 | J048245/0062 | Board walls below windows and behind heaters | Board | Surface Sealed | Low Damage | 1m <sup>2</sup> | Occasionally likely to be disturbed | Strongly Presumed | Amosite |

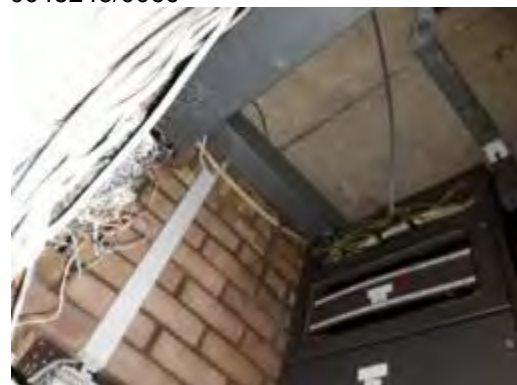
| Location 23 | | | | | | | | | | |
|---|---|---|---|---|---|---|---|---|---|---|
| Premier<br>house | 1 <sup>st</sup> floor/1.20 | J048245/0066 | Composite<br>putty to<br>ducting | Well<br>Bound<br>Material | Surface<br>Sealed | Low Damage | 2LM | Occasionally likely<br>to be disturbed | Strongly<br>Presumed | Chrysotile |

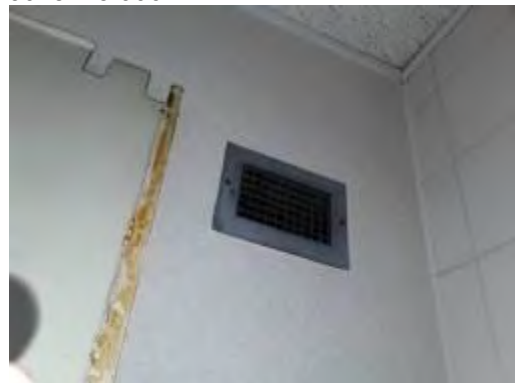
| Location 24 | | | | | | | | | | |
|---|---|---|---|---|---|---|---|---|---|---|
| Premier<br>house | 1 <sup>st</sup> floor/1.22 | J048245/0067 | Composite<br>putty to<br>ducting | Well<br>Bound<br>Material | Surface<br>Sealed | Low Damage | 3LM | Occasionally likely<br>to be disturbed | Strongly<br>Presumed | Chrysotile |

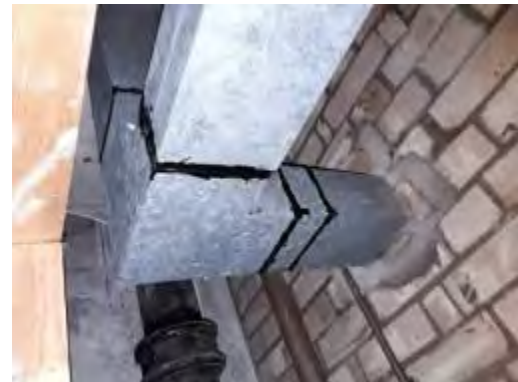
| Location 25 | | | | | | | | | | |
|---|---|---|---|---|---|---|---|---|---|---|
| Premier house | 1 <sup>st</sup> floor/1.23 | J048245/0070 | Floor tiles and bitumen to floor | Vinyl floor tiles | Completely Sealed | Low Damage | 12m <sup>2</sup> | Occasionally likely to be disturbed | Strongly Presumed | Chrysotile |
| Premier house | 1 <sup>st</sup> floor/1.23 | J048245/0071 | Composite putty to ducting | Well Bound Material | Surface Sealed | Low Damage | 3LM | Occasionally likely to be disturbed | Strongly Presumed | Chrysotile |
