**STRUCTURAL INVESTIGATION REPORT AT  
809 WILMSLOW ROAD, DIDSBURY, M20 2QR**

| Document Number | Revision | Description | Issue Date |
|---|---|---|---|
| 9989 | P1 | | 1/11/20 |

| Survey Date: | 27 <sup>th</sup> October 2020. Weather dry and overcast. |
| Survey/ Report By: | Richard Lomax MIStructe BEng (Hons) |

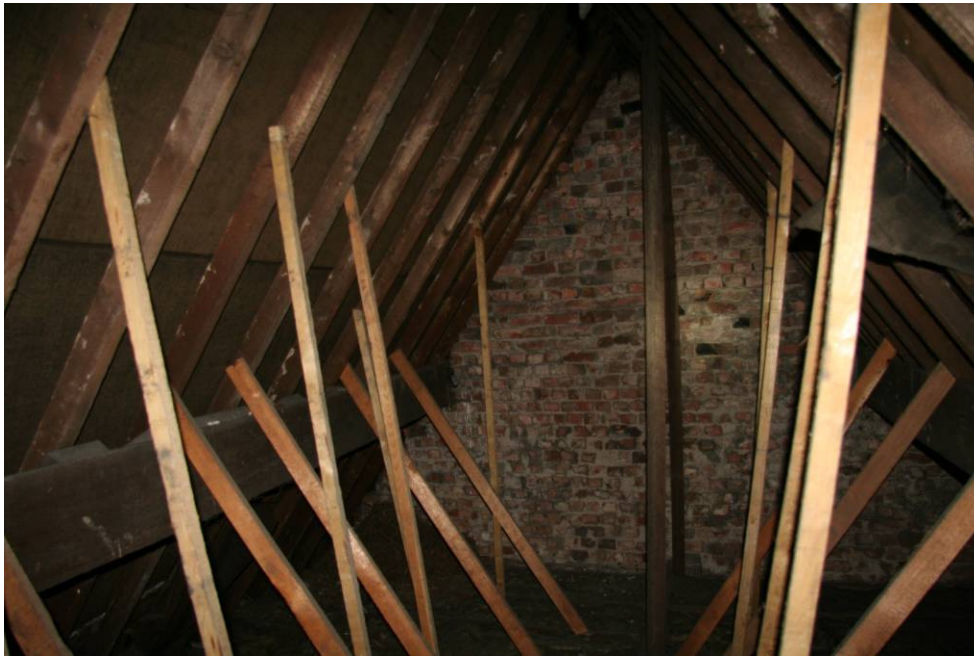
**P1**

The larger front section roof consisted of steep pitched 3" deep x 2-2.5" timber rafters at circa 16" centres with mid-span timber purlin measuring approximately 11" deep x 3" wide, refer photograph P1 below.

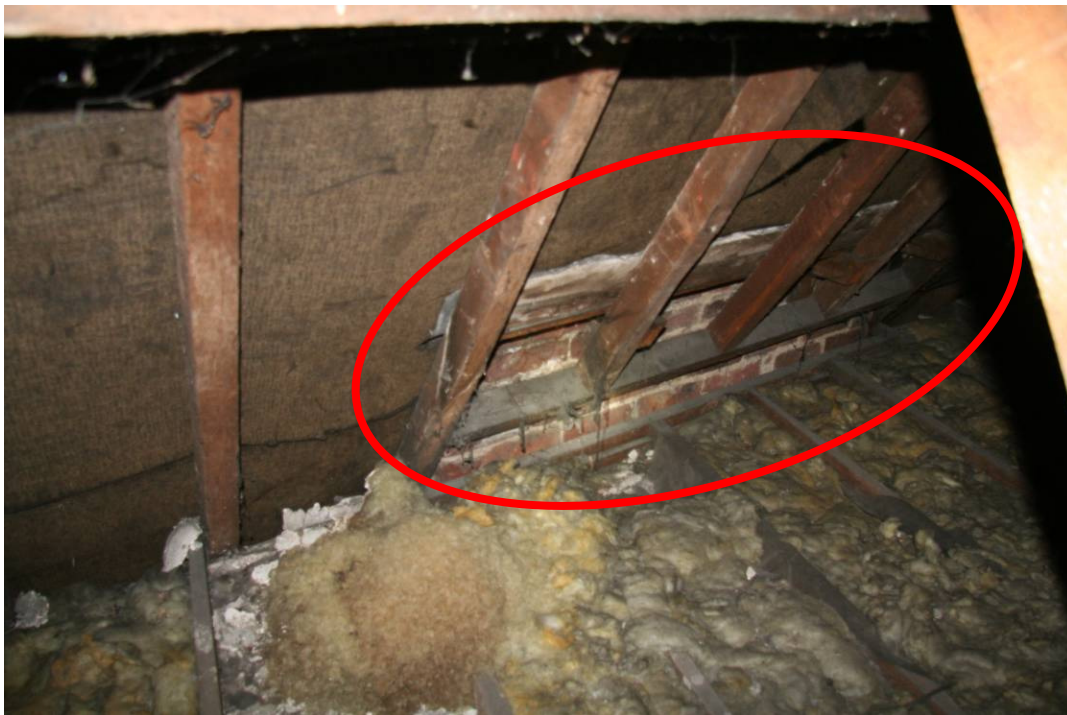
Timber rafters fixed off wall plate spanning along face of external chimney stack, refer photograph P2 below.

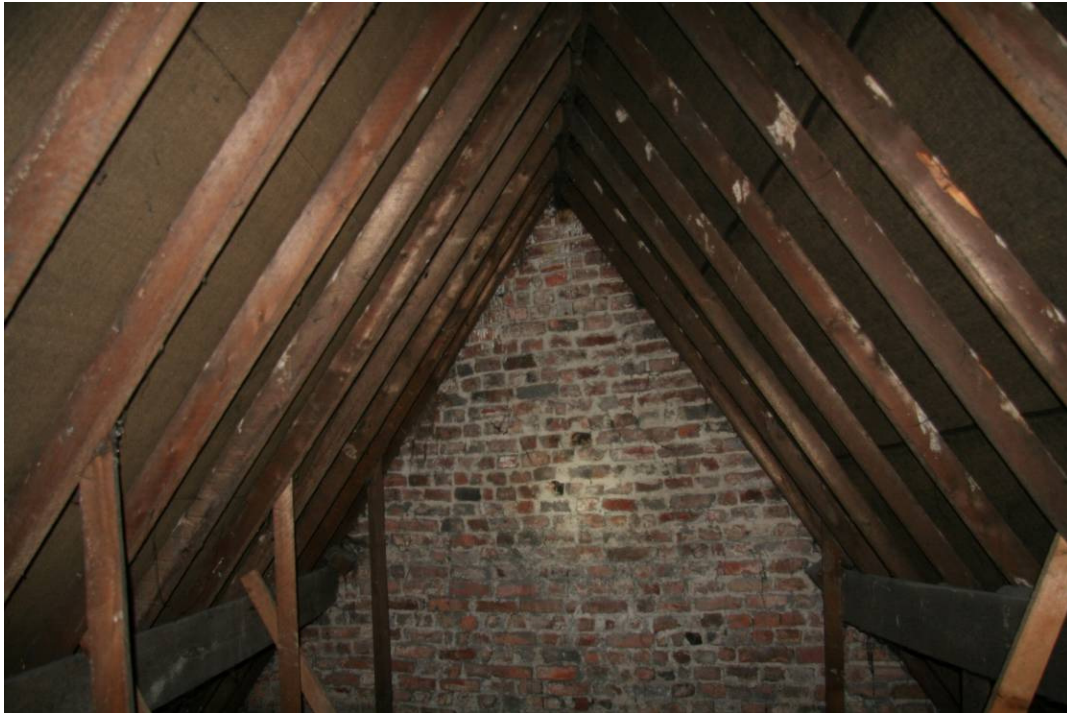
**P3**

The rear section roof consisted of similar steep pitched 3" deep x 2-2.5" timber rafters at circa 16" centres with mid-span purlin measuring approximately 9" deep x 3" wide, refer photograph P3 below.

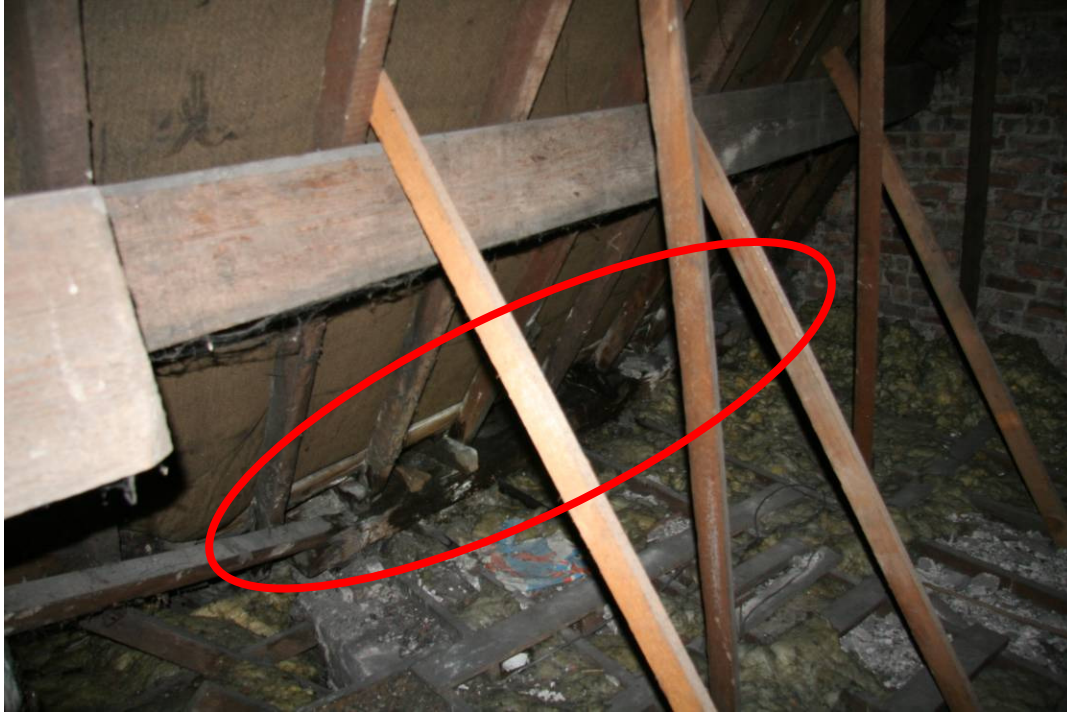
**P4**

Rafters seated off large timber bulkhead (understood to form valley with neighbouring roof) – evidence of historic water ingress evident, refer photograph P4 on the following page.

Generally, the timber roof structure is in fair condition considering its age. The Author would recommend a more closer inspection to elements local to the external fabric once proposed works are underway for water ingress/ rot infestation – purlins and rafter ends embedded in the external wall in particular. The timber bulkhead forming the valley to rear of the property also requires further close examination.

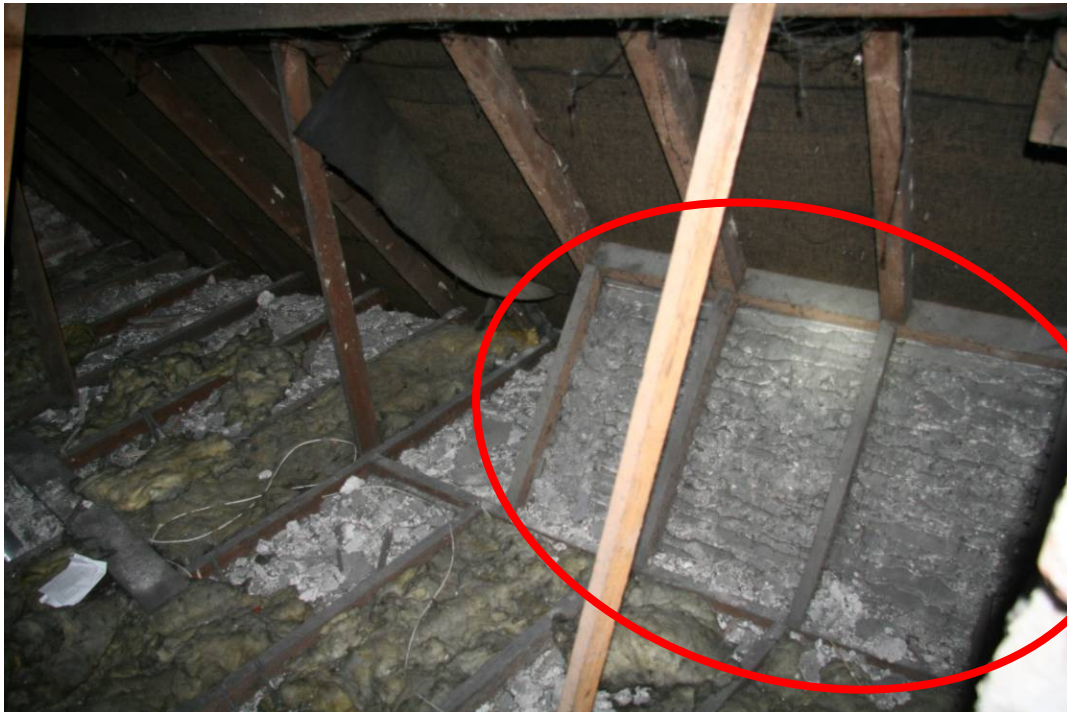
**P5**

Timber rafters fixed off wall plate spanning along external rooflight over stair landing, refer photograph P5 below.
