## HERITAGE, DESIGN & ACCESS STATEMENT

### No. 73 and 75 - Entrance Lobby Repair Work India House, Whitworth Street, Manchester.

July 2022

**India House, Whitworth Street, Manchester**  
**Investigation into the Condition of the Historic Ceiling**  
**Plasters, in the Entrance Foyers and a Profile of the**  
**Cornice from the Entrance Lobby**

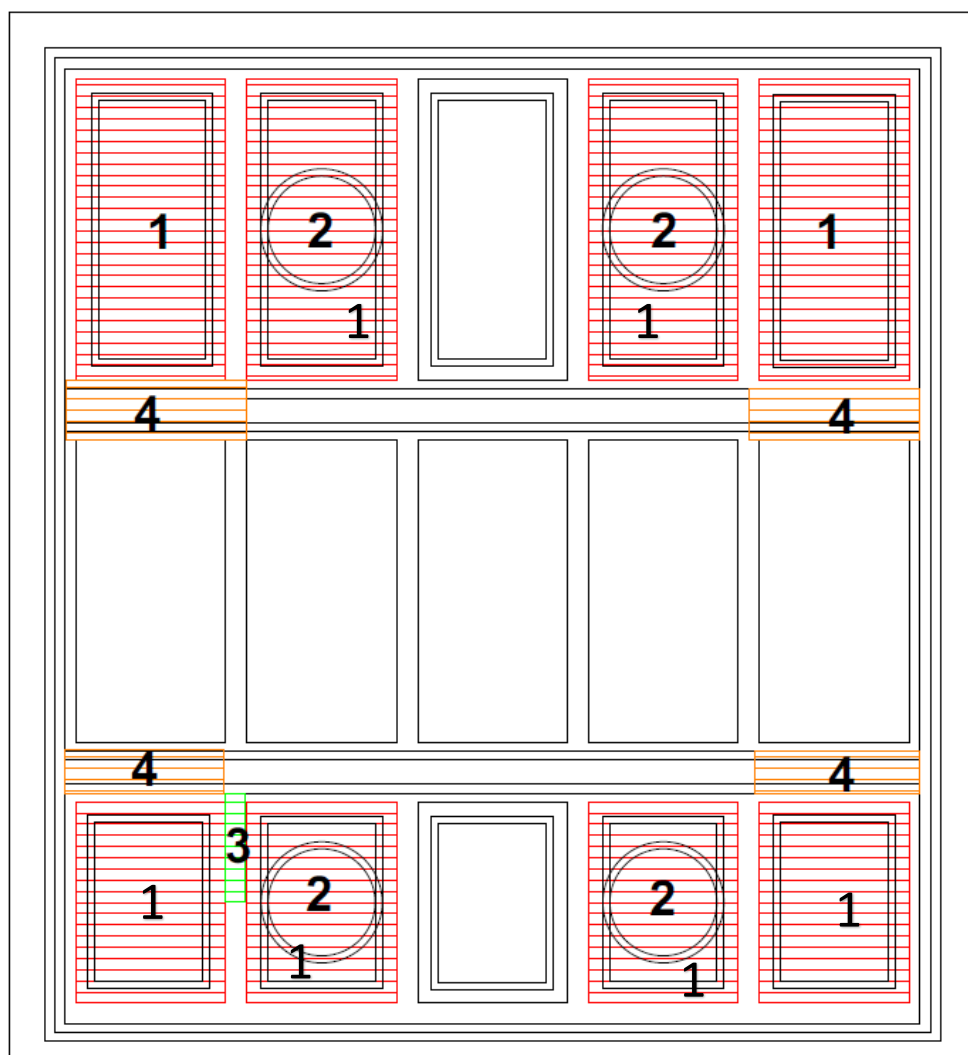
**Diagram 1: North-eastern Entrance Lobby (Ref room 73.)**

1. Areas of curving plain fibrous panels to replace.
2. Replace circular square section casts around lights.
3. Replace full width of the square ribs /stiles, edged with concave moulding, and raised frame.
4. Replace sections of the curved semi-circular ribs which run across the full width of the ceiling, and the decorative separate curving casts bands which decorate them.

| <b>Repairs and replacement work needed to the foyer entrance No 73, as shown on Diagram 1</b> | <b>Estimated Days</b> | <b>Plasterwork Cost</b> |
| Run and plant on 4 new circular approx. 15 mm square section frames of approx. 300 mm diameter, (ref No 2 on Diagram 1). | 3 | £1,670.00 |
| Take squeezes, create moulds, cast, and fix 1 lengths of square rib, finished with integral concave mouldings, at approx. 140 x 70 x 400 mm, (ref No 3 on Diagram 1). | 2 | £970.00 |
| Take squeezes, create moulds, cast, and fix 4 lengths of semi-circular rib, finished with concave mouldings at approx. 135 x 135 x 500 mm and form 16 internal mitres, (ref No 4 on diagram 1), take squeezes, create moulds, cast, and fix decorative curving, skewed bands to face of ribs. | 4 | £2,980.00 |

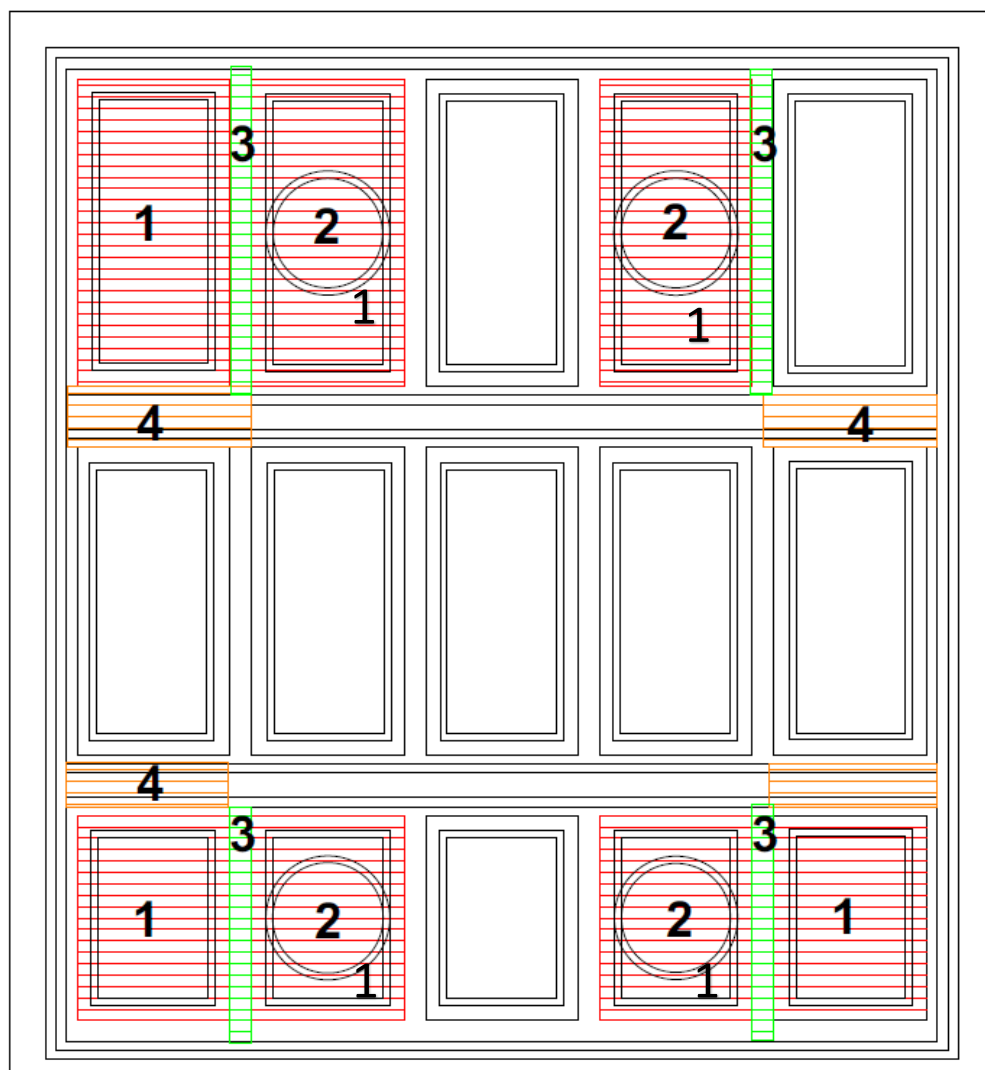
**Diagram 2: South-Western Entrance Lobby (Ref room 75.)**

1. Areas of curving plain fibrous panels to replace.
2. Replace round square section casts around lights.
3. Replace full width of the square ribs/ stiles, edged with concave moulding, and raised frame.
4. Replace sections of the curved semi-circular ribs which run across the full width of ceiling, and the decorative separate curving casts bands which decorate them.

| <b>Repairs and replacement work needed to the foyer entrance No 75, as shown on Diagram 2</b> | <b>Estimated Days</b> | <b>Plasterwork Cost</b> |
| Run and plant on 4 new circular approx. 15 mm square section frames of approx. 300 mm diameter, (ref No 2 on Diagram 2). | 2 | £1,180.00 |
| Take squeezes, create moulds, cast, and fix 4 lengths of square rib, finished with concave mouldings (2 at approx. 140 x 70 x 700 mm and 2 at approx. 140 x 70 x 1100 mm) and form 16 internal mitres, (ref No 3 on Diagram 2). | 4 | £2,740.00 |
| Take squeezes, create moulds, cast, and fix 4 lengths of semi-circular rib, finished with concave mouldings at approx. 135 x 135 x 500 mm and form 16 internal mitres, (ref No 4 on Diagram 2), take squeezes, create moulds, cast, and fix decorative curving, skewed bands to face of ribs. | 4 | £2,980.00 |

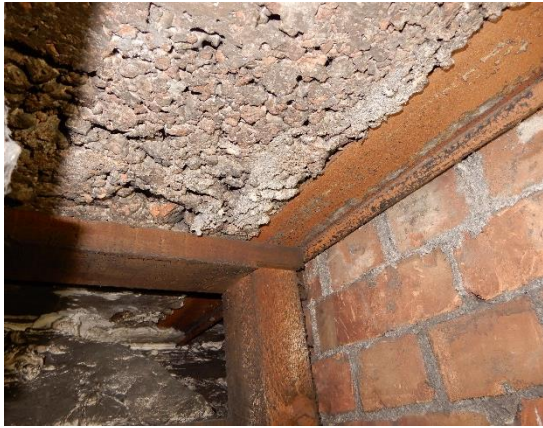
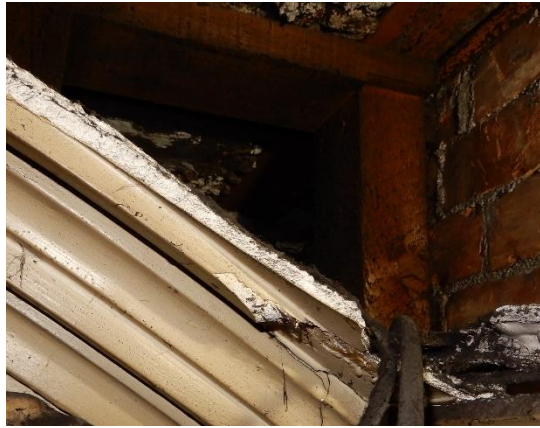
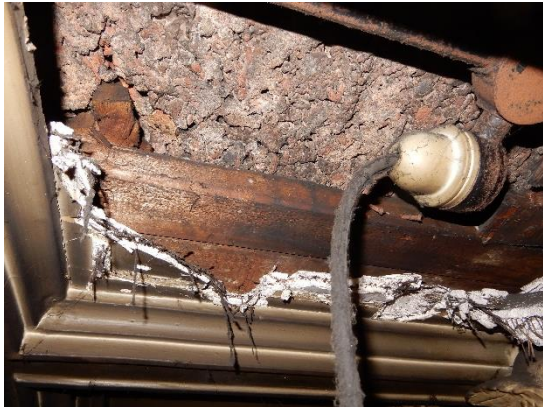
**Photos 1, 2 & 3: Early 20<sup>th</sup> century steel joists and shuttered concrete carry the floors above the foyers, whose ceilings are hung from a curving timber frame lined with timber boarding.**

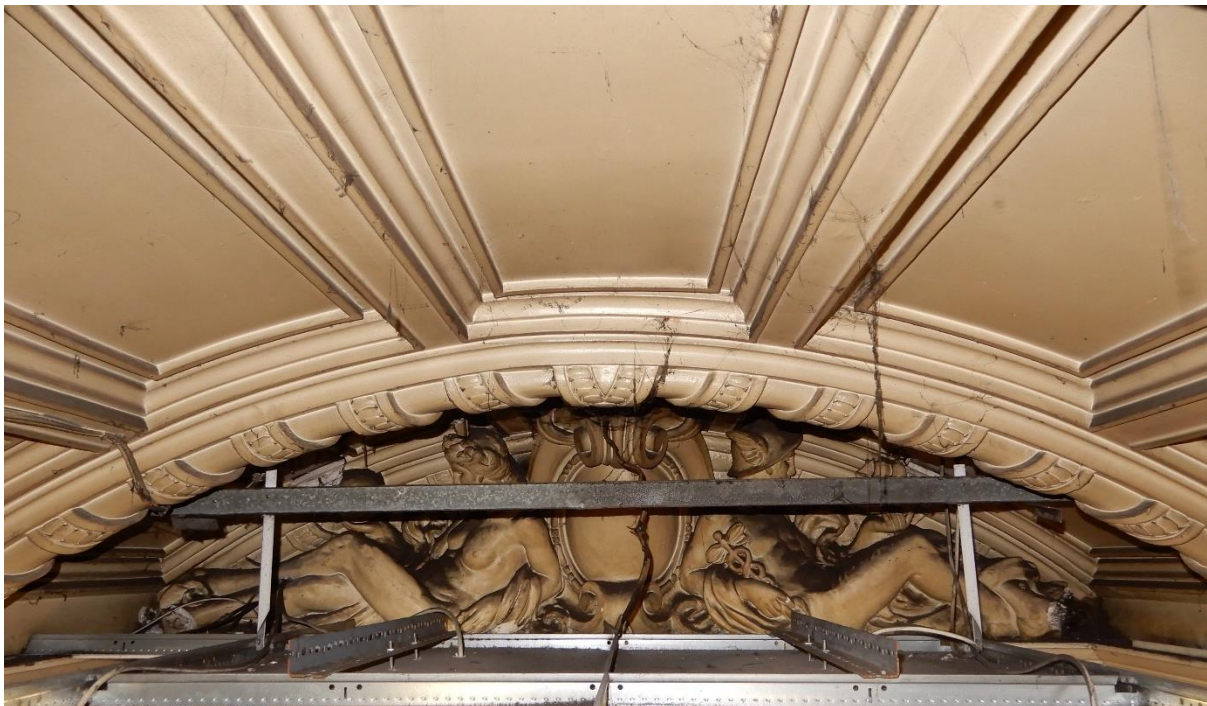
**Photo 4: The barrel vaulted ceilings, decorated with plain fibrous cast panels, sub-divided into 15 panels by square ribs, with concave mouldings down their length, and with semi-circular deeper ribs across the ceilings' width, decorated with simple bands. Both are finished with a cartouche and reclining ½ life size classical figures depicting the Greek god Hermes (the Roman Mercury) who was the god of translators and interpreters and ruled over wealth, good fortune, commerce. He carries a ship depicting the trade of goods from India, and opposite a Greek goddess with the world in her hand.**

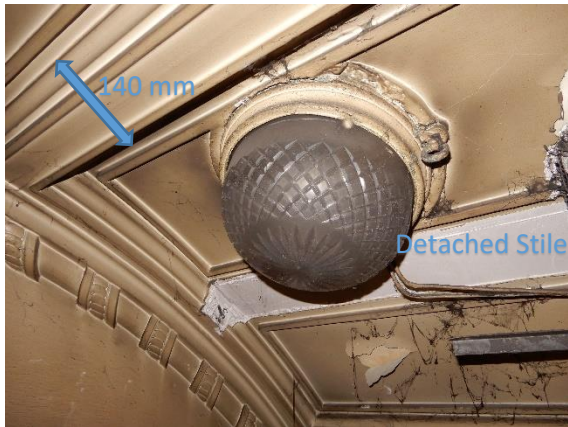
Photo 5: Showing the framed square ribs / stiles which run along the length of the ceiling, one of which has become detached; also showing the small planted on square section, creating a frame to the inner panel; and the cut glass light fitting.

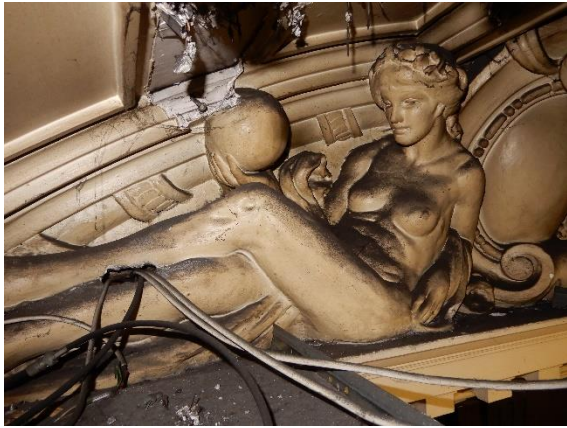
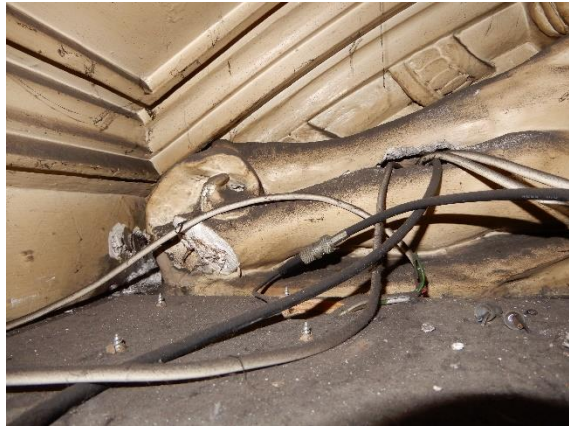
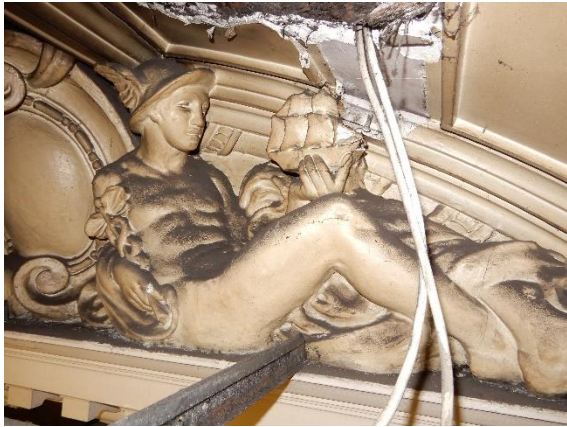
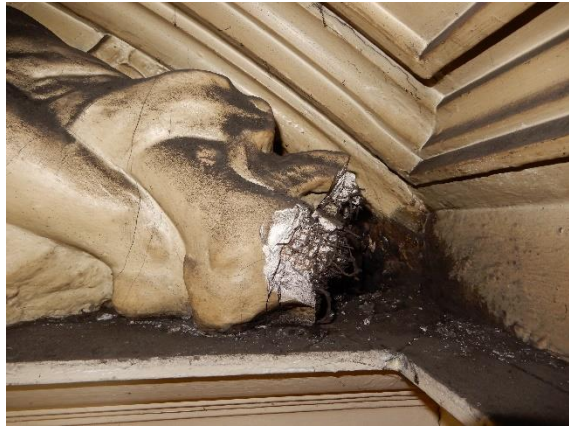
**Photos 9-12: Damaged feet on the two figures at entrance No. 73**

| <b>Repairs and replacement work needed to the foyer entrance No 73, as shown on Diagram 1</b> | <b>Estimated Days</b> | <b>Plasterwork Cost</b> |
|---|---|---|
| Sculpt one new foot for each of the two reclining figures in clay and create moulds and casts of each and fix. | 6 | £4,240.00 |

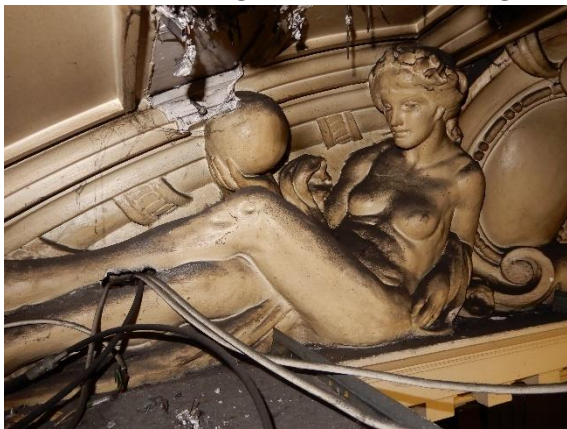
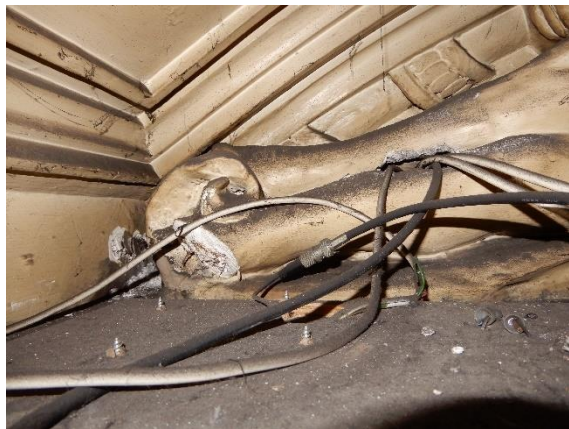
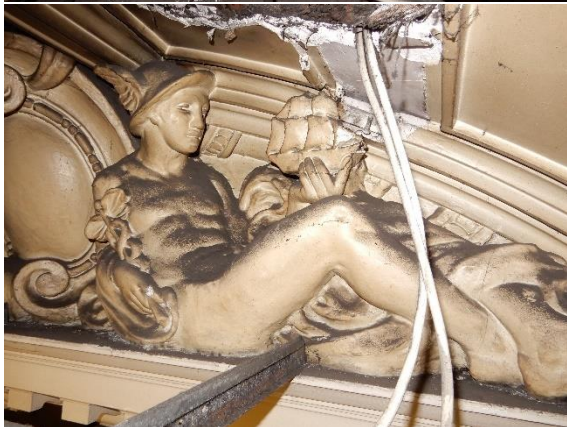
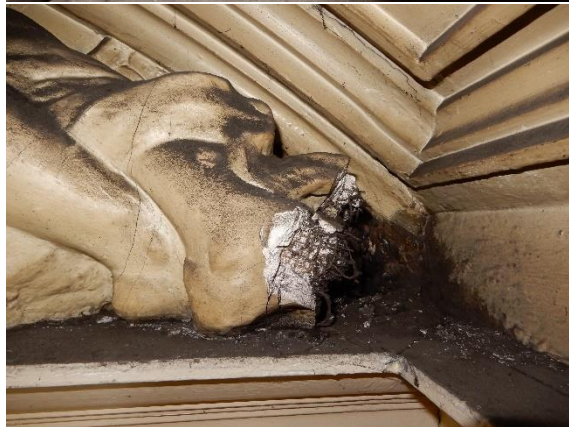
**Photos 13-16: Damaged feet on the two figures at entrance No. 75**

| <b>Repairs and replacement work needed to the foyer entrance No 75, as shown on Diagram 2</b> | <b>Estimated Days</b> | <b>Plasterwork Cost</b> |
|---|---|---|
| Sculpt one new foot for each of the two reclining figures in clay and create moulds and casts of each and fix. | 6 | £4,240.00 |

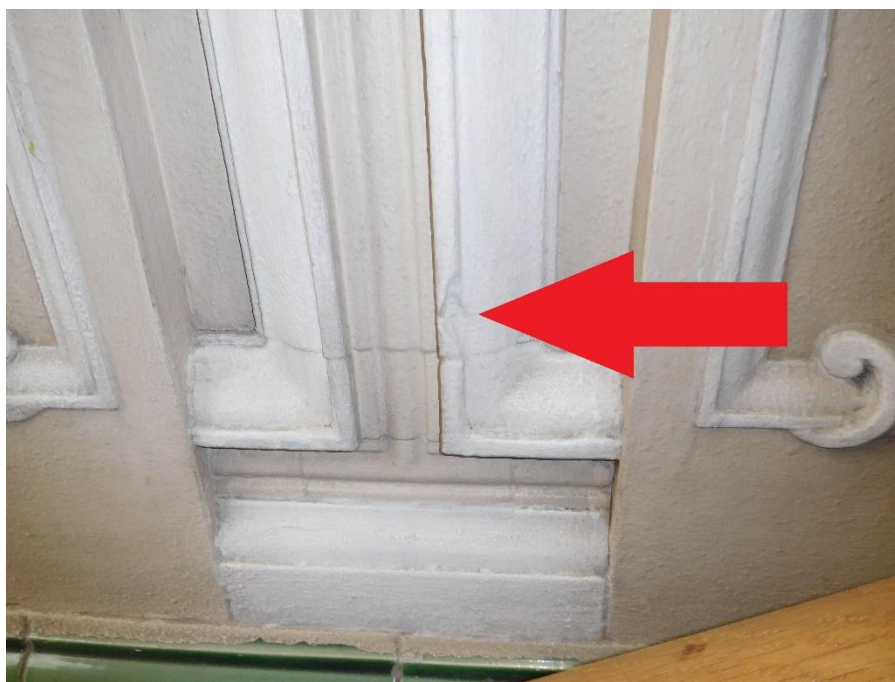
Fig 3.

Whilst there are one or two instances where it is possible to see some damage to the tiles beneath the paint, these instances are no more than a handful. There is no evidence of severe fracturing, though it is difficult to tell because of the thick coating of what seems to be an epoxy type of textured paint. Fig. 3.

The paintwork is ugly and unsympathetic and the look and feel of the entrances would benefit if it were removed. However, this should be done carefully, and be put in the hands of a professional who understands how to avoid further damage to the tiles during the paint removal process.

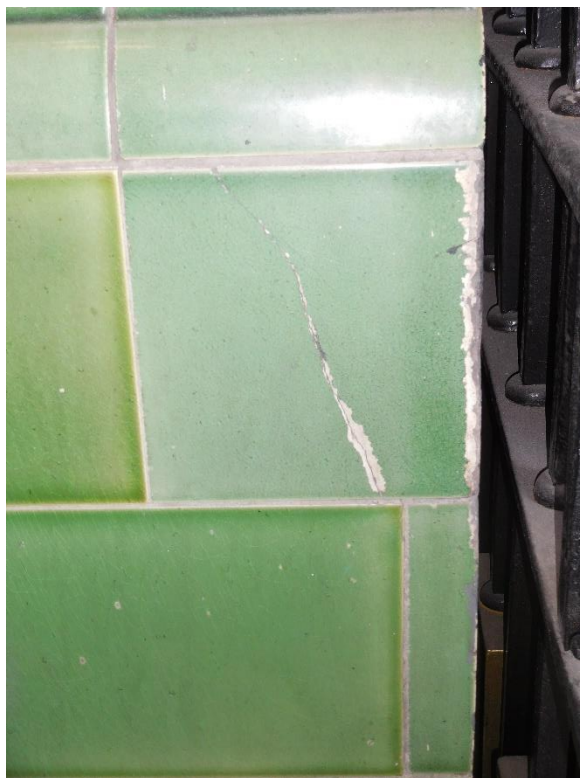
Fig.4

There are some small damage areas in amongst the lower part of the green glazed tilework, none of it is excessive and can be repaired by a ceramics conservator. Figs.4 & 5.

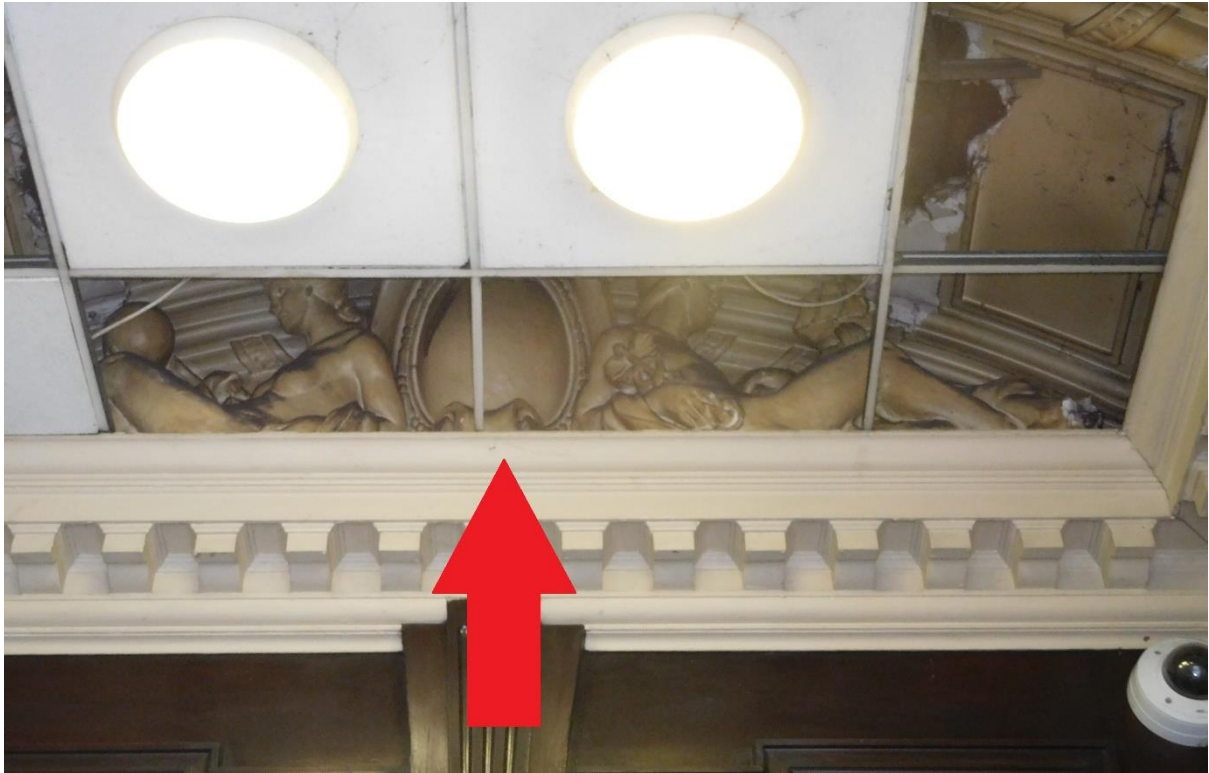
Fig 6 Barrel vault with cartouche and figures east entrance

There is some damage to the features of the figures and the barrel vaulting, a ceramics conservator would repair these elements without encountering problems.

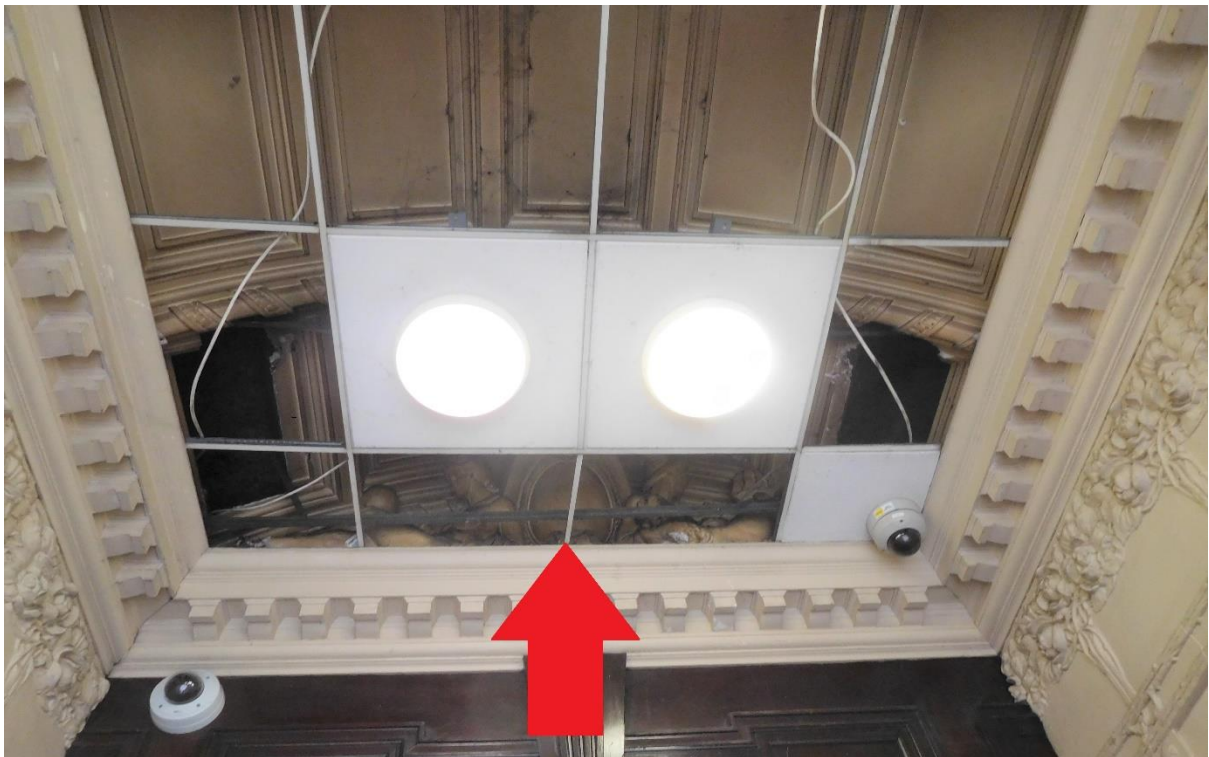
Fig 7 Barrel vault with cartouche and figures west entrance
