**Chorlton Library**  
Open Libraries Development  
Photographs  
July 2022

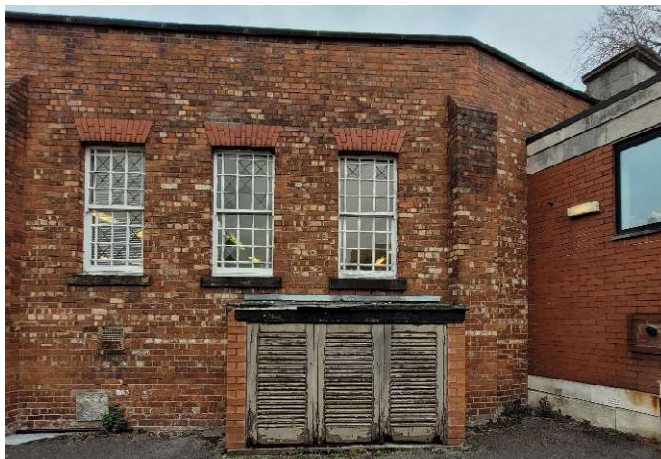
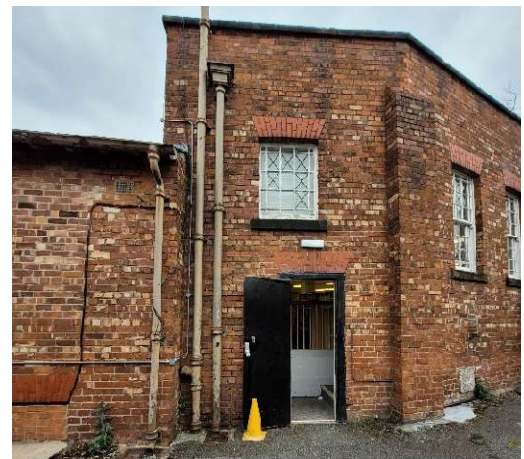
Extension abutment to the south/west walls of the original building. Store doors and roof to be renewed.

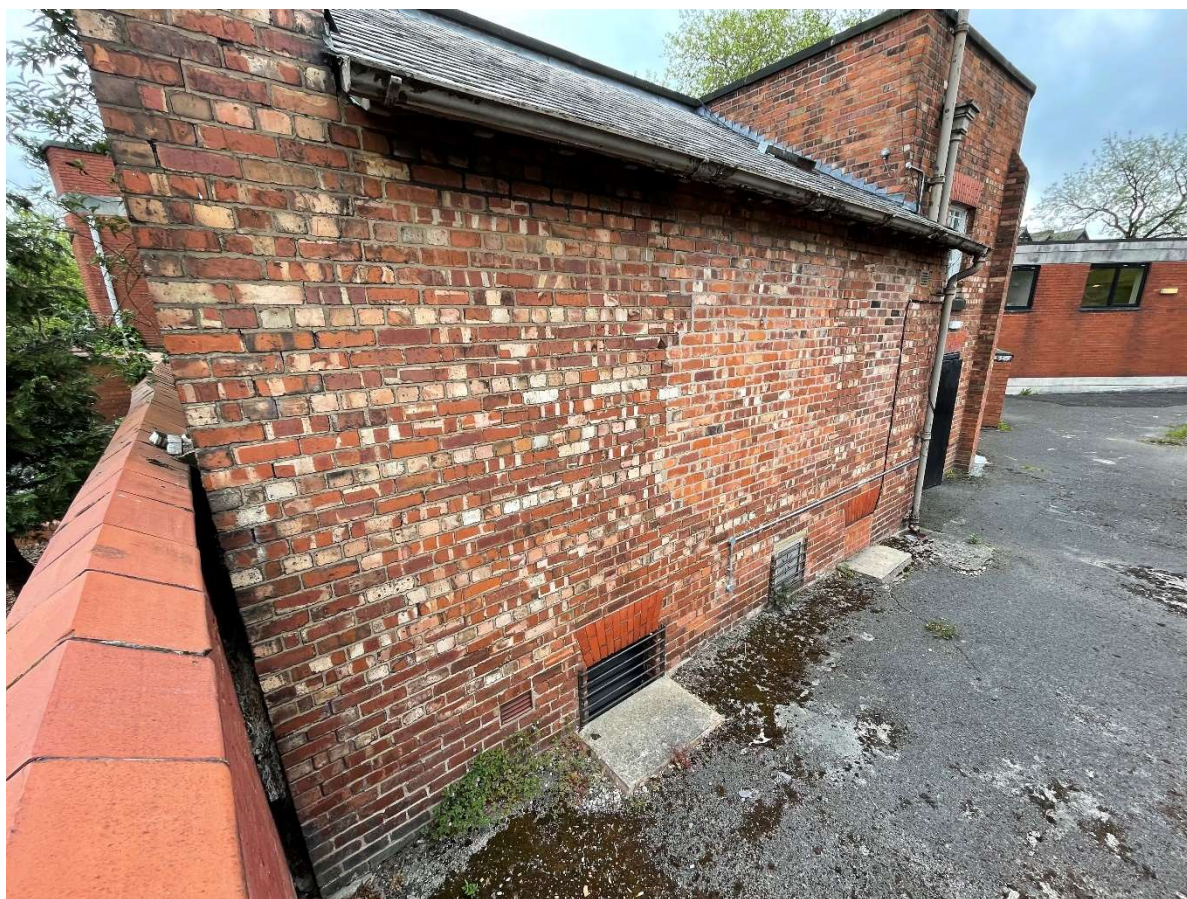
The much altered wall to the service yard beneath the slated roof, and over the basement boiler house.

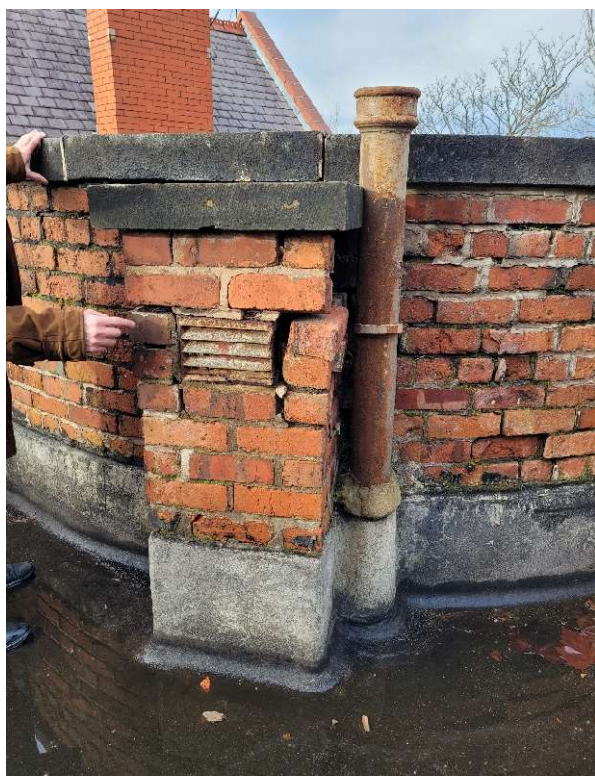
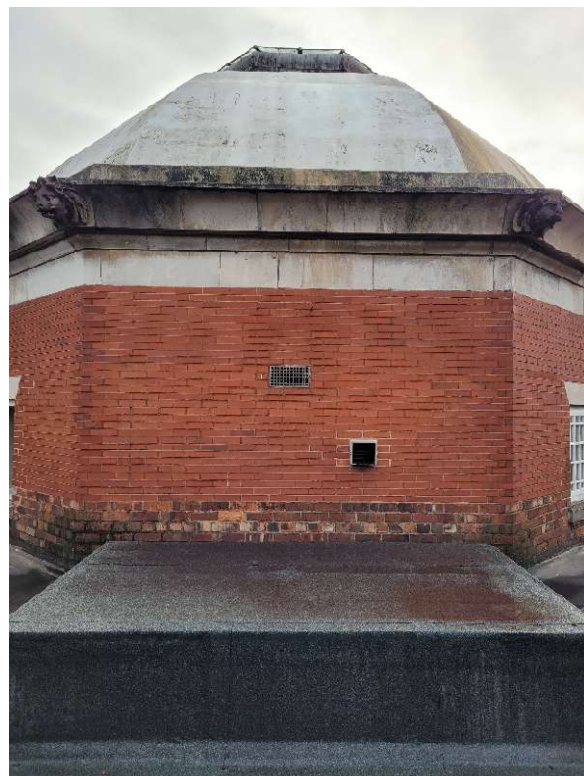
Duct to west of Portico to be rebuilt, and north wall of rotunda from the Portico roof.

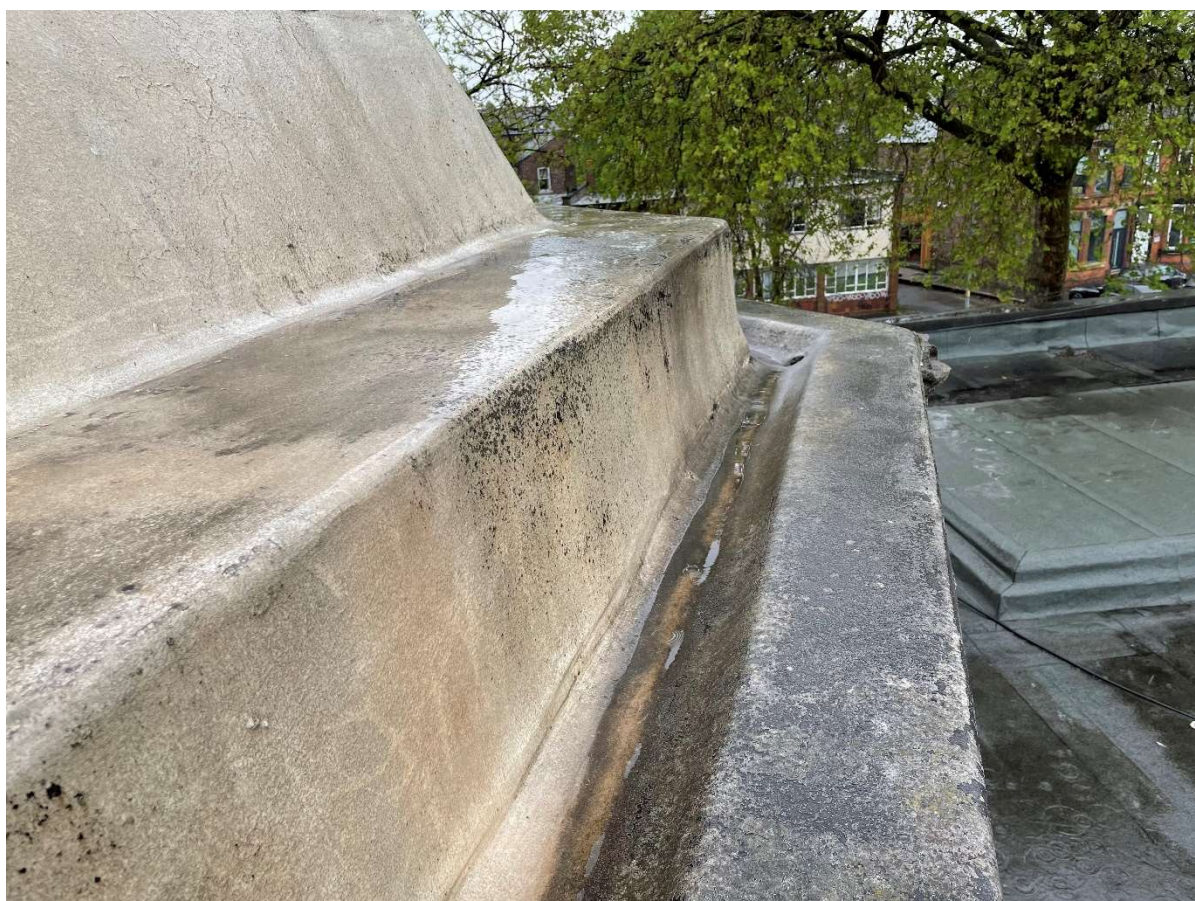
Asphalt finishes to Rotunda roof and parapet gutter, note corner gargoye outlet

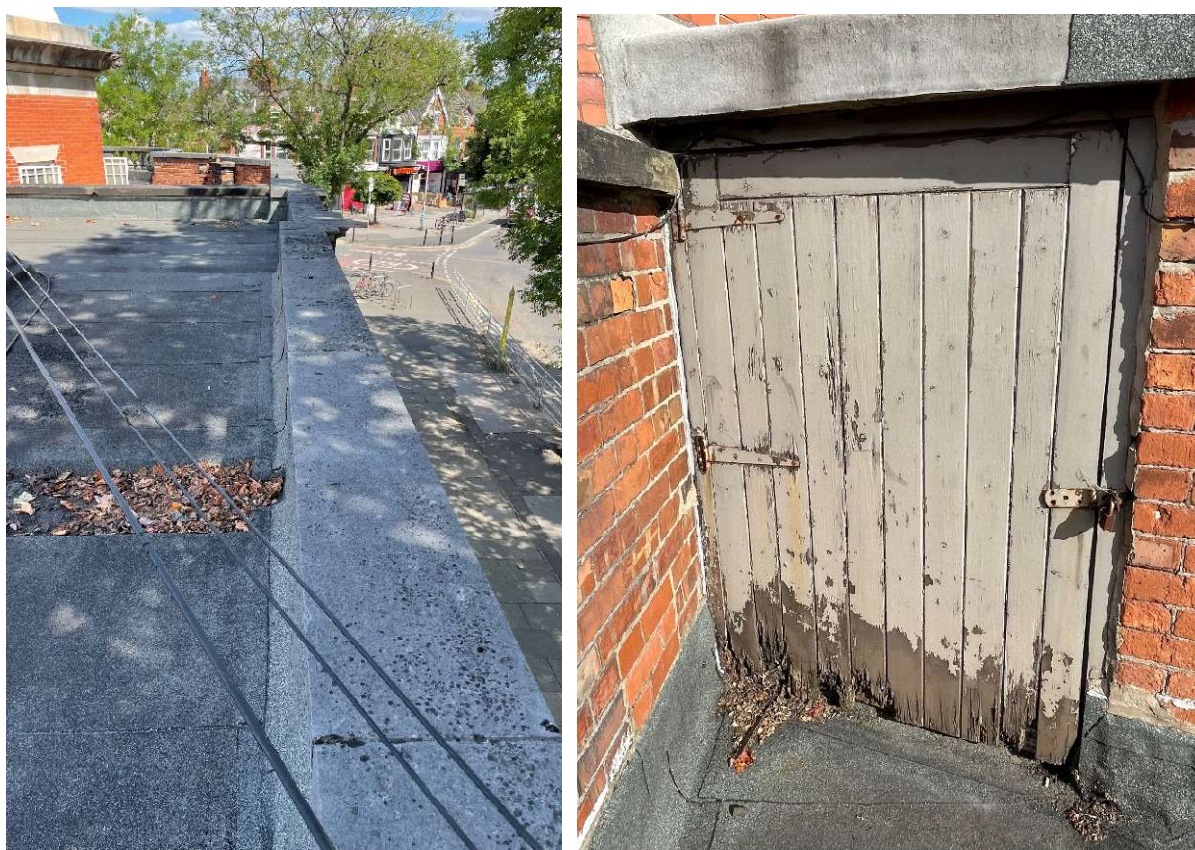
Looking north along the east parapet wall, and the decayed Tank Room door to be replaced.

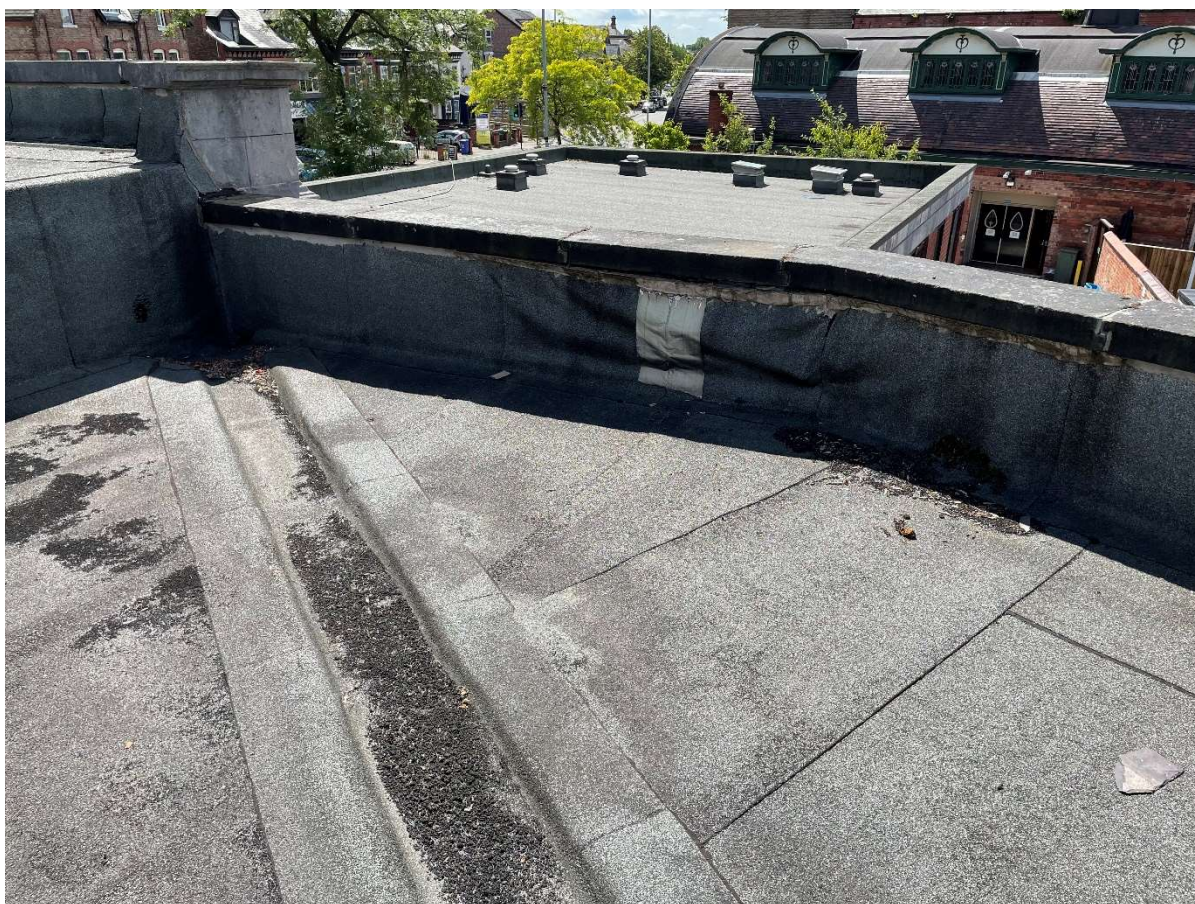
Area of sagging felt to be renewed, rear of south-west parapet wall, with the extension roof behind.

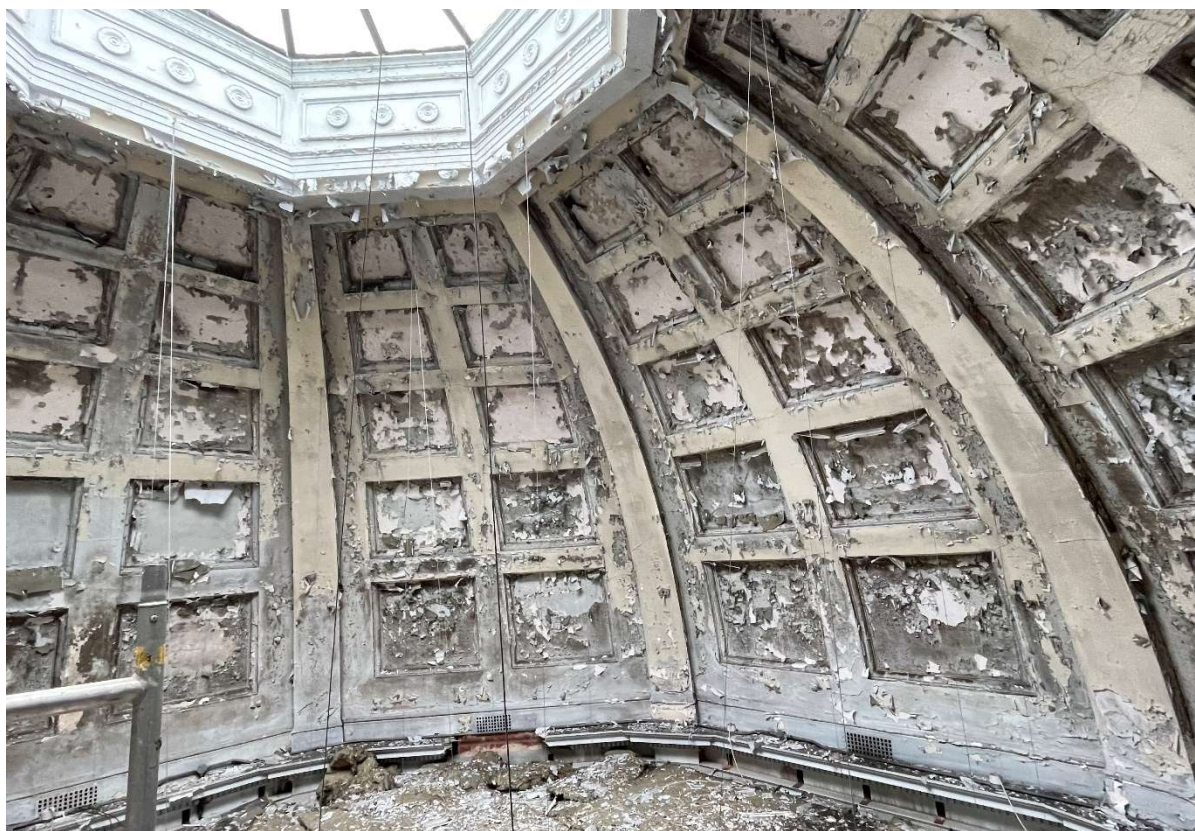
The detail of the Rotunda largely survives above the suspended ceiling in the Staff Room.

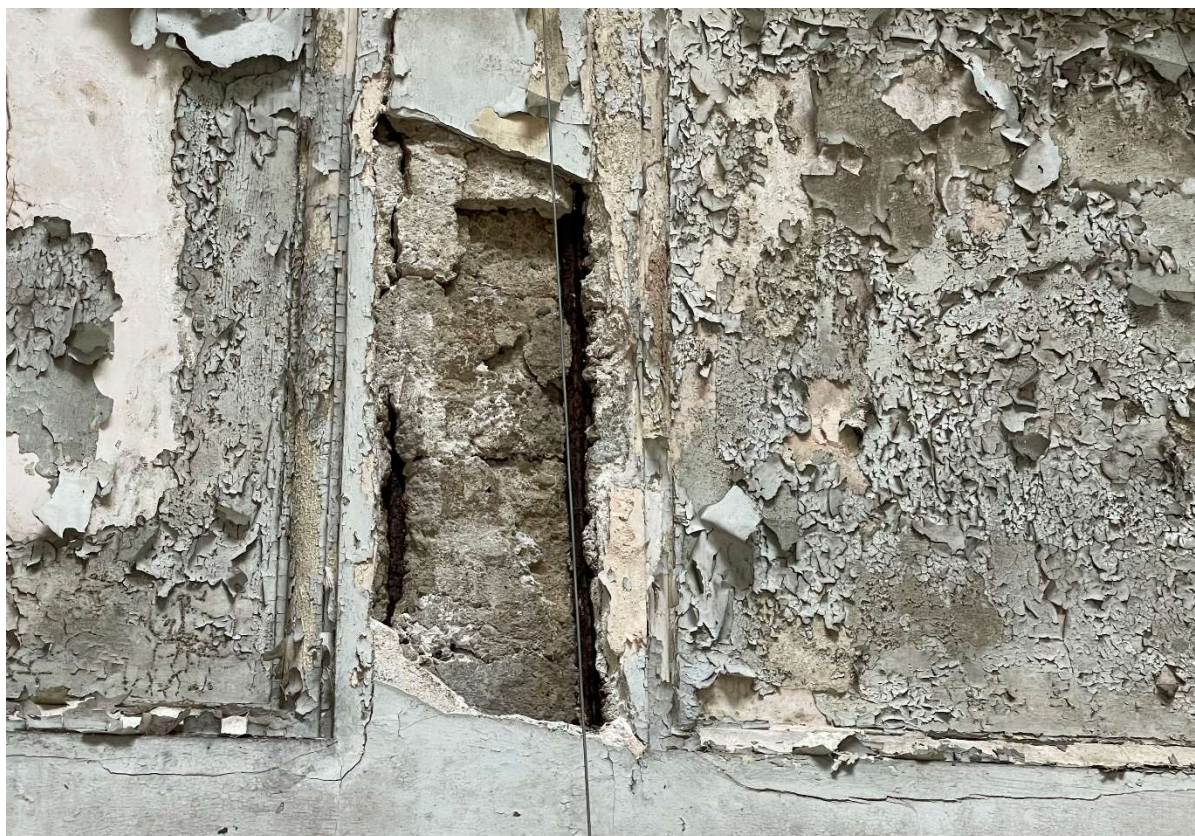
Specialist repair required to corroded reinforcement in the centre of the south facet.

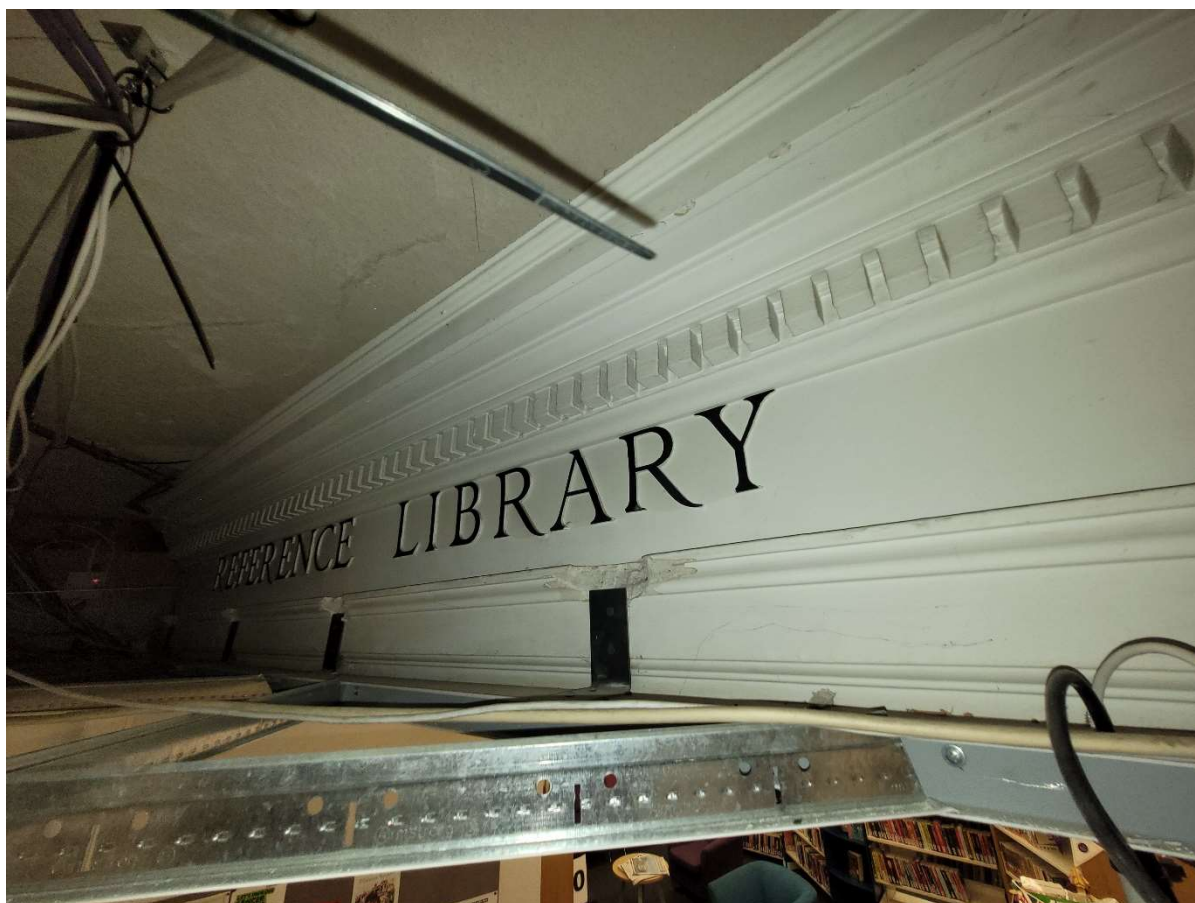
Beneath the original rotunda gallery floor much of the plaster detail remains above the suspended ceiling.

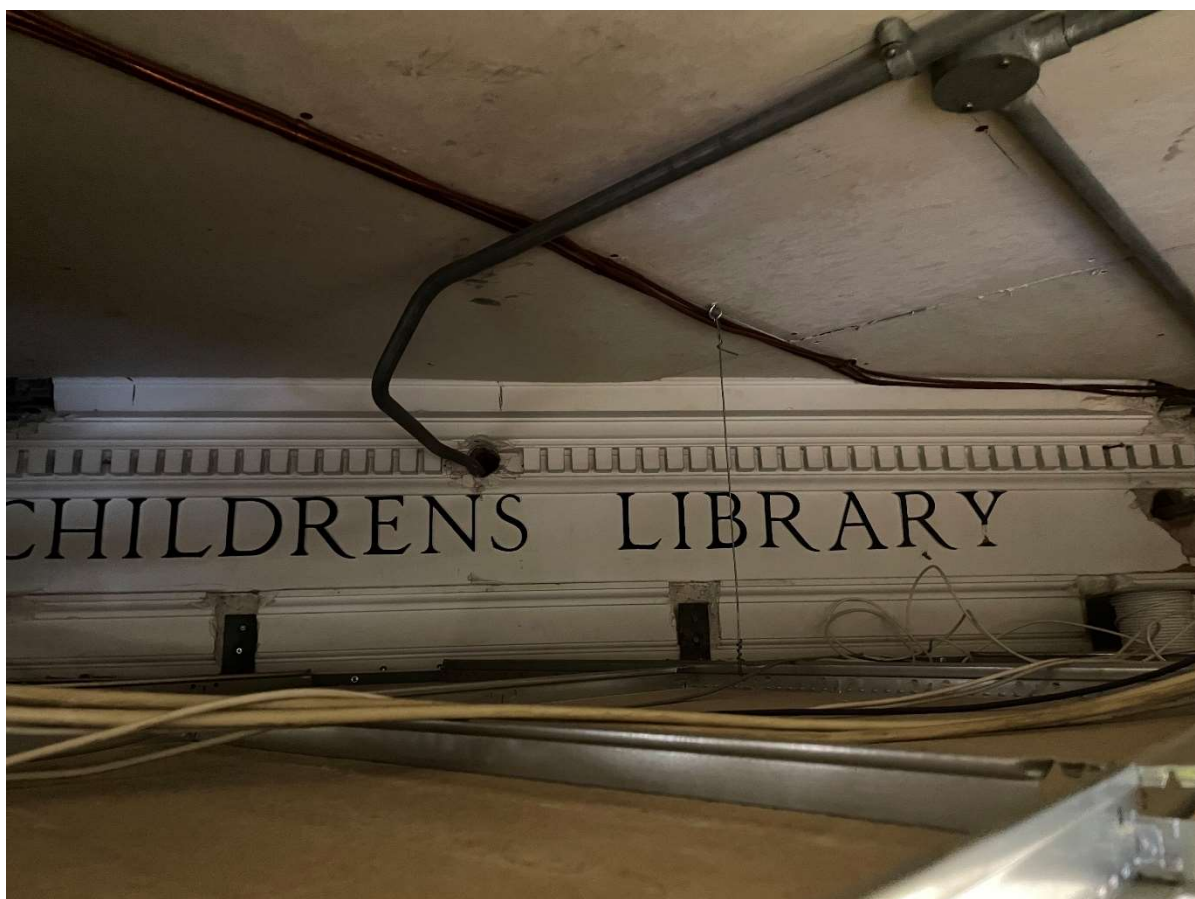
Some of this has been hacked about to insert beams for the floor, route services and fix the ceiling trim.
