## GAS MEMBRANE VALIDATION

| <b>Site: Bowes Street – Happi Block South</b> | |
| Date: 24-08-2021 | Project Number: 11-813 |
| <b>Ground Gas Risk Assessment: Hydrocarbon Resistant Membrane (VOC Blok and Visqueen GX)</b> | |

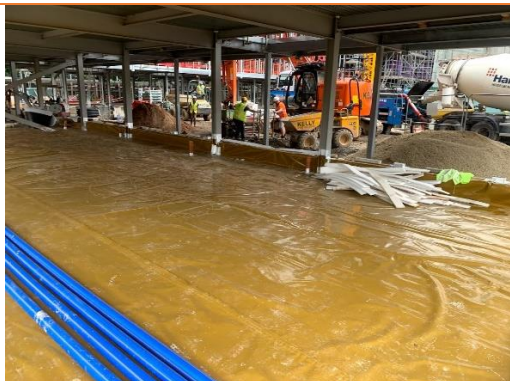
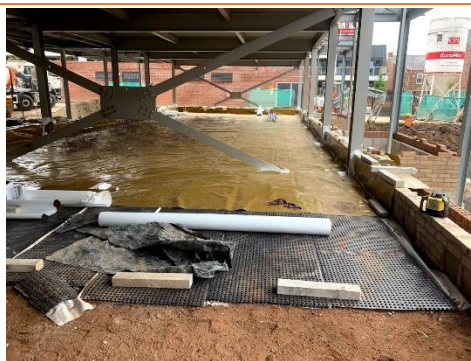
### General Condition of Membrane-Good Condition

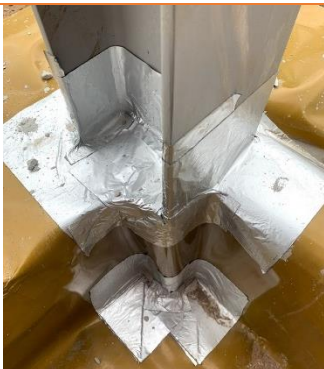
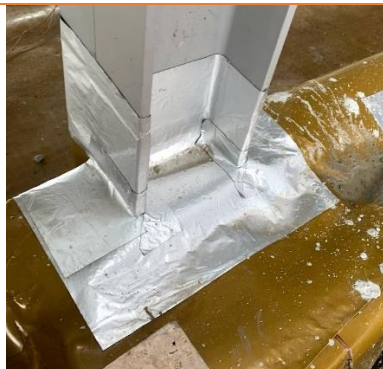
### Verification of Joints and Seals-Good Condition

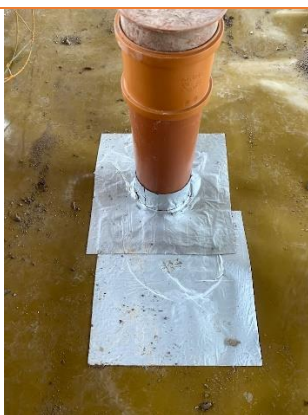
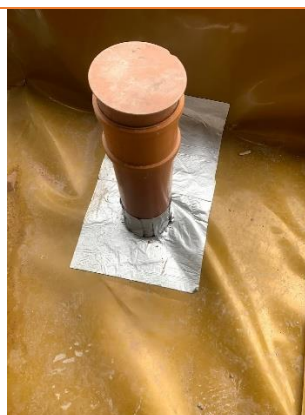
### Verification of Service Penetrations-Good Condition

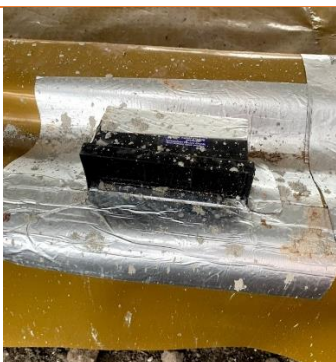
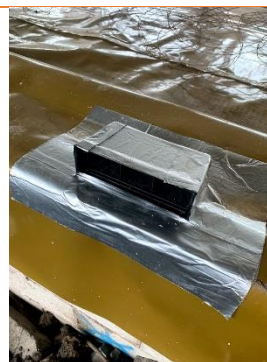
### Verification of ventilation – Good Condition
