# DAYTIME BAT SURVEY AT TALBOT MILL, ELLESMERE STREET, MANCHESTER

**FEBRUARY 2017**

**RACHEL HACKING ECOLOGY**

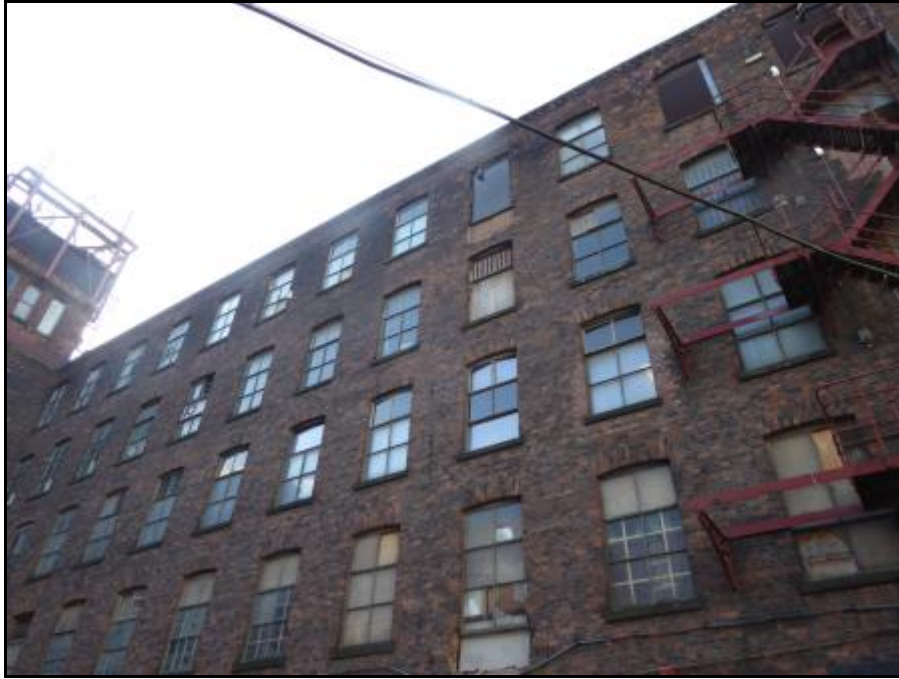
- 3.1 Mill 01 and Mill 02 comprise two attached four-storey mill buildings, constructed from brick, which have flat, felted roofs. The brickwork is largely complete throughout the side and front elevations (see Photograph 1 and the front cover of this report) but with some minor areas of damaged bricks and crumbling or missing mortar towards the upper levels, and at the roof edges. The window frames are all in-situ, with most window panes complete. Broken window panes are boarded up. The lintels above the windows are intact, with no noticeable gaps in the brickwork.

**Photograph 1 showing the brickwork at the front elevation**

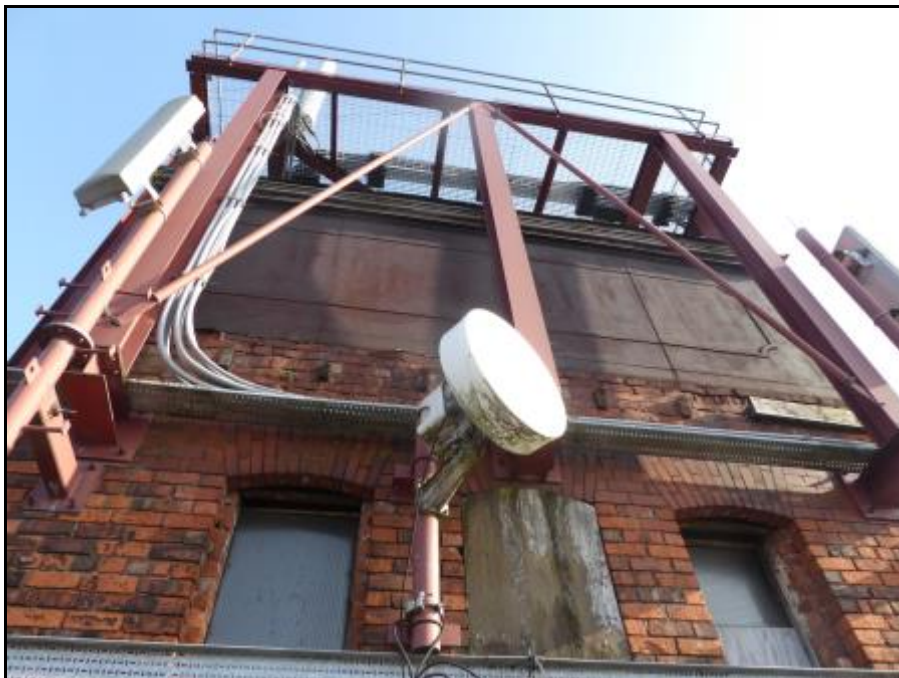
- 3.2 The tower that sits on top of Mill 01 (housing the lift shaft) is constructed from brick, with most bricks in position, but with very small gaps where the roofing timbers penetrate the outer brick (see Photograph 2). These gaps were inspected and found to offer no suitable bat roosting cavities. The windows on the tower are boarded up. The tower is used as a communications mast.

**Photograph 2 showing tower on top of the Main Building**

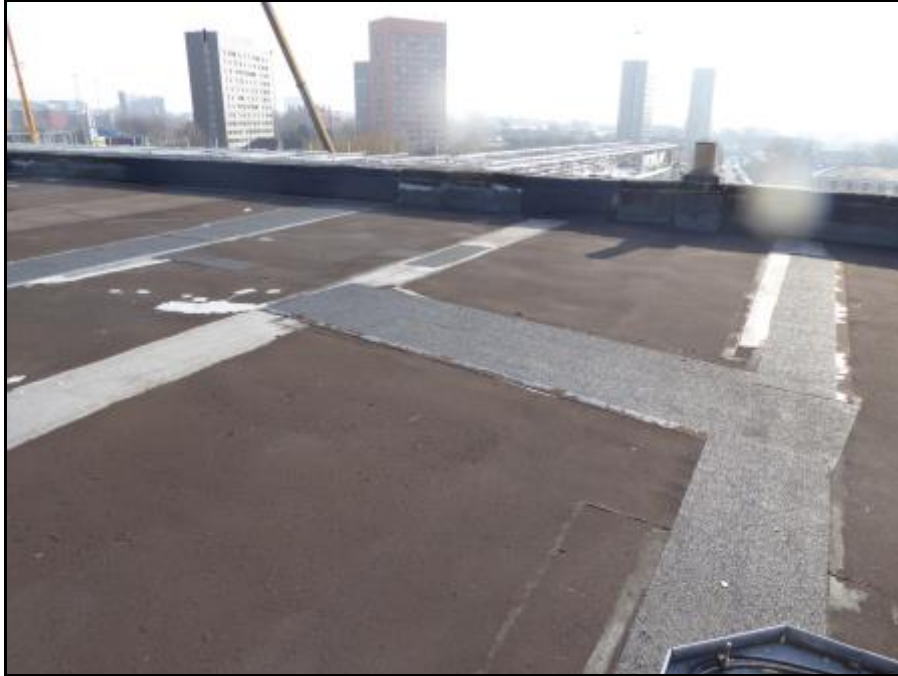
- 3.3 The property has a flat, felted roof which is complete, well maintained and appears to be well-sealed (see Photograph 3). The concrete coping stones at the roof edges are complete, with only minor, negligible gaps between the stones, the brickwork and the roof felt (see Photograph 4).

**Photograph 3 showing the flat roof of the property**

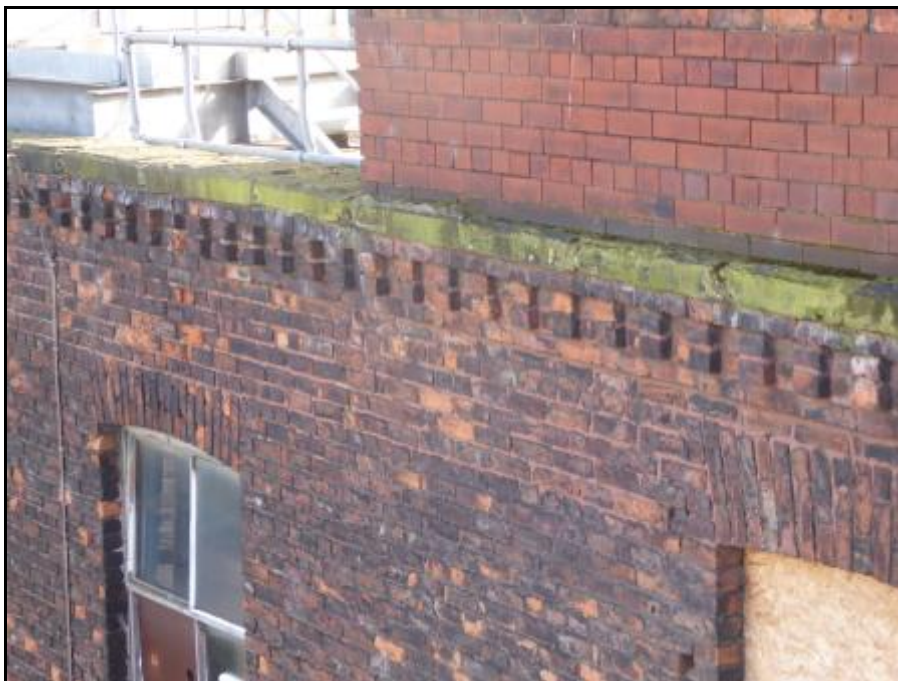
**Photograph 4 showing the roof edges**

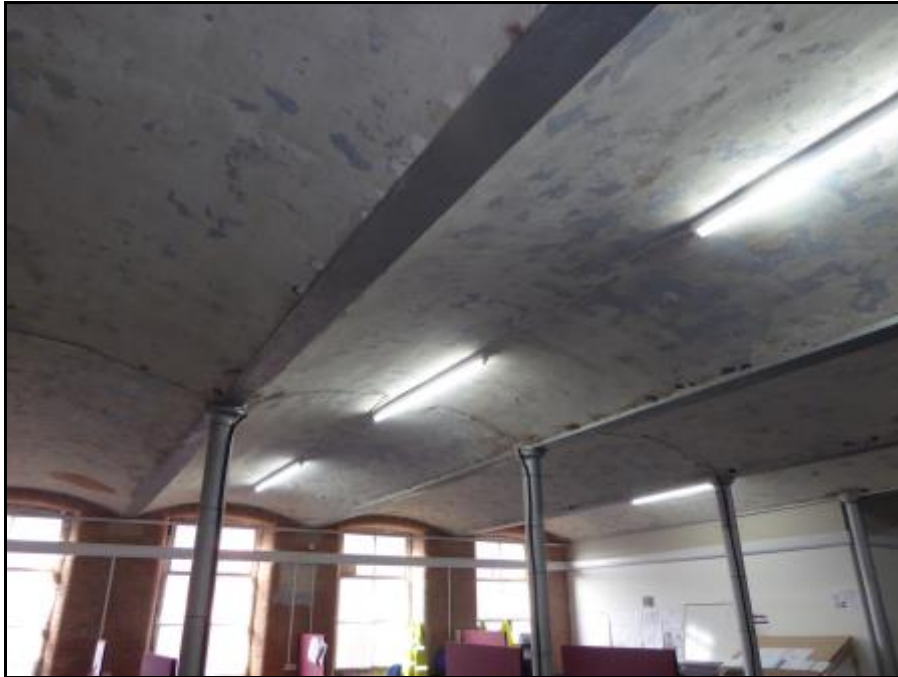
- 3.5 The internal spaces are used commercially and are mostly well-lit with vaulted or panelled ceilings (see Photographs 5 and 6). The internal brickwork is complete throughout most of the units with only minor amounts of damage to the brickwork in some units. Negligible opportunities exist for bats inside the industrial units.

**Photograph 5 showing the interior vaulted ceiling of one of the industrial units**

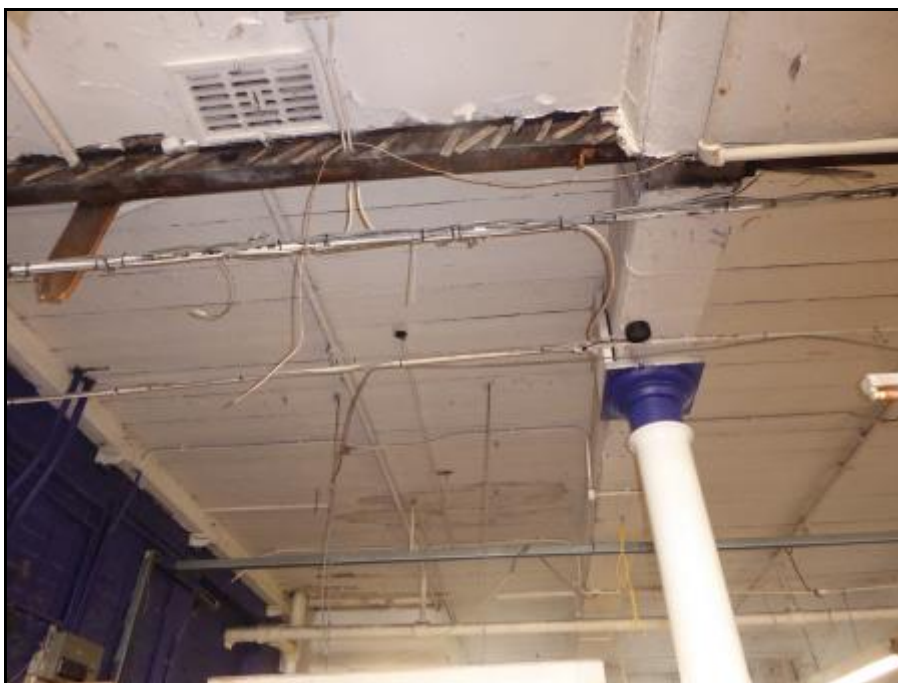
**Photograph 6 showing a panelled ceiling**

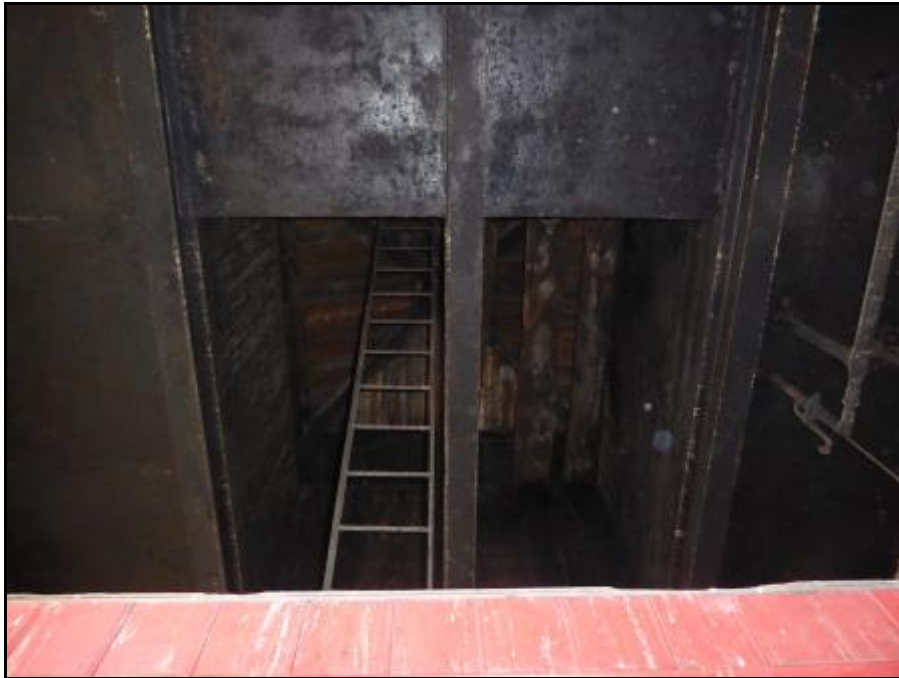
- 3.6 The tower (lift shaft) is in use and open to the roof timbers (see Photograph 7). The roof timbers are in position, but showing signs of damp and rot due to their approximate age. The tower itself is

moderately sealed internally, with only minor gaps at the edges of the doorways leading out onto the roof. No evidence of bat activity and no potential cavities or voids suitable for bats exist within the tower.

**Photograph 7 showing the wooden timbers of the tower**

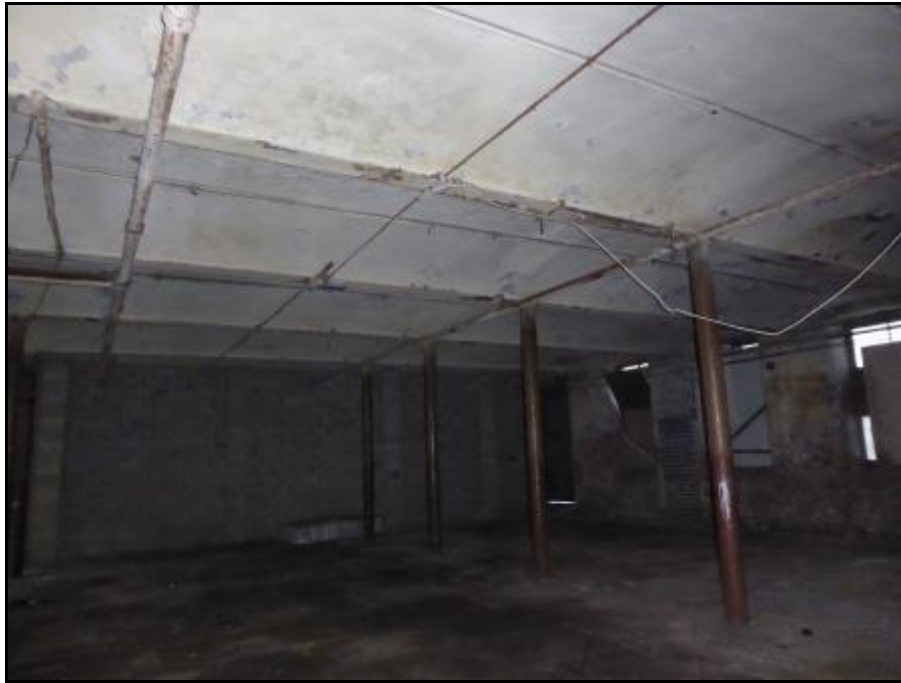
- 3.7 The property has extensive cellar spaces, which were fully inspected (see Photograph 8). The cellar spaces are cold and dusty, with daylight entering the cellars through gaps in the window boards. Minor gaps exist above the brickwork and the windows that lead onto the courtyard and road. No voids or cavities suitable for bats exist within the cellars. Only negligible opportunities exist for bats inside the cellar spaces. No evidence of bat activity was found within the interior spaces of Talbot Mill.

**Photograph 8 showing one of the basement sections**

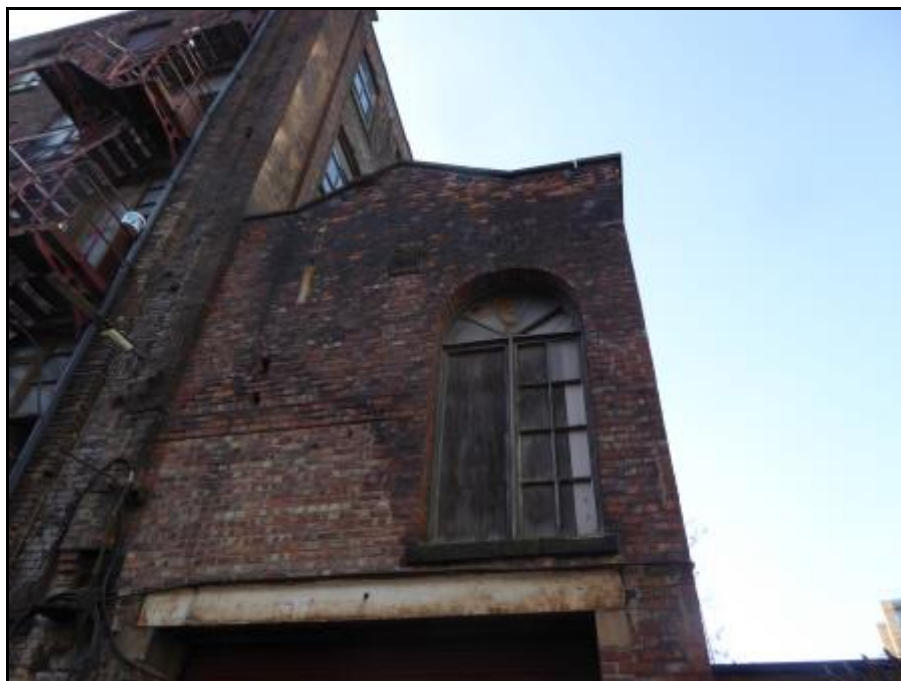
- 3.8 Building A is attached to the main mill building at the north-facing elevation. This unit was not accessible internally. The external brickwork is mostly complete but with minor gaps in the brick at the front elevation (see Photograph 9). The window at the front is boarded up and the steel shutters are intact. A minor gap exists above the shutter. The coping stones along the roof edges are complete but with minor gaps between the stones.

**Photograph 9 showing the exterior of Building A (Engine House)**

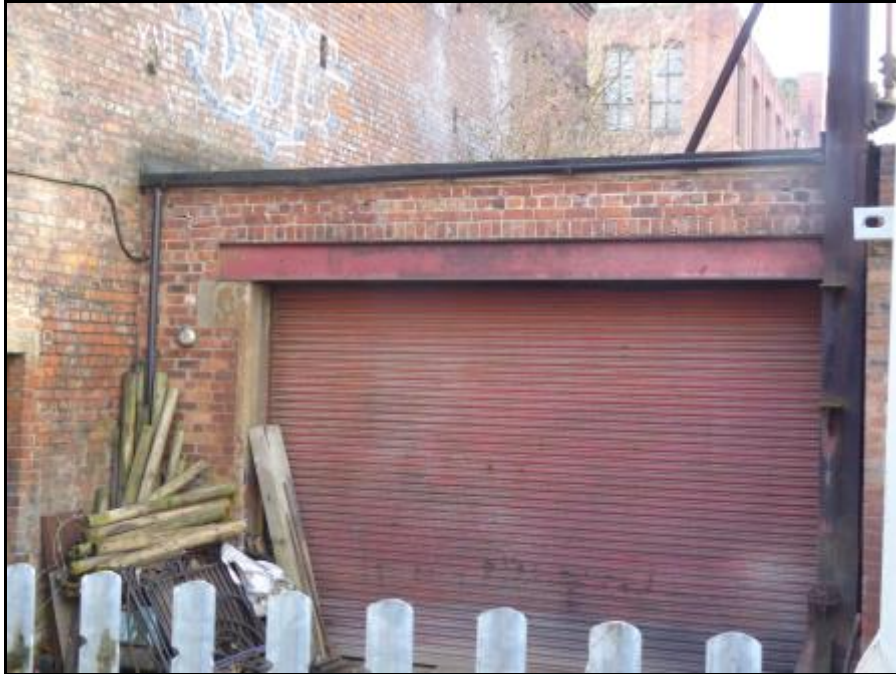
- 3.9 Building B, attached to Building A, is a single-storey garage (see Photograph 10). The brickwork is intact and the metal shutter at the front appears to be complete, but with a minor gap above the shutter. The garage has a flat roof, which is well-sealed on all sides.

**Photograph 10 showing the exterior of the garage attached to the Engine Room**

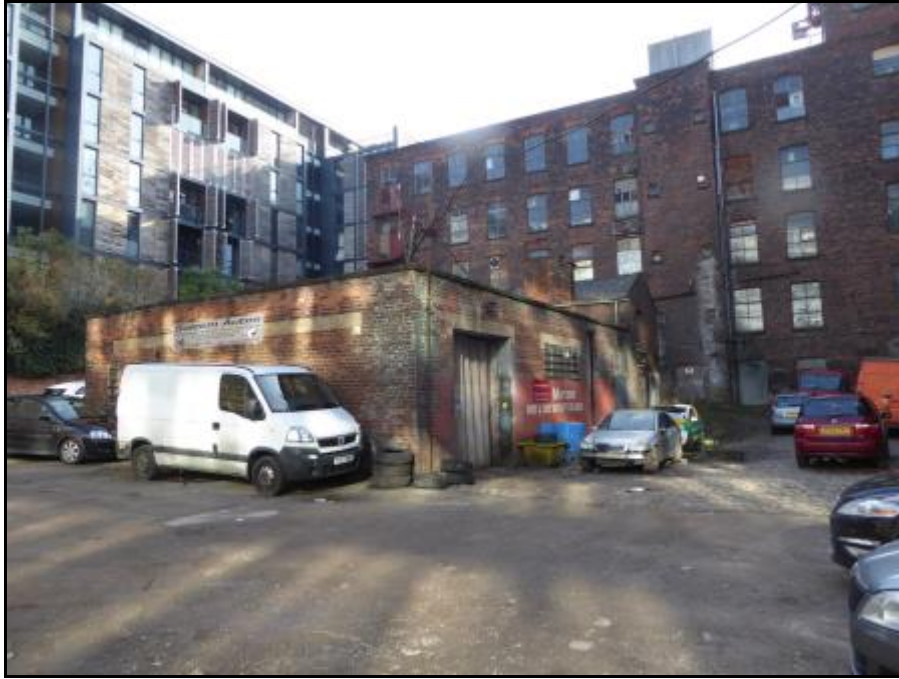
- 3.10 Building C is a flat-roofed disused garage (see Photograph 11). The brickwork is complete throughout, and the flat, felted roof is well-sealed. Minor gaps occur around the edges of the metal shutters. Part of the garage has a sheet metal roof, which is well-sealed to the outer brickwork and offers no noticeable roosting cavities for bats.

Photograph 11 showing the exterior of Building C

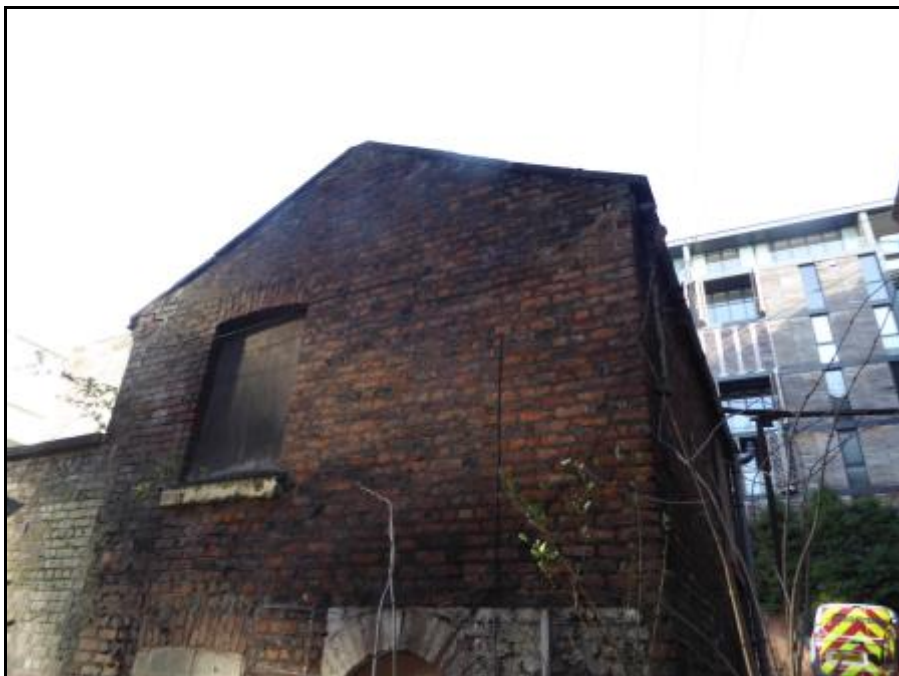
- 3.11 Building D is a detached building of brick construction. No internal access was possible. The external brickwork is complete and without gaps or external cavities. The windows have been replaced with breezeblock or boarded up (see Photograph 12). The building has a pitched, tiled roof. The roof and ridge tiles are complete and in position, with no slipped or broken tiles (see Photograph 13). The coping stones at the roof edges are complete, with no missing mortar.

Photograph 12 showing the exterior brickwork of Building D

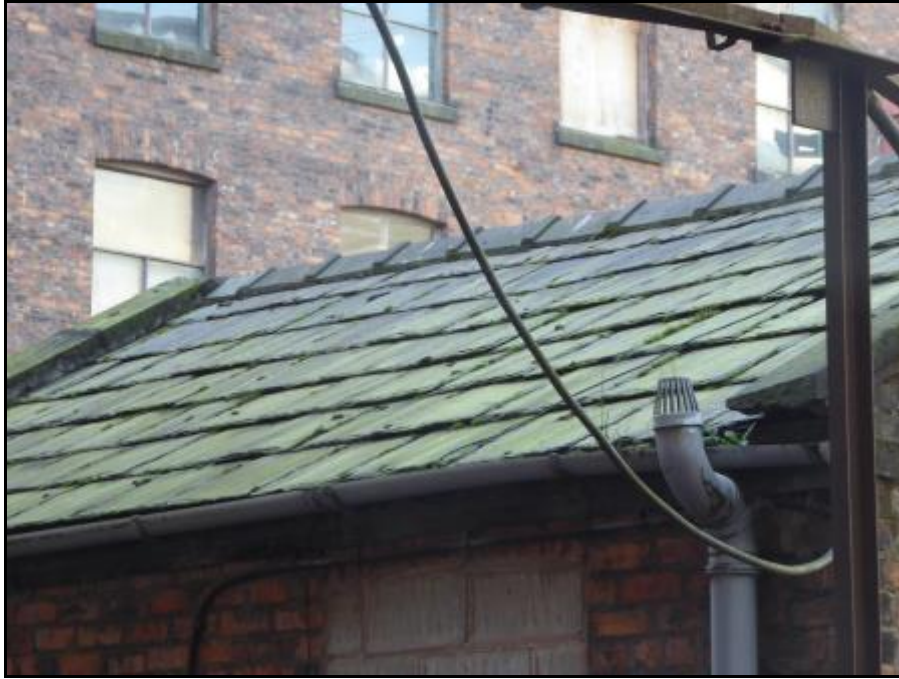
**Photograph 13 showing the roof of the Building D**

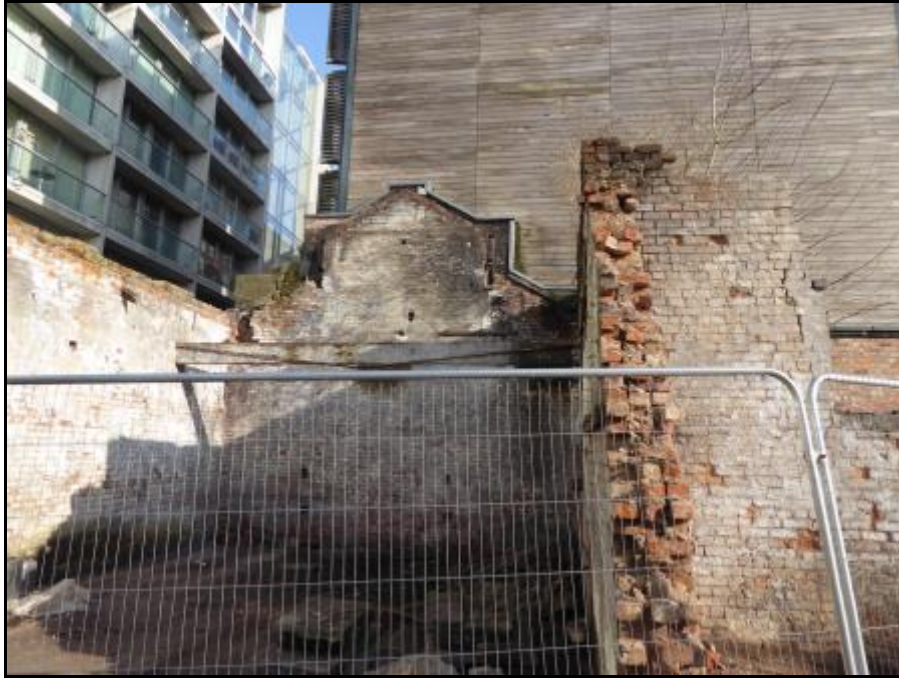
- 3.12 Building E was in a poor condition and it has been demolished under Section 81 of the Building Act 1984, which deals with defective and dangerous buildings and Schedule 17 part 6 of the Enterprise and Regulatory Reform Act 2013. Manchester City Council Building Control issued consent for this demolition on 15 December 2016. However, for completeness this application seeks retrospective planning permission for this demolition.
- 3.13 The remaining brick walls were inspected and offer no suitable cavities for bats between the damaged bricks (see Photograph 14).

**Photograph 14 showing the remaining brick walls of Building C**

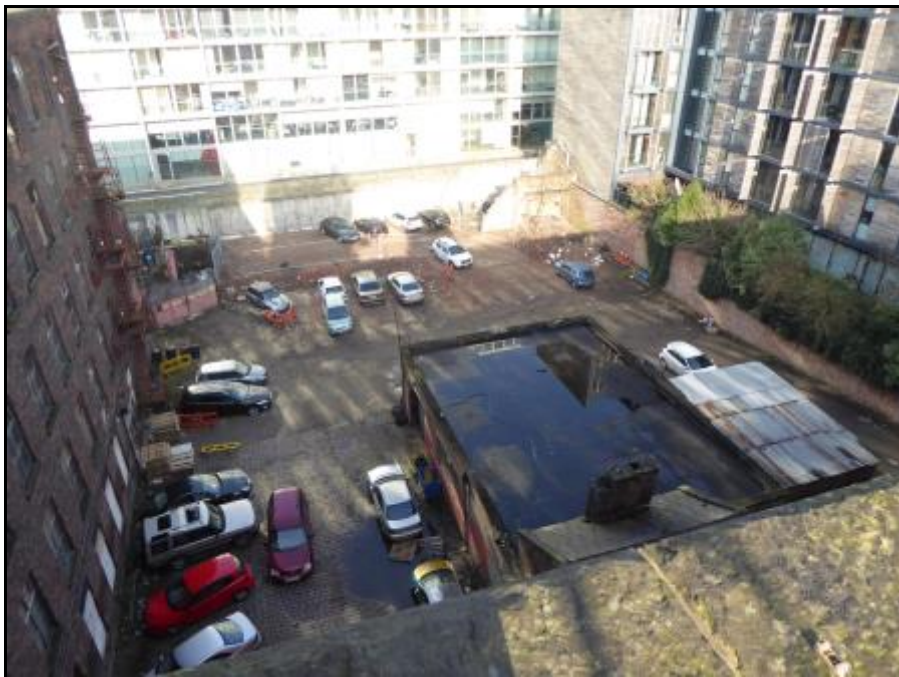
- 3.14 The buildings on the site are situated entirely on hardstanding (see Photograph 15). Only two self-seeded trees exist on site, which offer no potential roosting features for bats. No invasive species were found on the site. The existing proposals do not impact on habitat of significant ecological value.

**Photograph 15 showing aerial view of the courtyard**

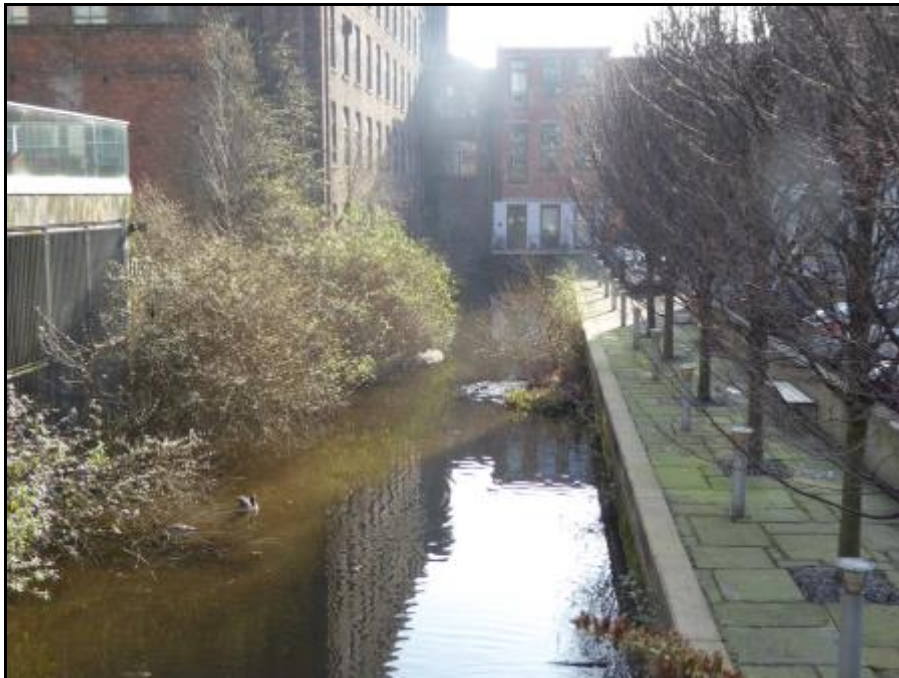
- 3.15 A canal basin sits adjacent to the Mill 02 and Buildings A & B (see Photograph 16). The canal basin is extremely shallow and shaded, and offers limited ecological value. Scrub, such as Goat Willow *Salix caprea*, grows at the edges of the canal. The existing proposals do not affect the canal and the ecological impacts of the proposed development on wildlife using the canal basin is therefore negligible. No evidence of protected species, such as Badger, was located on the site or immediately adjacent to the site.

**Photograph 16 showing the canal basin adjacent to Mill 02 and Buildings A & B**
