**Job title:** Rochdale Road, Manchester

**Report type:** Remedial Validation Report

**Prepared for:** Beech Design and Build

**Date:** July 2022

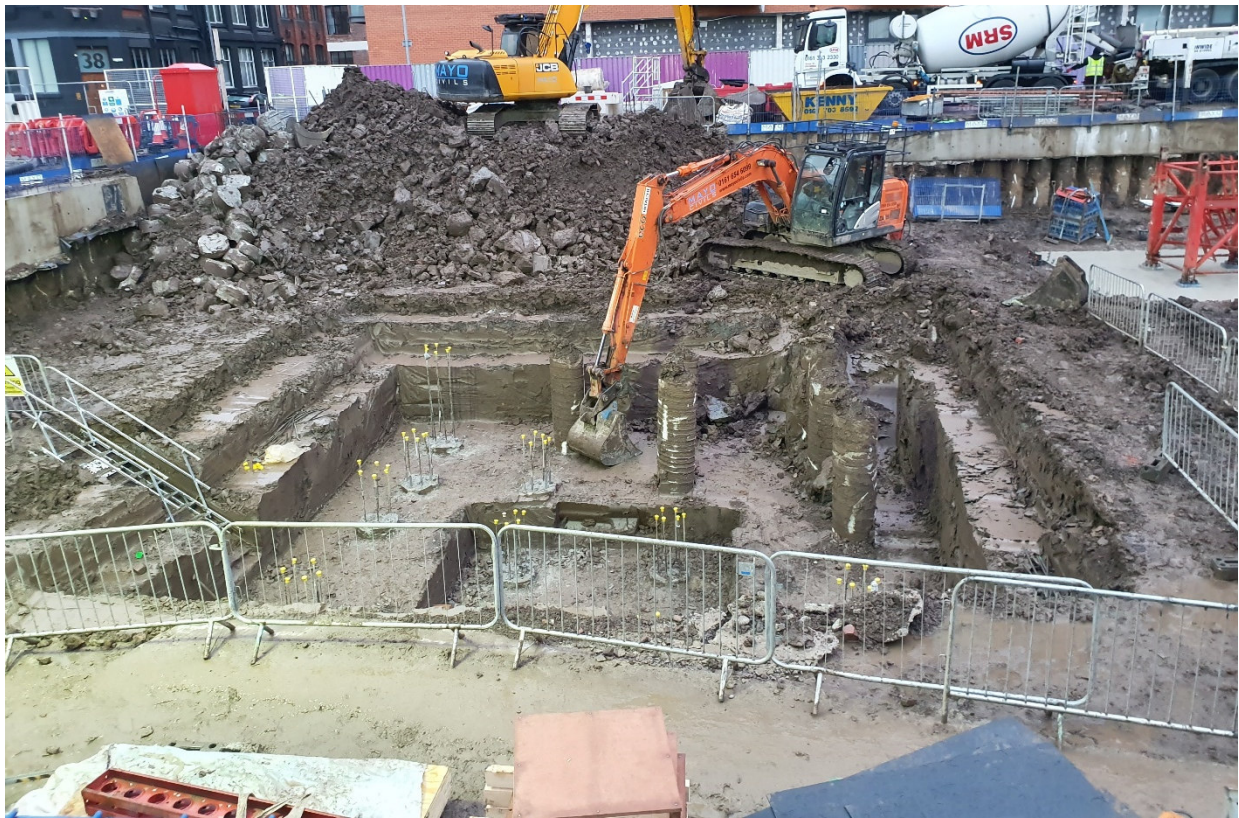
To facilitate construction of the basement substantial excavations were undertaken with the vast majority of the Made Ground soils being removed as part the excavation works. Photograph of the basement excavation are presented in *Appendix 2*.

No exceedances were recorded with in the Made Ground soils and additionally to facilitate the basement construction the majority of the Made Ground across the site was removed when the basement excavations were progressed to depths between 3.0m bgl and 5.0m bgl.

Photograph 1 – Basement excavation showing that all Made Ground soils have been removed.

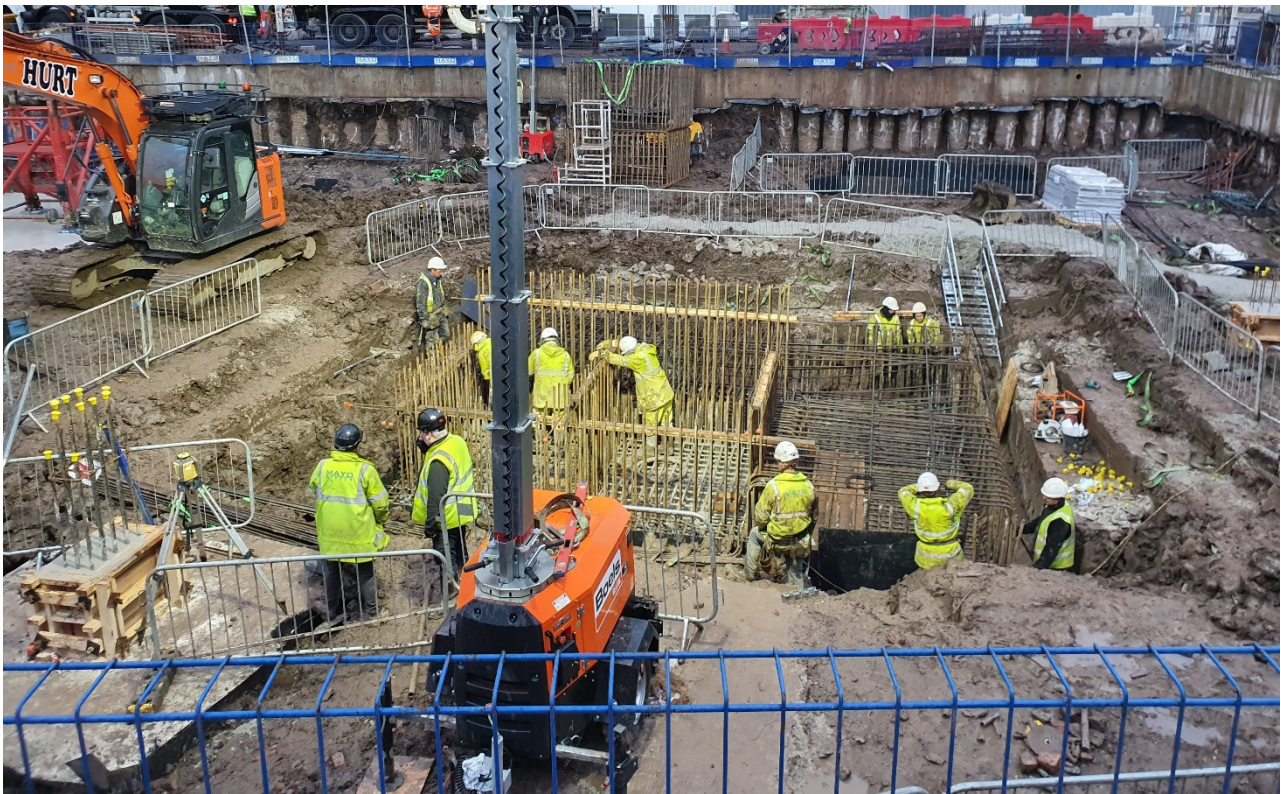
Photograph 2 – Basement excavation showing that all Made Ground soils have been removed.
