# Asbestos Re-inspection Survey

**National Grid - Care of Mitie**

**Bradford Road  
Manchester  
Greater Manchester  
M40 7BW**

**Project Reference: P-401550**

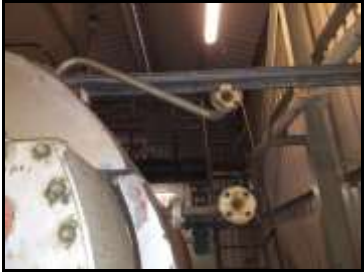
| Location: | 001 - Boiler room | Sample No / ID (Type): | P-265754/004 (Sampled) | | | | |

| | Item description: | Gaskets to front of boiler | | | | | |
| | Analysis: | Chrysotile | | | | | |
| | Material identification: | Asbestos gasket | | | | | |
| Product Type: | 2 | Condition: | 1 | Surface Treatment: | 1 | Asbestos Type: | 1 |
| Material Score: | 5 | Priority Score | 2 | Total Score: | 7 | Risk Rating: | Low |

| Recommended action: | Monitor condition. | | | | | | |

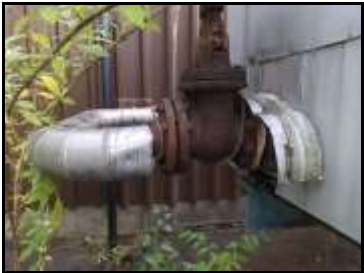
| Location: | 002 - External | Sample No / ID (Type): | P-265754/007 (Sampled) | | | | |

| | Item description: | Gasket to cold storage tank | | | | | |
| | Analysis: | Chrysotile | | | | | |
| | Material identification: | Asbestos gasket | | | | | |
| Product Type: | 2 | Condition: | 1 | Surface Treatment: | 1 | Asbestos Type: | 1 |
| Material Score: | 5 | Priority Score | 1 | Total Score: | 6 | Risk Rating: | Low |

| Recommended action: | Monitor condition. | | | | | | |
