**Re: Thomas Street, Manchester - Timber Survey**

## SURVEY REPORT TIMBER INSPECTION

48-50 THOMAS STREET  
MANCHESTER

26TH MAY 2022

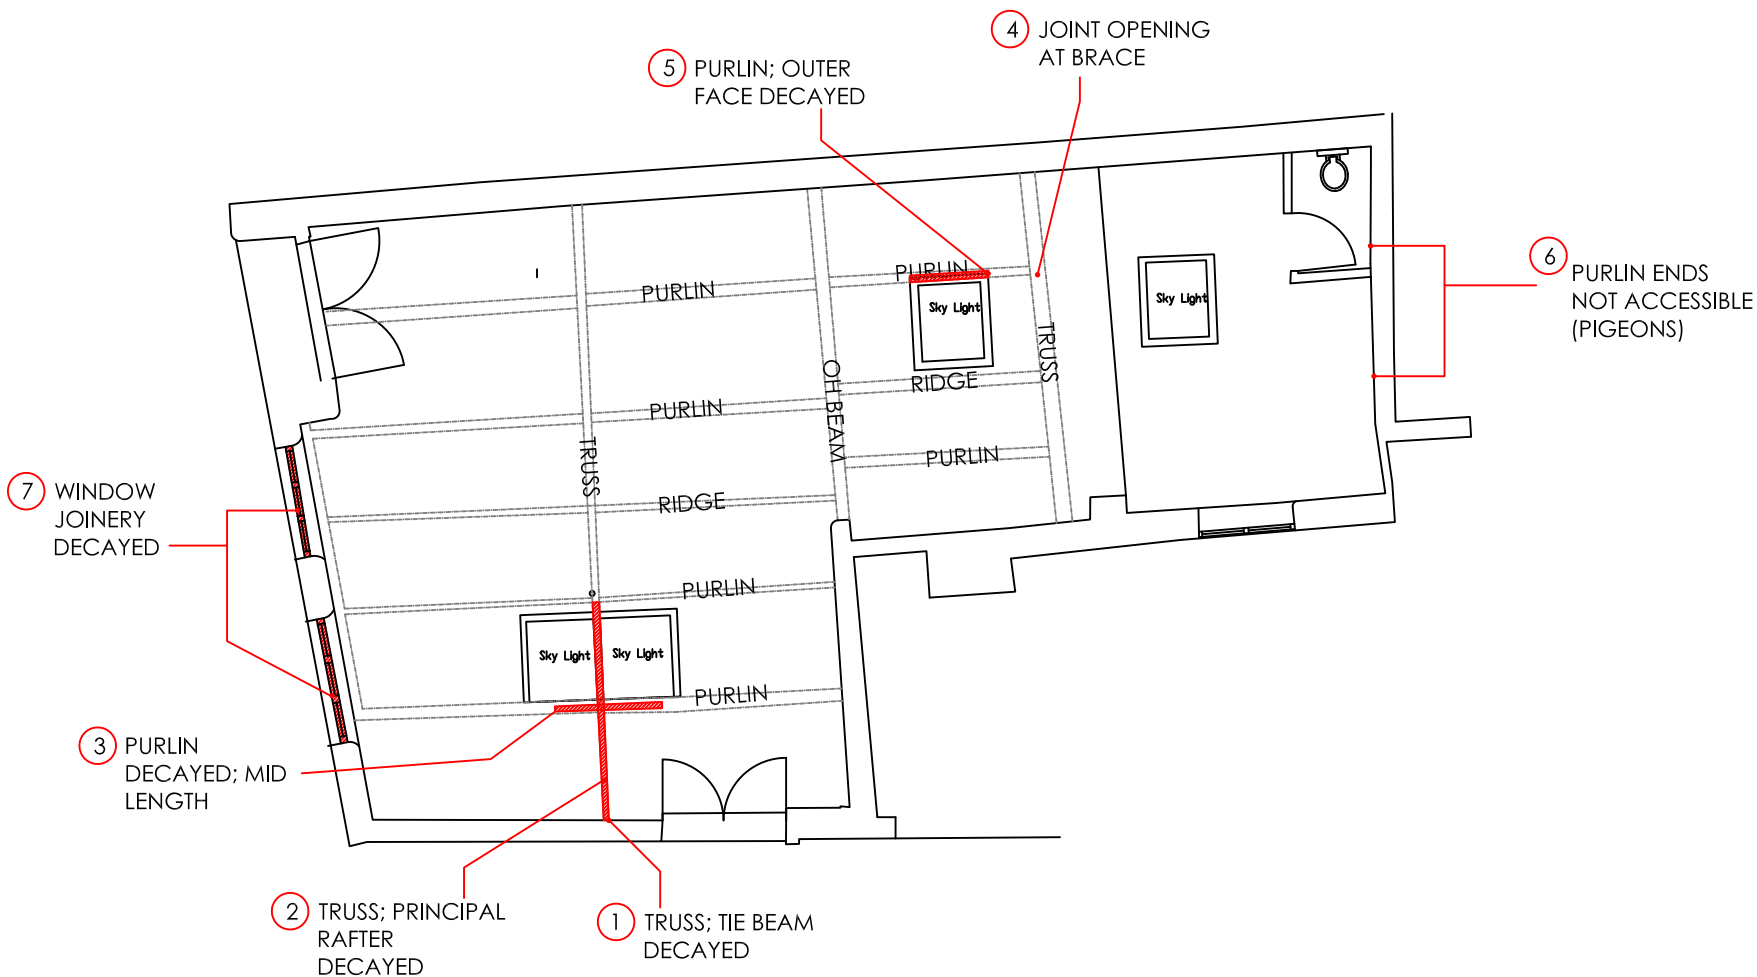
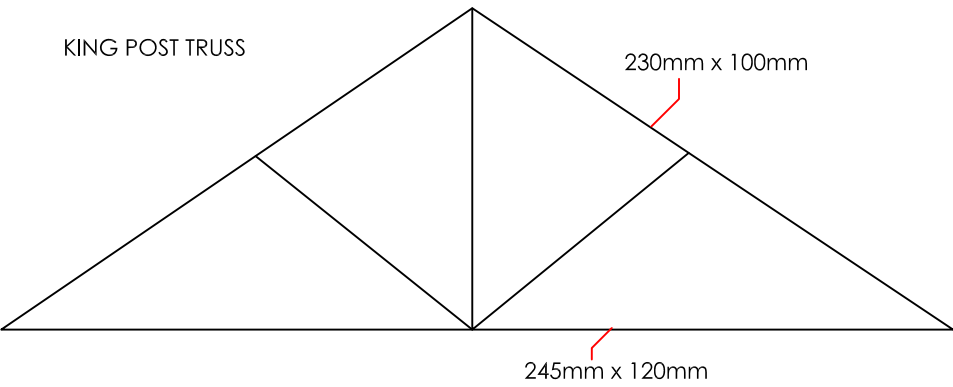
SECOND FLOOR LAYOUT - OVERHEAD ROOF TIMBER

| NO. | DESCRIPTION | BUDGET COST |
|---|---|---|
| 1. | TRUSS; TIE BEAM DECAYED 245MM X 120MM; BEARING END IS DECAYED AND SEPARATELY THE MAIN LENGTH HAD DECAY AND IS COMPROMISED TO MID LENGTH BELOW THE ROOFLIGHT INGRESS APPROX. 2M LENGTH<br><br>REPAIR<br>CUT BACK BEYOND EXTENT OF DECAY; FABRICATE PFC STEEL PLATES; 150MM C/C HOLES; SPLICE ON NEW C24 SOFTWOOD TIMBER; TREAT CUT ENDS; ISOLATE END ON DPC (LOOSE); FORM NOTCH FOR PRINCIPAL RAFTER CONNECTION | £2,309.38 |
| 2. | TRUSS; PRINCIPAL RAFTER DECAYED 230MM X 100MM; BEARING END IS DECAYED AND SEPARATELY THE MAIN LENGTH HAD DECAY AND IS COMPROMISED TO MID LENGTH BELOW THE ROOFLIGHT INGRESS APPROX. 2M LENGTH<br><br>REPAIR<br>CUT BACK BEYOND EXTENT OF DECAY; FABRICATE PFC STEEL PLATES; 150MM C/C HOLES; SPLICE ON NEW C24 SOFTWOOD TIMBER; TREAT CUT ENDS; ISOLATE END ON DPC (LOOSE); FORM NOTCH FOR PRINCIPAL RAFTER CONNECTION | £2,309.38 |
| 3. | PURLIN DECAYED MID-LENGTH AT ROOFLIGHT INGRESS; 275MM X 75MM<br><br>REPAIR<br>(X2 SPLICE REPAIRS); PROP EITHER SIDE; CUT OUT CENTRAL SECTION BEYOND EXTENT OF DECAY; FORM HALF LAP JOINT AT EACH END X2; OFFER UP NEW C24 SOFTWOOD TO MATCH EXISTING WITH HALF-LAP JOINT; TREAT CUT ENDS; FABRICATE PFC STEEL PLATES; 150MM C/C HOLES; BOLT THROUGH; PLATE TO EXTEND OVER EACH JOINT X2 | £2,303.13 |
| 4. | JOINT OPENING AT BRACE<br><br>REPAIR<br>DRILL AND INSERT ROTAFLEX DOWEL; RESIN FIX WITH ROTAFIX STREUCTURAL ADHESIVE (RSA) | £250 |
| 5. | PURLIN EDGE DECAYED MID-LENGTH AT ROOFLIGHT; 240MM X 95MM<br><br>REPAIR<br>CUT OUT TOP SECTION OF PURLIN; ROUTE OUT TO FORM SQUARE CUT; PLANT ON NEW C24 SOFTWOOD; TREAT CUT ENDS; VERTICALLY DOWEL; ROTAFLEX RODS; RESIN FIX WITH ROTAFIX STREUCTURAL ADHESIVE (RSA) | £650 |
| 6. | PURLIN ENDS NOT ACCESSIBLE; EXCESSIVE PIGEONS<br><br>REPAIR<br>ALLOW PROVISIONAL SUM FOR PURLIN SPLICE REPAIR X 2 | £1,500<br>£1,500 |
| 7. | WINDOW JOINERY DECAYED<br>*ASSUME WINDOWS TO BE REPLACED AS PART OF WIDER SCHEME | £- |

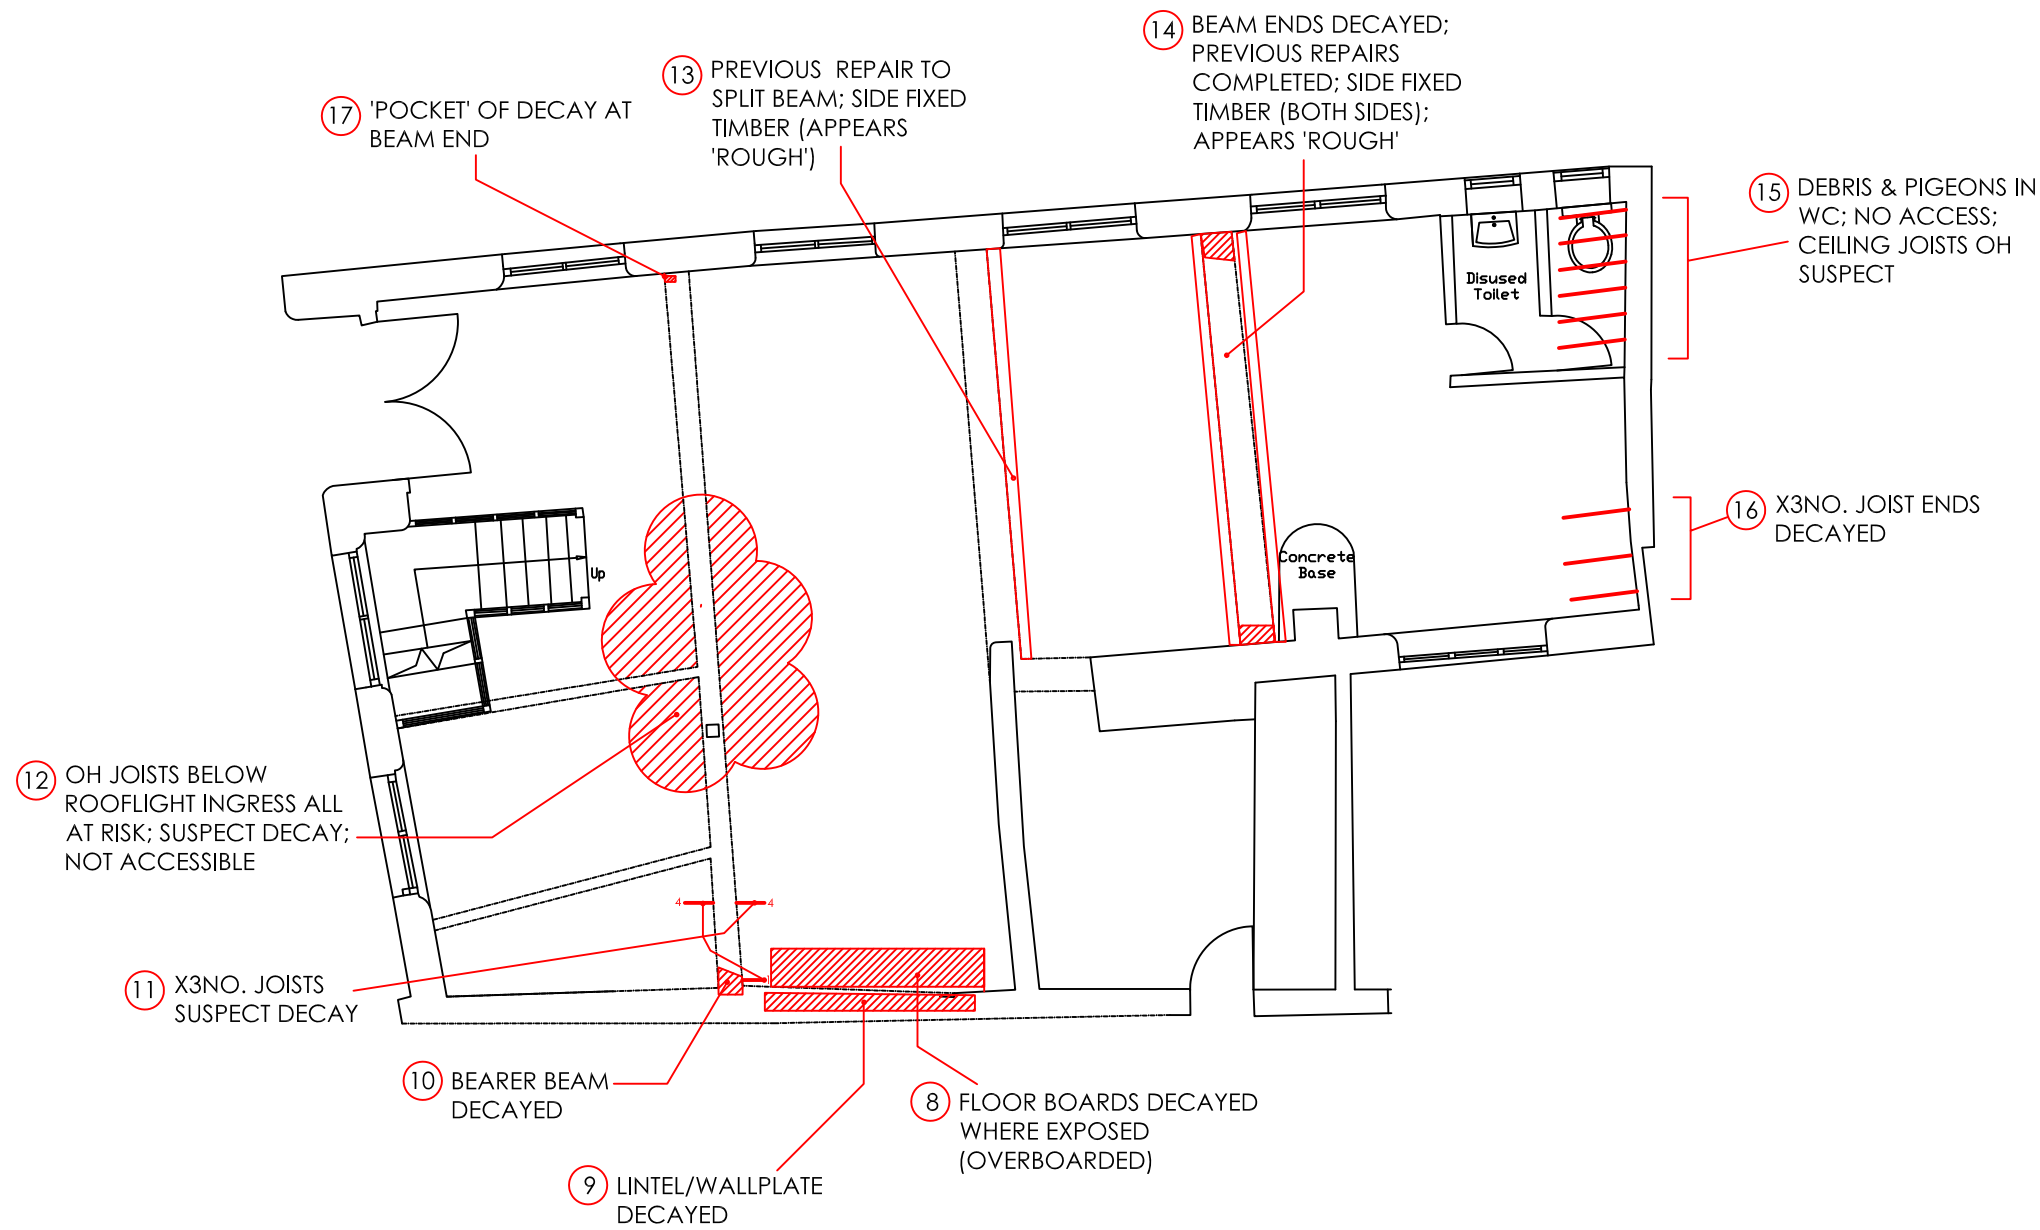
FIRST FLOOR LAYOUT - OVERHEAD 2ND FLOOR TIMBER

| NO. | DESCRIPTION | BUDGET COST |
|---|---|---|
| 8. | FLOOR BOARDS DECAYED WHERE EXPOSED AT OPENING; WIDER FLOORBOARDS ARE OVER-BOARDED, SO NOT ACCESSIBLE FOR INSPECTION; EXPECT DECAY PARTICULARLY BELOW ROOF LIGHTS WITH ONGOING INGRESS<br><br>REPAIR<br>MAKE GENERAL ALLOWANCE FOR FLOOR BOARDS SEPARATELY; EXTENT UNKNOWN | £- |
| 9. | LINTEL DECAYED OVERHEAD; 265MM X 125MM X 2.5M LENGTH<br><br>REPAIR<br>STRONGBOY PROP TO GROUND; CUT OUT AND REPLACE WITH NEW PRE-TREATED SOFTWOOD TO MATCH EXISTING; TREAT CUT ENDS (ALTERNATIVELY REPLACE WITH CONCRETE EQUIV.) | £550 |
| 10. | BEAR BEAM; END DECAYED; 345MM X 215MM X 1M LENGTH<br><br>REPAIR<br>CUT BACK BEYOND EXTENT OF DECAY; FABRICATE PFC STEEL PLATES; 150MM C/C HOLES; SPLICE ON NEW C24 SOFTWOOD TIMBER; TREAT CUT ENDS; ISOLATE END ON DPC (LOOSE) | £2,375 |
| 11. | X3NO. JOISTS DECAYED<br><br>REPAIR<br>CUT BACK BEYOND THE EXTENT OF DECAY; SPLICE ON NEW PRE-TREATED TIMBER; CONNECT WITH PREFABRICATED METAL SPLICE PLATE CONNECTORS; TREAT CUT ENDS; INSTALL JHA JOIST HANGER BY SIMPSON STRONG-TIE | £531 |
| 12. | FLOOR GENERALLY WET BELOW ROOFLIGHT INGRESS; FLOORS OVER BOARDED; NO ACCESS TO JOISTS; JOISTS GENERALLY AT RISK TO DECAY<br><br>REPAIR<br>MAKE GENERAL ALLOWANCE FOR JOIST REPAIRS TO RISK AREAS SEPARATELY; EXTENT UNKNOWN | £- |
| 13. | PREVIOUS REPAIR TO SPLIT BEAM; SIDE FIXED TIMBER X1 SIDE; ROUGH REPAIR<br><br>REPAIR<br>RENAISSANCE TO REVIEW IF ACCEPTABLE; ALLOW PROVISION SUM REPAIR AT THIS STAGE | £2,300 |
| 14. | BEAM ENDS DECAYED X2; PREVIOUS REPAIR; SIDE FIXED TIMBER X2 SIDES; ROUGH REPAIR<br><br>REPAIR<br>RENAISSANCE TO REVIEW IF ACCEPTABLE; ALLOW PROVISION SUM REPAIR AT THIS STAGE X2 SPLICE REPAIRS | £2,375<br>£2,375 |
| 15. | DEBRIS & PIGEONS; JOIST ENDS SUSPECT; NOT ACCESSIBLE<br><br>REPAIR<br>CUT BACK BEYOND THE EXTENT OF DECAY; SPLICE ON NEW PRE-TREATED TIMBER; CONNECT WITH PREFABRICATED METAL SPLICE PLATE CONNECTORS; TREAT CUT ENDS; PROVISIONAL SUM - X6 JOISTS | £1,062 |
| 16. | X3NO. JOISTS DECAYED<br><br>REPAIR<br>CUT BACK BEYOND THE EXTENT OF DECAY; SPLICE ON NEW PRE-TREATED TIMBER; CONNECT WITH PREFABRICATED METAL SPLICE PLATE CONNECTORS; TREAT CUT ENDS; INSTALL JHA JOIST HANGER BY SIMPSON STRONG-TIE | £531 |
| 17. | 'POCKET' OF DECAY AT BEAM END<br><br>REPAIR<br>CUT OUT TOP SECTION OF PURLIN; ROUTE OUT TO FORM SQUARE CUT; PLANT ON NEW C24 SOFTWOOD; TREAT CUT ENDS; VERTICALLY DOWEL; ROTAFLEX RODS; RESIN FIX WITH ROTAFIX STREUCTURAL ADHESIVE (RSA) | £650 |

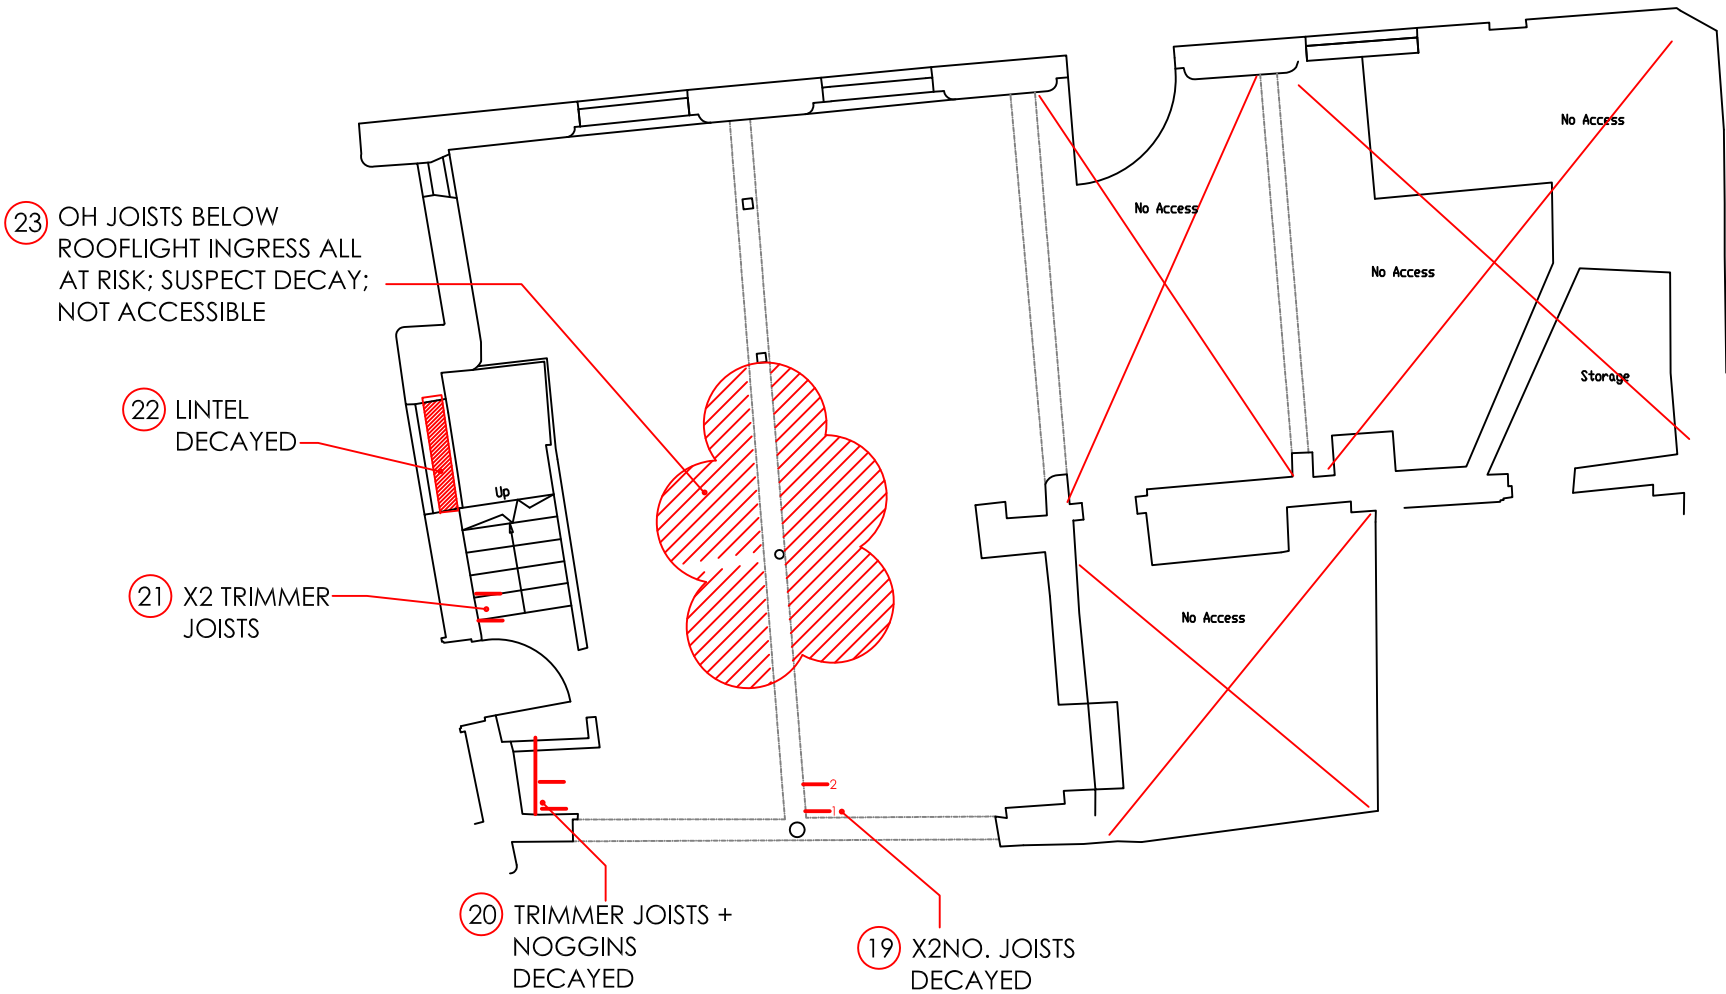
GROUND FLOOR LAYOUT - OVERHEAD 1ST FLOOR TIMBER

| NO. | DESCRIPTION | BUDGET COST |
|---|---|---|
| 19. | X2NO. JOISTS DECAYED AT BEAM BEARING; 175MM X 65MM X 3.4M LENGTH<br><br>REPAIR<br>CUT BACK BEYOND THE EXTENT OF DECAY; SPLICE ON NEW PRE-TREATED TIMBER; CONNECT WITH PREFABRICATED METAL SPLICE PLATE CONNECTORS; TREAT CUT ENDS; INSTALL JHA JOIST HANGER BY SIMPSON STRONG-TIE | £354 |
| 20. | TRIMMER JOIST + X2NO. NOGGINS DECAYED<br><br>REPAIR<br>REPLACE WITH NEW PRETREATED SOFTWOOD TO MATCH EXISTING; TREAT CUT ENDS; INSTALL JHA JOIST HANGER BY SIMPSON STRONG-TIE | £250 |
| 21. | X2NO. TRIMMER JOISTS DECAYED<br><br>REPAIR<br>REPLACE WITH NEW PRETREATED SOFTWOOD TO MATCH EXISTING; TREAT CUT ENDS; INSTALL JHA JOIST HANGER BY SIMPSON STRONG-TIE | £250 |
| 22. | LINTEL DECAYED OVERHEAD; 70MM X 90MM X 1.5M LENGTH<br><br>REPAIR<br>STRONGBOY PROP TO GROUND; CUT OUT AND REPLACE WITH NEW PRE-TREATED SOFTWOOD TO MATCH EXISTING; TREAT CUT ENDS (ALTERNATIVELY REPLACE WITH CONCRETE EQUIV.) | £450 |
| 23. | OH FLOOR GENERALLY WET BELOW ROOFLIGHT INGRESS; FLOORS OVER BOARDED; NO ACCESS TO JOISTS; JOISTS GENERALLY AT RISK TO DECAY<br><br>REPAIR<br>MAKE GENERAL ALLOWANCE FOR JOIST REPAIRS TO RISK AREAS SEPARATELY; EXTENT UNKNOWN | £- |

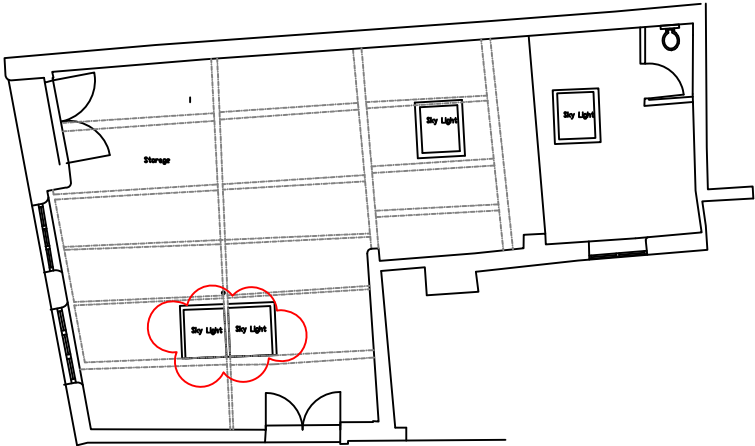
SECOND FLOOR/ROOF

NOT NECESSARILY LOCATION OF  
JOIST REPAIRS; FURTHER  
INSPECTION DURING WORKS  
REQUIRED WHEN MORE  
ACCESSIBLE

ONGOING SEVERE INGRESS AT ROOF  
LIGHT DISCHARGING MOISTURE INTO  
BUILDING

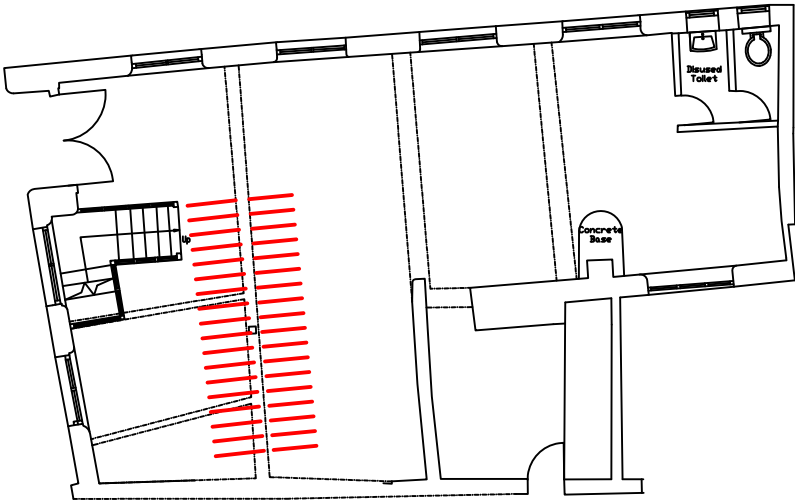
FIRST FLOOR LAYOUT - OH JOISTS TO SECOND FLOOR

SUPPORT SCAFFOLD AND OVERBOARDING  
TO FLOOR & SARKING BOARD TO SOFFITS;  
JOISTS NOT ACCESSIBLE; INGRESS WILL  
STAND ON FLOORING AND SPREAD  
ACROSS FOOTPRINT

PRUDENT TO ASSUME ALL JOISTS LOCALLY  
AT RISK TO DECAY  
PROVISIONAL SUM - ALLOW APPROX.  
X36NO. JOIST REPAIRS TO SECOND FLOOR

| NO. | DESCRIPTION | BUDGET COST |
|---|---|---|
| | REPAIR<br>CUT BACK BEYOND THE EXTENT OF DECAY; SPLICE ON NEW PRE-TREATED TIMBER; CONNECT WITH PREFABRICATED METAL SPLICE PLATE CONNECTORS; TREAT CUT ENDS; INSTALL JHA JOIST HANGER BY SIMPSON STRONG-TIE | |

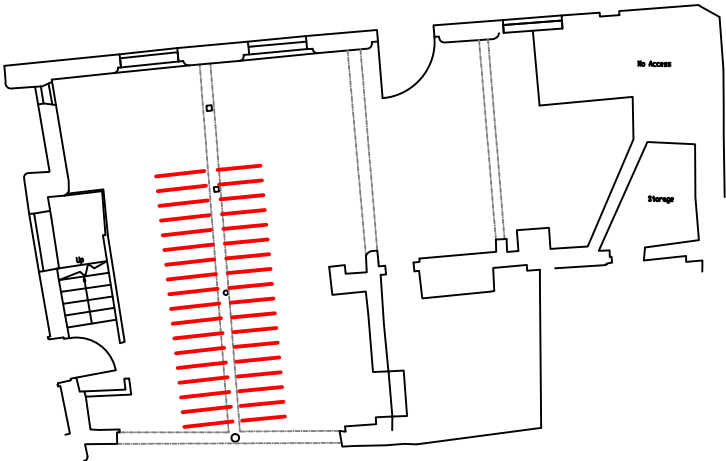
GROND FLOOR LAYOUT - OH JOISTS TO FIRST FLOOR

SUPPORT SCAFFOLD AND OVERBOARDING  
TO FLOOR & SARKING BOARD TO SOFFITS;  
JOISTS NOT ACCESSIBLE; INGRESS WILL  
STAND ON FLOORING AND SPREAD  
ACROSS FOOTPRINT

PRUDENT TO ASSUME ALL JOISTS LOCALLY  
AT RISK TO DECAY  
PROVISIONAL SUM - ALLOW APPROX.  
X36NO. JOIST REPAIRS TO SECOND FLOOR

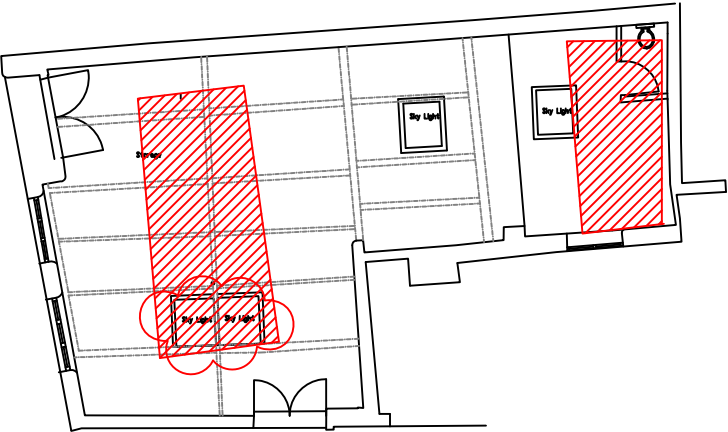
SECOND FLOOR

ONGOING SEVERE INGRESS AT ROOF  
LIGHT DISCHARGING MOISTURE INTO  
BUILDING

NOT NECESSARILY LOCATION OF  
FLOOR BOARD REPAIRS; FURTHER  
INSPECTION DURING WORKS  
REQUIRED WHEN MORE  
ACCESSIBLE

PROVISIONAL SUM - ALLOW APPROX. 25 SQ M  
FLOORBOARDS TO SECOND FLOOR; BESPOKE SIZE TBC

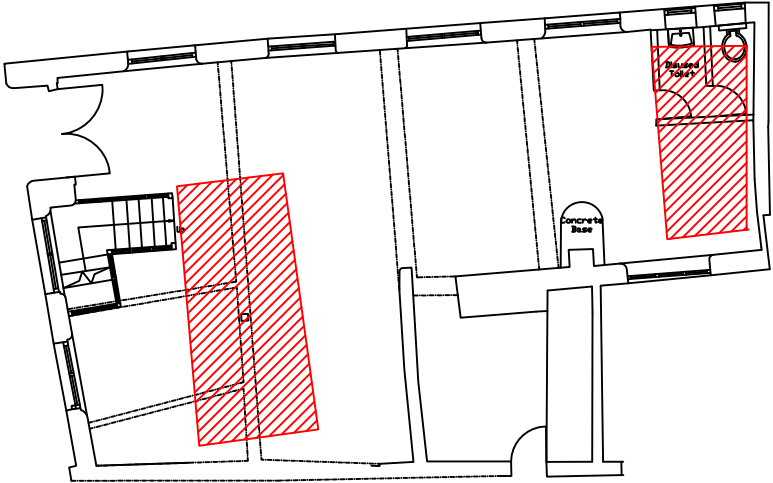
FIRST FLOOR LAYOUT

SUPPORT SCAFFOLD AND OVERBOARDING TO FLOOR &  
SARKING BOARD TO SOFFITS; BOARDS NOT ACCESSIBLE;  
INGRESS WILL STAND ON FLOORING AND SPREAD ACROSS  
FOOTPRINT

PRUDENT TO ASSUME A PROPORTION OF FLOOR BOARDS  
WILL REQUIRE REPLACEMENT

PROVISIONAL SUM - ALLOW APPROX. 25 SQ M  
FLOORBOARDS TO FIRST FLOOR

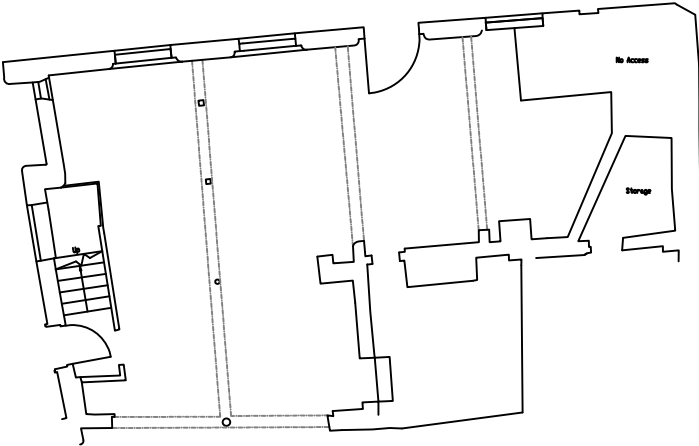
GROND FLOOR LAYOUT -

GROUND FLOOR APPEARS TO INCLUDE FLAGS, SOME FORM  
OF SOLID FLOOR

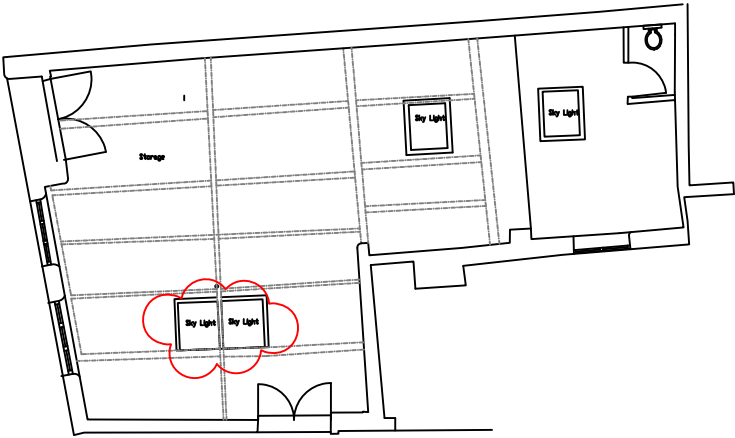
SECOND FLOOR

ONGOING SEVERE INGRESS AT ROOF LIGHT DISCHARGING MOISTURE INTO BUILDING

NOT NECESSARILY LOCATION OF SOFFIT BOARD REPAIRS; FURTHER INSPECTION DURING WORKS REQUIRED WHEN MORE ACCESSIBLE

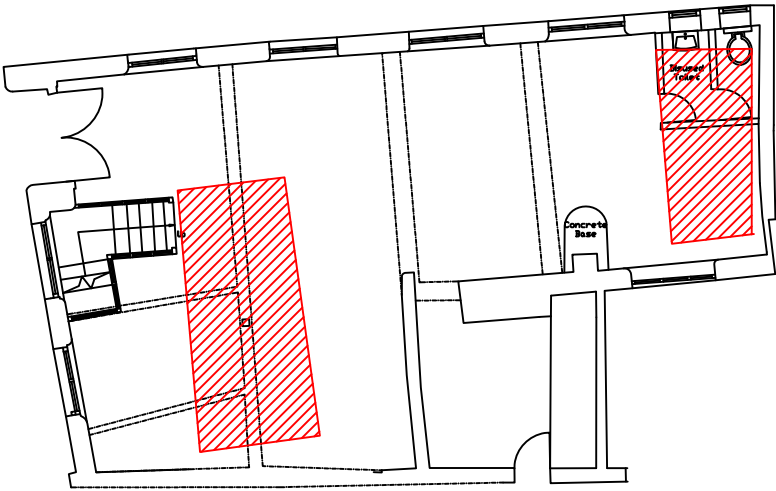
FIRST FLOOR LAYOUT

SUPPORT SCAFFOLD TO SARKING BOARD TO SOFFITS; SOFFIT BOARDS NOT ACCESSIBLE; INGRESS WILL STAND ON FLOORING AND SPREAD ACROSS FOOTPRINT

PRUDENT TO ASSUME A PROPORTION OF SOFFIT BOARDS WILL REQUIRE REPLACEMENT

PROVISIONAL SUM - ALLOW APPROX. 25 SQ M SOFFIT BOARDS TO FIRST FLOOR (NO ALLOWANCE FOR LATH AND PLASTER TO SOFFITS)

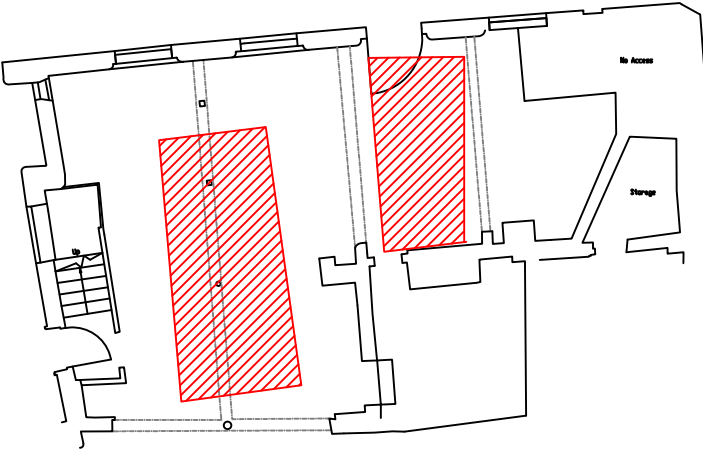
GROND FLOOR LAYOUT -

SUPPORT SCAFFOLD TO SARKING BOARD TO SOFFITS; SOFFIT BOARDS NOT ACCESSIBLE; INGRESS WILL STAND ON FLOORING AND SPREAD ACROSS FOOTPRINT

PRUDENT TO ASSUME A PROPORTION OF SOFFIT BOARDS WILL REQUIRE REPLACEMENT

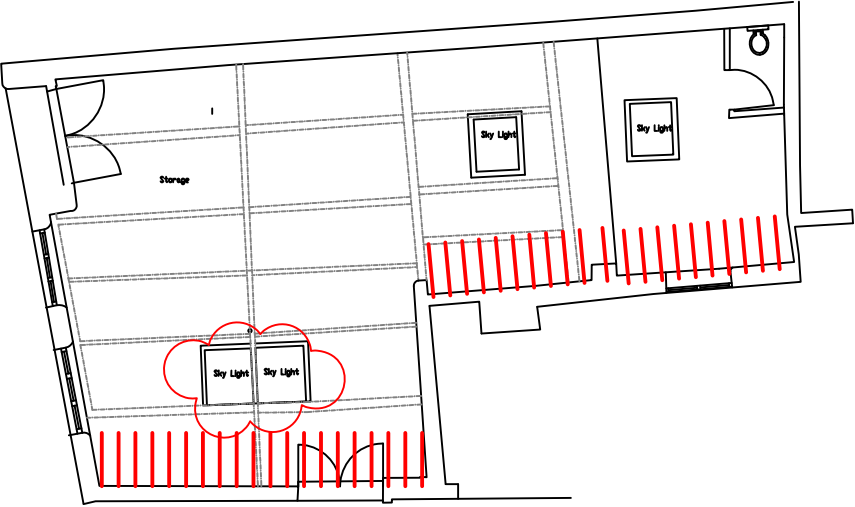
## SECOND FLOOR/ROOF

NOT NECESSARILY LOCATION OF  
RAFTER REPAIRS; FURTHER  
INSPECTION DURING WORKS  
REQUIRED WHEN MORE  
ACCESSIBLE

ONGOING SEVERE INGRESS AT ROOF  
LIGHT DISCHARGING MOISTURE INTO  
BUILDING

PRUDENT TO ASSUME A PROPORTION  
OF SARKING BOARDS WILL REQUIRE  
REPLACEMENT

PRUDENT TO ASSUME A PROPORTION  
OF RAFTER ENDS WILL REQUIRE REPAIR

| NO. | DESCRIPTION | BUDGET COST |
|---|---|---|
| 27. | <p>PRUDENT TO ASSUME A PROPORTION OF SARKING BOARDS WILL REQUIRE REPLACEMENT &amp; RAFTER REPAIRS</p> <p>REPAIR<br/>CUT BACK BEYOND THE EXTENT OF DECAY; REPLACE WITH NEW BOARDS; BESPOKE SIZE TBC</p> <p>PROVISIONAL SUM.<br/>- SARKING BOARD X 25 SQ M</p> <p>CUT BACK RAFTER BEYOND EXTENT OF DECAY; SPLICE ON NEW PRE-TREATED TIMBER; SIDE FIX X2 MATCHING TIMBERS TO EITHER SIDE; BOLTED THROUGH WITH THREADED BAR AND OVERSIZED WASHER AT EQUIDISTANCE; X41</p> | <p>£1,875</p> <p>£6,150</p> |

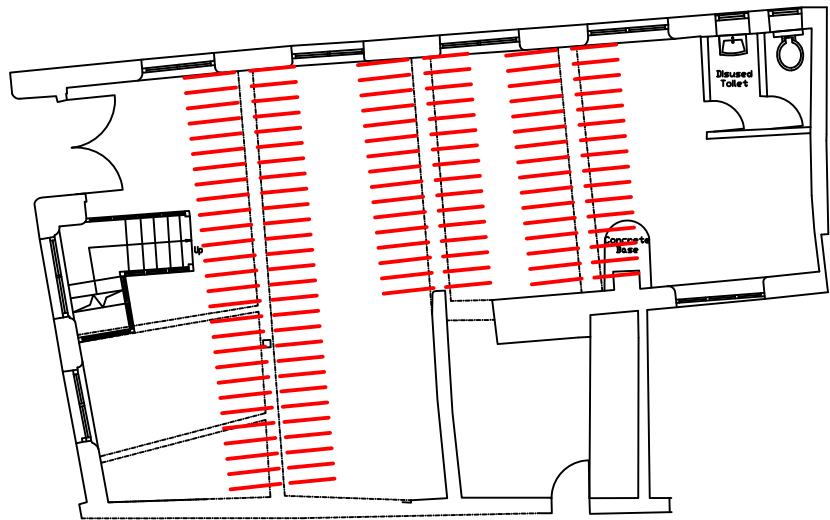
FIRST FLOOR LAYOUT - OH JOISTS TO SECOND FLOOR

EXACT NO. OF JOISTS NOT ACCESSIBLE TO CONFIRM; ESTIMATE NUMBER

RENAISSANCE SPEC. TO INSTALL 2NO. 30 WIDE X 2.5 THK X 1000 LONG MILD STEEL STRAP (1 EITHER SIDE OF JOIST)FIXED WITH X4 6MM WOOD SCREWS (65 LONG) TO EACH FACE

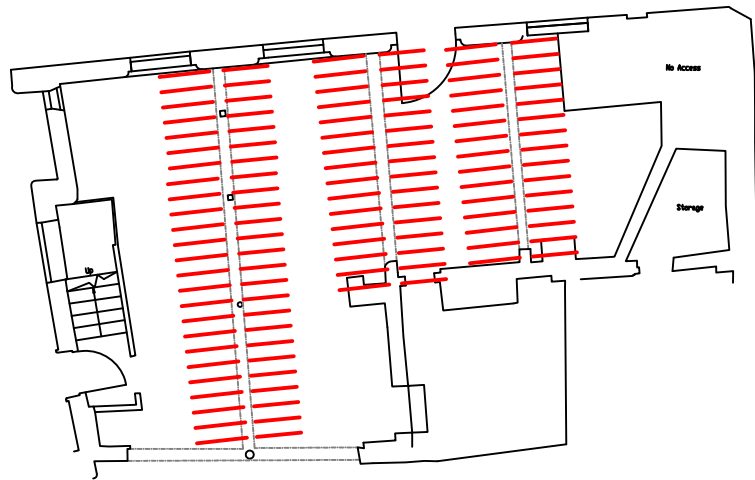
GROND FLOOR LAYOUT - OH JOISTS TO FIRST FLOOR

EXACT NO. OF JOISTS NOT ACCESSIBLE TO CONFIRM; ESTIMATE NUMBER

RENAISSANCE SPEC. TO INSTALL 2NO. 30 WIDE X 2.5 THK X 1000 LONG MILD STEEL STRAP (1 EITHER SIDE OF JOIST)FIXED WITH X4 6MM WOOD SCREWS (65 LONG) TO EACH FACE

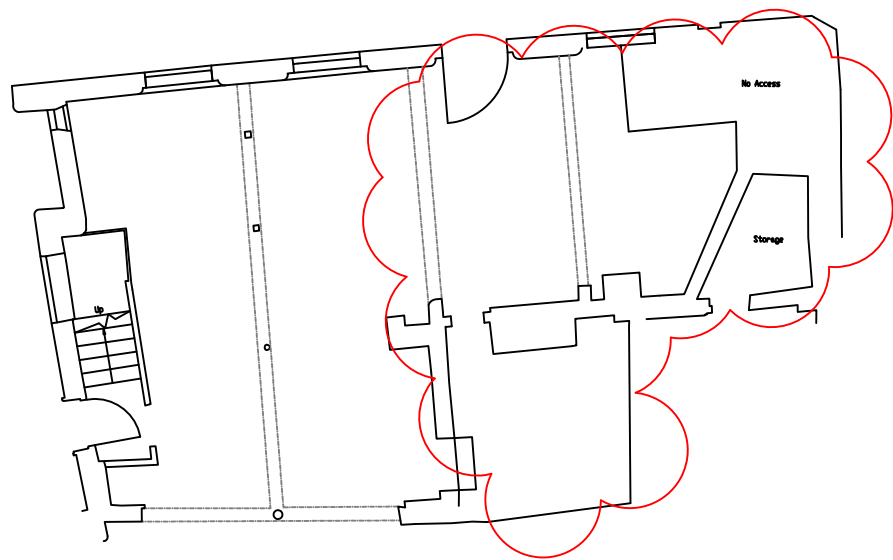
GROND FLOOR LAYOUT - OH JOISTS TO FIRST FLOOR

AREA NOT ACCESSIBLE AT TIME OF INSPECTION

PRUDENT TO ALLOW PROVISIONAL SUM FOR UNKNOWN WORKS

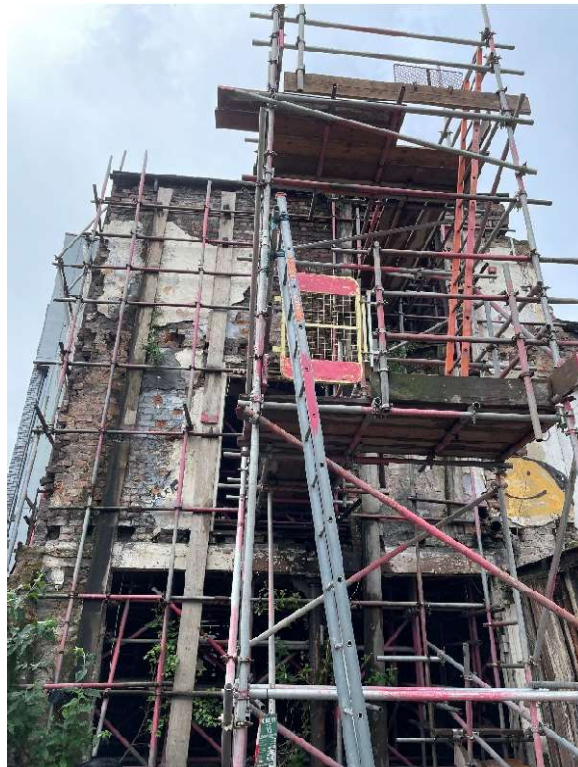
**General View**

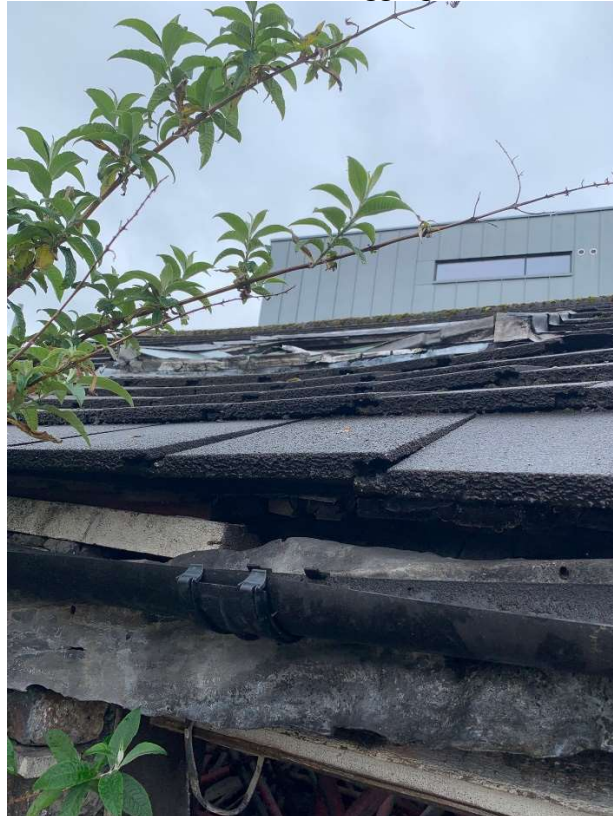
**Roof Pitch 'sagging'**

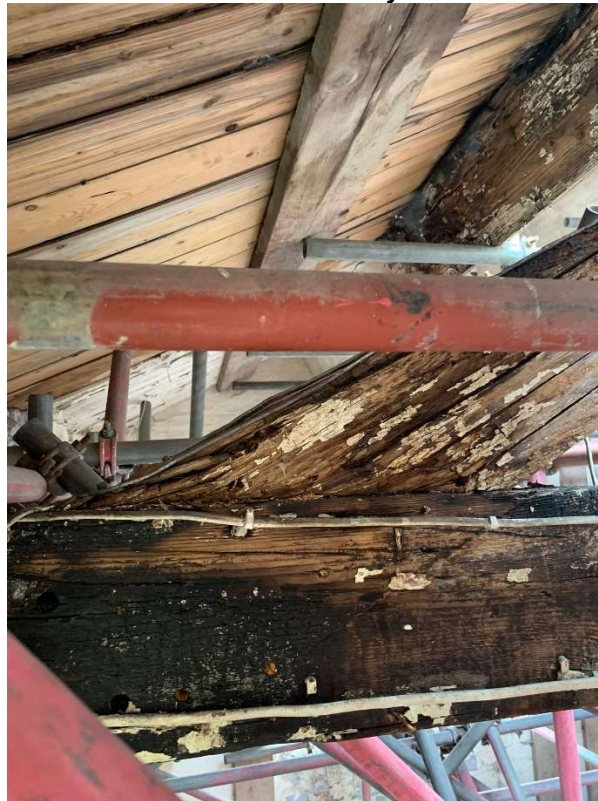
**Truss End Decayed**

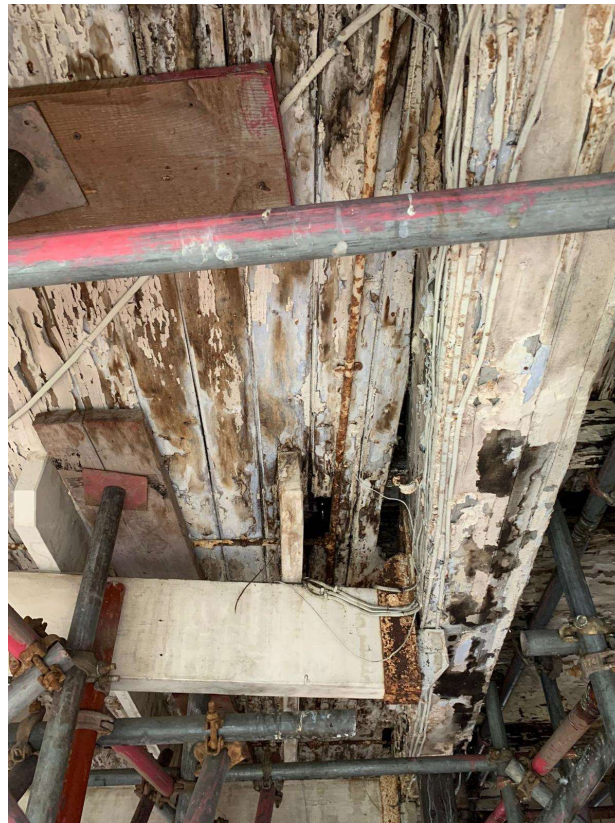
**Soffit board to floors**

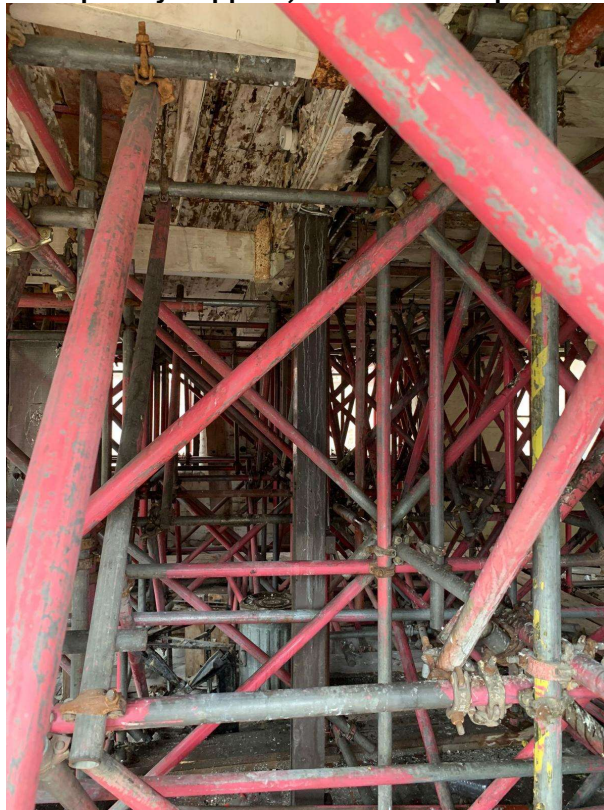
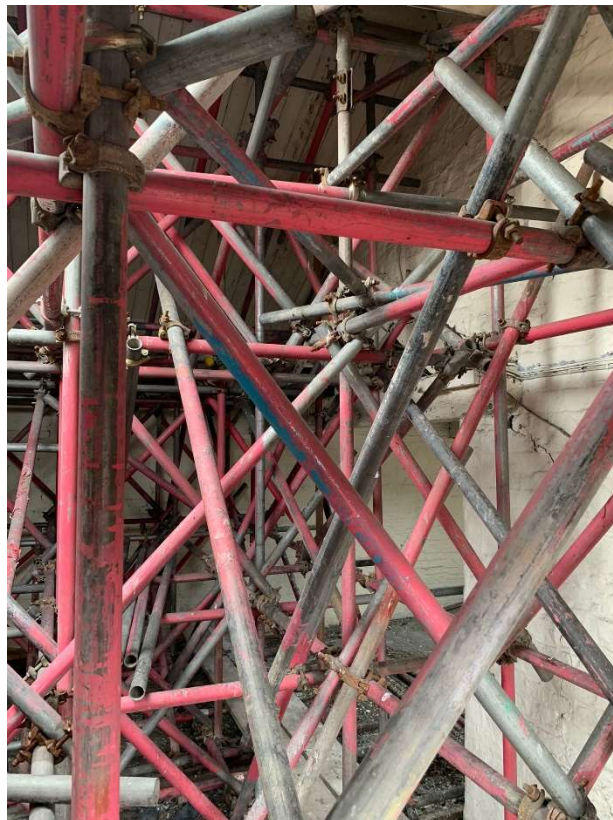
### Temporary Support; Restricted Inspection
