10 Minshull Street and 11 Bloom Street

**ADDITIONAL FEATURES**

PLANNING CONDITIONS RELEASE 11(a), (h), (r), (s)

Planning Permission 119374/FO/2018 – BOTH BUILDINGS

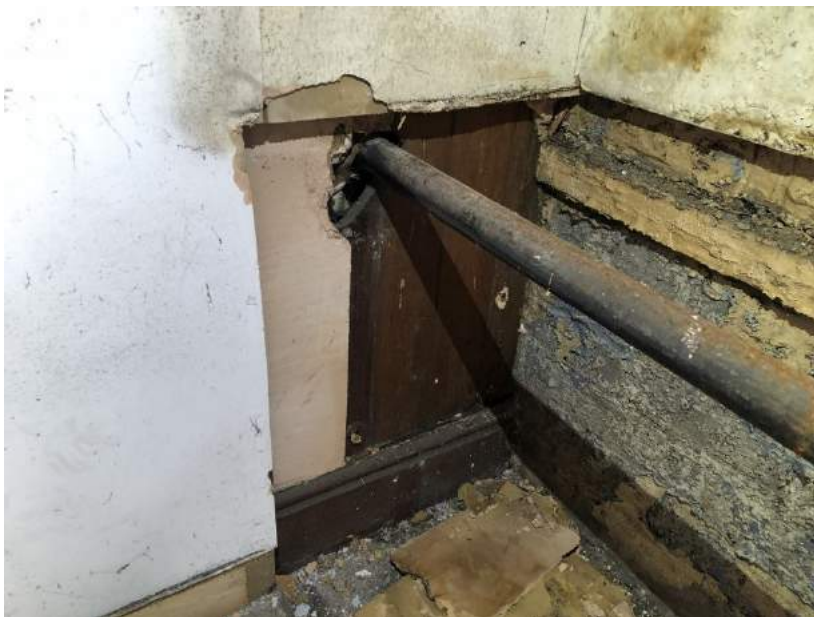
**Fig 4:**

Fourth Floor, MS-401; showing modern plasterboard lining to stud partition

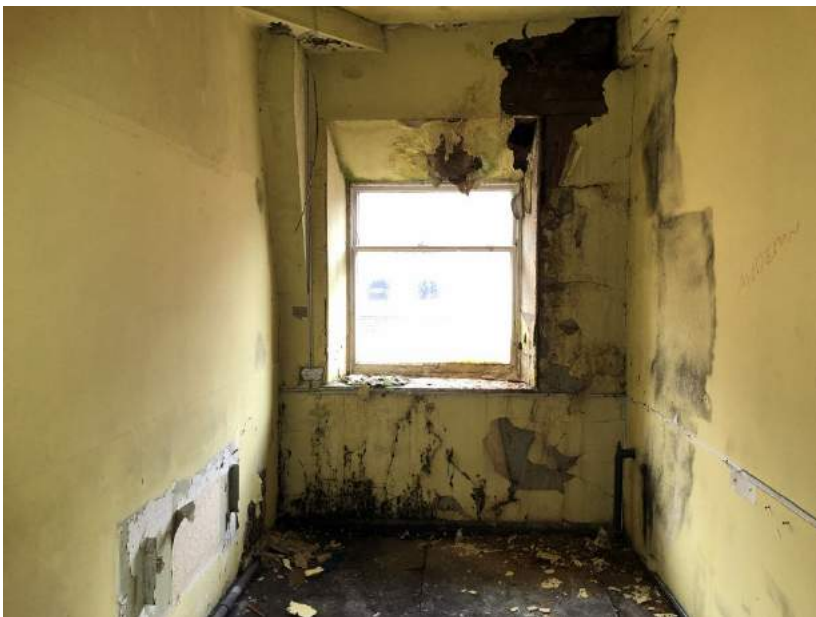
**Fig 20:**

Fourth Floor, MS-404; showing a close-up of the plasterboard that was applied to either side of this stud partition

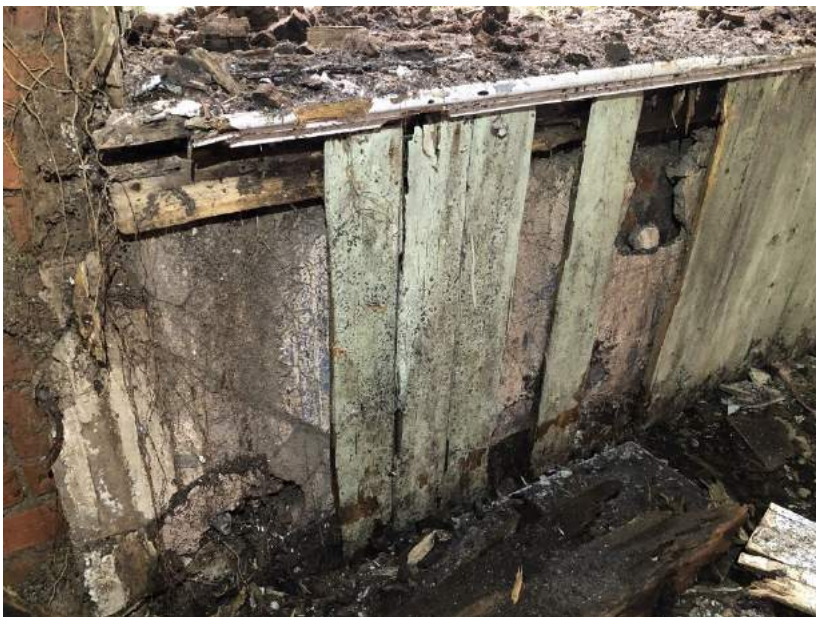
**Fig 30:**

Third Floor, MS-312-MS-320; showing deterioration of the wall finishes in the area of water penetration

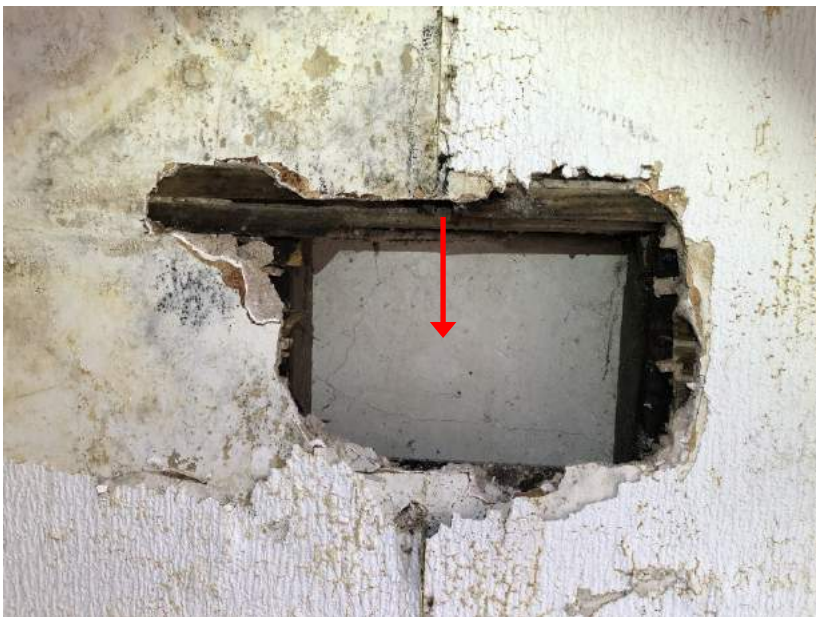
**Fig 38:**

Third Floor, MS-302; showing deterioration of the external and internal wall finishes in the area of water penetration

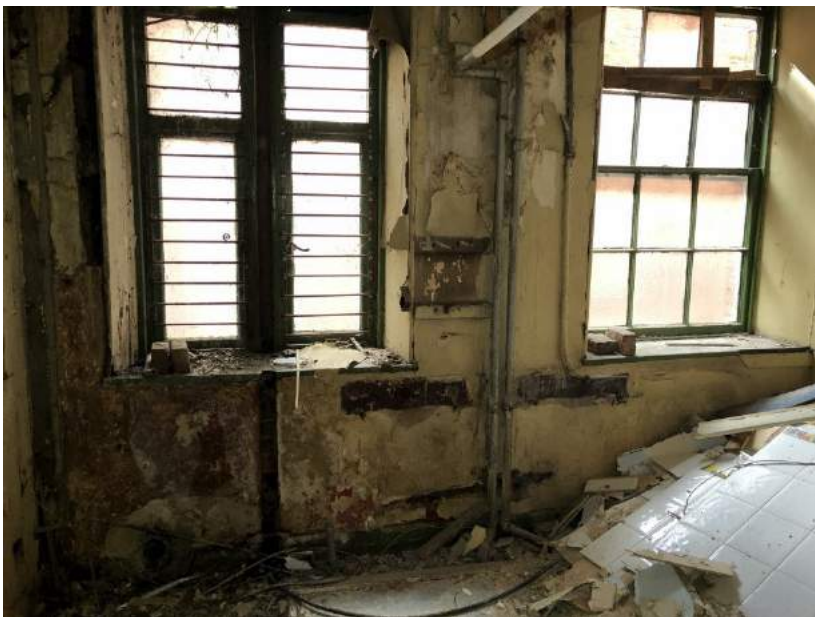
**Fig 48:**

Second Floor, MS-213; showing deterioration of the lime plaster in an area of ongoing water penetration

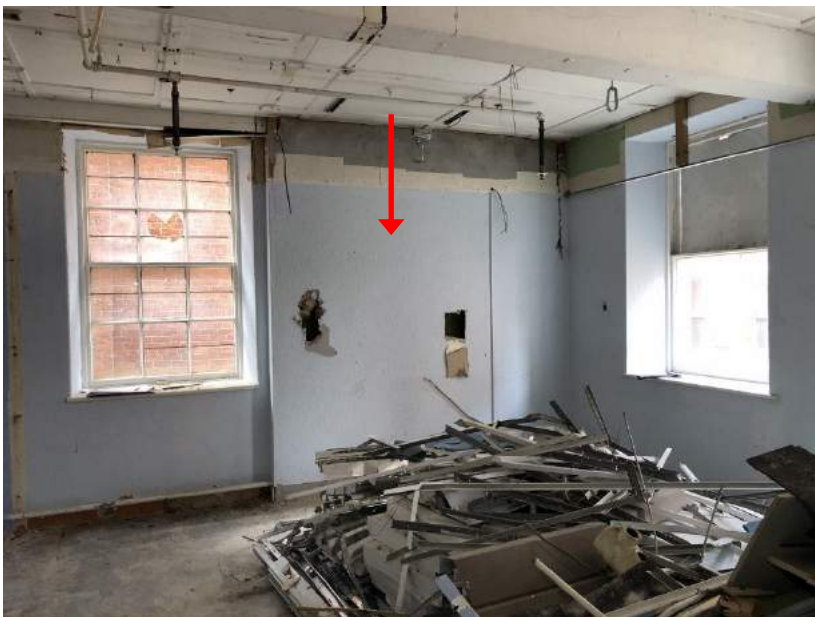
**Fig 50:**

Second Floor, MS-216; showing an area of lath and lime plaster used behind the cupboard of MS-218. The lath and plaster was damp and partially decayed where abutting the external wall

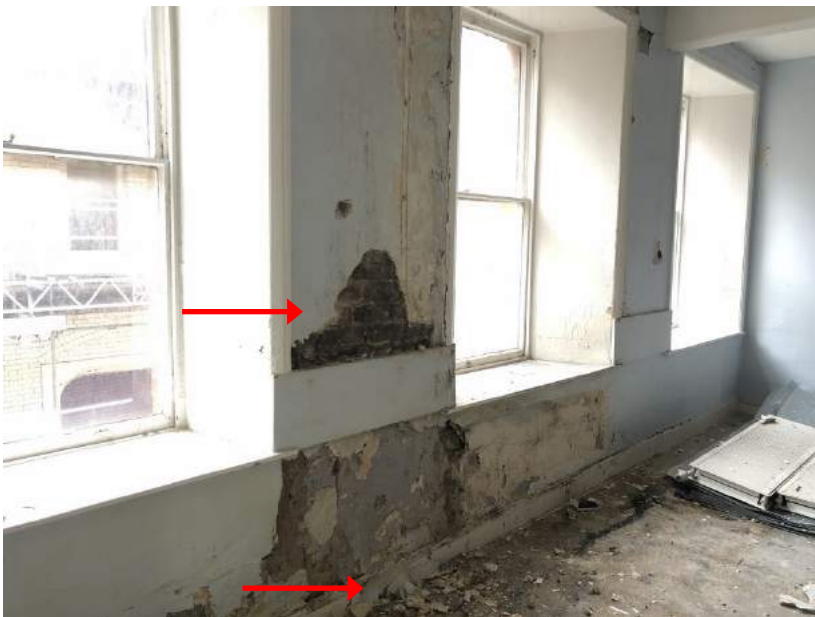
**Fig 62:**

First Floor, MS-102; showing lime plaster with a softwood skirting board. The plaster was generally in fair condition with localised areas of debonding

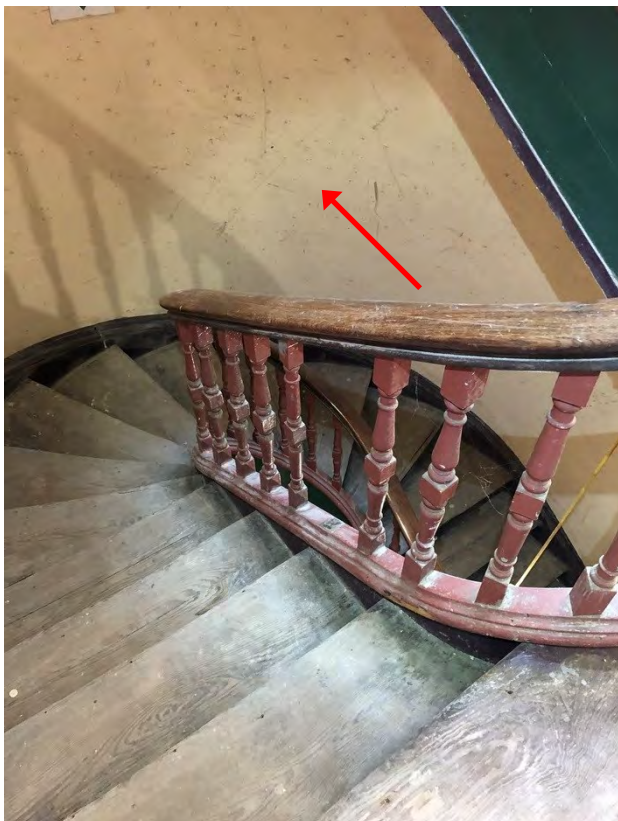
**Fig 24:**

Second floor, West staircase; showing a small area of lath and plaster and vertical softwood timber dado panelling. There was localised mechanical damage but the lath and plaster was repairable. There was no significant defect in the timber panelling

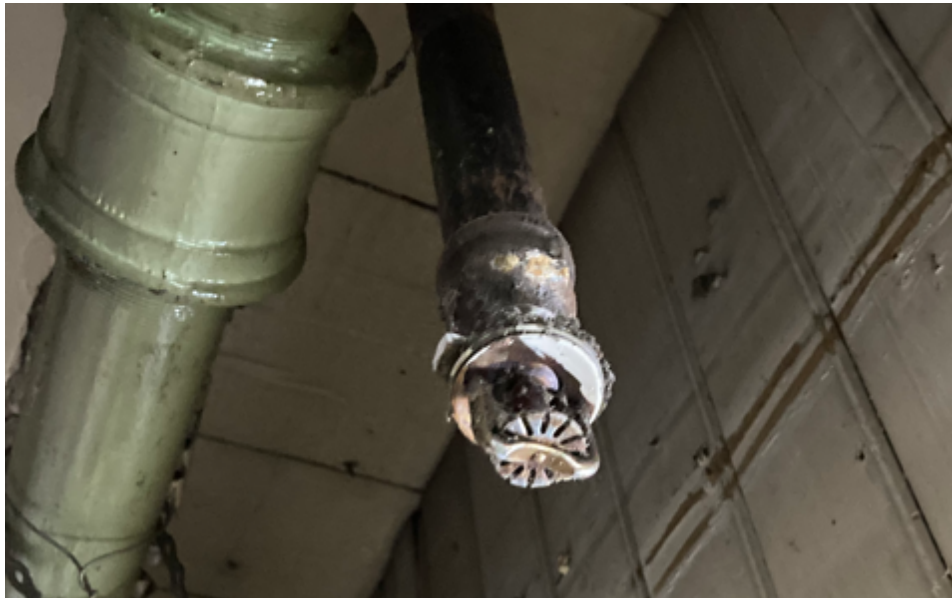
Photo 4B: Probably oldest visible sprinkler head  
Note external corrosion on range pipe above head

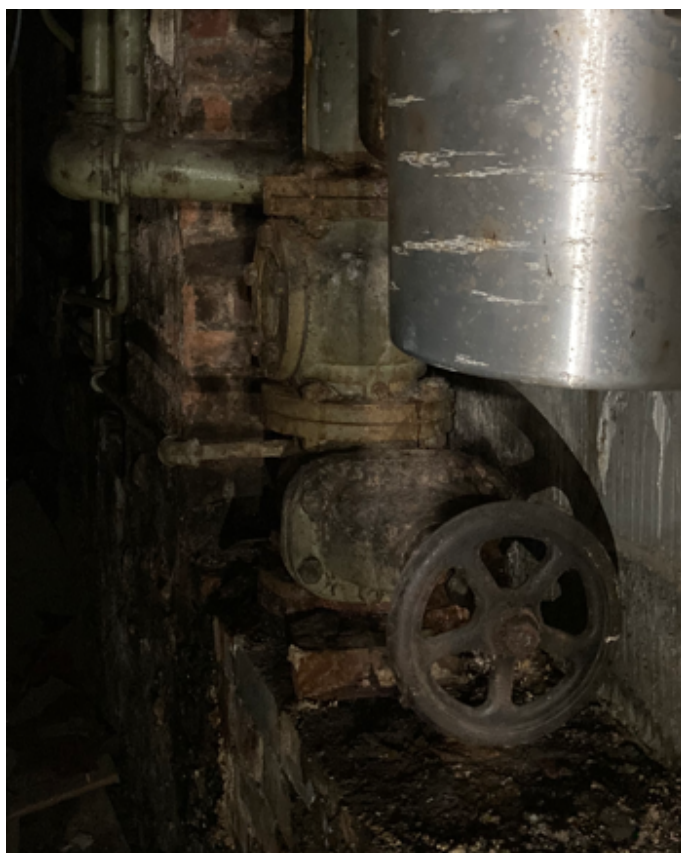
Photo 6: Extensively corroded alarm valve
