**Asbestos Survey Report**  
**Public Car Park**  
**below Renaissance Hotel, Manchester**

**Report No. IC20126**

**Date of Issue: 3<sup>rd</sup> February 2021**

| <b>Survey Type:</b> | <b>Refurbishment &amp; Demolition</b> |

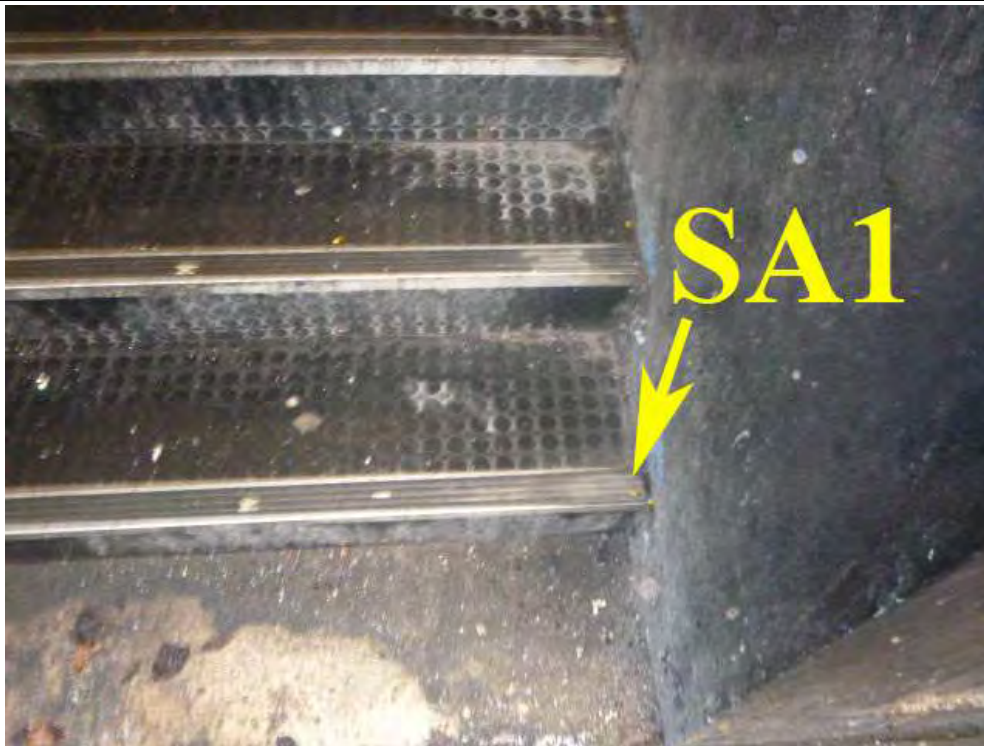
| | | Sample No. | SA1 |

| Approximate Quantity: All Main Stairs | | | | ACM BAR | | | | | |
| Analysis | | NAD | | | | | | | |

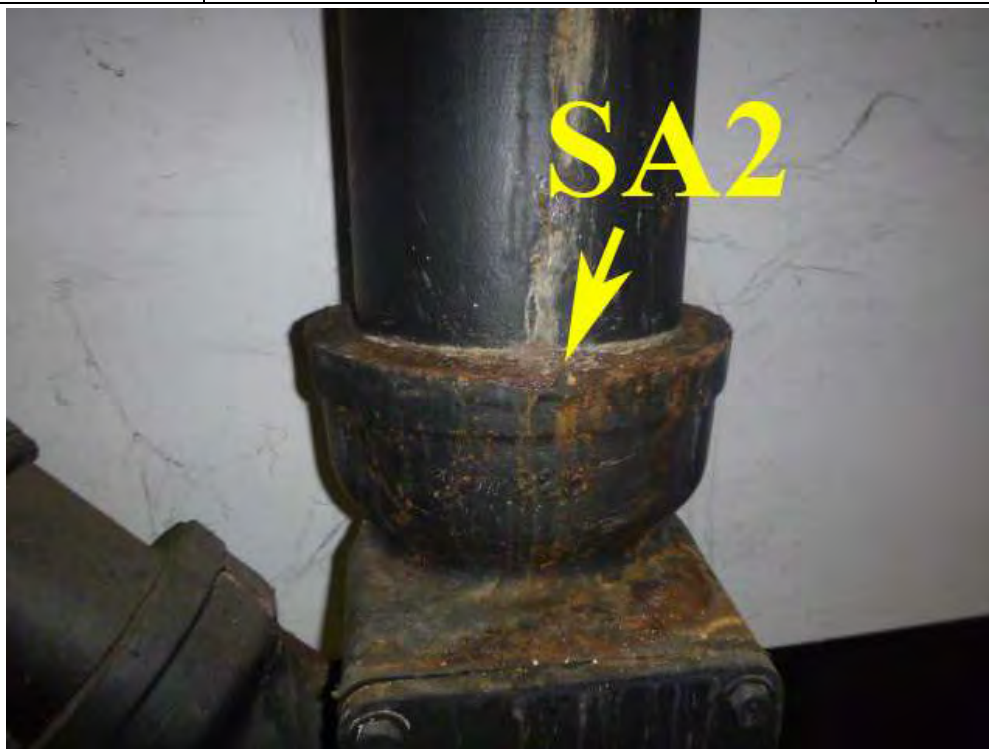
| | | Sample No. | SA2 |

| Approximate Quantity: Assume all joints identical | | | | ACM BAR | | | | | |
| Analysis | | NAD | | | | | | | |

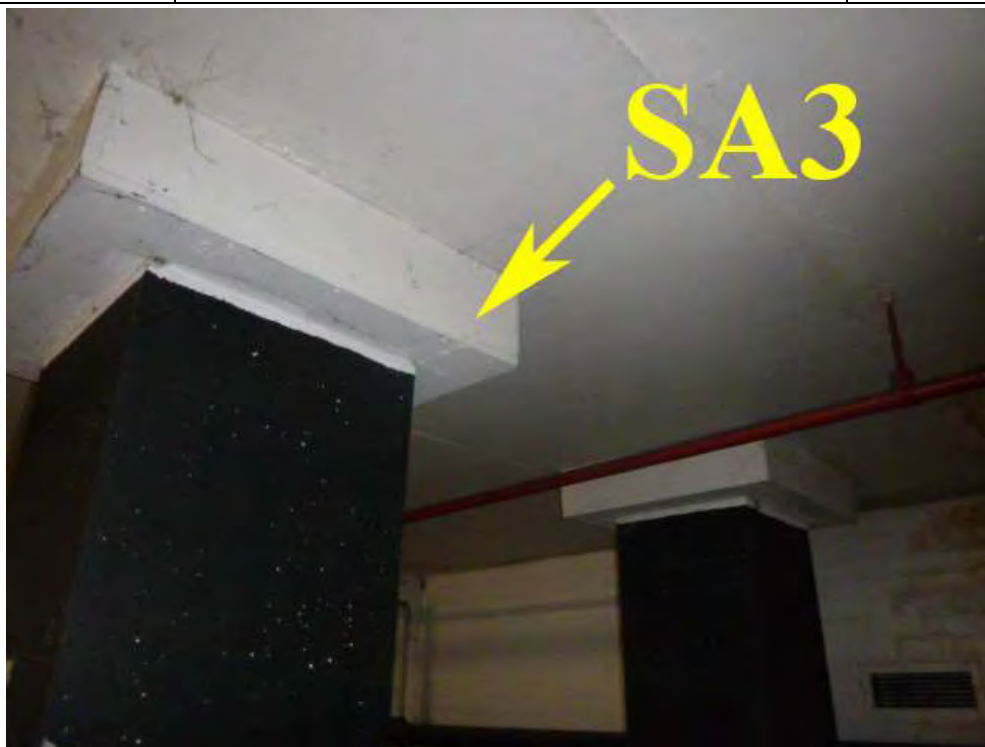
| Date<br>Sampled | 25 <sup>th</sup> January<br>2021 | Sampled<br>By | Ian Chew<br>Sample No.<br><b>SA3</b> |

| Approximate Quantity: 2 Columns | | | | ACM BAR | | | | | |
| Analysis | | NAD | | | | | | | |

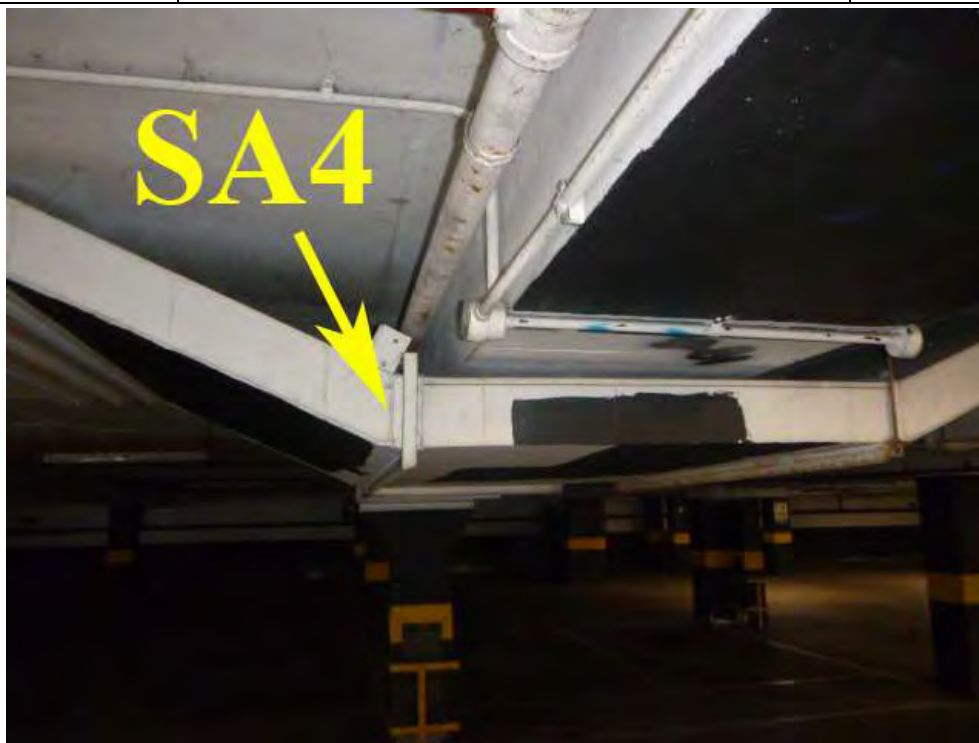
| | | Sample No. | SA4 |

| Approximate Quantity: All Metal Ducting | | | | ACM BAR | | | | | |
| Analysis | | NAD | | | | | | | |

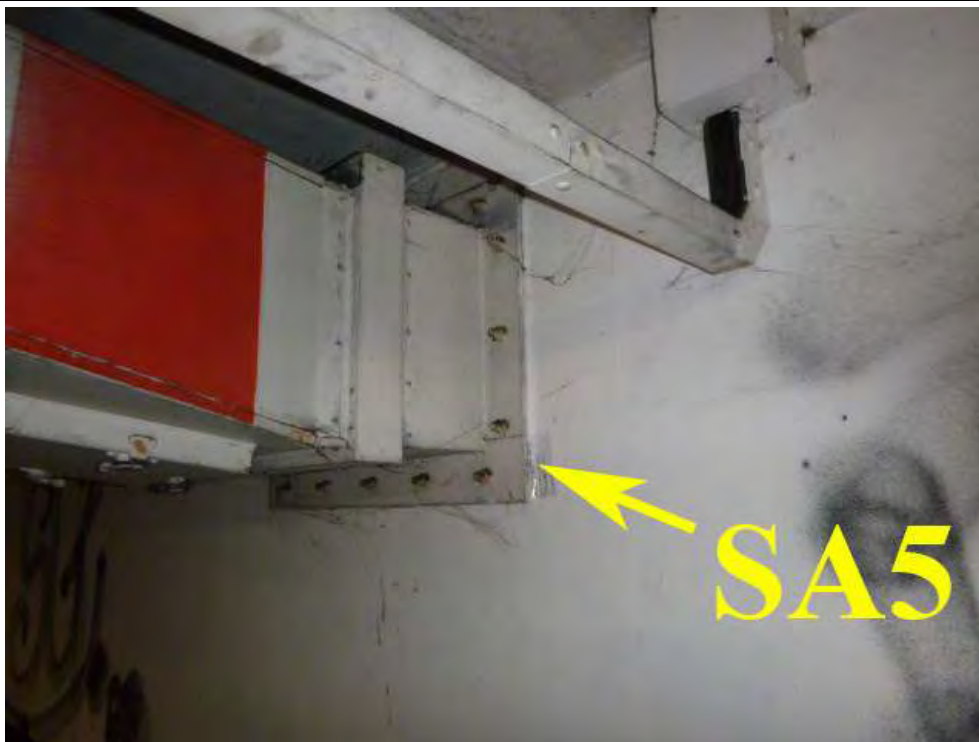
| | | Sample No. | <b>SA5</b> |

| <b>SA5</b><br><br>26 <sup>th</sup><br>January<br>2021 | Large Metal Ducting | Mastic to joints where<br>ducts goes through walls | Material Risk<br>Assessment | 2 |
| | | Chrysotile<br>(White)Asbestos | Occupational Risk<br>Assessment | N/A |

| Approximate Quantity: Assume All Joints | | | | ACM BAR | | | | | |
| Analysis | | Chrysotile (White) Asbestos | | | | | | | |

- 1.3.3** The mastic to the duct wall joints may be removed by a general contractor as it is non-licensable. The contractor employed to carry out the removal however, should have sufficient information, instruction and training on working with non-licensable asbestos materials.

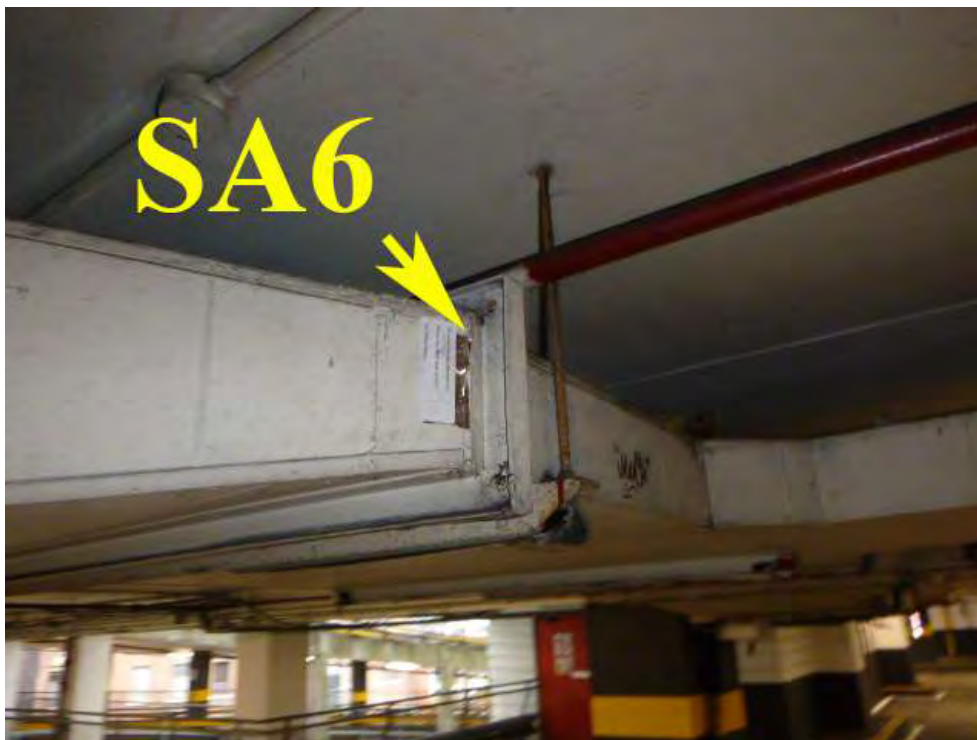
| Date<br>Sampled | 26 <sup>th</sup> January<br>2021 | Sampled<br>By | Ian Chew | Sample No.<br><b>SA6</b> |

| Approximate Quantity: All Metal Ducting | | | | ACM BAR | | | | | |
| Analysis | | NAD | | | | | | | |

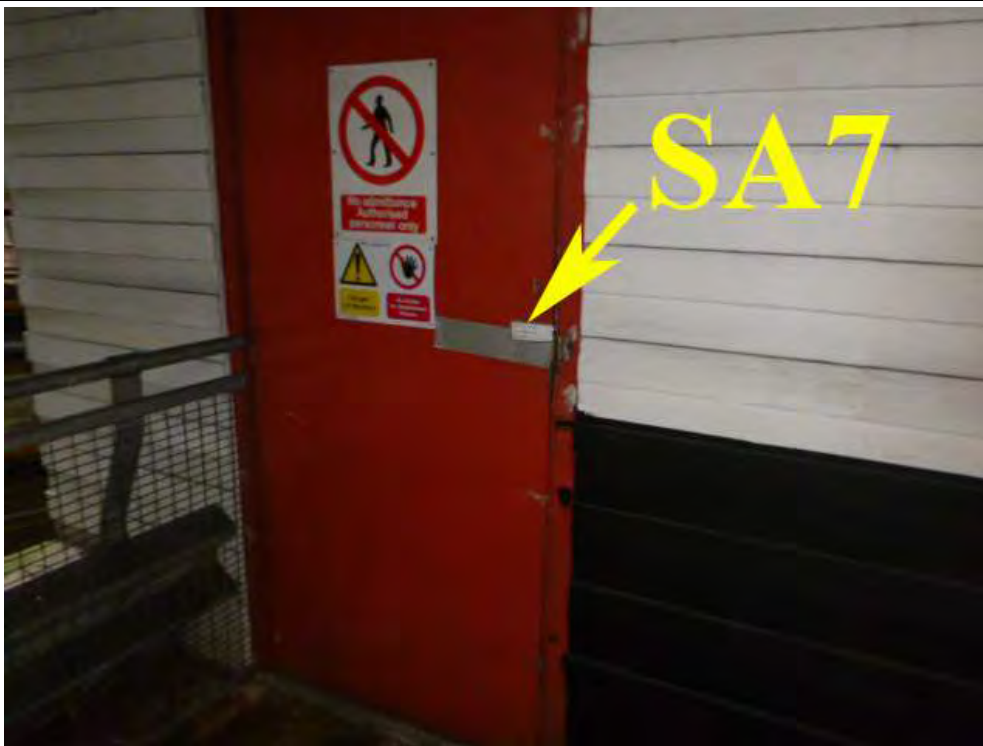
| Date<br>Sampled | <b>26<sup>th</sup> January<br/>2021</b> | Sampled<br>By | <b>Ian Chew</b> | Sample No.<br><b>SA7</b> |

| <b>SA7</b><br><br>26 <sup>th</sup><br>January<br>2021 | Door To Room | Insulation Board within<br>boarding to Door | Material Risk<br>Assessment | 7 |
| | | Amosite (Brown) &<br>Chrysotile<br>(White)Asbestos<br>Insulation Board | Occupational Risk<br>Assessment | N/A |

| Material Assessment<br>Risk Band | <b>B – Medium Risk</b> | | Provisional<br>Priority Risk | <b>N/A</b> |

| Approximate Quantity: 2 sq m | | ACM BAR | | | | | | | |
| Analysis | | Amosite (Brown) & Chrysotile (White) Asbestos Insulation Board | | | | | | | |

- 1.3.2** The door containing asbestos insulation board should be removed as a complete unit to avoid disturbing the asbestos. The work should be carried out by a licensed contractor under controlled conditions.

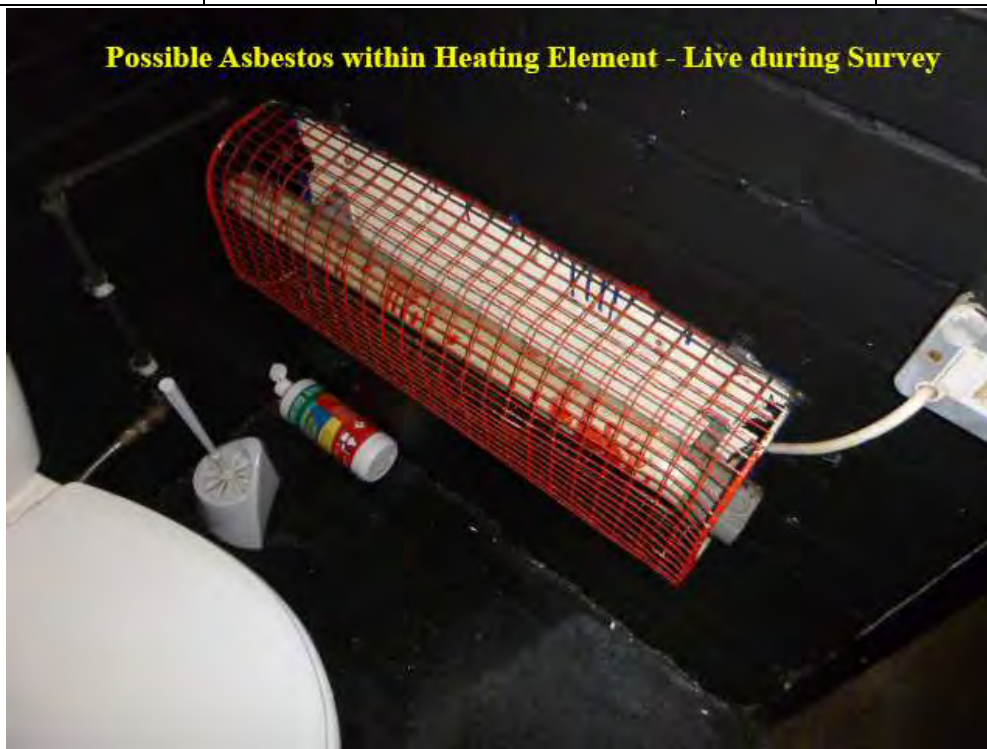
| Material Assessment<br>Risk Band | <b>D – Minimum Risk</b> | | Provisional<br>Priority Risk | <b>N/A</b> |

| Approximate Quantity: Single Heater | | | | ACM BAR | | | | | |
| Analysis | | Presumed Chrysotile (White) Asbestos Insulation | | | | | | | |

- 1.3.4** The heater element in the staff WC and the older style electrical switch and fuse boxes were unable to be internally inspected as they were live at the time of the survey. These are therefore presumed to contain asbestos until they can be isolated and fully checked.

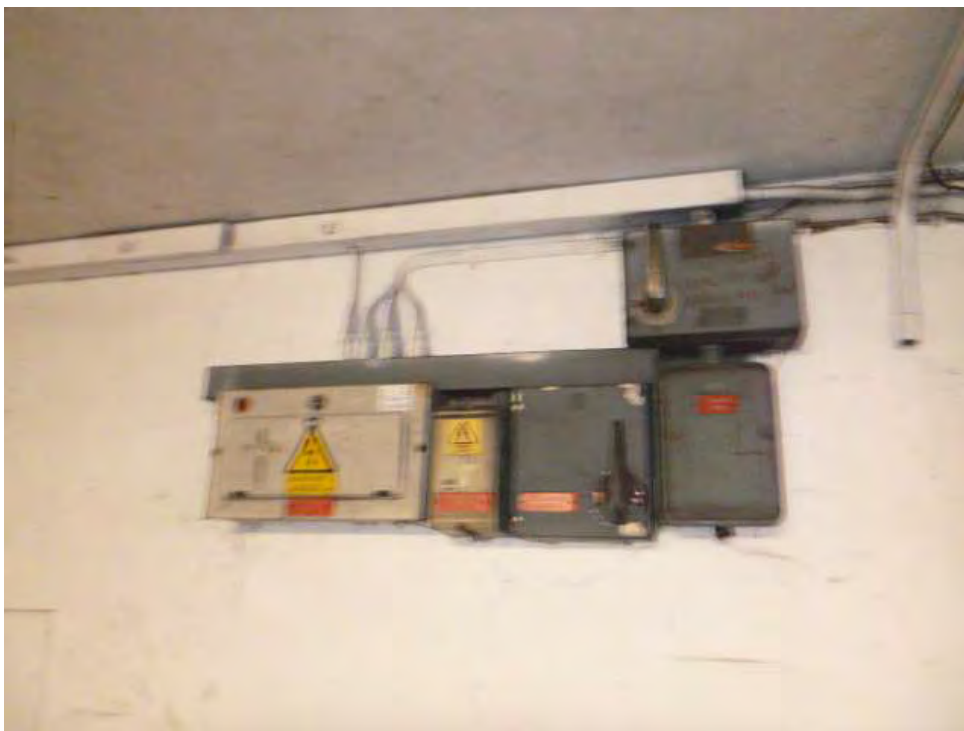
| Approximate Quantity: All Older style Boxes | | | | ACM BAR | | | | | |
| Analysis | | Presumed Chrysotile (White) Asbestos Insulation | | | | | | | |
