**Project Name:** HMG PAINTS  
**Project Description:** WinCan Import in Miraculix WRc4 Standard  
**Project Date:** 21/04/2021

## Section Inspection - 21/04/2021 - A/P 1X

## Section Inspection - 21/04/2021 - INFALLX

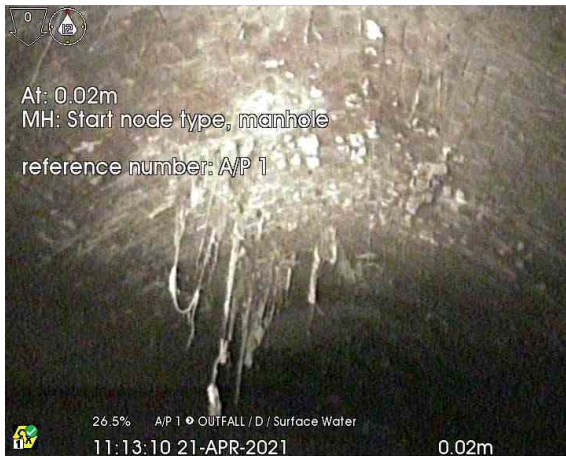
1\_0-02m\_111310.jpg, 00:00:03, 0.00 m  
 Start node type, manhole, reference number: A/P 1

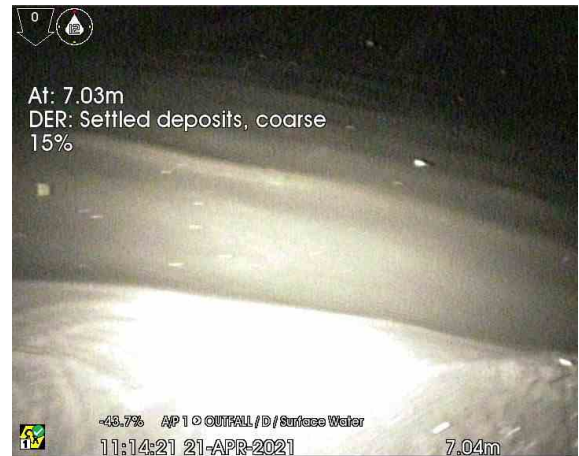
| Scale: 1:558 | Position [m] | Code | Observation | MPEG | Photo | Grade |
|---|---|---|---|---|---|---|
| | 7.04 | DER | Settled deposits, coarse, 15% cross-sectional area loss | 00:00:52 | 1_7-04m_111421.jpg | 3 |

1\_7-04m\_111421.jpg, 00:00:52, 7.04 m  
 Settled deposits, coarse, 15% cross-sectional area loss

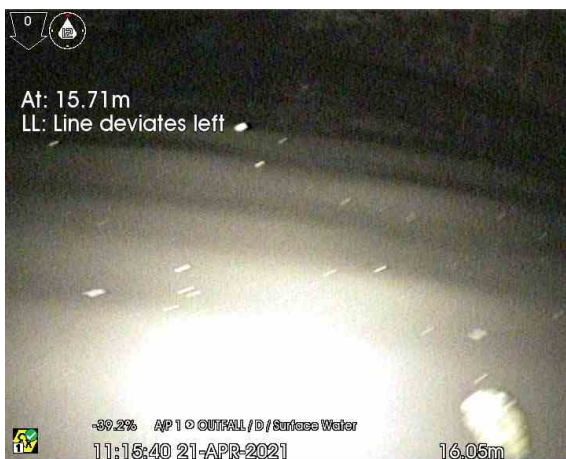
1\_16-05m\_111540.jpg, 00:02:06, 16.05 m  
 Line deviates left

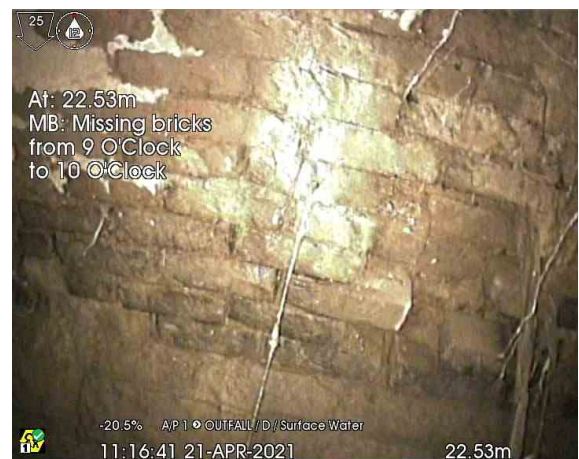
| Scale: 1:558 | Position [m] | Code | Observation | MPEG | Photo | Grade |
|---|---|---|---|---|---|---|
| | 22.53 | MB | Missing bricks from 9 o'clock to 10 o'clock | 00:02:49 | 1_22-53m_111641.jpg | 4 |

1\_22-53m\_111641.jpg, 00:02:49, 22.53 m  
 Missing bricks from 9 o'clock to 10 o'clock

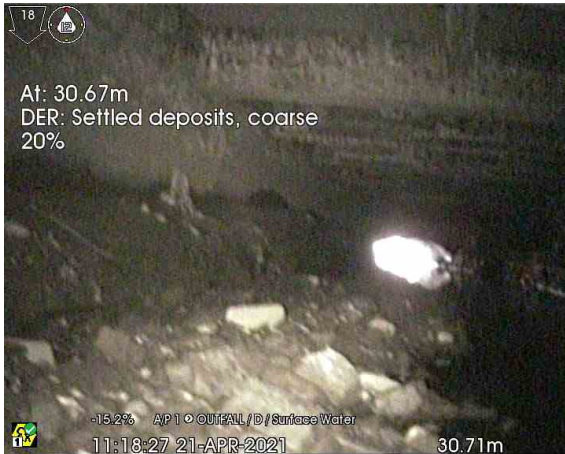
| Scale: 1:558 | Position [m] | Code | Observation | MPEG | Photo | Grade |
|---|---|---|---|---|---|---|
| | 30.78 | DER | Settled deposits, coarse, 20% cross-sectional area loss | 00:03:47 | 1_30-78m_111827.jpg | 3 |

1\_30-78m\_111827.jpg, 00:03:47, 30.78 m  
 Settled deposits, coarse, 20% cross-sectional area loss

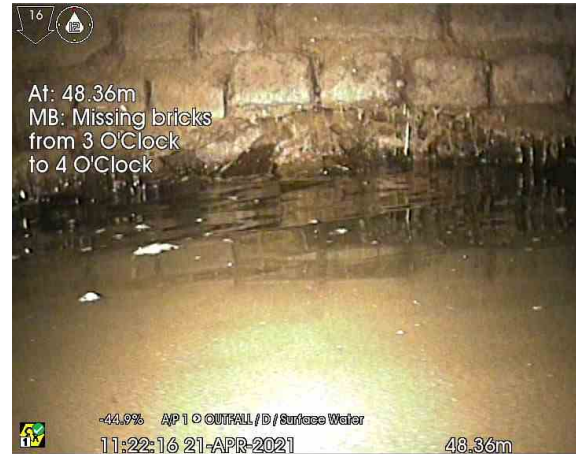
| Scale: 1:558 | Position [m] | Code | Observation | MPEG | Photo | Grade |
|---|---|---|---|---|---|---|
| | 48.36 | MB | Missing bricks from 3 o'clock to 4 o'clock | 00:06:04 | 1_48-36m_112216.jpg | 4 |

1\_48-36m\_112216.jpg, 00:06:04, 48.36 m  
 Missing bricks from 3 o'clock to 4 o'clock

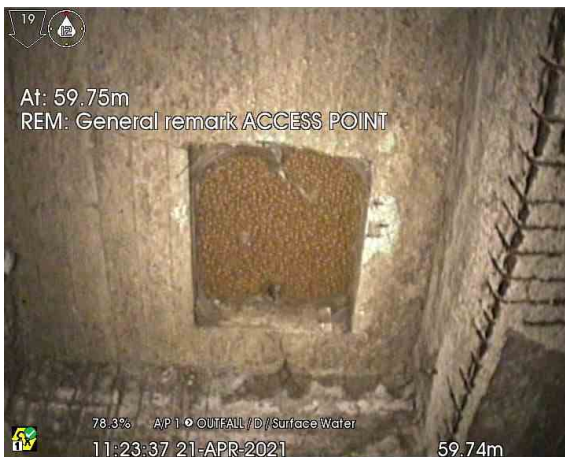
1\_59-74m\_112337.jpg, 00:07:13, 59.74 m  
 General remark, ACCESS POINT

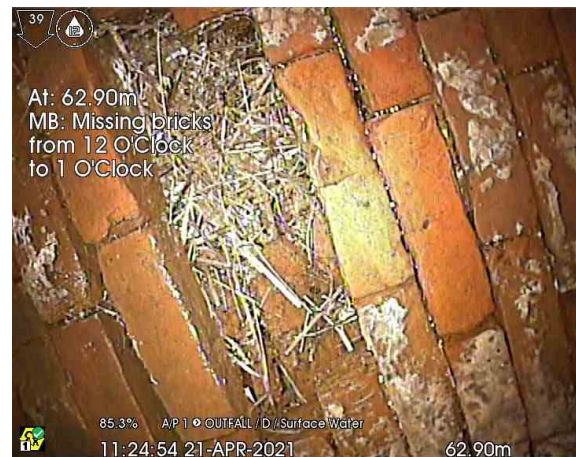
| Scale: 1:558 | Position [m] | Code | Observation | MPEG | Photo | Grade |
|---|---|---|---|---|---|---|
| | 62.90 | MB | Missing bricks from 12 o'clock to 1 o'clock | 00:08:20 | 1_62-90m_112454.jpg | 4 |

1\_62-90m\_112454.jpg, 00:08:20, 62.90 m  
 Missing bricks from 12 o'clock to 1 o'clock

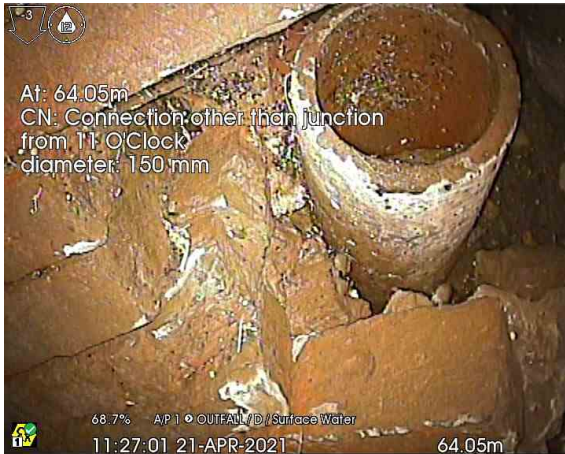
1\_64-05m\_112701.jpg, 00:08:51, 64.05 m  
 Connection other than junction at 11 o'clock, diameter: 150mm

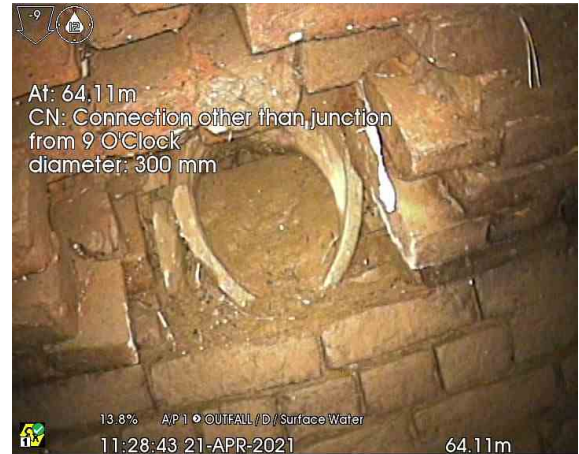
1\_64-11m\_112843.jpg, 00:09:21, 64.11 m  
 Connection other than junction at 9 o'clock, diameter: 300mm

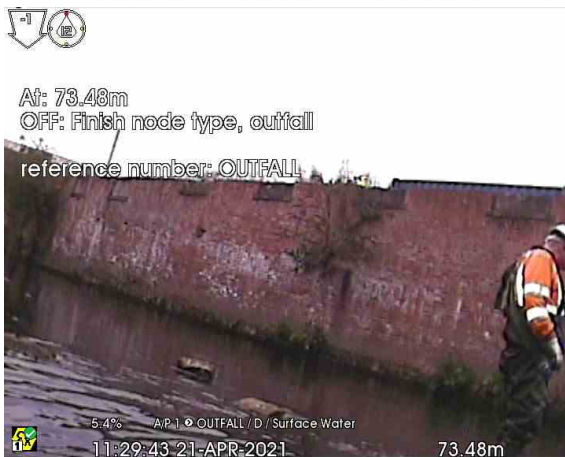
1\_73-48m\_112943.jpg, 00:10:12, 73.48 m  
 Finish node type, outfall, reference number: OUTFALL

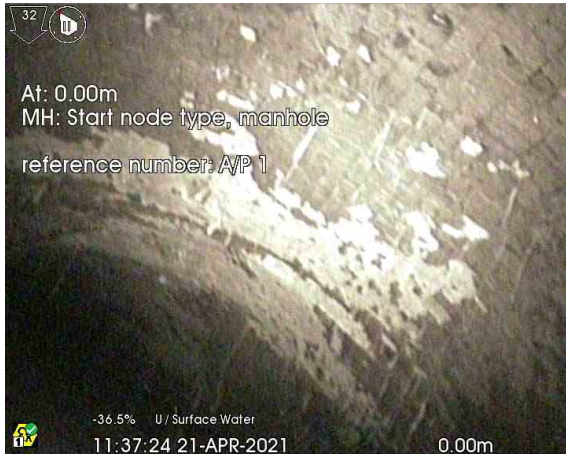
2\_0-00m\_113724.jpg, 00:00:01, 0.00 m  
 Start node type, manhole, reference number: A/P 1

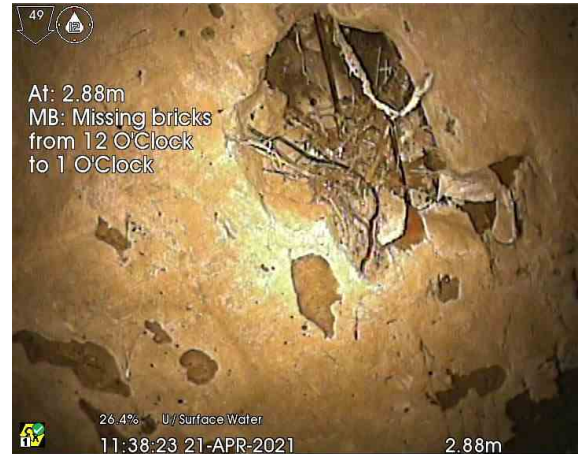
| Scale: 1:325 | Position [m] | Code | Observation | MPEG | Photo | Grade |
|---|---|---|---|---|---|---|
| | 2.88 | MB | Missing bricks from 12 o'clock to 1 o'clock | 00:00:40 | 2_2-88m_113823.jpg | 4 |

2\_2-88m\_113823.jpg, 00:00:40, 2.88 m  
 Missing bricks from 12 o'clock to 1 o'clock

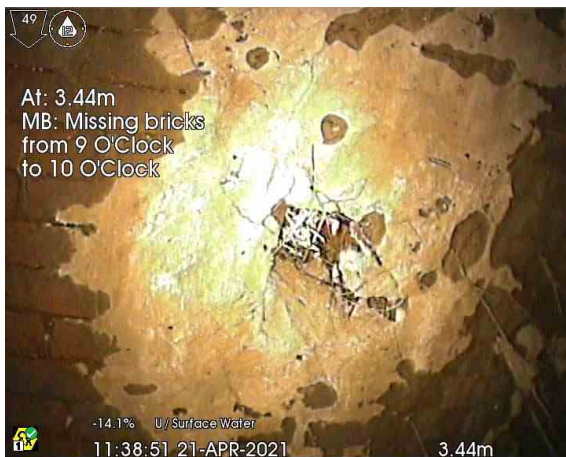
| Scale: 1:325 | Position [m] | Code | Observation | MPEG | Photo | Grade |
|---|---|---|---|---|---|---|
| | 3.44 | MB | Missing bricks from 9 o'clock to 10 o'clock | 00:00:53 | 2_3-44m_113851.jpg | 4 |

2\_3-44m\_113851.jpg, 00:00:53, 3.44 m  
 Missing bricks from 9 o'clock to 10 o'clock

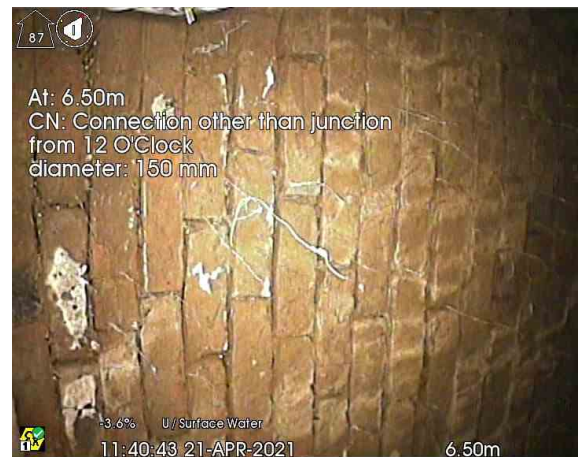
2\_6-50m\_114043.jpg, 00:02:18, 6.50 m  
 Connection other than junction at 12 o'clock, diameter: 150mm

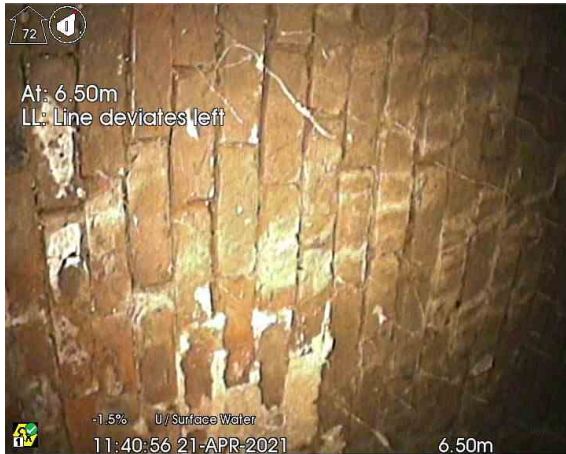
2\_6-50m\_114056.jpg, 00:02:26, 6.50 m  
 Line deviates left

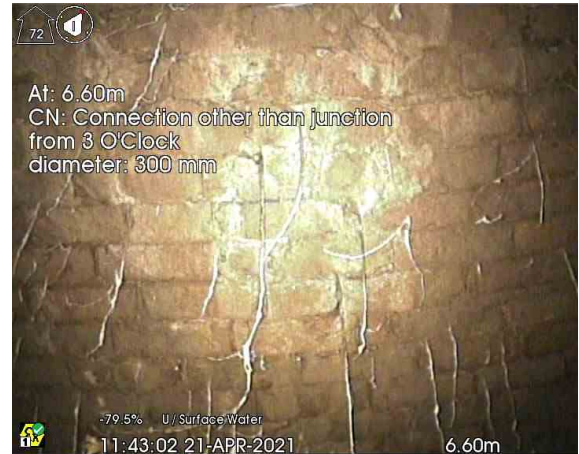
2\_6-60m\_114302.jpg, 00:04:21, 6.60 m  
 Connection other than junction at 3 o'clock, diameter: 300mm

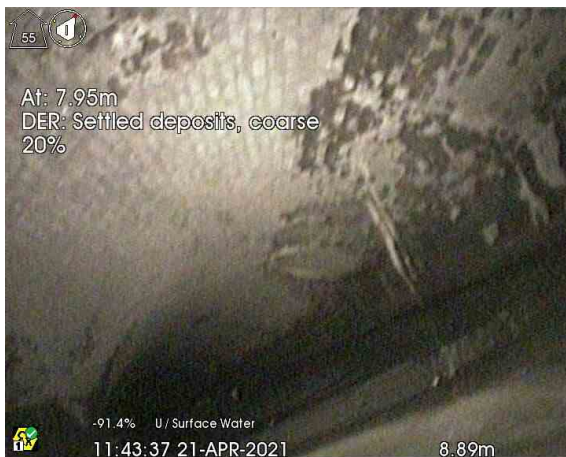
| Scale: 1:325 | Position [m] | Code | Observation | MPEG | Photo | Grade |
|---|---|---|---|---|---|---|
| | 8.89 | DER | Settled deposits, coarse, 20% cross-sectional area loss | 00:04:42 | 2_8-89m_114337.jpg | 3 |

2\_8-89m\_114337.jpg, 00:04:42, 8.89 m  
 Settled deposits, coarse, 20% cross-sectional area loss

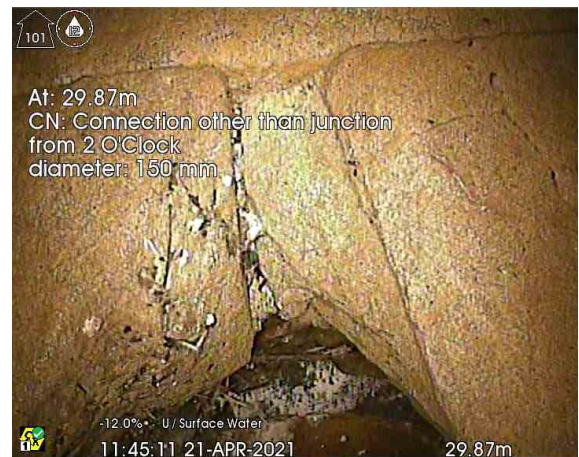
2\_29-87m\_114511.jpg, 00:06:07, 29.87 m  
 Connection other than junction at 2 o'clock, diameter: 150mm

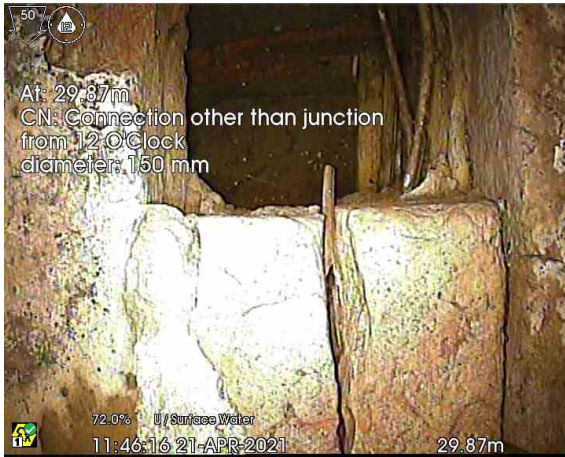
2\_29-87m\_114616.jpg, 00:07:01, 29.87 m  
 Connection other than junction at 12 o'clock, diameter: 150mm

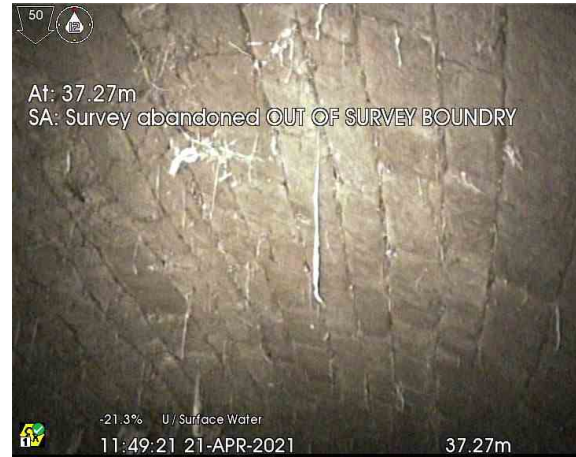
2\_37-27m\_114921.jpg, 00:09:34, 37.27 m  
 Survey abandoned, OUT OF SURVEY BOUNDRY
