# Contaminated Land Phase One Desk Study for proposed residential development at 4 Thirsfield Drive, Manchester, M11 4BF.

June 2022

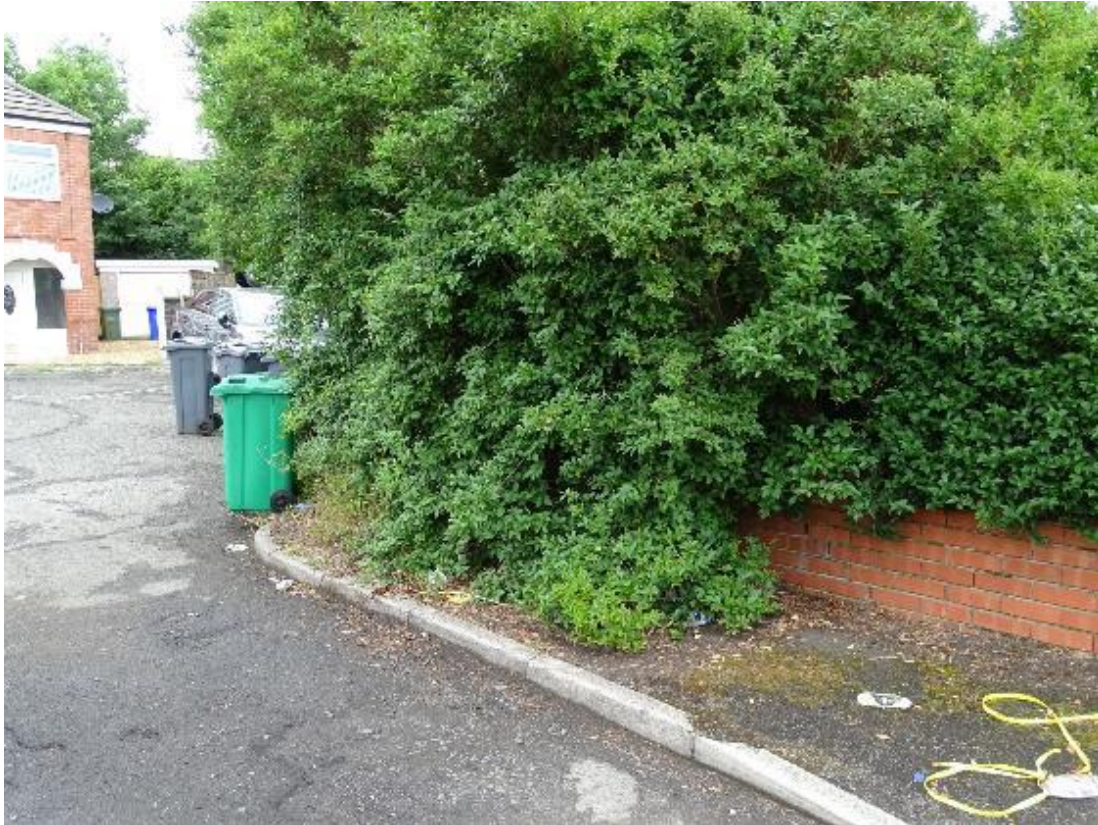
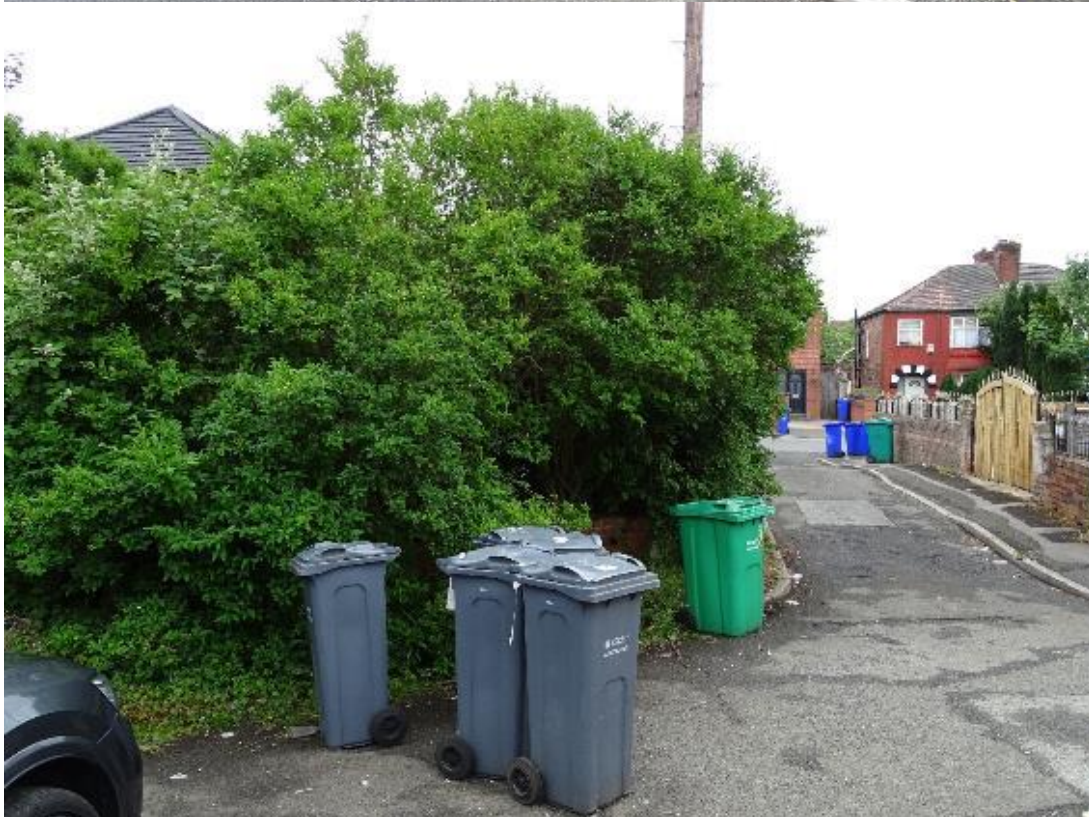
The view from the road along the eastern boundary looking north then south

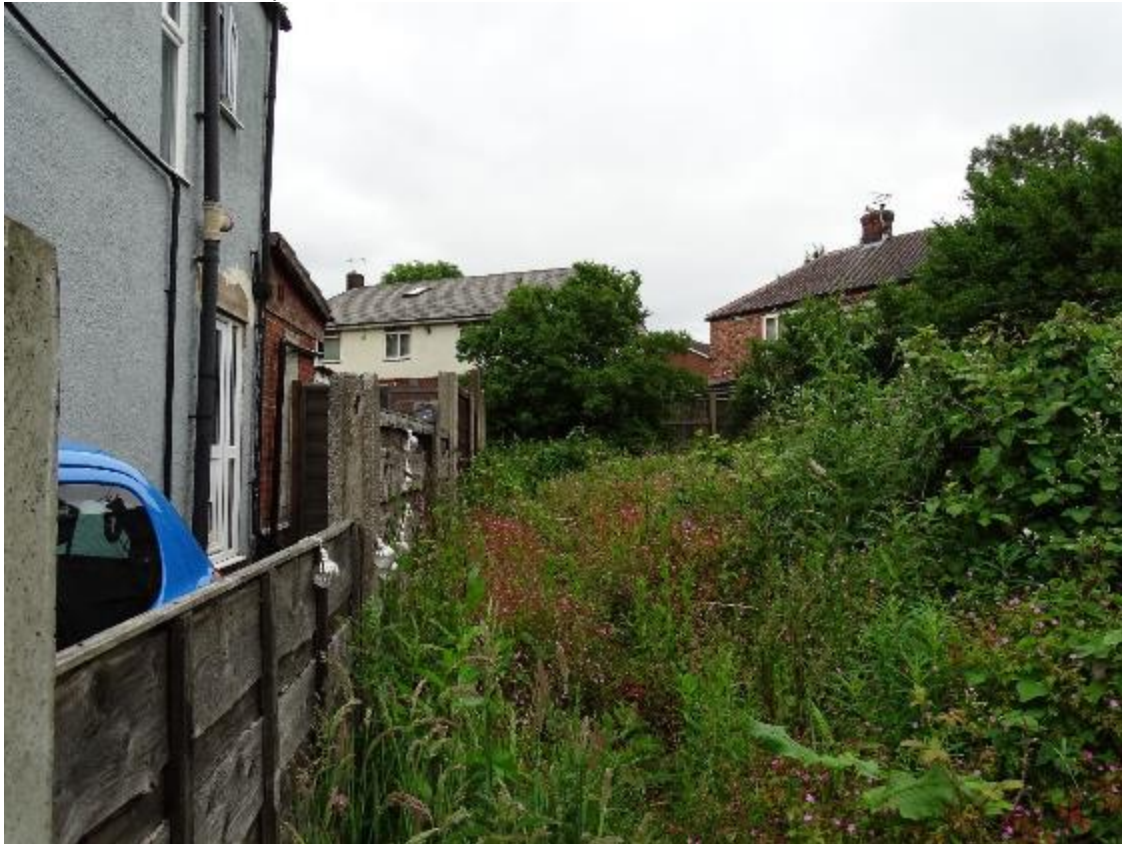
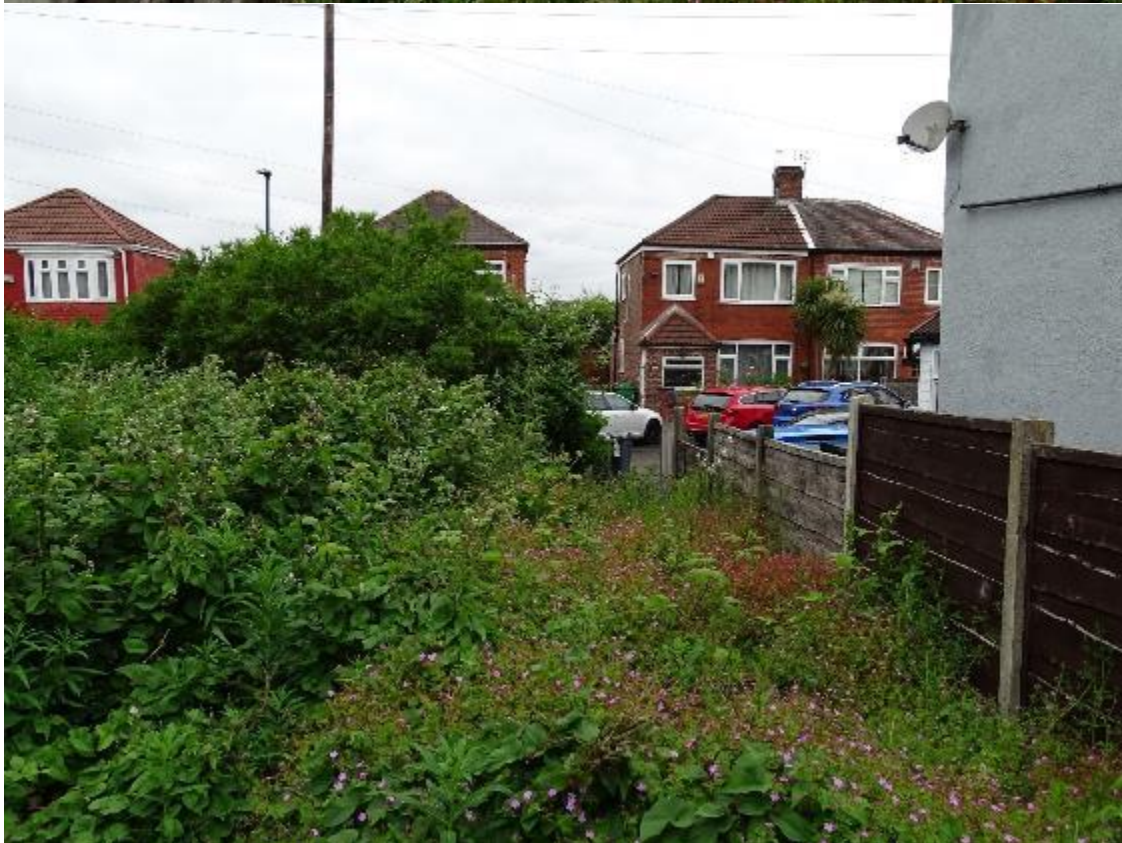
The northern boundary

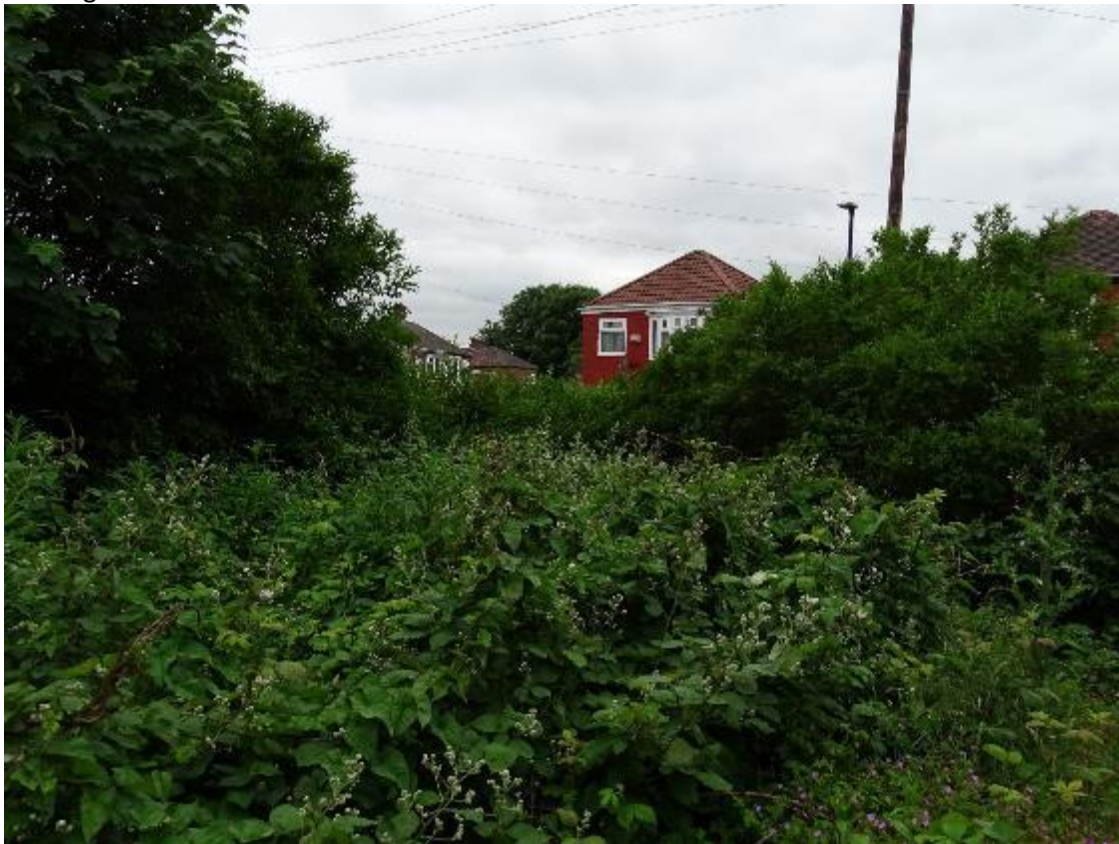
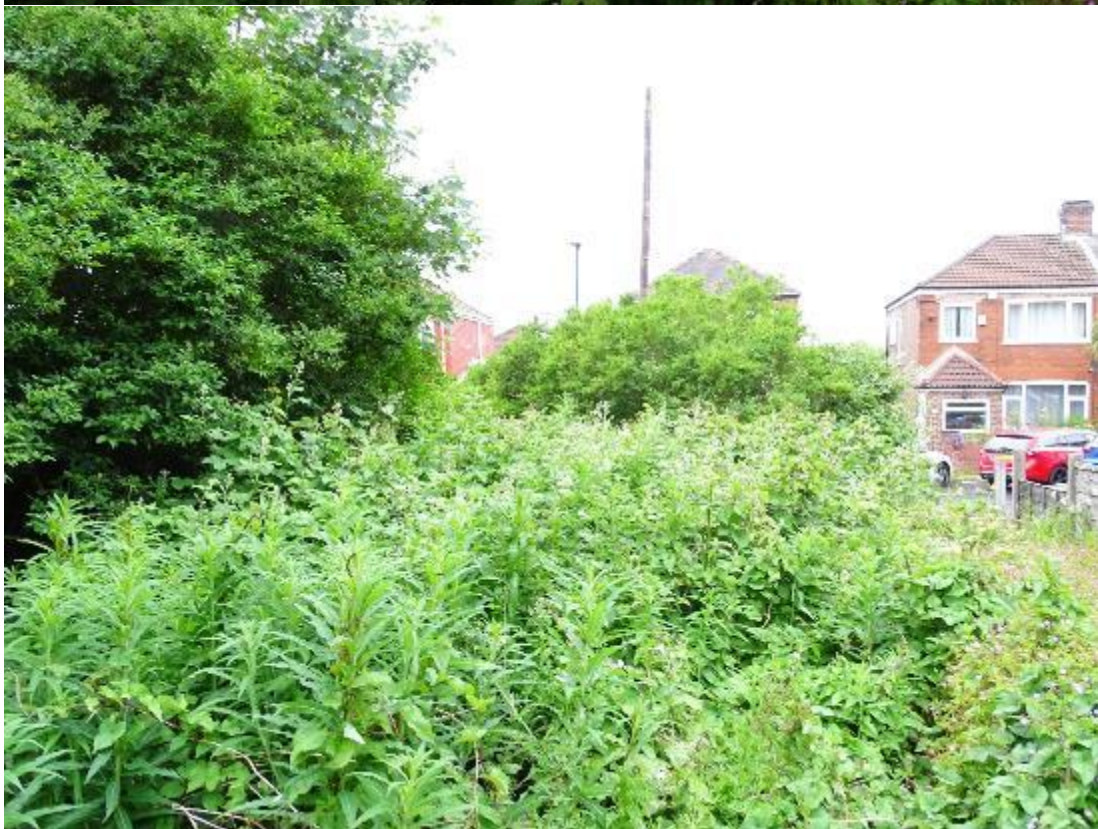
Looking back east across the site

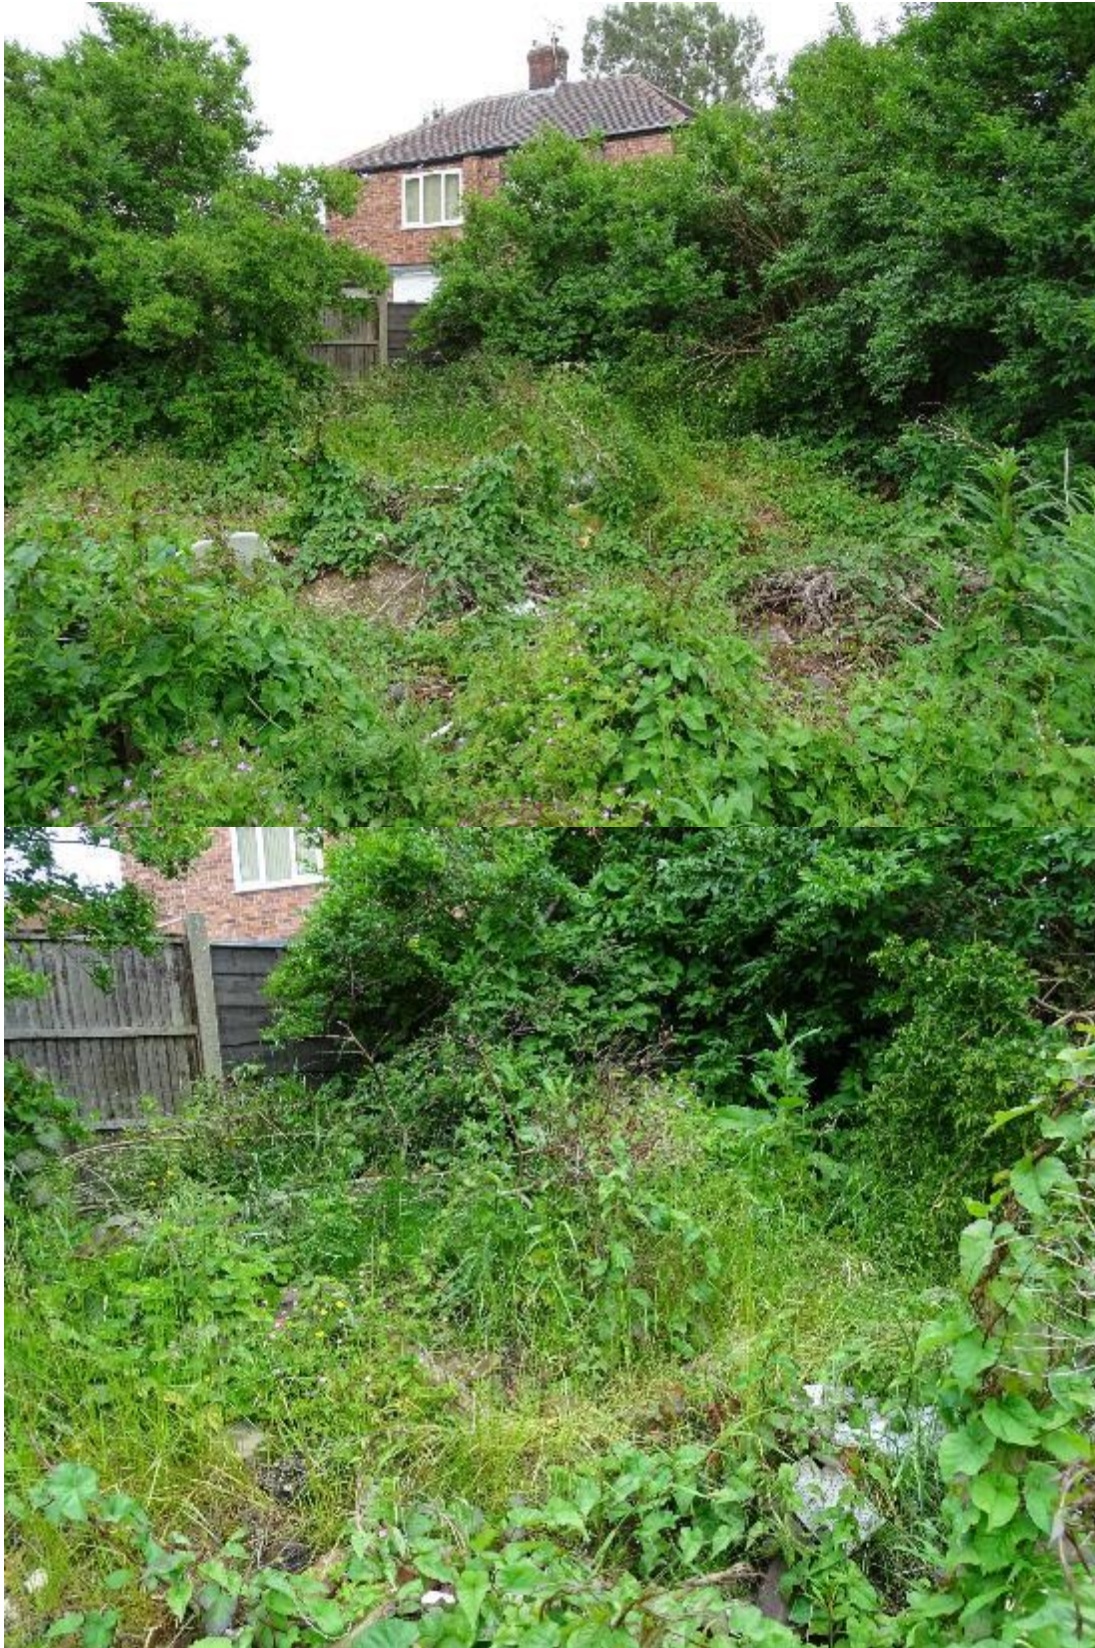
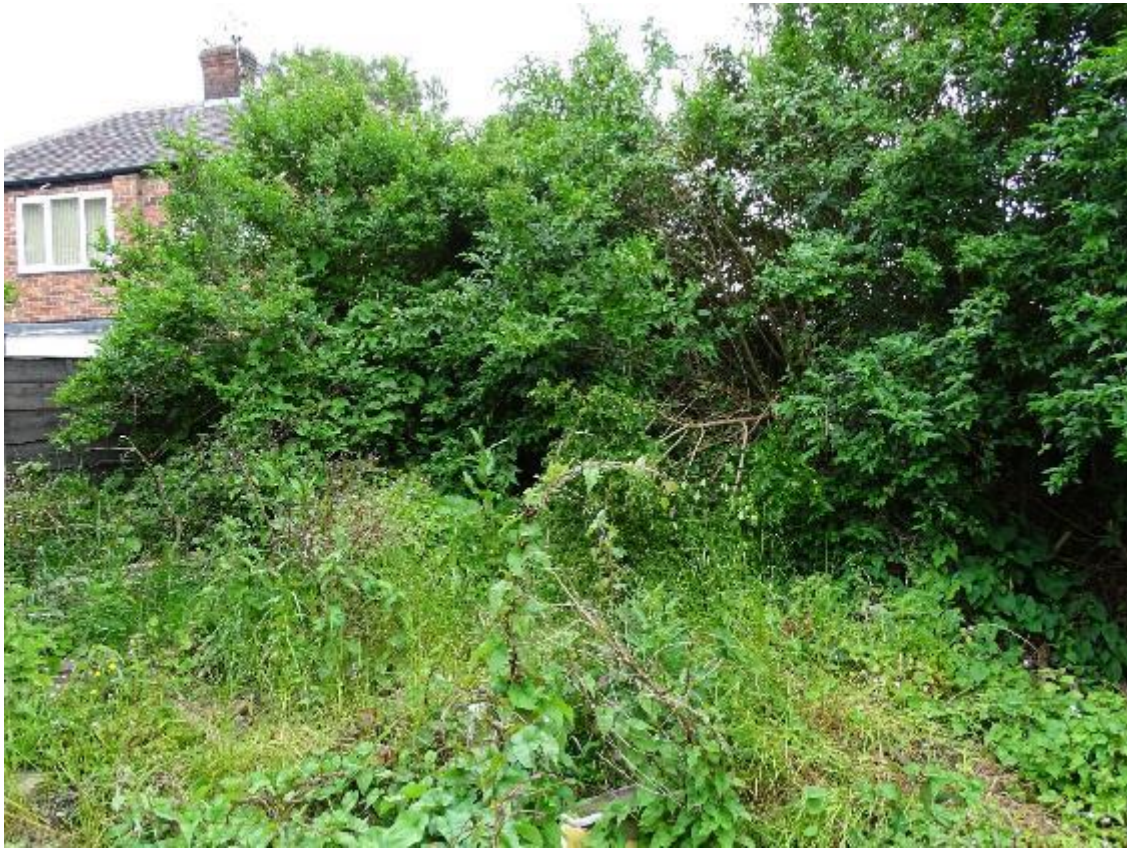
The western and southern boundaries
