**Asbestos Survey Report**  
**Premier House**  
**Deansgate, Manchester**

**Beams and Columns  
Premier House  
Manchester**

**Report No. IC21148**

**Survey Type: Refurbishment**

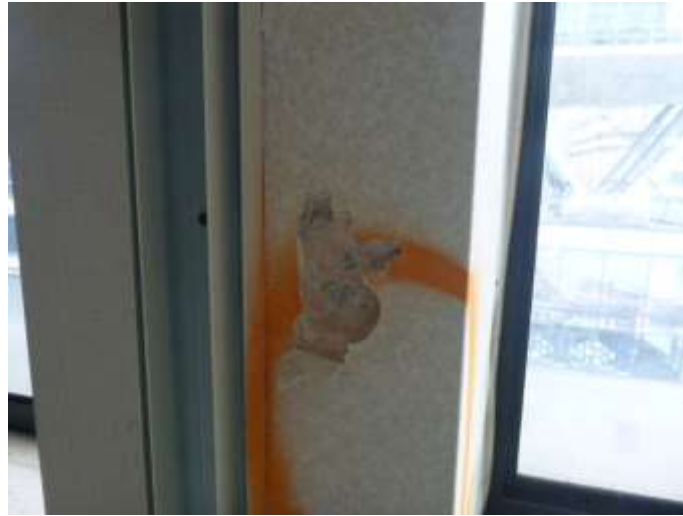
**Plaster to Column C1**

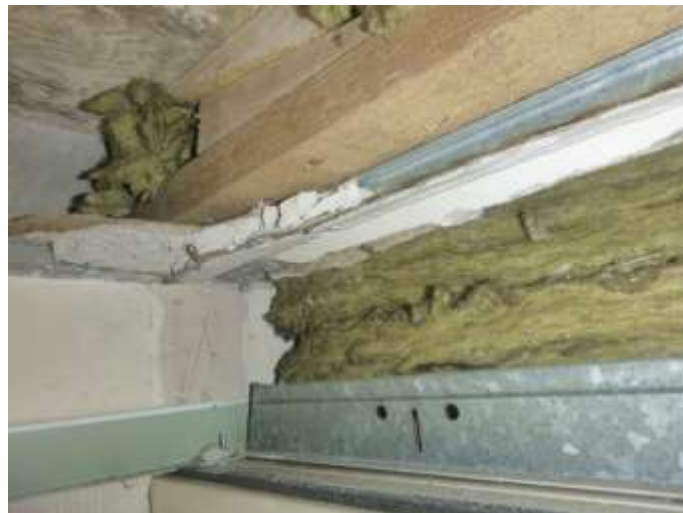
**Plasterboard and Rockwool adjacent to the Top of Column C1**

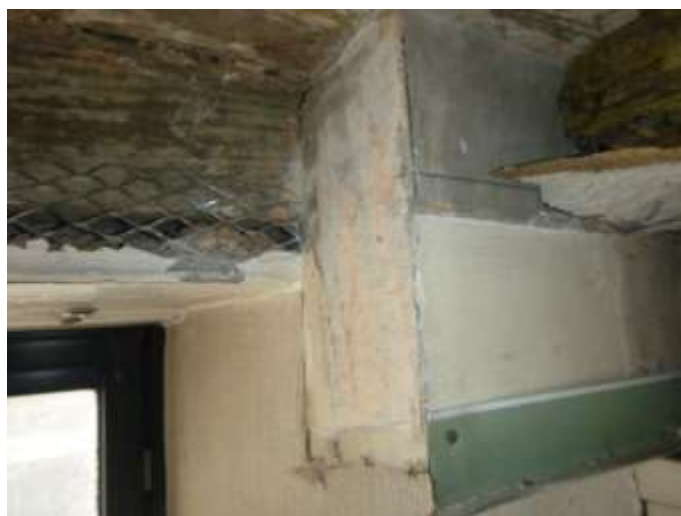
**Concrete and Plaster to Beam at Top of Column C1**

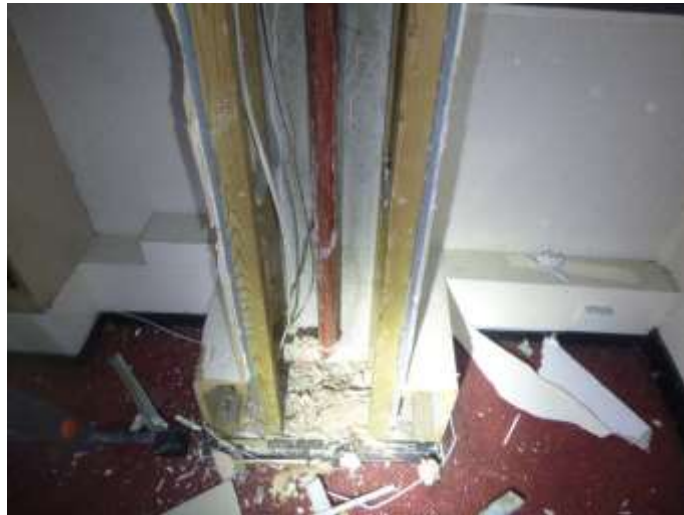
**Timber with Mesh and Plaster to Front of Column C2**

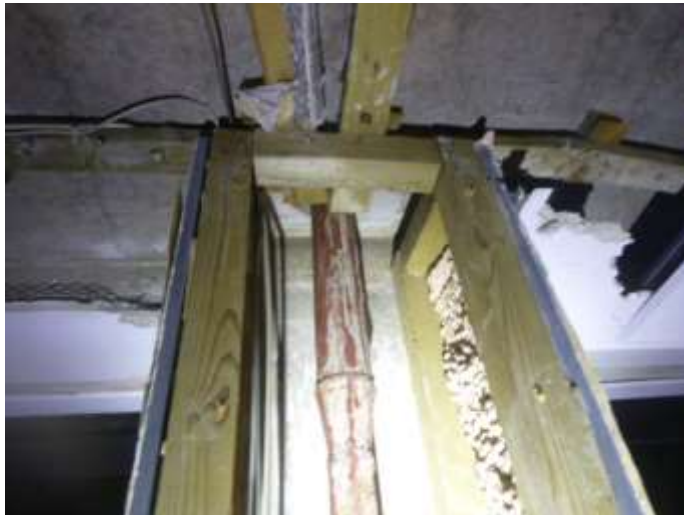
**Non-Insulated Pipe in Boxing to Column C2**

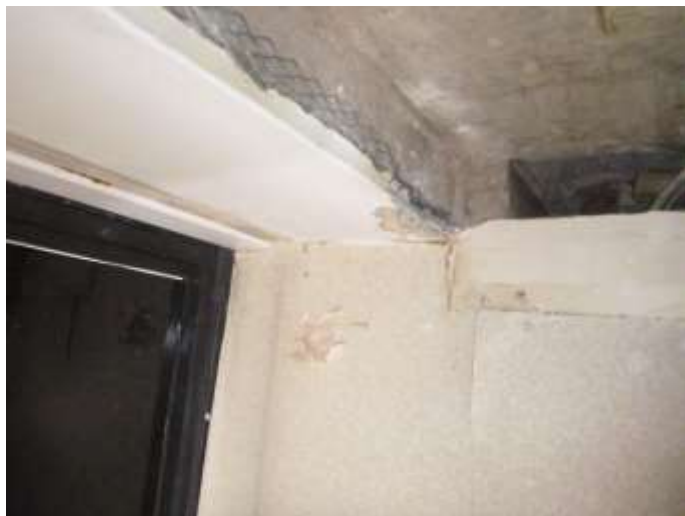
**Concrete and Plaster to Beam at Top of Column C2**

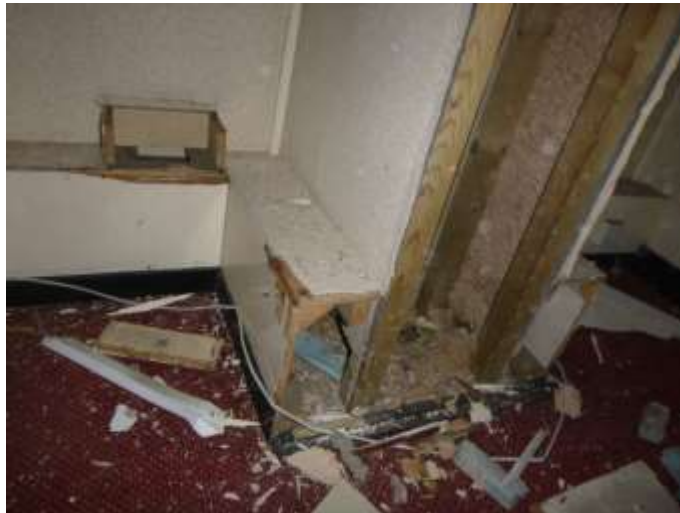
**Timber Boxing to Base of Column C2**

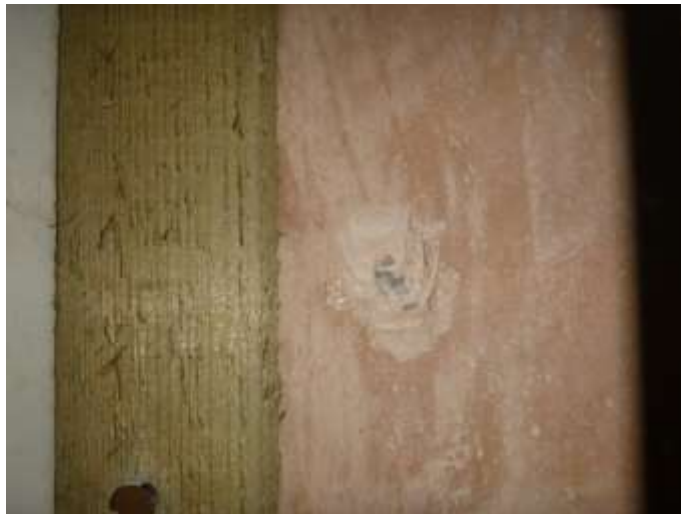
**Plaster over Concrete to Column C3**

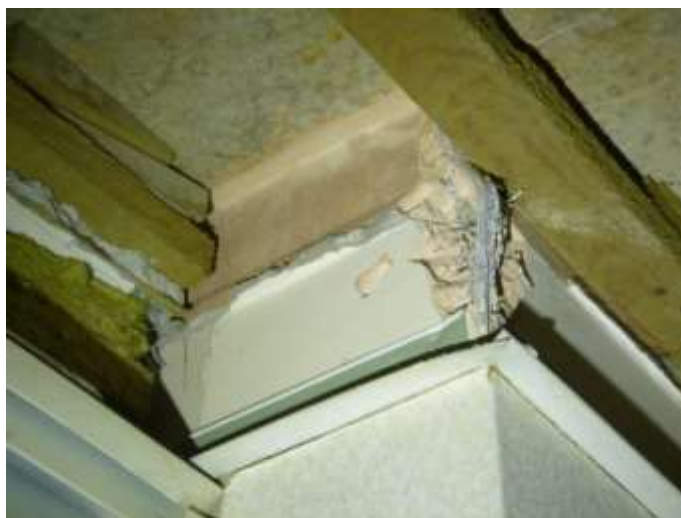
**Rockwool and Timber to Top of Column C3**

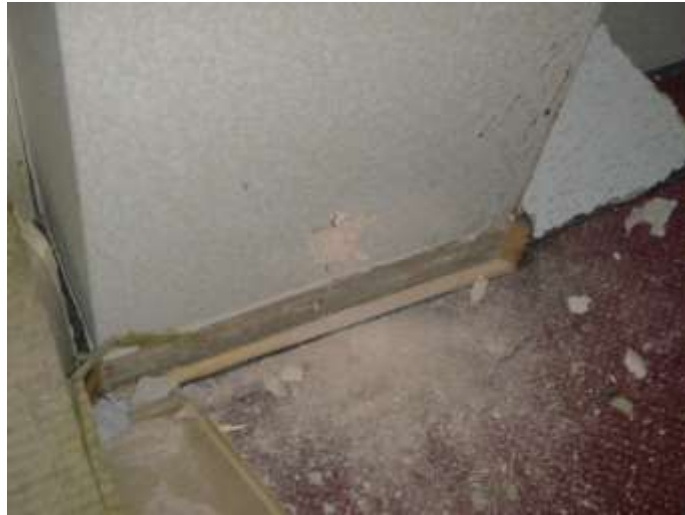
**Concrete and Plaster with Timber Skirting to Base of Column C3**

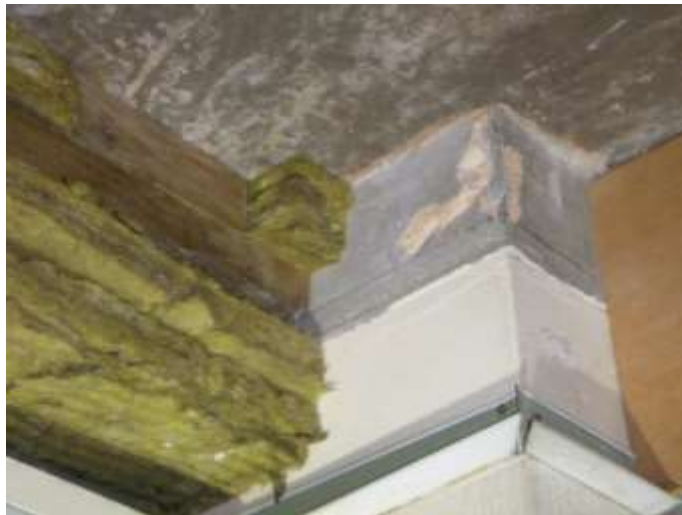
**Concrete and Plaster to Top of Column C4**

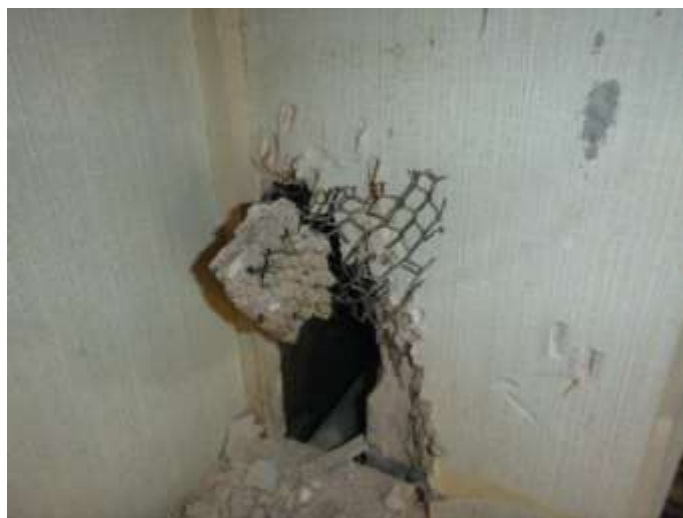
**Mesh and Plaster to Base of Column C4**

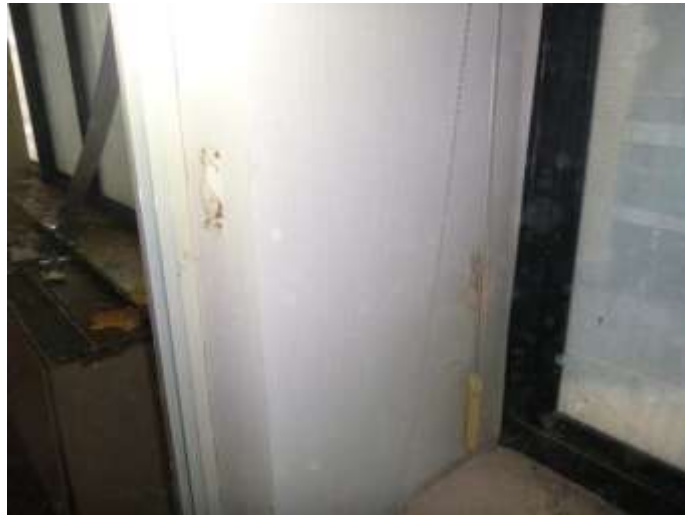
**Concrete and Plaster to Column C4**

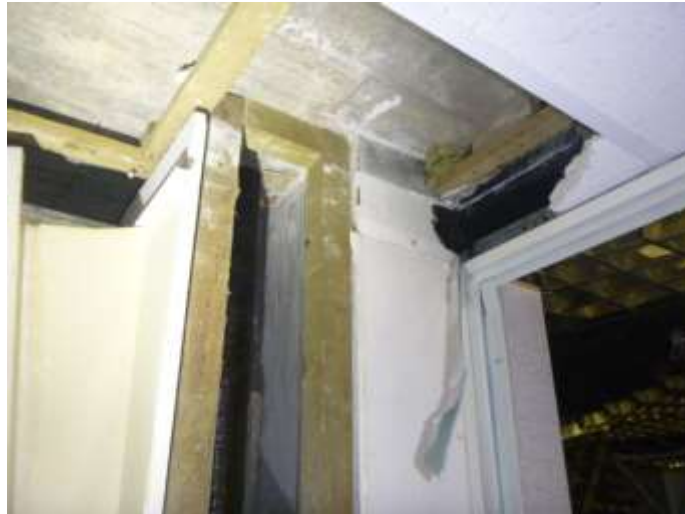
**Timber Boxing to Column C5**

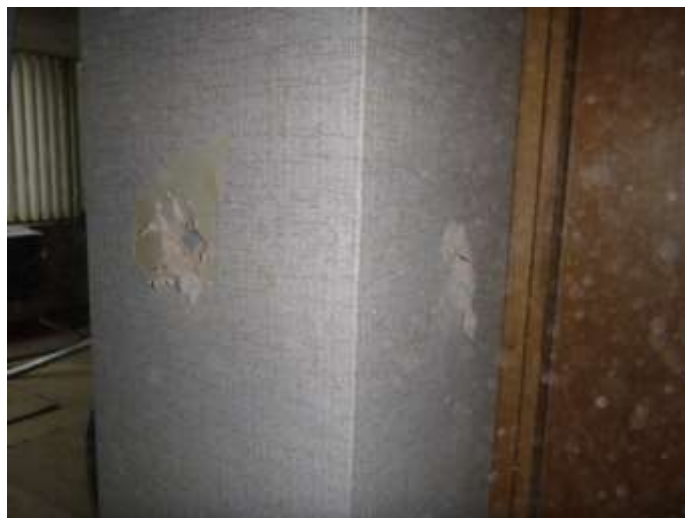
**Concrete and Plaster to Column C5**

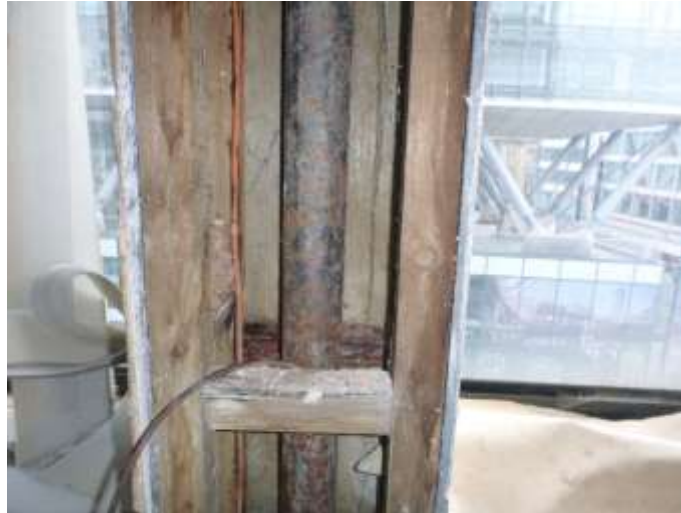
**Timber and Plaster Boxing to Column C6**

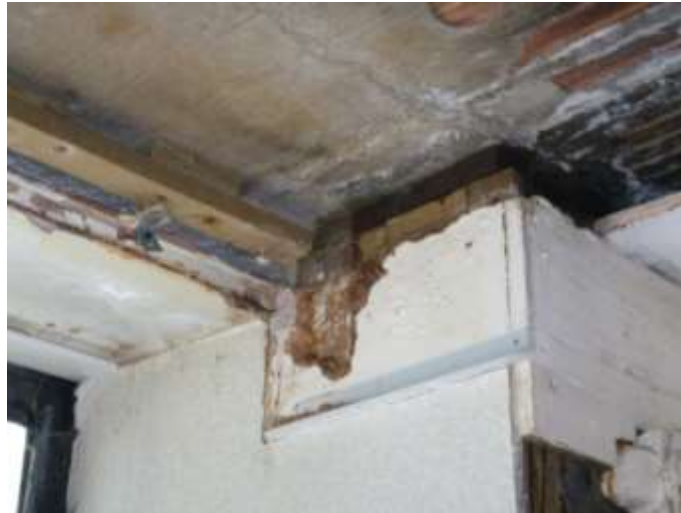
**Plaster to Beam and Timber Boxing to Top of Column C6**

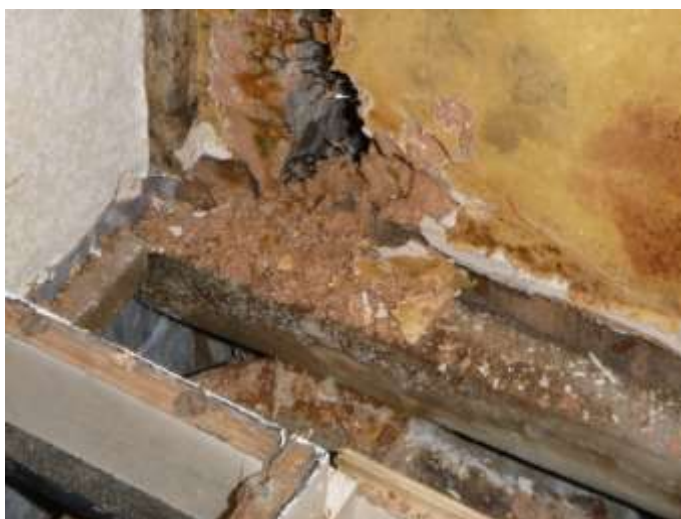
**Mesh and Plaster with Timber Boxing to Base of Column C6**

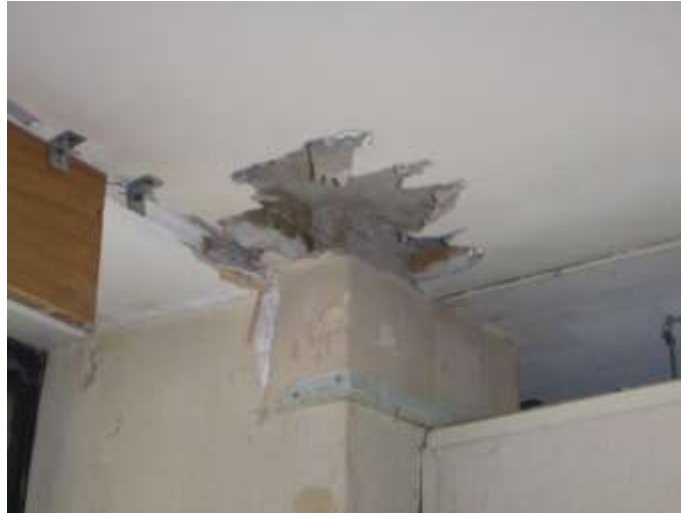
**Concrete and Plaster to Top of Column C6**

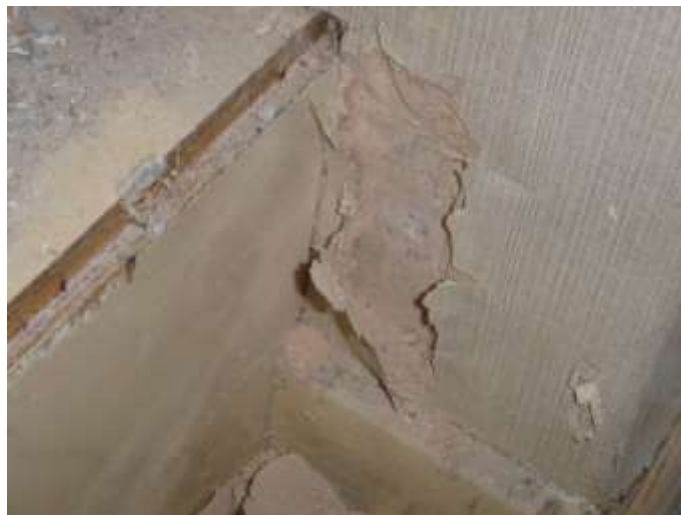
**Concrete and Plaster to Column C7**

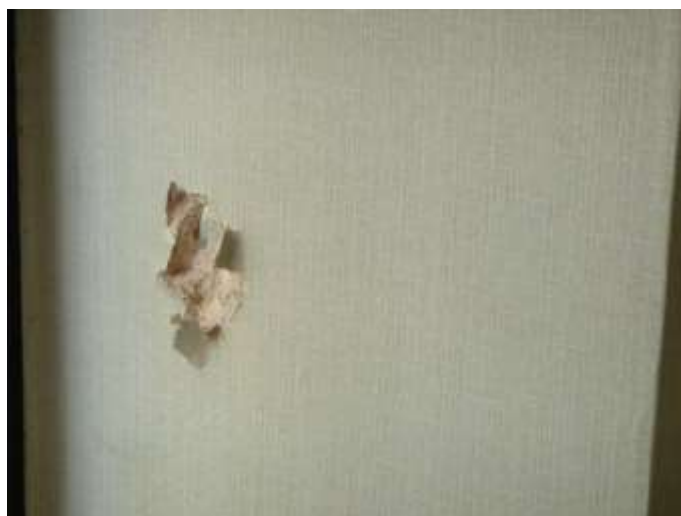
**Concrete and Plaster to Column C7**

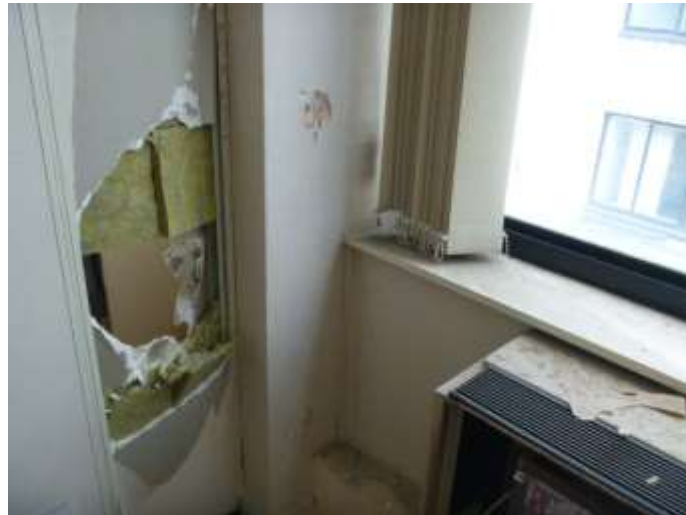
**Concrete and Plaster to Column C7 (Plasterboard and Rockwool to Partition)**

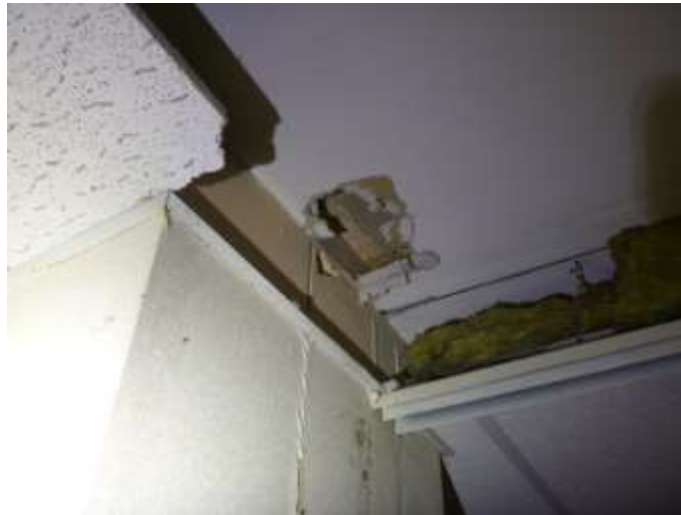
**Plasterboard to Ceiling at Top of Column C7**

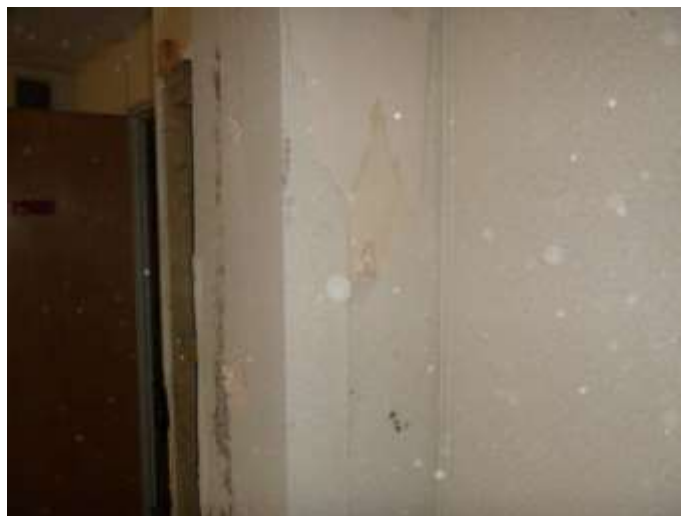
**Concrete and Plaster to Column C8**

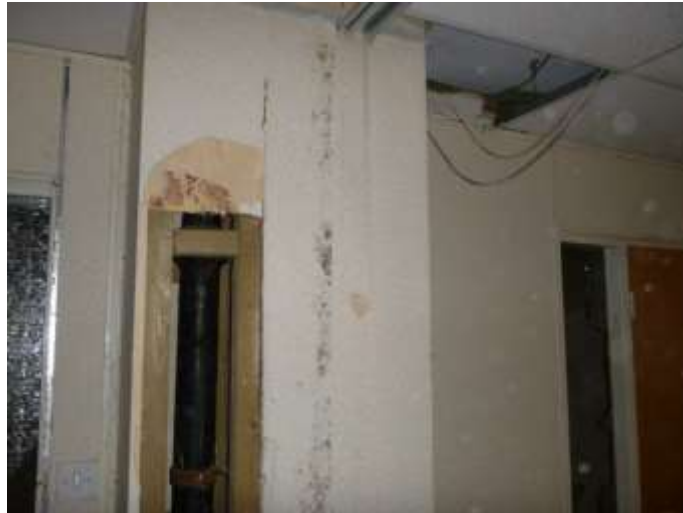
**Timber Boxing to side of Column C8**

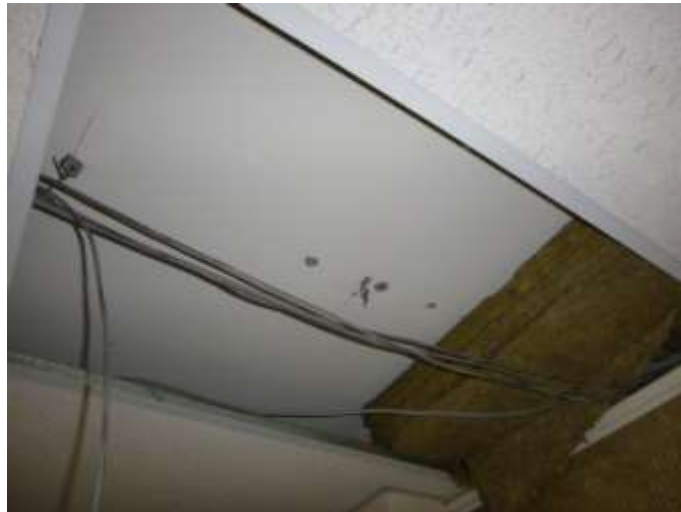
**Plasterboard to Ceilings below L02 Slab**

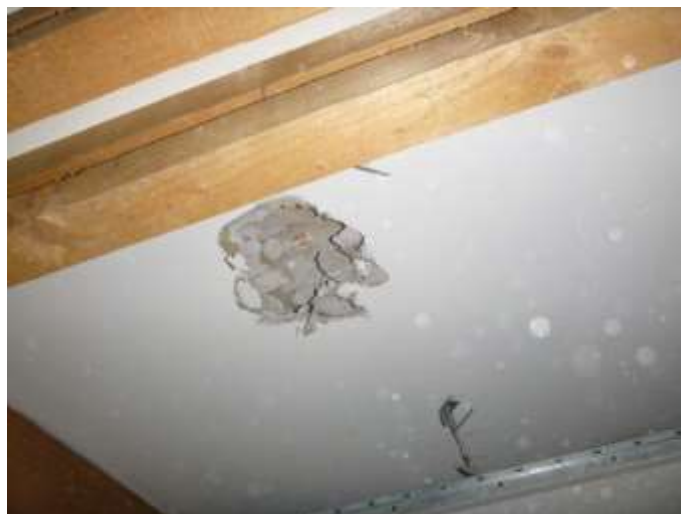
**Plasterboard to Ceilings below L02 Slab**

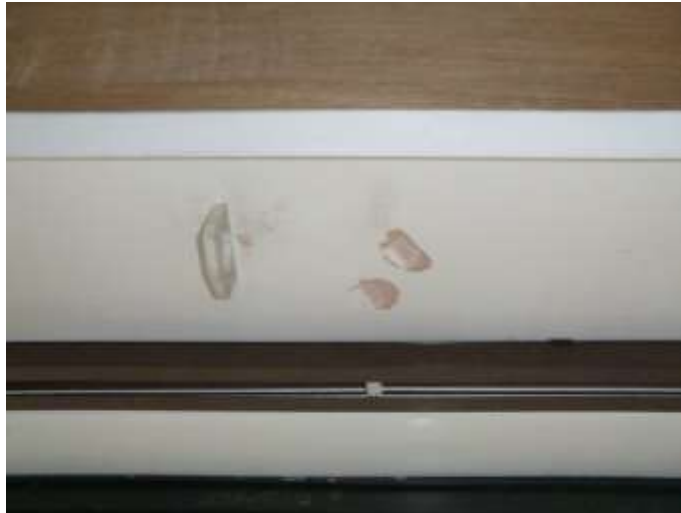
**Plaster to Beams above Windows**

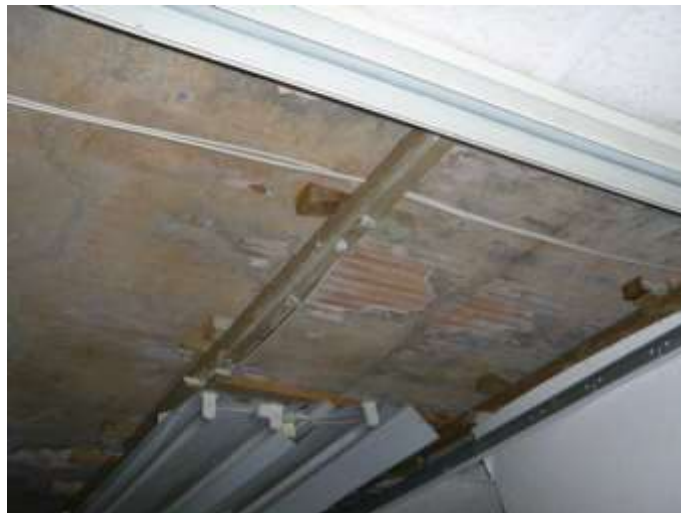
**Pot and Beam to L03 Slab**
