# Geo-Environmental Preliminary Risk Assessment Talbot Mill, Ellesmere Street, Manchester

Presented to **Capital and Centric Ltd**

Issued: January 2017

Delta-Simons Project No. 16-1144.01

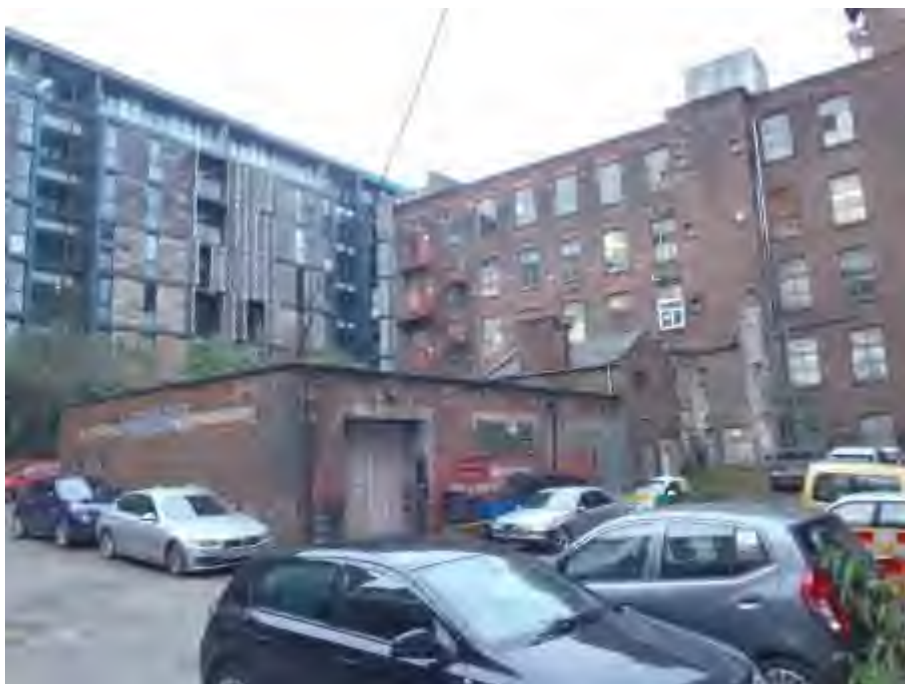
Photograph 1 – Looking south-east at courtyard area, garage and southern mill building

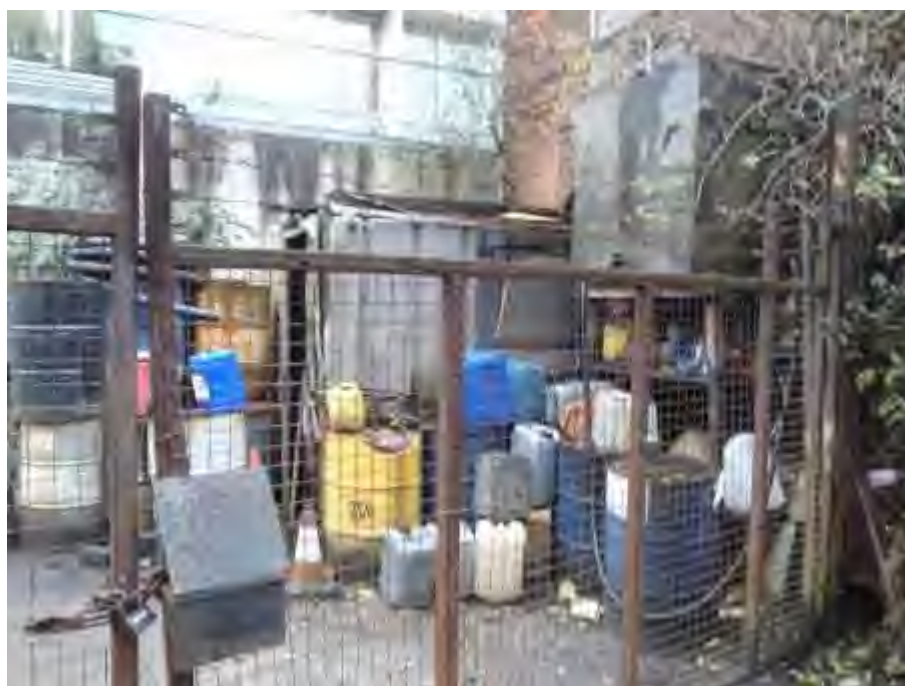
| Pollutant Linkage Assessment | | | | |
|---|---|---|---|---|
| S5 Existing yard area | P1, P2, P4 | R1, R2, R3, R4, R5, R6, R7 | <b>Moderate Risk</b> | The existing yard could not be thoroughly inspected during the walkover; however, an AST, oil drums and cans were observed to be stored in this area with the hardstanding appearing to be in relatively poor condition, thus providing a potential pathway to underlying ground. It is considered that potential pollutant linkages may exist between soils / waters contaminated by this sources and future residents and the identified controlled waters receptors. As discussed for S1 potential risks to construction workers and off-site receptors during construction is considered low. |

Photograph 2 – AST, drum and jerry can storage in yard in north-west of Site

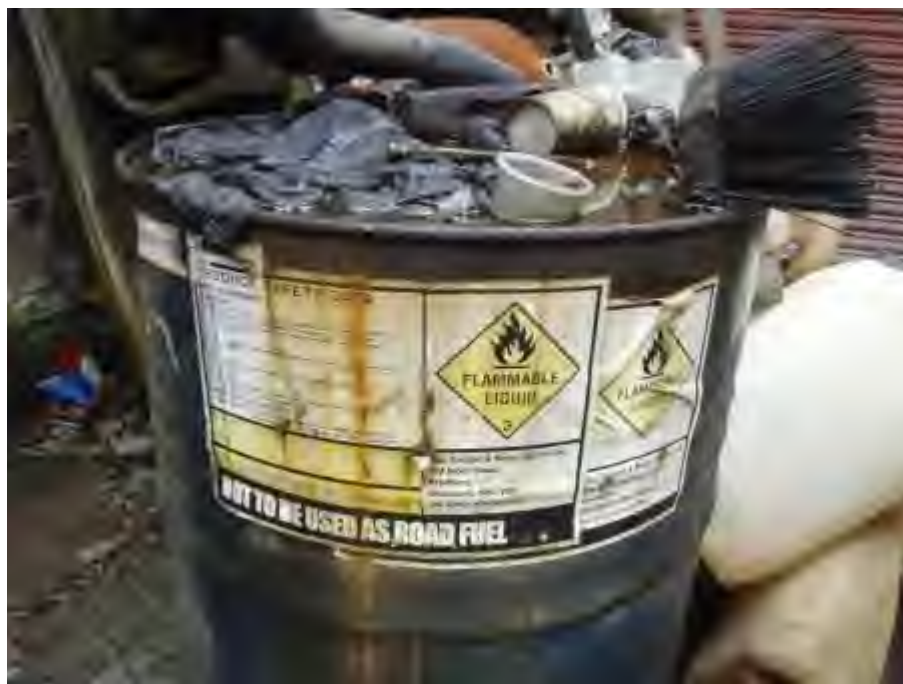
| Pollutant Linkage Assessment | | | | |
|---|---|---|---|---|
| S6 Existing Garage | P1, P2, P4 | R1, R2, R3, R4, R5, R6, R7 | <b>Moderate Risk</b> | Dark staining of the floor and localised oil spillages were observed within the existing garage located in the courtyard along with storage of motor oil. The hardstanding appeared to be in relatively poor condition thus providing a potential pathway to underlying ground. It is considered that potential pollutant linkages may exist between soils / waters contaminated by this sources and future residents and the identified controlled waters receptors. As discussed for S1 potential risks to construction workers and off-site receptors during construction is considered low. |

Photograph 3 – Motor oil drum in north-west of Site

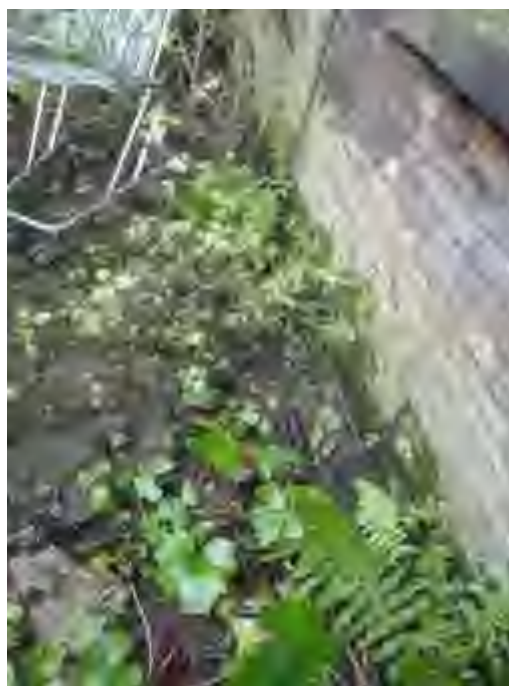
| | External surfacing on Site comprised a mix of hardstanding and cobbles, in relatively poor condition. Drainage grates appeared to be in poor repair and overgrown in several places (Photograph 4). | |

Photograph 4 – Overgrown drainage

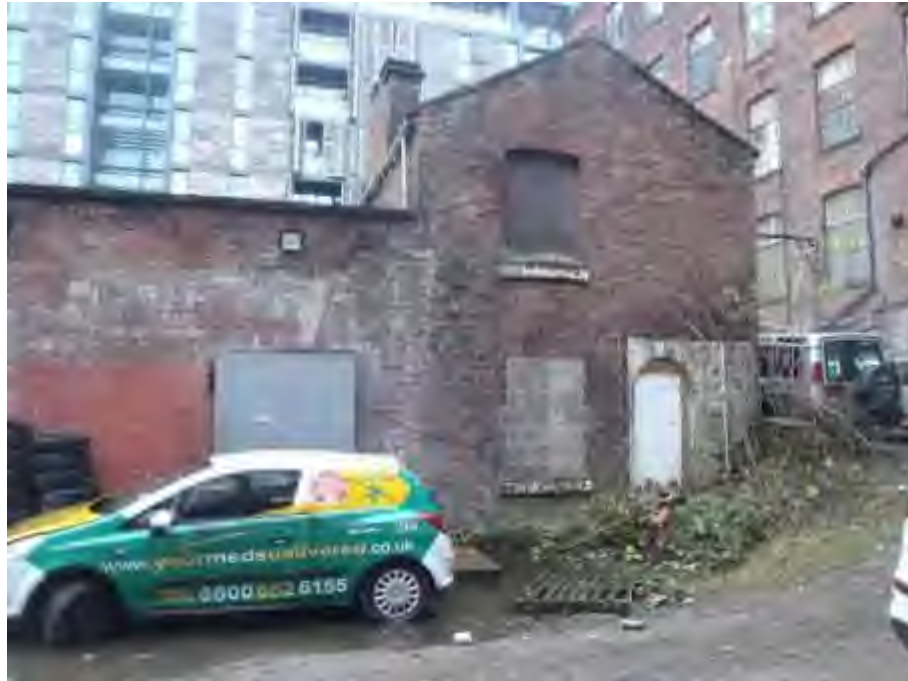
| <b>Groundworks</b> | <p>Anecdotal information from existing tenants indicated that the basement and ground floor of the existing buildings flooded recently indicating shallow groundwater depths which may cause issues during construction.</p> |

Photograph 5 – Garage and attached cottage in central courtyard, with standing water west of the garage

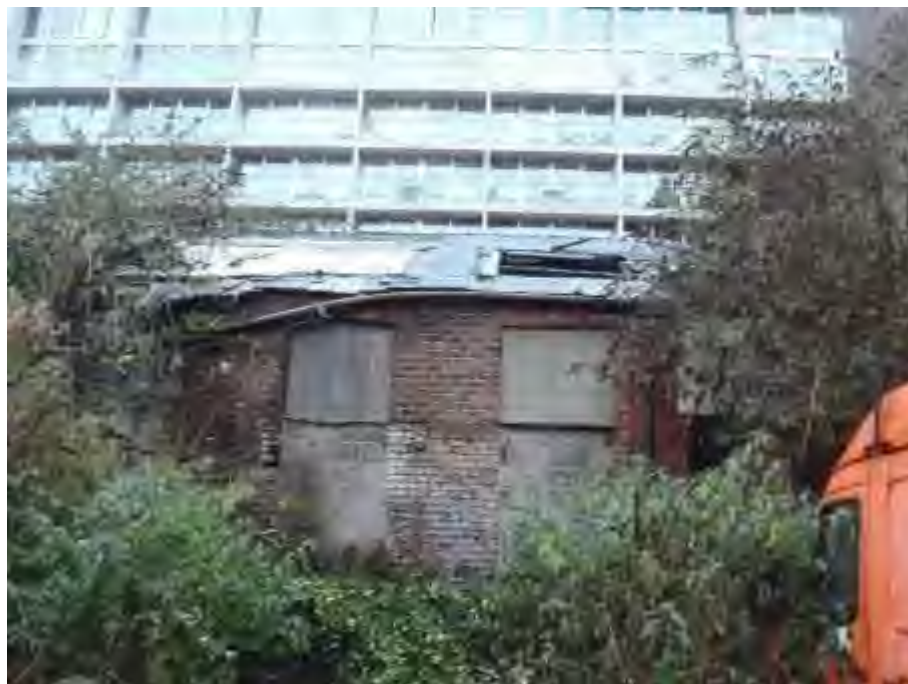
Photograph 6 – Derelict building in north of Site

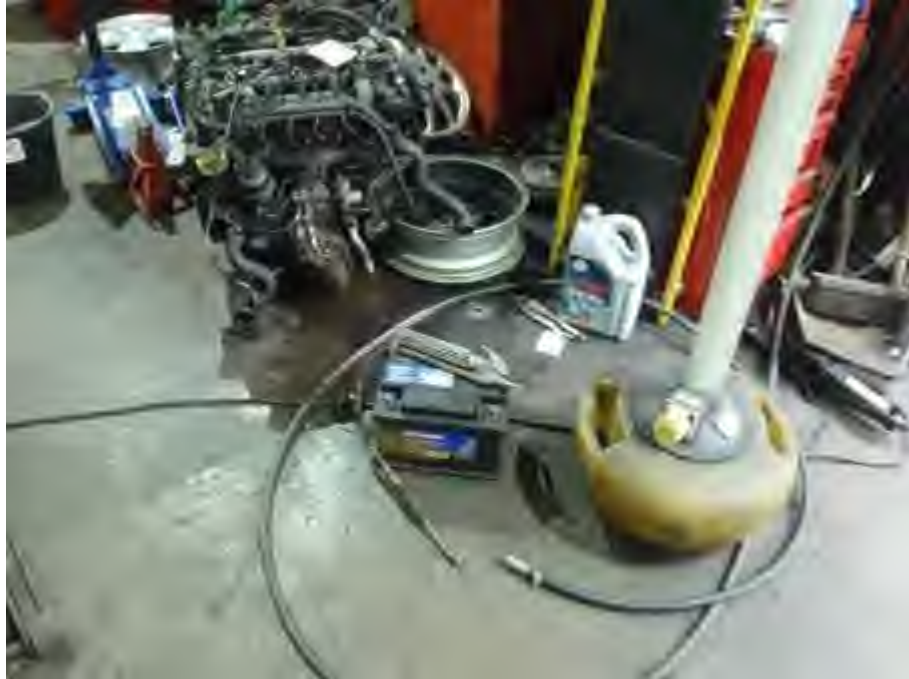
Photograph 7 – Garage interior and staining

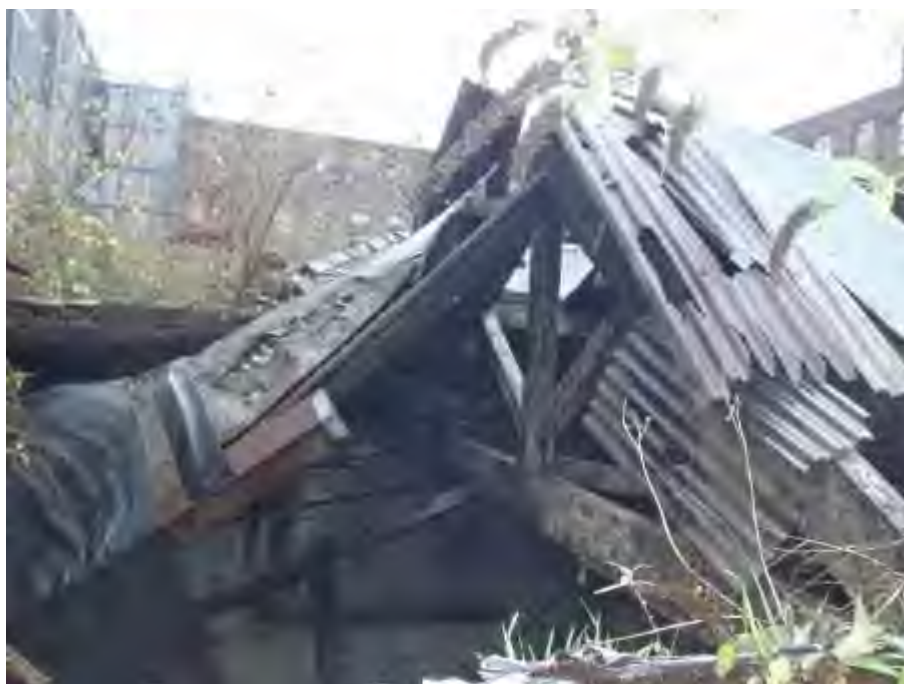
| Pollutant Linkage Assessment | | | | |
|---|---|---|---|---|
| S4 Existing Building | P1 | R1, R2, R3 | <b>Low Risk</b> | It is understood that some asbestos removal works have been undertaken recently within the basement area; however, potential ACMs were noted during the walkover. It is considered that all the existing buildings may contain ACMs, which during demolition may contaminate the ground. A pre-demolition asbestos survey should be undertaken followed by a controlled removal by an appropriate contractor to mitigate the risk. |

Photograph 14 – Derelict building roof in north of Site; suspected ACM panels

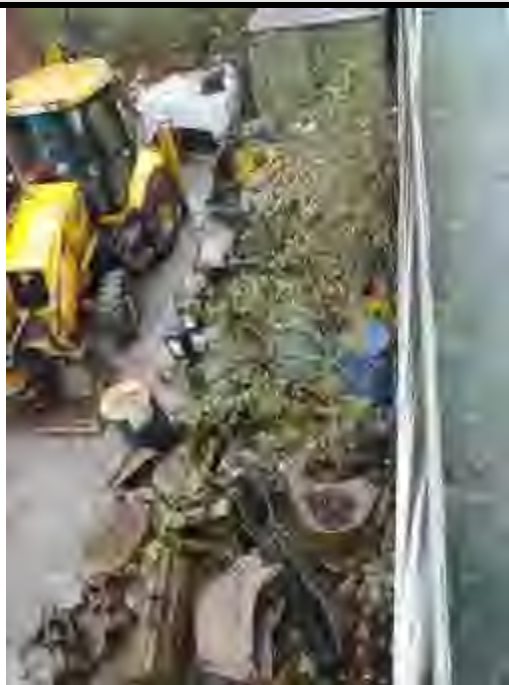
Photograph 15 – Storage yard in north-west of Site

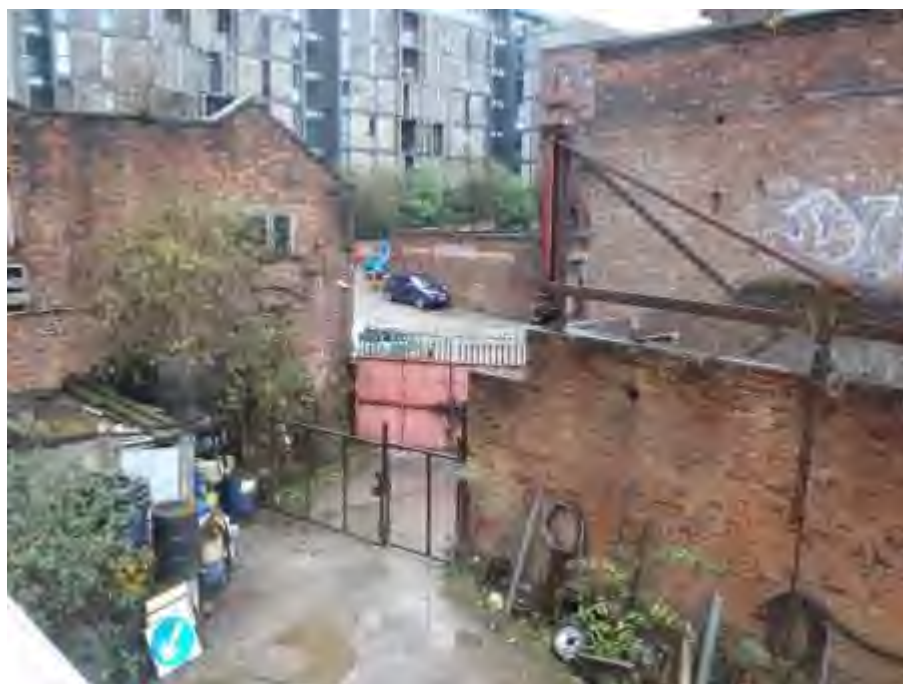
Photograph 16 – Storage yard with AST in north-west of Site
