10 Minshull Street and 11 Bloom Street

**SCAFFOLDING OPTIONAL APPRAISAL**

LISTED BUILDING CONSENT CONDITION RELEASE 5

Planning Permission 119375/LO/2018 & 119373/LO/2018

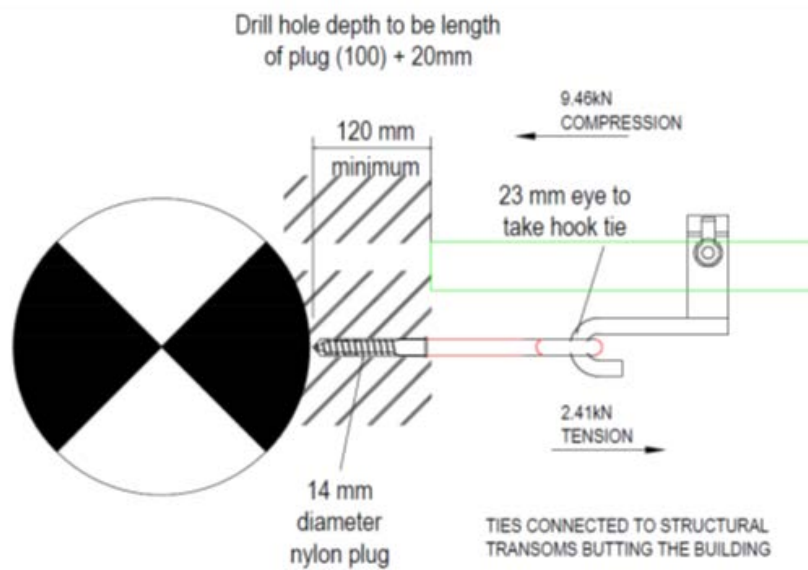
Fig.1 – Tie detail

The proposed ties will be drilled precisely and exclusively at the 'T' junction of the horizontal bed and vertical perp joints in order to avoid damaging the adjacent brickwork. From tests carried out to date the existing joints at these locations accommodate the ties without damage being caused to the existing brickwork / stonework.

The initial design based on circa 402no. ties required a calculated test load of 7.00kN to be achieved to safely secure the scaffold structure, taking into account the condition of the substrate and potential for 'creep' in the ties. However, after onsite testing, the tie failure load into the existing substrate was below 5.00kN, therefore notably less than the required test load value. Subsequently, it has been necessary to consider an alternative design and to re-calculate the number of ties required.

Ties are to be drilled precisely at the 'T' junction of the existing horizontal bed and vertical perp joints in order to avoid damaging adjacent brickwork. From tests carried out to date, the existing joints will accommodate the ties without damage being caused to the existing brickwork / stonework. Upon removal of ties from existing mortar joints, any holes or damaged mortar is to be repointed, where necessary, using an NHL 2 mortar. Being the closest to the original non-hydraulic mortar in terms of softness and permeability, NHL 2 mortar is to be used with a suitable well graded sharp sand to match existing mortar in terms of colour, texture, finish and worked appearance (in the event of any supply difficulties with NHL 2, it may be necessary to use NHL 3.5, but only if absolutely necessary). Following striking of the scaffolding, we shall attend site to identify and agree / mark up specific areas of repointing. Photographic records will be taken prior to commencement and during the works. Suitable protection will be employed. Repointing will be undertaken only where necessary. The affected mortar will be raked out in small sections to a sound surface using appropriate hand tools minimum depth of 20mm where necessary taking care to avoid damaging existing masonry. If any mortar is too hard / non-original and unable to be broken with hand tools without the potential to damage the original masonry, a suitable approved heritage blade may be used. Masonry will be adequately dampened prior to application. Mortar to be repointed flush and unfinished. Setting times will be sufficient to enable the mortar to stiffen and set. Mortar to be finished with a suitable soft bristled brush to a stippled finish showing off the aggregate in the mortar. Mortars to be adequately protected and appropriate humidity levels maintained to prevent rapid drying.

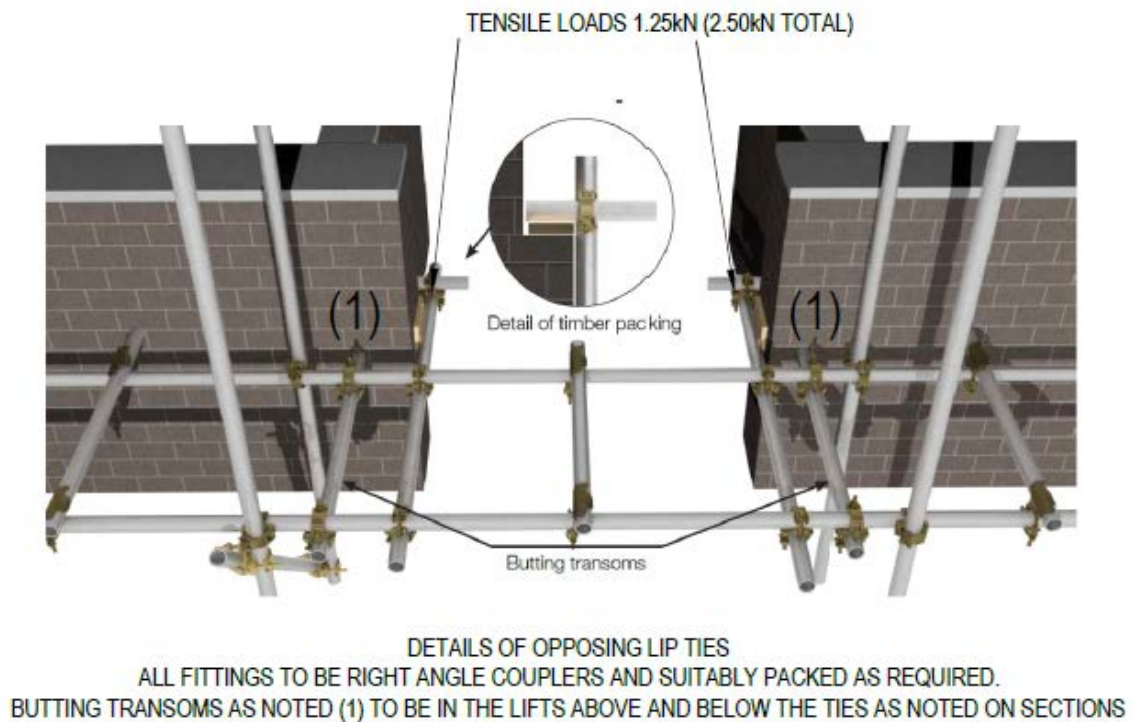
**Fig.2 Detail of opposing lip ties**

This option will require scaffolding tubes to form opposing lip ties through each window opening. Temporary protection will be installed to protect the window frame - as the load would exert on the inner side of the wall and not on the lateral side of the windows / window reveals.

This option would obstruct the window repair sequence, the façade cleaning and repairs and the internal side of the wall works (i.e. Mindel House plasterwork).

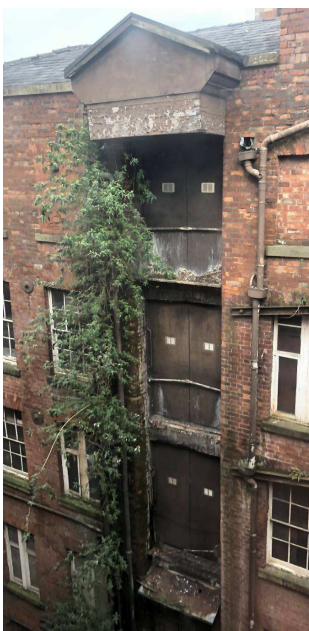
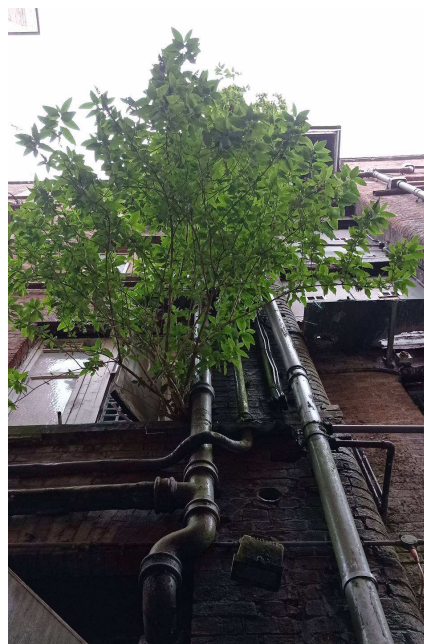
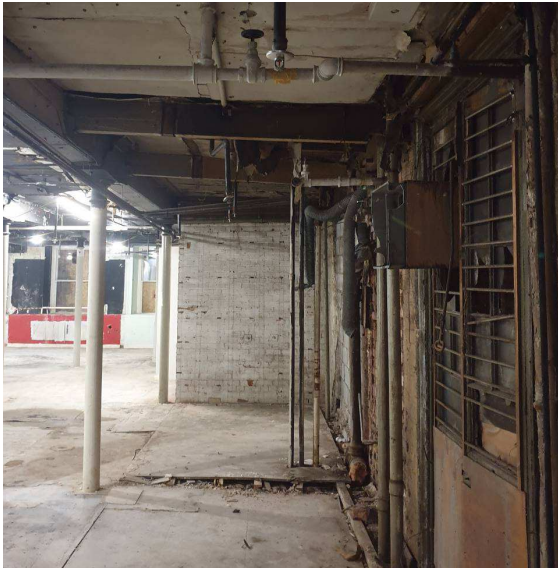
Following previous site surveys and meetings at the Mindel House building, we have raised concerns regarding the structural stability of part of the external elevation which faces the Bloom St building. There has been considerable structural movement to the central area of the wall, which is adjacent to the original goods hoist area (see image 1 below). The wall appears to have dropped in level and there is significant movement to the floor structure adjoining at every level (image 3). The timber construction around this area has suffered from rot, due to constant leaking from surface water drainage (and possibly foul in the past). As can be seen on the images below there is also considerable vegetation growth growing out of the masonry to this area.

The movement is concentrated to the masonry return to the goods hoist, which also has windows to the other side. The floors need complete removal and replacement to this area and in doing so the masonry may become unstable during the removal and re-construction, due to both the condition of the masonry and lack of restraint (the hoist and window openings create a tall 'pillar' of unrestrained masonry). We cannot guarantee the wall, and therefore likely further structure to this area, will be stable if any of the current floors are removed.

It is our recommendation temporary restraint is installed, to maintain the stability of the wall while remedial works are carried out. Once the restraint is in place, and safe access enabled, the original damaged, rotten and unstable floor structure should be removed, to allow assessment of the remaining masonry in place. At this point it can be confirmed if further remedial works are required to the masonry. The foundations of the wall should also be exposed and inspected to confirm if the movement to the wall is historic or possibly ongoing.
