# **BS 5837:2012**

## **Tree Survey and Preliminary Assessment**

**Report No:** LTM0055.PAA.01

**Project:** 120a Withington Rd, Manchester. M16 8FA

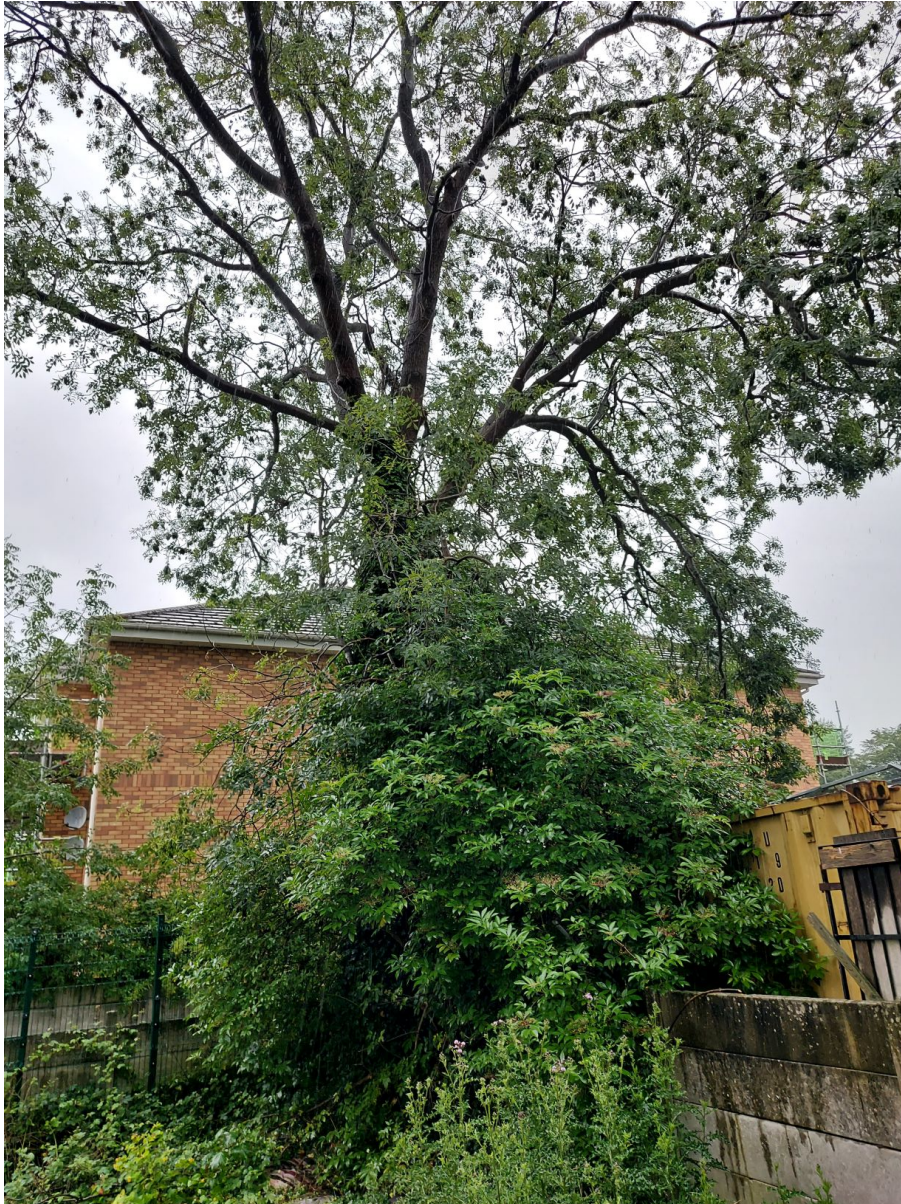
| | Arboricultural Data Sheet: 120a Withington Rd | | | | | Date of Survey: 18/06/20 | | Surveyor: Matthew Lally | | | | | | |
|---|---|---|---|---|---|---|---|---|---|---|---|---|---|---|
| T1 | Ash | 720 | 235m2 | 18 | M | 8 | 6 | 8 | 8 | 8N | B | A tree of average forma and good vigour located on site boundary adjacent to alley way. Trees is Highly Visible from public viewpoints. Limited inspection due to Ivy on stem. Overextended limbs present. Minor deadwood present<br>-<br><b>Reduce crown by 20%. Remove major deadwood. Sever Ivy</b> | 20+ | B1 |

T1. A large specimen located on the boundary of the site.

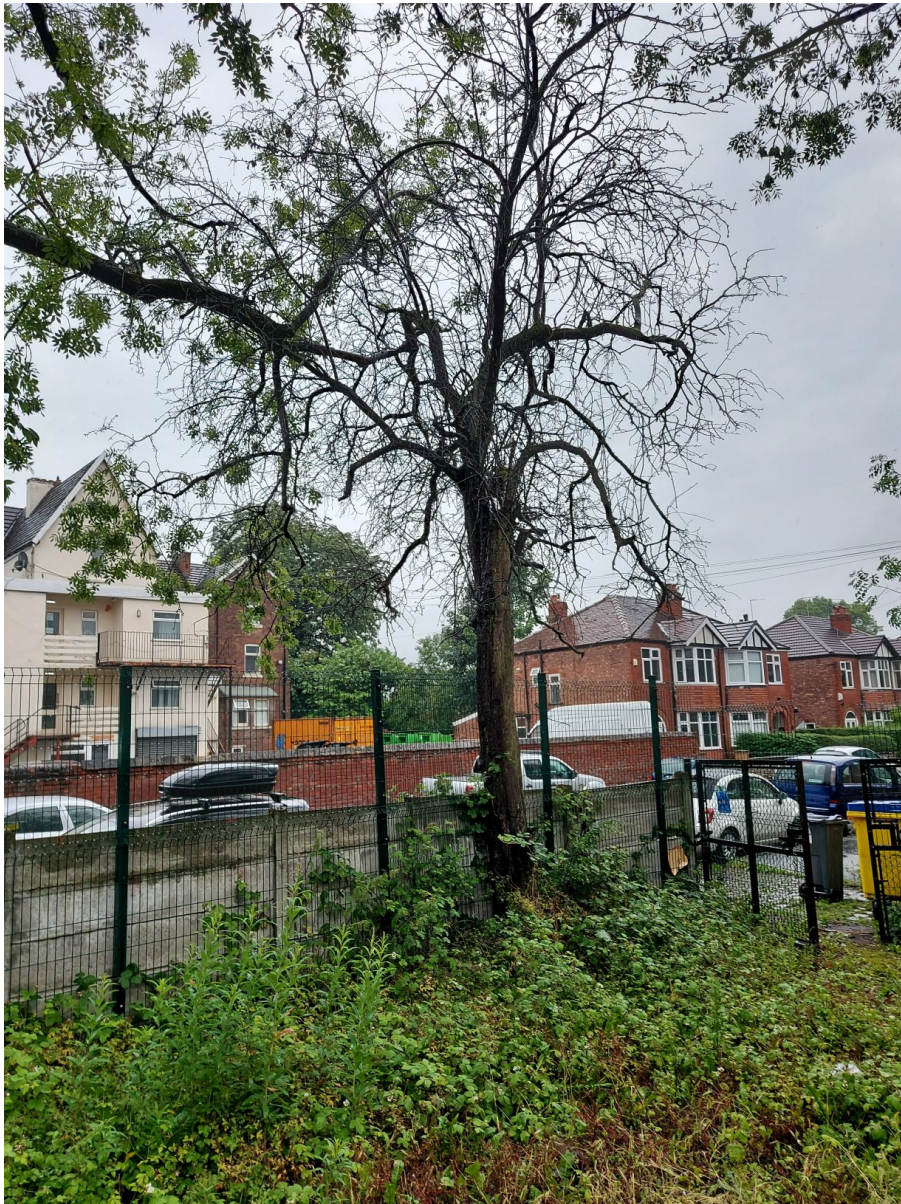
There are 3 category B trees and 1 category C tree located on the site boundaries. There is a category U tree located adjacent to the main gates. This category U tree has died and should be removed to prevent damage of injury.

| | Arboricultural Data Sheet: 120a Withington Rd | | | | | Date of Survey: 18/06/20 | | Surveyor: Matthew Lally | | | | | | |
|---|---|---|---|---|---|---|---|---|---|---|---|---|---|---|
| T2 | Thorn | 300 | 41m2 | 9 | M | 4 | 4 | 4 | 4 | 3.5W | D | A dead standing tree located on site boundary adjacent to May Rd. Branches leaning over footpath.<br>-<br><b>Fell to ground</b> | - | U |

T2. A dead standing tree that should be removed regardless of the planning outcome.

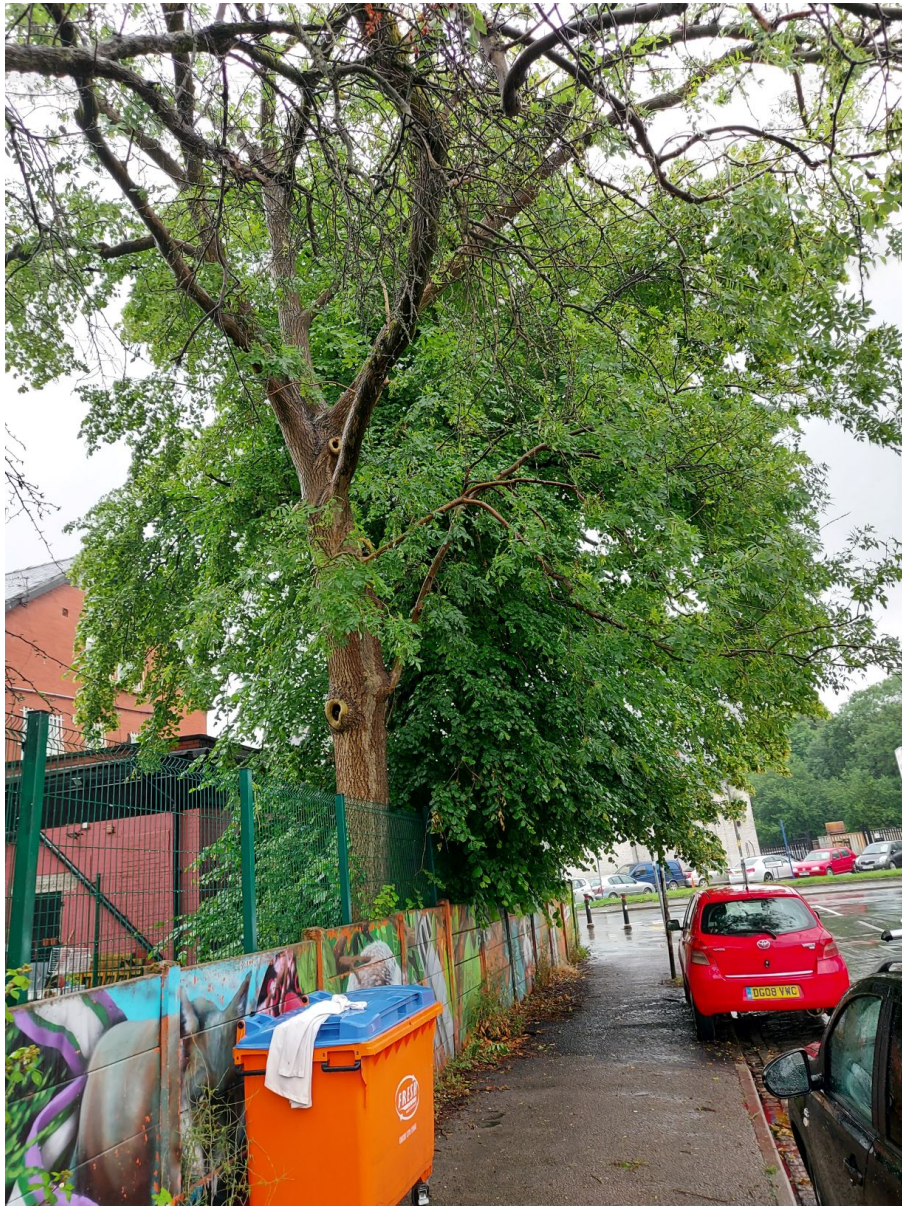
| | Arboricultural Data Sheet: 120a Withington Rd | | | | | Date of Survey: 18/06/20 | | Surveyor: Matthew Lally | | | | | | |
|---|---|---|---|---|---|---|---|---|---|---|---|---|---|---|
| T3 | Ash | 580 | 152m2 | 14 | M | 4 | 4 | 8 | 7 | 2.5W | C | A tree with reduced vigour located on site boundary adjacent to May Rd. Large pruning wounds on main stem with only minor occlusion and significant levels of decay. Possible column of decay in main stem. Early stages of die back in upper and mid crown possibly caused by Ash Die Back. Tree is Highly Visible from public viewpoints. Low branches over footpath.<br>-<br><b>Crown lift to 4m. remove major deadwood. Monitor annually</b> | 10+ | C1 |

T3. Old Pruning wounds with decay can clearly be seen on the main stem.

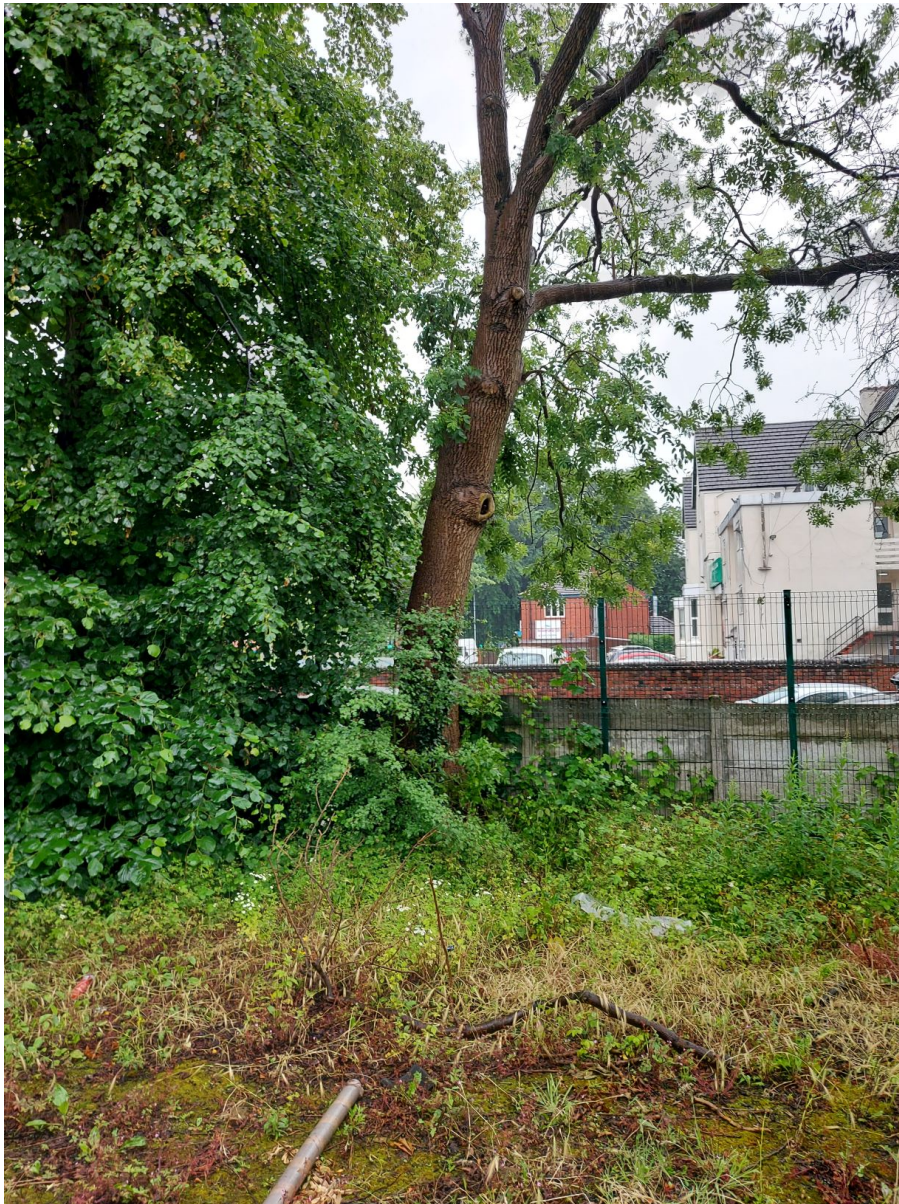
T3. This tree has reduced vigour and an asymmetrical crown

Biased towards the May Rd

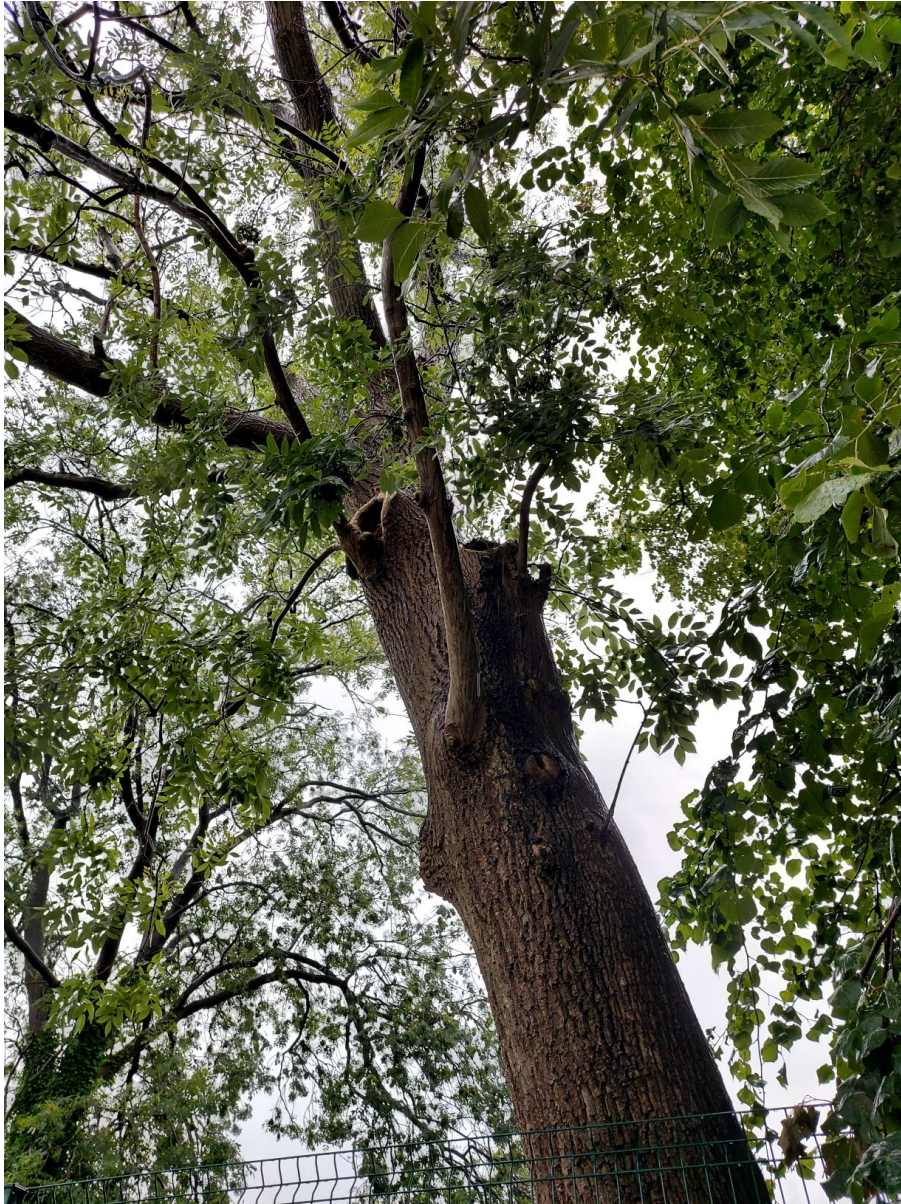
T3. Old pruning wounds with cavities can be seen on the main stem. Vigour is weak with early signs of Ash Die Back.

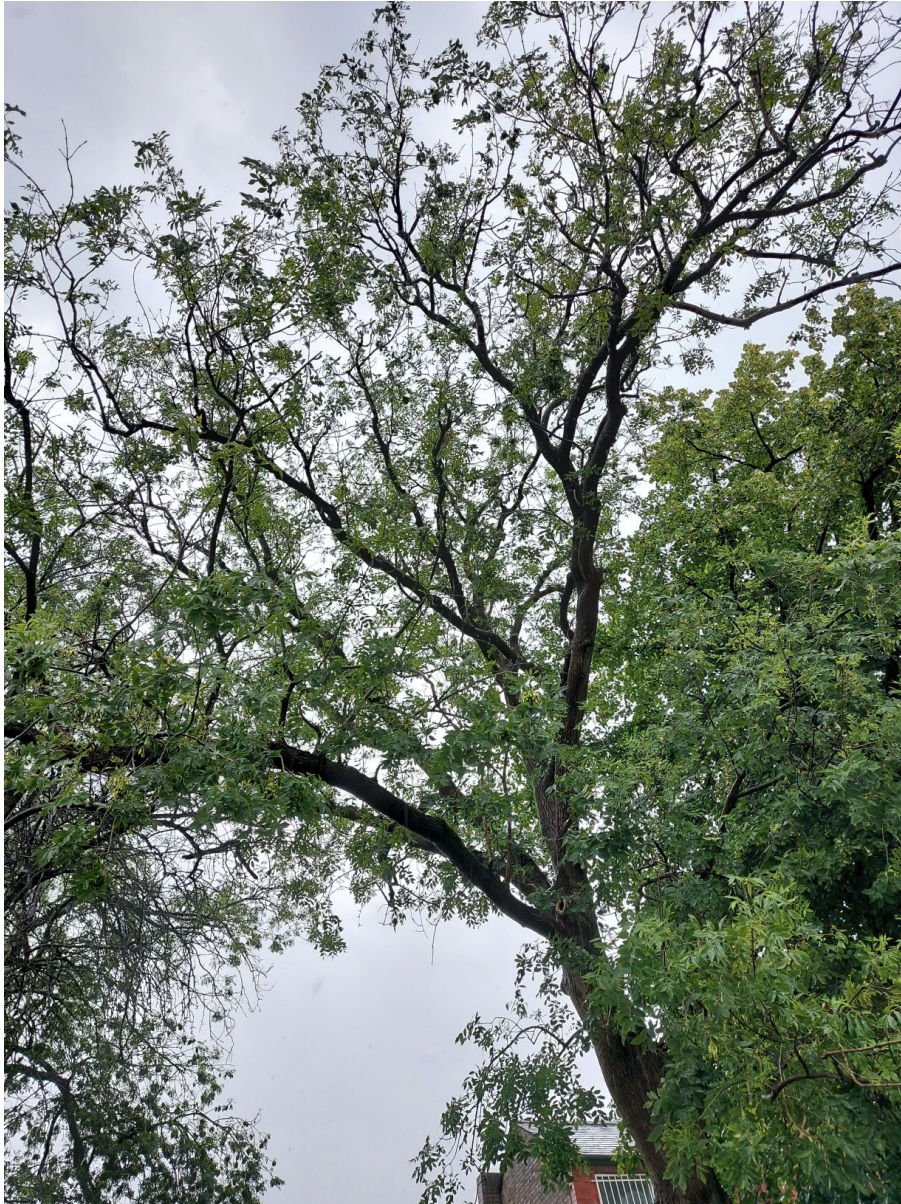
T3. Die back in mid and upper crown.

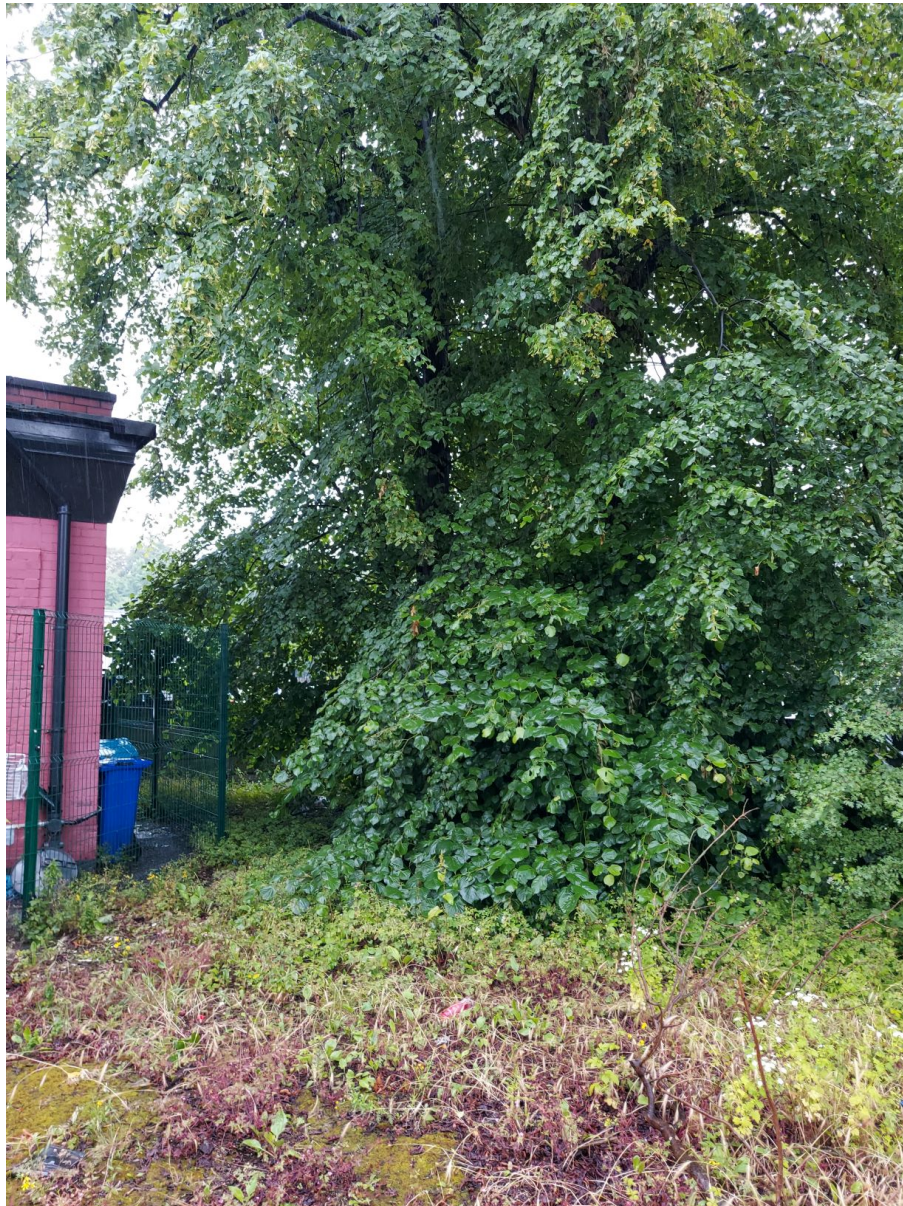
| | Arboricultural Data Sheet: 120a Withington Rd | | | | | Date of Survey: 18/06/20 | | Surveyor: Matthew Lally | | | | | | |
|---|---|---|---|---|---|---|---|---|---|---|---|---|---|---|
| T4 | Lime | 490 | 109m2 | 16 | M | 5 | 3 | 4 | 4 | 0N | B | A tree of good form and vigour located on site boundary adjacent to May Rd. Dense epicormic growths at base prevented a detailed inspection. Low branches present.<br>-<br><b>Crown lift to 5m. Remove major deadwood</b> | 40+ | B1 |
| T5 | Lime | 650 | 191m2 | 16 | M | 5 | 5 | 4 | 3 | 0N | B | A tree of good form and vigour located on site boundary adjacent to May Rd. Low branches present.<br>-<br><b>Crown lift to 5m. Remove major deadwood</b> | 40+ | B1 |

T4 and T5. Located in close proximity to each other. Low branches and epicormic growth prevented a detailed inspection
