# Your survey report

17 Athol Road Manchester M16 8QW

24 June, 2021

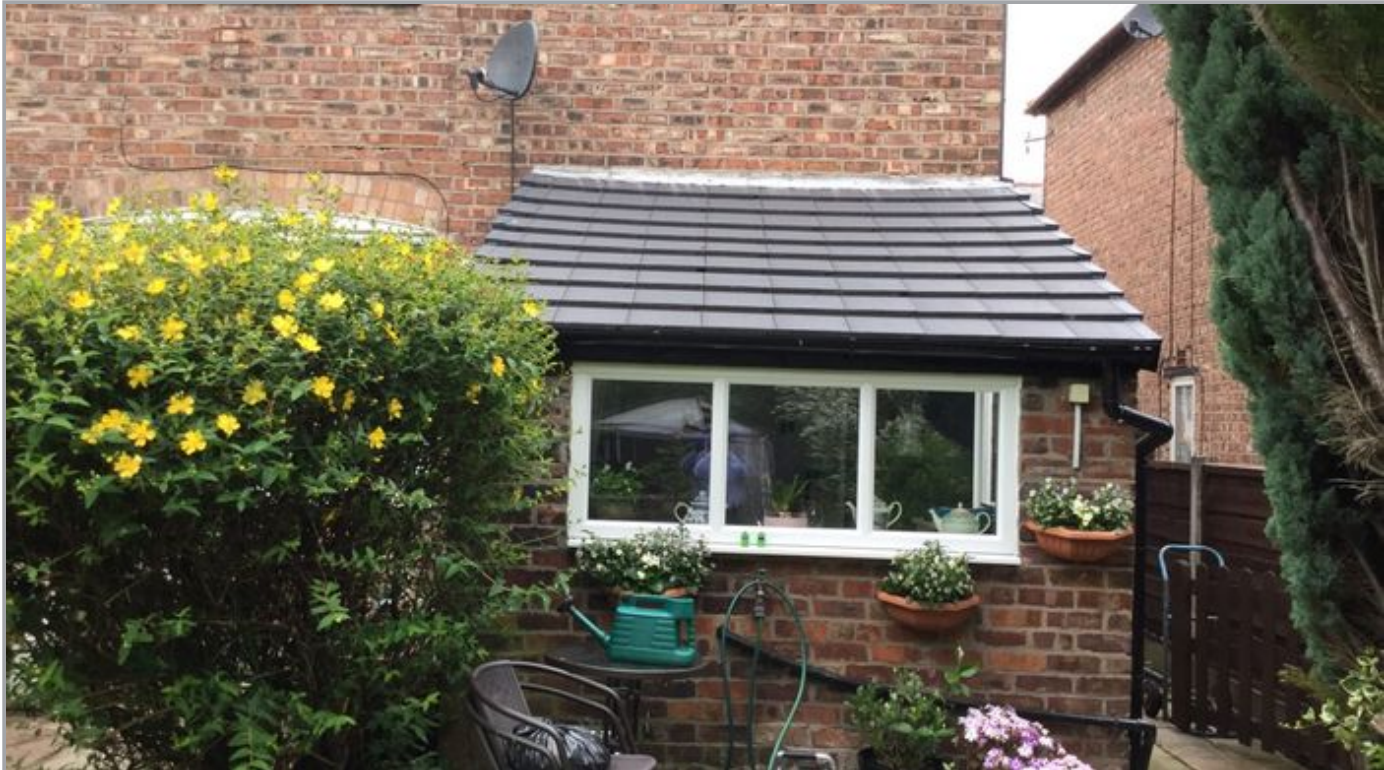
No significant defects nor significant dishing of roof pitches were noted from a ground level perspective beyond slight sagging to the roof structure of the utility room roof. The utility room roof is an enclosed construction and as such we are unable to comment upon the presence within the roof of adequate ventilation or insulation. Rot within timber decks and surrounding joinery may be present.

The sagging to the utility room roof is likely to be caused, at least in part, by the weight of the replacement tiles, however it is recommended that you instruct a competent roofing contractor to check the roof structure of the utility room roof and provide you with a report and estimate for recommended remedial works. In order that you are aware of the cost of such works the report and estimate should be obtained prior to commitment to legal purchase.

Slight sagging of utility room roof structure

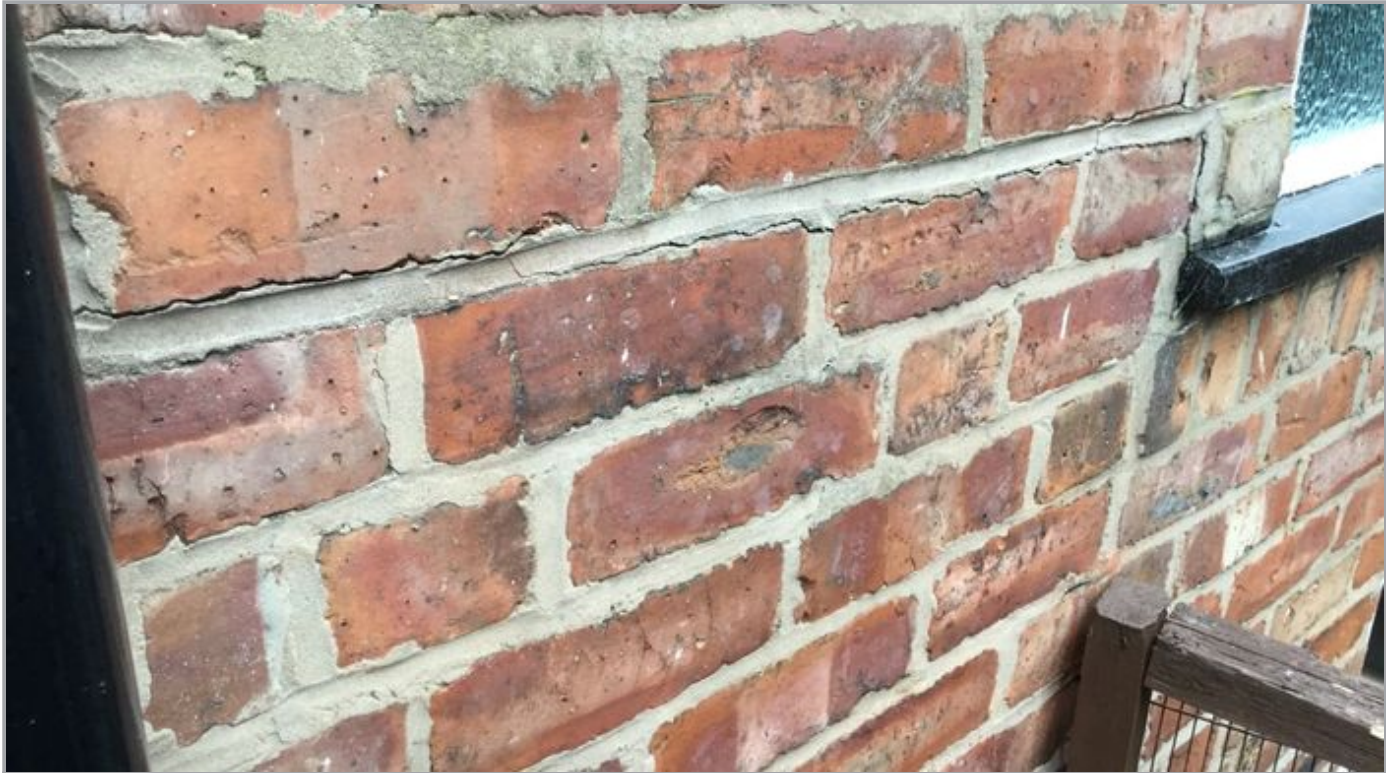
Evidence of movement was observed in the form of stepped and horizontal cracking most of which was hairline e.g. around door and window openings. This appears to be likely to be of longstanding and likely to be non-progressive and the likelihood of further significant movement appears remote. However further investigation by a specialist prior to commitment to legal purchase would be prudent as a precaution.

Horizontal cracking to wall of utility area

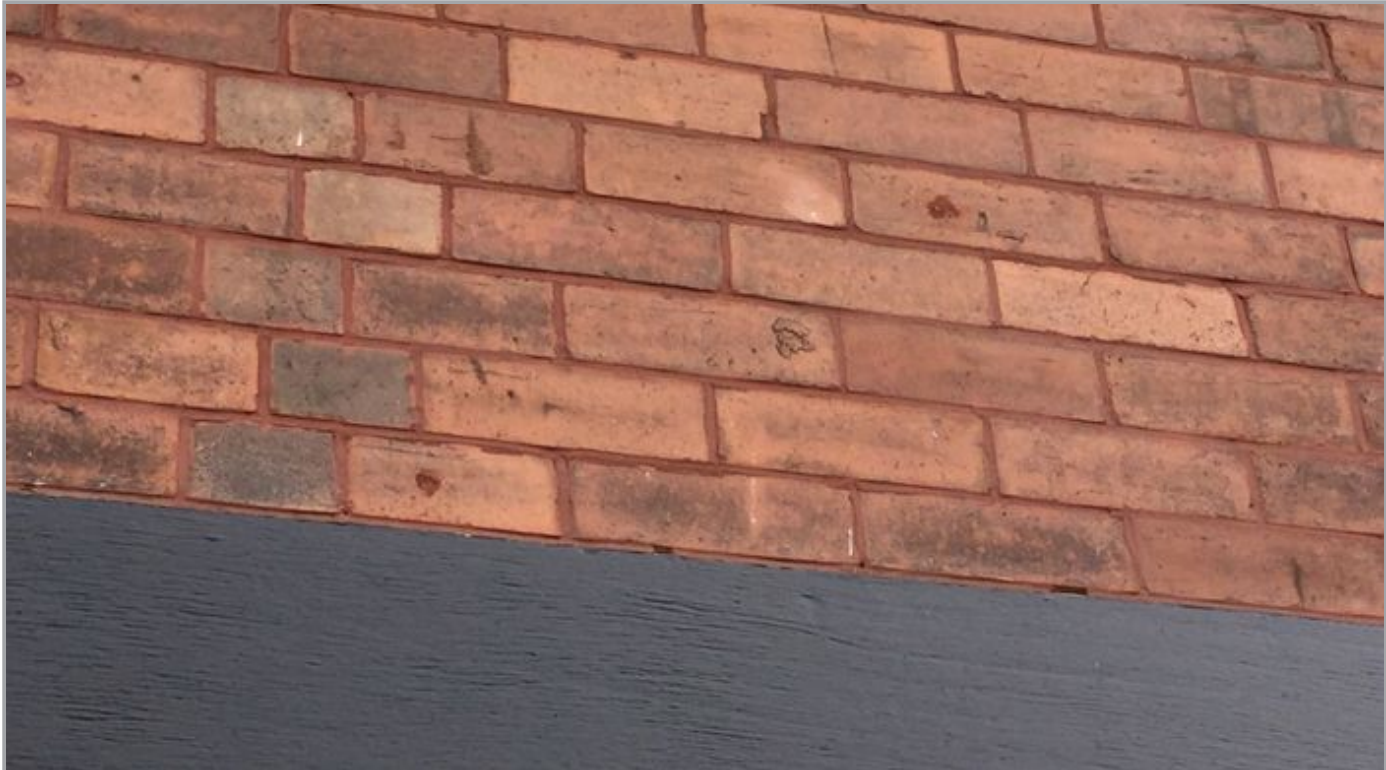
Plugged holes were noted to sections of the external elevations which is consistent with cavity wall ties having been installed in these areas in the past. We are unable to confirm this and your legal advisers should check if there are any transferrable guarantees in this respect which will confirm their installation.

Plugged holes indicative of cavity wall ties

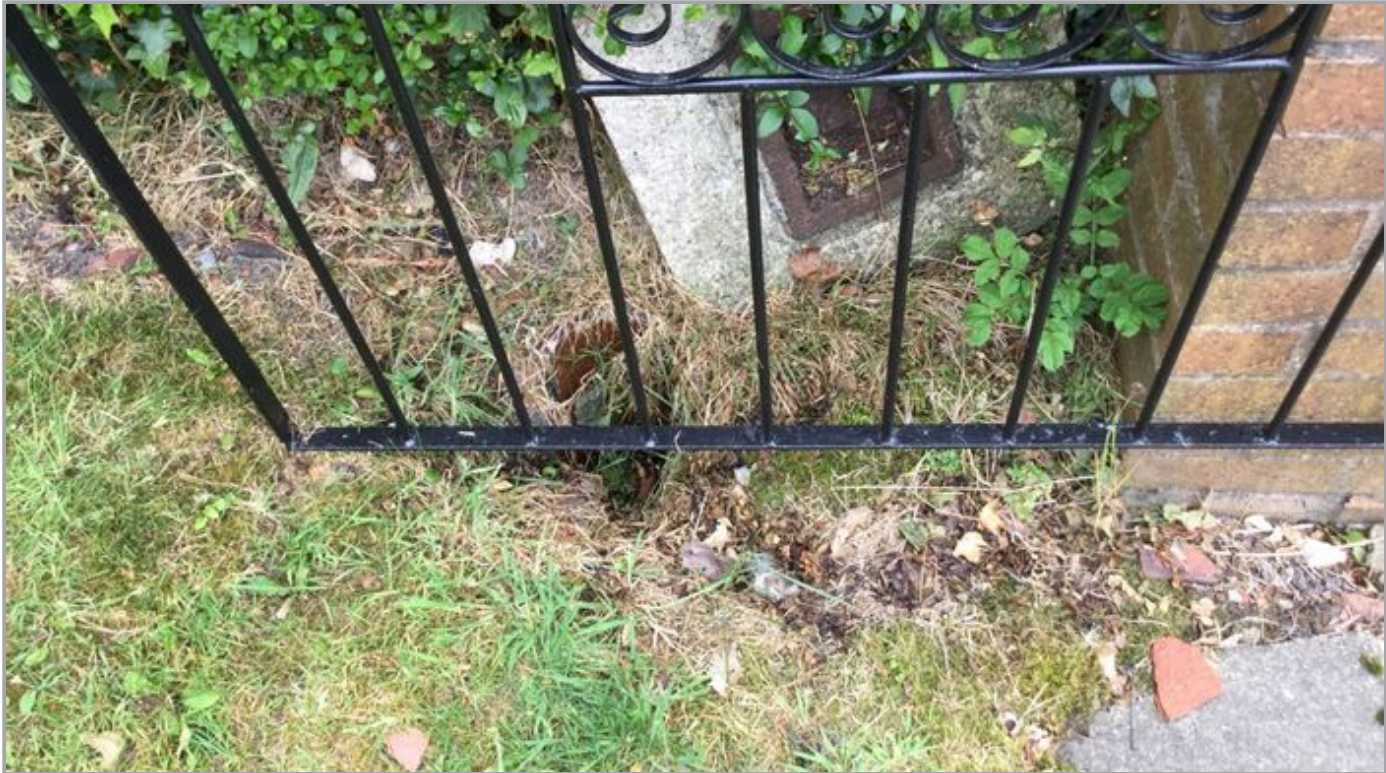
No inspection chamber covers were noted within the curtilage of the property and we are therefore unable to inspect or comment upon any aspect of the below ground drainage system. All that can be said is that, at the time of the inspection, the wc was flushed with no signs of backing up. If complete reassurance is required then you should contact a drainage contractor to carry out a CCTV scan of the underground drainage system prior to commitment to purchase. The lack of inspection chamber covers may cause a problem should a blockage arise. A rainwater gulley cover in the front garden was found to have been removed. This is a safety hazard and requires a grille/grid.

Exposed gulley in front garden

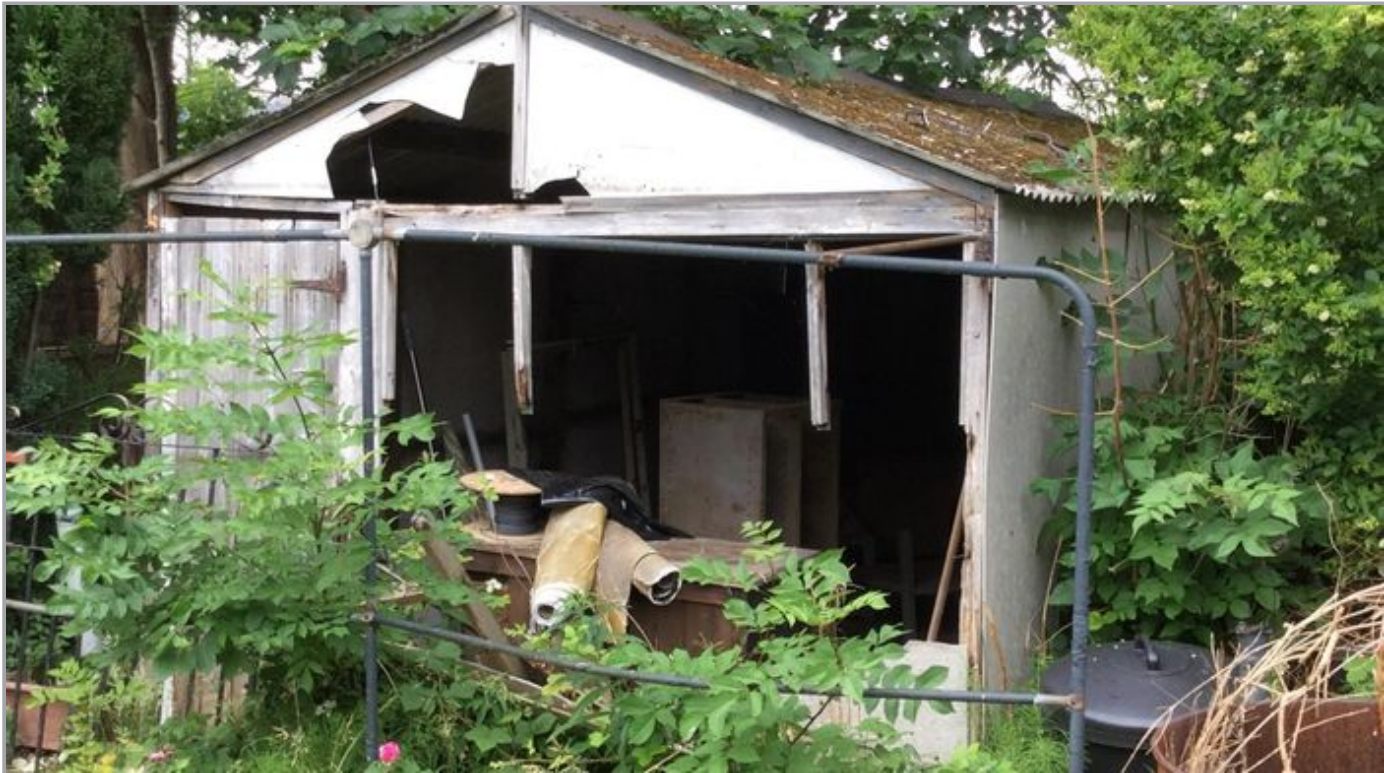
There is a dilapidated garage to the rear of the plot which was found to be in very poor condition. This is constructed of materials which are likely to contain traces of Asbestos and we draw your attention to our comments below and in Section J3. This is a serious danger to health and must only be removed by a properly licensed contractor.

External store likely to be constructed of Asbestos panelling

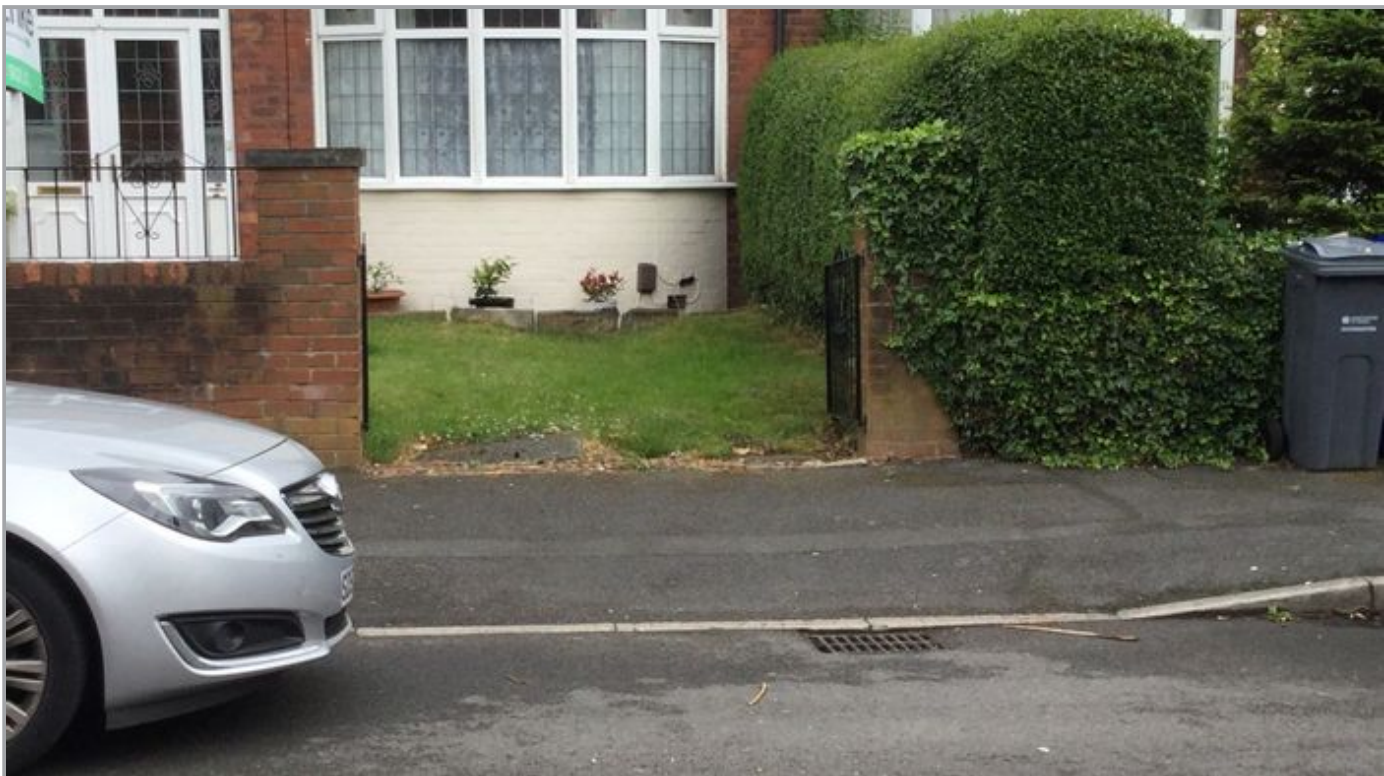
Although the property to the front of the house has a dropped kerb and brick gate posts, the plot to the front of the house is almost fully lawned with no paved area to park any car. The gap between the posts also appears to be rather narrow and may not be wide enough to accommodate an average sized modern car. The lawn is noticeably unlevel. In addition to the gulley mentioned within Section F6, there is an old tree stump close to the front external wall. One of the brick gate posts was found to lean significantly and loose coping stones to the walls require securing.

Narrow gateposts to the front of the property
