## REFURBISHMENT SURVEY FOR ASBESTOS-CONTAINING MATERIALS

**CLIENT:** Property Alliance Group Ltd

**SITE:** Premier House, 22 Deansgate, Manchester, M3 1PH

**TYPE OF SURVEY:** Refurbishment

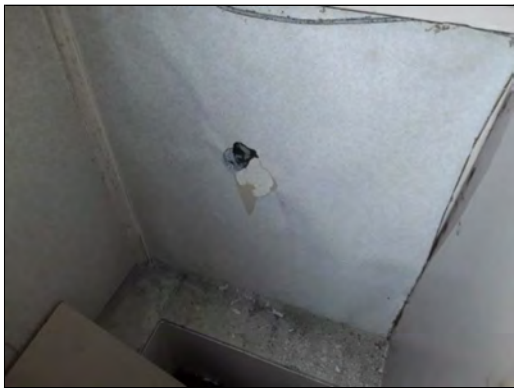
| Assessment details | | | | Comments | Photograph |
|---|---|---|---|---|---|
| Building | Premier house | Floor/ room | 2nd Floor / 2.0 | | |

| Assessment details | | | | Comments | Photograph |
|---|---|---|---|---|---|
| Assessment no. | 0001 | Accessibility | Occasionally likely to be disturbed | | |

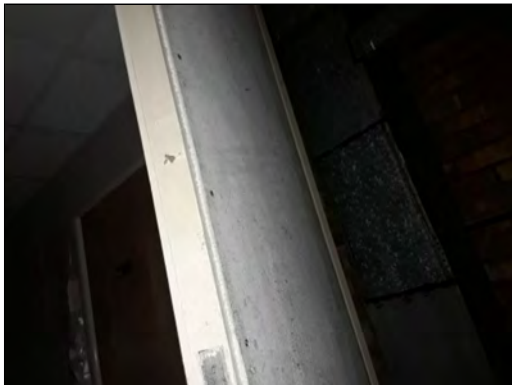
| Assessment details | | | | Comments | Photograph |
|---|---|---|---|---|---|
| Building | Premier house | Floor/ room | 2nd Floor / 2.1 | | |

| Assessment details | | | | Comments | Photograph |
|---|---|---|---|---|---|
| Assessment no. | 0002 | Accessibility | Occasionally likely to be disturbed | | |

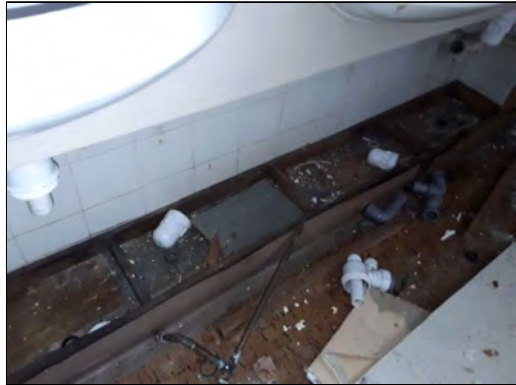
| Assessment details | | | | Comments | |
|---|---|---|---|---|---|
| Building | Premier house | Floor/ room | 2nd Floor / 2.2 | | |

| Assessment details | | | | Comments | |
|---|---|---|---|---|---|
| Assessment no. | 0004 | Accessibility | | | |

| Assessment details | | | | Comments | |
|---|---|---|---|---|---|
| Action | No further action required | | | | |

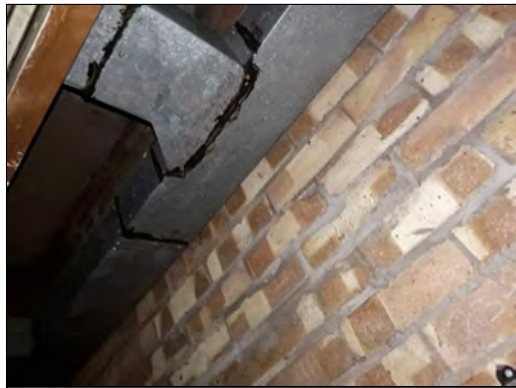
| Assessment details | | | | Comments | |
|---|---|---|---|---|---|
| Building | Premier house | Floor/ room | 2nd Floor / 2.2 | | |

| Assessment details | | | | Comments | |
|---|---|---|---|---|---|
| Assessment no. | 0005 | Accessibility | Occasionally likely to be disturbed | | |

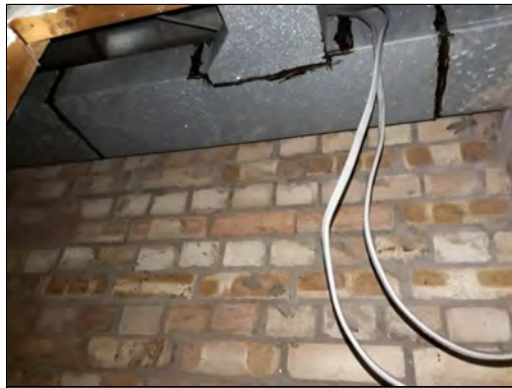
| Assessment details | | | | Comments | Photograph |
|---|---|---|---|---|---|
| Building | Premier house | Floor/ room | 2nd Floor / 2.3 | | |

| Assessment details | | | | Comments | Photograph |
|---|---|---|---|---|---|
| Assessment no. | 0006 | Accessibility | Occasionally likely to be disturbed | | |

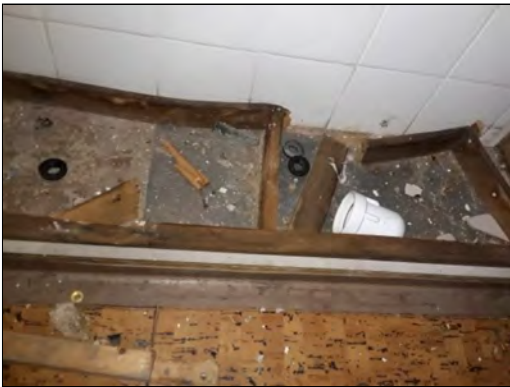
| Assessment details | | | | Comments | <div>Photograph</div> |
|---|---|---|---|---|---|
| Building | Premier house | Floor/ room | 2nd Floor / 2.3 | | |

| Assessment details | | | | Comments | <div>Photograph</div> |
|---|---|---|---|---|---|
| Assessment no. | 0007 | Accessibility | | | |

| Assessment details | | | | Comments | <div>Photograph</div> |
|---|---|---|---|---|---|
| Action | No further action required | | | | |

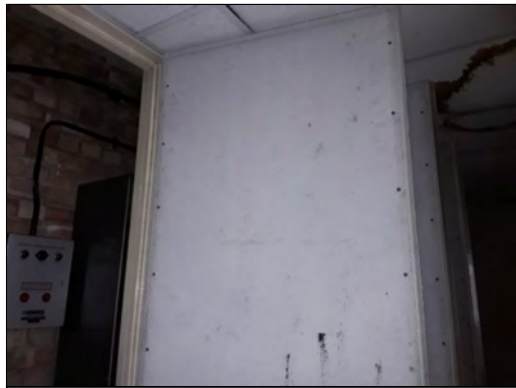
| Assessment details | | | | Comments | Photograph |
|---|---|---|---|---|---|
| Building | Premier house | Floor/ room | 2nd Floor / 2.5 | | |

| Assessment details | | | | Comments | Photograph |
|---|---|---|---|---|---|
| Assessment no. | 0008 | Accessibility | Occasionally likely to be disturbed | | |

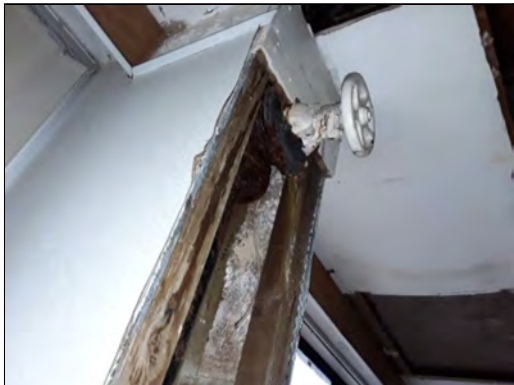
| Assessment details | | | | Comments | |
|---|---|---|---|---|---|
| Building | Premier house | Floor/ room | 2nd Floor / 2.30 | | |

| Assessment details | | | | Comments | |
|---|---|---|---|---|---|
| Assessment no. | 0042 | Accessibility | | | |

| Assessment details | | | | Comments | |
|---|---|---|---|---|---|
| Action | Remove | | | | |

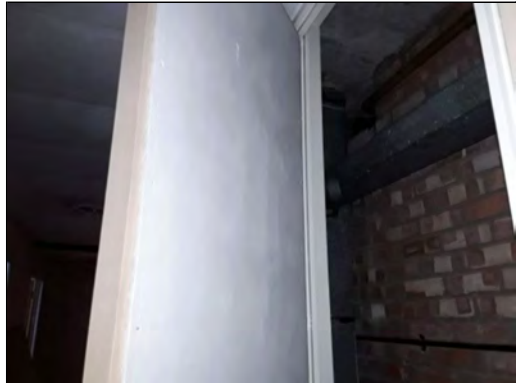
| Assessment details | | | | Comments | Photograph |
|---|---|---|---|---|---|
| Building | Premier house | Floor/ room | 1st Floor / 1.1 | | |

| Building | Floor/<br>Room | Assessment<br>Number | Location/<br>position | Product<br>type | Surface<br>treatment | Condition | Extent | Accessibility | Level of<br>identification | Asbestos<br>type | Material<br>risk | Priority<br>risk | Action |
|---|---|---|---|---|---|---|---|---|---|---|---|---|---|
| Premier house | 1st Floor / 1.1 | 0044 | Board panel to doors | Board | Unsealed | Low Damage | 4no. | Occasionally likely to be disturbed | Identified | Amosite | ( 7 )<br>Medium | - | Remove |

| Assessment details | | | | Comments | Photograph |
|---|---|---|---|---|---|
| Assessment no. | 0044 | Accessibility | Occasionally likely to be disturbed | | |

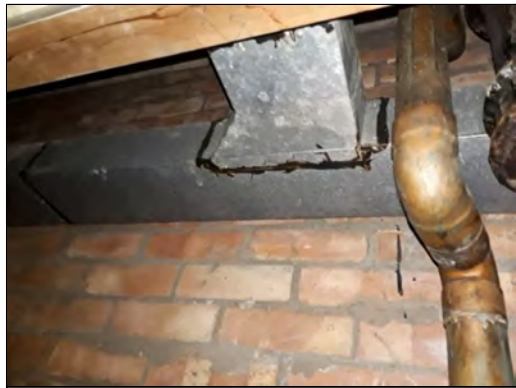
| Assessment details | | | | Comments | |
|---|---|---|---|---|---|
| Building | Premier house | Floor/ room | 1st Floor / 1.2 | | |

| Building | Floor/<br>Room | Assessment<br>Number | Location/<br>position | Product<br>type | Surface<br>treatment | Condition | Extent | Accessibility | Level of<br>identification | Asbestos<br>type | Material<br>risk | Priority<br>risk | Action |
|---|---|---|---|---|---|---|---|---|---|---|---|---|---|
| Premier house | 1st Floor / 1.2 | 0046 | Composite putty to ducting | Well Bound Material | Surface Sealed | Low Damage | 3lm | Occasionally likely to be disturbed | Strongly Presumed (045) | Chrysotile | ( 4 )<br>Very low | - | Remove |

| Assessment details | | | | Comments | |
|---|---|---|---|---|---|
| Assessment no. | 0046 | Accessibility | Occasionally likely to be disturbed | | |

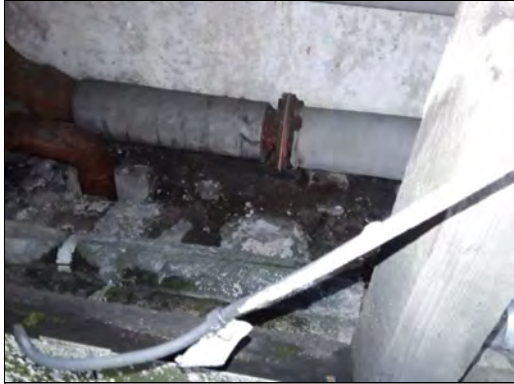
| Assessment details | | | | Comments | Photograph |
|---|---|---|---|---|---|
| Building | Premier house | Floor/ room | External / E8 | | |

| Building | Floor/<br>Room | Assessment<br>Number | Location/<br>position | Product<br>type | Surface<br>treatment | Condition | Extent | Accessibility | Level of<br>identification | Asbestos<br>type | Material<br>risk | Priority<br>risk | Action |
|---|---|---|---|---|---|---|---|---|---|---|---|---|---|
| Premier house | External / E8 | 0108 | Gaskets to pipes in wall void | Gaskets | Surface Sealed | Low Damage | 38no. | Occasionally likely to be disturbed | Identified | Chrysotile | ( 5 ) Low | - | Remove |

| Assessment details | | | | Comments | Photograph |
|---|---|---|---|---|---|
| Assessment no. | 0108 | Accessibility | Occasionally likely to be disturbed | | |

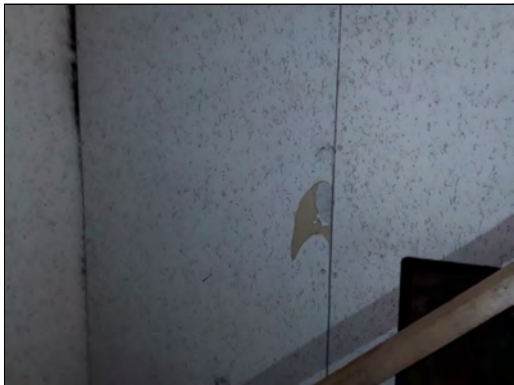
| Assessment details | | | | Comments | Photograph |
|---|---|---|---|---|---|
| Building | Premier house | Floor/ room | External / Stairs 1 | | |

| Building | Floor/<br>Room | Assessment<br>Number | Location/<br>position | Product<br>type | Surface<br>treatment | Condition | Extent | Accessibility | Level of<br>identification | Asbestos<br>type | Material<br>risk | Priority<br>risk | Action |
|---|---|---|---|---|---|---|---|---|---|---|---|---|---|
| Premier house | External / Stairs 1 | 0112 | Board panels | Board | Surface Sealed | Low Damage | 8m <sup>2</sup> | Occasionally likely to be disturbed | Identified | Amosite | ( 6 ) Low | - | Remove |

| Assessment details | | | | Comments | Photograph |
|---|---|---|---|---|---|
| Assessment no. | 0112 | Accessibility | Occasionally likely to be disturbed | | |
