## REFURBISHMENT SURVEY FOR ASBESTOS-CONTAINING MATERIALS

**CLIENT:** Property Alliance Group Ltd

**SITE:** Premier House, 22 Deansgate, Manchester, M3 1PH

**TYPE OF SURVEY:** Refurbishment

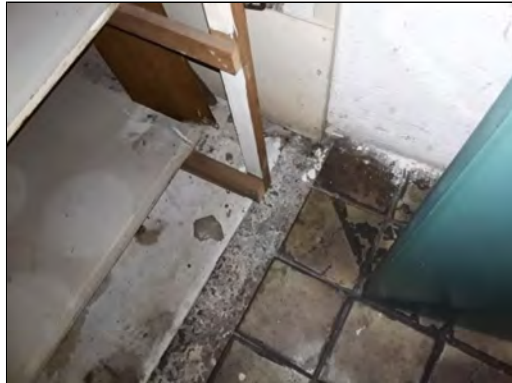
| Assessment details | | | | Comments | Photograph |
|---|---|---|---|---|---|
| Building | 22 Deansgate | Floor/ room | 2nd Floor / S2 | | |

| Building | Floor/<br>Room | Assessment<br>Number | Location/<br>position | Product<br>type | Surface<br>treatment | Condition | Extent | Accessibility | Level of<br>identification | Asbestos<br>type | Material<br>risk | Priority<br>risk | Action |
|---|---|---|---|---|---|---|---|---|---|---|---|---|---|
| 22<br>Deansgate | 2nd Floor /<br>S2 | 0003 | Board panel to<br>floor and debris | Board | Unsealed | Medium<br>Damage | 2m² | Occasionally<br>likely to be<br>disturbed | Identified | Amosite | ( 8 )<br>Medium | - | Remove |

| Assessment details | | | | Comments | Photograph |
|---|---|---|---|---|---|
| Assessment no. | 0003 | Accessibility | Occasionally likely to be disturbed | | |

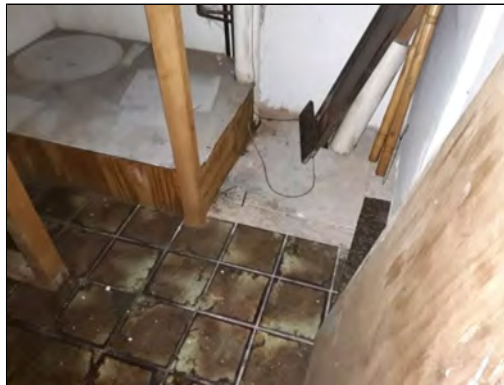
| Assessment details | | | | Comments | Photograph |
|---|---|---|---|---|---|
| Building | 22 Deansgate | Floor/ room | 2nd Floor / S3 | | |

| Building | Floor/<br>Room | Assessment<br>Number | Location/<br>position | Product<br>type | Surface<br>treatment | Condition | Extent | Accessibility | Level of<br>identification | Asbestos<br>type | Material<br>risk | Priority<br>risk | Action |
|---|---|---|---|---|---|---|---|---|---|---|---|---|---|
| 22<br>Deansgate | 2nd Floor /<br>S3 | 0005 | Board panel to<br>floor and debris | Board | Unsealed | Medium<br>Damage | 1m <sup>2</sup> | Occasionally<br>likely to be<br>disturbed | Identified | Amosite | ( 8 )<br>Medium | - | Remove |

| Assessment details | | | | Comments | Photograph |
|---|---|---|---|---|---|
| Assessment no. | 0005 | Accessibility | Occasionally likely to be disturbed | | |

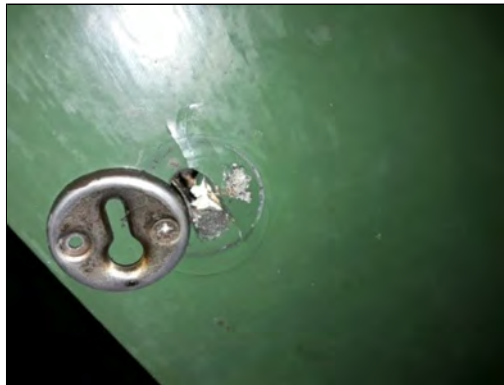
| Assessment details | | | | Comments | Photograph |
|---|---|---|---|---|---|
| Building | 22 Deansgate | Floor/ room | 1st Floor / F1 | 2x doors | |

| Building | Floor/<br>Room | Assessment<br>Number | Location/<br>position | Product<br>type | Surface<br>treatment | Condition | Extent | Accessibility | Level of<br>identification | Asbestos<br>type | Material<br>risk | Priority<br>risk | Action |
|---|---|---|---|---|---|---|---|---|---|---|---|---|---|
| 22<br>Deansgate | 1st Floor /<br>F1 | 0012 | Board lining to fire<br>doors | Board | Surface<br>Sealed | Low<br>Damage | 3m² | Occasionally<br>likely to be<br>disturbed | Identified | Chrysotile | ( 5 ) Low | - | Remove |

| Assessment details | | | | Comments | Photograph |
|---|---|---|---|---|---|
| Assessment no. | 0012 | Accessibility | Occasionally likely to be disturbed | | |

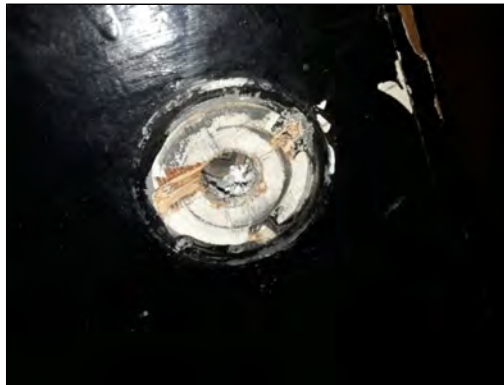
| Assessment details | | | | Comments | Photograph |
|---|---|---|---|---|---|
| Building | 22 Deansgate | Floor/ room | Ground Floor / G1 | | |

| Building | Floor/<br>Room | Assessment<br>Number | Location/<br>position | Product<br>type | Surface<br>treatment | Condition | Extent | Accessibility | Level of<br>identification | Asbestos<br>type | Material<br>risk | Priority<br>risk | Action |
|---|---|---|---|---|---|---|---|---|---|---|---|---|---|
| 22<br>Deansgate | Ground Floor /<br>G1 | 0018 | Board lining within<br>door | Board | Surface<br>Sealed | Low<br>Damage | 3m <sup>2</sup> | Occasionally<br>likely to be<br>disturbed | Identified | Chrysotile +<br>Amosite | ( 6 ) Low | - | Remove |

| Assessment details | | | | Comments | Photograph |
|---|---|---|---|---|---|
| Assessment no. | 0018 | Accessibility | Occasionally likely to be disturbed | | |

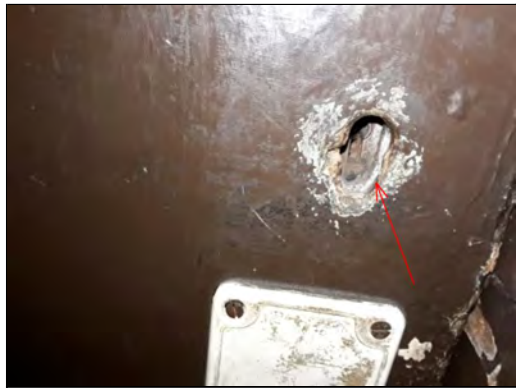
| Assessment details | | | | Comments | Photograph |
|---|---|---|---|---|---|
| Building | 22 Deansgate | Floor/ room | Ground Floor / G7 | | |

| Building | Floor/<br>Room | Assessment<br>Number | Location/<br>position | Product<br>type | Surface<br>treatment | Condition | Extent | Accessibility | Level of<br>identification | Asbestos<br>type | Material<br>risk | Priority<br>risk | Action |
|---|---|---|---|---|---|---|---|---|---|---|---|---|---|
| 22<br>Deansgate | Ground Floor /<br>G7 | 0026 | Board lining within<br>door | Board | Surface<br>Sealed | Low<br>Damage | 3m <sup>2</sup> | Occasionally<br>likely to be<br>disturbed | Strongly<br>Presumed (018) | Chrysotile +<br>Amosite | ( 6 ) Low | - | Remove |

| Assessment details | | | | Comments | Photograph |
|---|---|---|---|---|---|
| Assessment no. | 0026 | Accessibility | Occasionally likely to be disturbed | | |

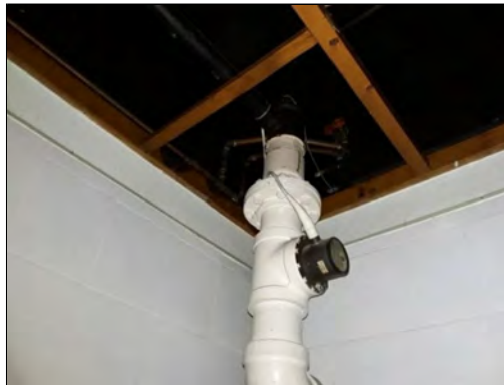
| Assessment details | | | | Comments | Photograph |
|---|---|---|---|---|---|
| Building | 22 Deansgate | Floor/ room | 1st Floor / F3 | | |

| Building | Floor/<br>Room | Assessment<br>Number | Location/<br>position | Product<br>type | Surface<br>treatment | Condition | Extent | Accessibility | Level of<br>identification | Asbestos<br>type | Material<br>risk | Priority<br>risk | Action |
|---|---|---|---|---|---|---|---|---|---|---|---|---|---|
| 22<br>Deansgate | 1st Floor /<br>F3 | 0029 | Gasket to water<br>pipes | Gaskets | Surface<br>Sealed | Low<br>Damage | 2no. | Occasionally<br>likely to be<br>disturbed | Presumed | Chrysotile | ( 5 ) Low | - | Remove |

| Assessment details | | | | Comments | Photograph |
|---|---|---|---|---|---|
| Assessment no. | 0029 | Accessibility | Occasionally likely to be disturbed | | |

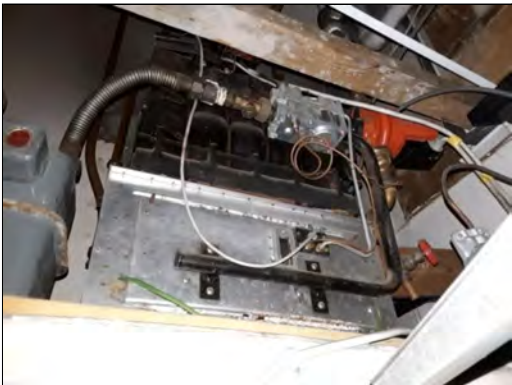
| Assessment details | | | | Comments | |
|---|---|---|---|---|---|
| Building | 22 Deansgate | Floor/ room | Ground Floor / G11 | | |

| Building | Floor/<br>Room | Assessment<br>Number | Location/<br>position | Product<br>type | Surface<br>treatment | Condition | Extent | Accessibility | Level of<br>identification | Asbestos<br>type | Material<br>risk | Priority<br>risk | Action |
|---|---|---|---|---|---|---|---|---|---|---|---|---|---|
| 22<br>Deansgate | Ground Floor /<br>G11 | 0033 | Textiles around<br>small boiler top<br>seal | Textiles | Surface<br>Sealed | Low<br>Damage | 1m | Occasionally<br>likely to be<br>disturbed | Identified | Chrysotile | ( 5 ) Low | - | Remove |

| Assessment details | | | | Comments | |
|---|---|---|---|---|---|
| Assessment no. | 0033 | Accessibility | Occasionally likely to be disturbed | | |

| Assessment details | | | | Comments | |
|---|---|---|---|---|---|
| Action | Remove | | | | |

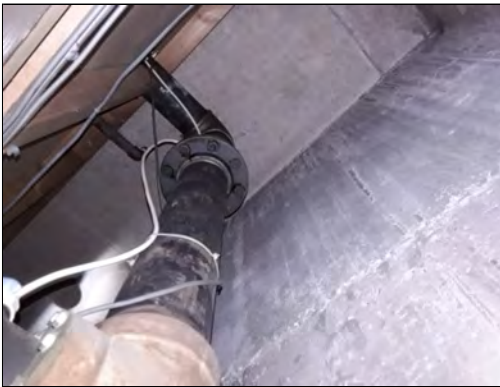
| Assessment details | | | | Comments | |
|---|---|---|---|---|---|
| Building | 22 Deansgate | Floor/ room | 1st Floor / F4 | | |

| Building | Floor/<br>Room | Assessment<br>Number | Location/<br>position | Product<br>type | Surface<br>treatment | Condition | Extent | Accessibility | Level of<br>identification | Asbestos<br>type | Material<br>risk | Priority<br>risk | Action |
|---|---|---|---|---|---|---|---|---|---|---|---|---|---|
| 22<br>Deansgate | 1st Floor /<br>F4 | 0034 | Gasket to water<br>pipes | Gaskets | Surface<br>Sealed | Low<br>Damage | 1no. | Occasionally<br>likely to be<br>disturbed | Presumed | Chrysotile | ( 5 ) Low | - | Remove |

| Assessment details | | | | Comments | |
|---|---|---|---|---|---|
| Assessment no. | 0034 | Accessibility | Occasionally likely to be disturbed | | |

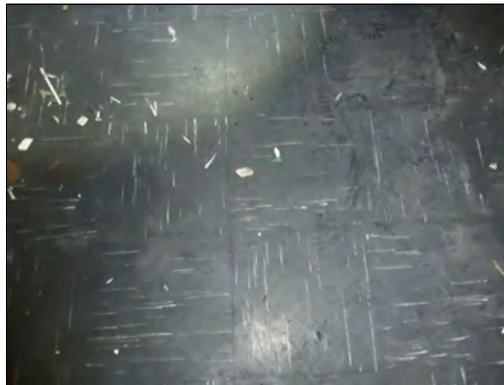
| Assessment details | | | | Comments | Photograph |
|---|---|---|---|---|---|
| Building | 22 Deansgate | Floor/ room | Ground Floor / G13 | | |

| Building | Floor/<br>Room | Assessment<br>Number | Location/<br>position | Product<br>type | Surface<br>treatment | Condition | Extent | Accessibility | Level of<br>identification | Asbestos<br>type | Material<br>risk | Priority<br>risk | Action |
|---|---|---|---|---|---|---|---|---|---|---|---|---|---|
| 22<br>Deansgate | Ground Floor /<br>G13 | 0035 | Floor tiles and<br>bitumen to floor | Vinyl Floor<br>Tiles | Completely<br>Sealed | Low<br>Damage | 14m <sup>2</sup> | Occasionally<br>likely to be<br>disturbed | Identified | Chrysotile | ( 3 )<br>Very low | - | Remove |

| Assessment details | | | | Comments | Photograph |
|---|---|---|---|---|---|
| Assessment no. | 0035 | Accessibility | Occasionally likely to be disturbed | | |

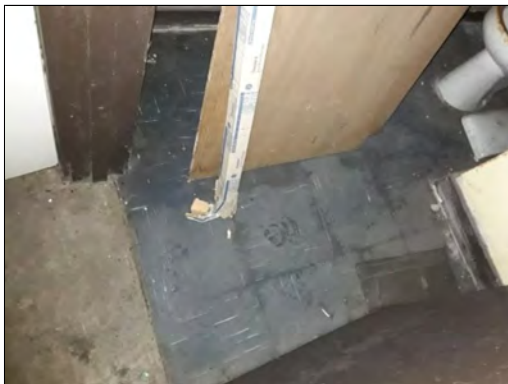
| Assessment details | | | | Comments | Photograph |
|---|---|---|---|---|---|
| Building | 22 Deansgate | Floor/ room | Ground Floor / G14 | | |

| Building | Floor/<br>Room | Assessment<br>Number | Location/<br>position | Product<br>type | Surface<br>treatment | Condition | Extent | Accessibility | Level of<br>identification | Asbestos<br>type | Material<br>risk | Priority<br>risk | Action |
|---|---|---|---|---|---|---|---|---|---|---|---|---|---|
| 22<br>Deansgate | Ground Floor /<br>G14 | 0038 | Floor tiles and<br>bitumen to floor | Vinyl Floor<br>Tiles | Completely<br>Sealed | Low<br>Damage | 8m <sup>2</sup> | Occasionally<br>likely to be<br>disturbed | Strongly<br>Presumed (035) | Chrysotile | ( 3 )<br>Very low | - | Remove |

| Assessment details | | | | Comments | Photograph |
|---|---|---|---|---|---|
| Assessment no. | 0038 | Accessibility | Occasionally likely to be disturbed | | |

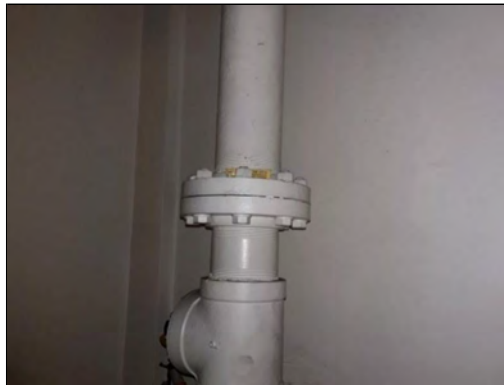
| Assessment details | | | | Comments | Photograph |
|---|---|---|---|---|---|
| Building | 22 Deansgate | Floor/ room | 1st Floor / F5 | | |

| Building | Floor/<br>Room | Assessment<br>Number | Location/<br>position | Product<br>type | Surface<br>treatment | Condition | Extent | Accessibility | Level of<br>identification | Asbestos<br>type | Material<br>risk | Priority<br>risk | Action |
|---|---|---|---|---|---|---|---|---|---|---|---|---|---|
| 22<br>Deansgate | 1st Floor /<br>F5 | 0043 | Gasket to water<br>pipes | Gaskets | Surface<br>Sealed | Low<br>Damage | 1no. | Occasionally<br>likely to be<br>disturbed | Presumed | Chrysotile | ( 5 ) Low | - | Remove |

| Assessment details | | | | Comments | Photograph |
|---|---|---|---|---|---|
| Assessment no. | 0043 | Accessibility | Occasionally likely to be disturbed | | |

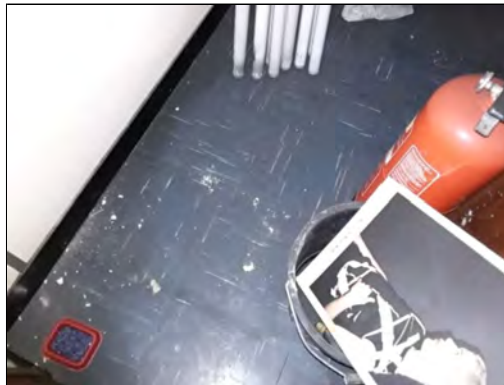
| Assessment details | | | | Comments | Photograph |
|---|---|---|---|---|---|
| Building | 22 Deansgate | Floor/ room | Ground Floor / G16 | blue tiles continue under all partitions false walls | |

| Building | Floor/<br>Room | Assessment<br>Number | Location/<br>position | Product<br>type | Surface<br>treatment | Condition | Extent | Accessibility | Level of<br>identification | Asbestos<br>type | Material<br>risk | Priority<br>risk | Action |
|---|---|---|---|---|---|---|---|---|---|---|---|---|---|
| 22<br>Deansgate | Ground Floor /<br>G16 | 0046 | Floor tiles and<br>bitumen to floor | Vinyl Floor<br>Tiles | Completely<br>Sealed | Low<br>Damage | 80m <sup>2</sup> | Occasionally<br>likely to be<br>disturbed | Identified | Chrysotile | ( 3 )<br>Very low | - | Remove |

| Assessment details | | | | Comments | Photograph |
|---|---|---|---|---|---|
| Assessment no. | 0046 | Accessibility | Occasionally likely to be disturbed | | |

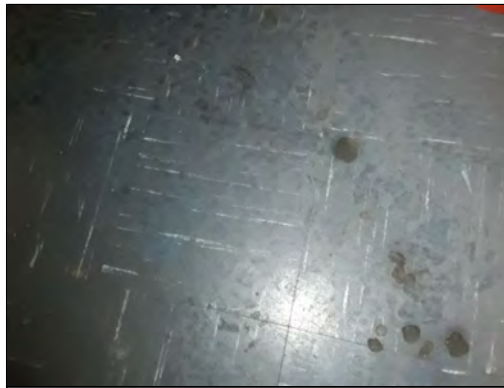
| Assessment details | | | | Comments | Photograph |
|---|---|---|---|---|---|
| Building | 22 Deansgate | Floor/ room | Ground Floor / G17 | | |

| Building | Floor/<br>Room | Assessment<br>Number | Location/<br>position | Product<br>type | Surface<br>treatment | Condition | Extent | Accessibility | Level of<br>identification | Asbestos<br>type | Material<br>risk | Priority<br>risk | Action |
|---|---|---|---|---|---|---|---|---|---|---|---|---|---|
| 22<br>Deansgate | Ground Floor /<br>G17 | 0049 | Floor tiles and<br>bitumen to floor | Vinyl Floor<br>Tiles | Completely<br>Sealed | Low<br>Damage | 12m <sup>2</sup> | Occasionally<br>likely to be<br>disturbed | Strongly<br>Presumed (046) | Chrysotile | ( 3 )<br>Very low | - | Remove |

| Assessment details | | | | Comments | Photograph |
|---|---|---|---|---|---|
| Assessment no. | 0049 | Accessibility | Occasionally likely to be disturbed | | |

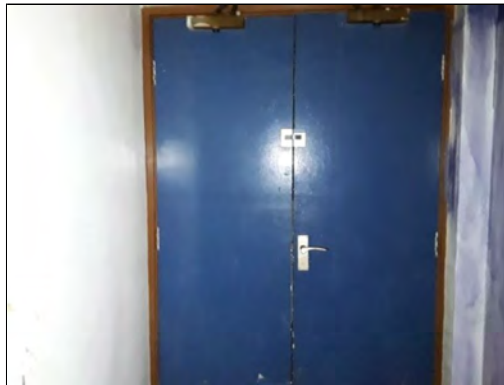
| Assessment details | | | | Comments | Photograph |
|---|---|---|---|---|---|
| Building | 22 Deansgate | Floor/ room | Ground Floor / G20 | 2x double doors | |

| Building | Floor/<br>Room | Assessment<br>Number | Location/<br>position | Product<br>type | Surface<br>treatment | Condition | Extent | Accessibility | Level of<br>identification | Asbestos<br>type | Material<br>risk | Priority<br>risk | Action |
|---|---|---|---|---|---|---|---|---|---|---|---|---|---|
| 22<br>Deansgate | Ground Floor /<br>G20 | 0058 | Board lining within<br>doors | Board | Surface<br>Sealed | Low<br>Damage | 6m² | Occasionally<br>likely to be<br>disturbed | Identified | Amosite | ( 6 ) Low | - | Remove |

| Assessment details | | | | Comments | Photograph |
|---|---|---|---|---|---|
| Assessment no. | 0058 | Accessibility | Occasionally likely to be disturbed | | |
