## Museum of Science & Industry Fire Compartmentation Survey Report

## **Fire Stopping Report**

### **Neo Property Solutions**

## Ancillary Buildings - Goods Office, VE Block, Toilet Block, Workshop, Stores and Photographic Studio

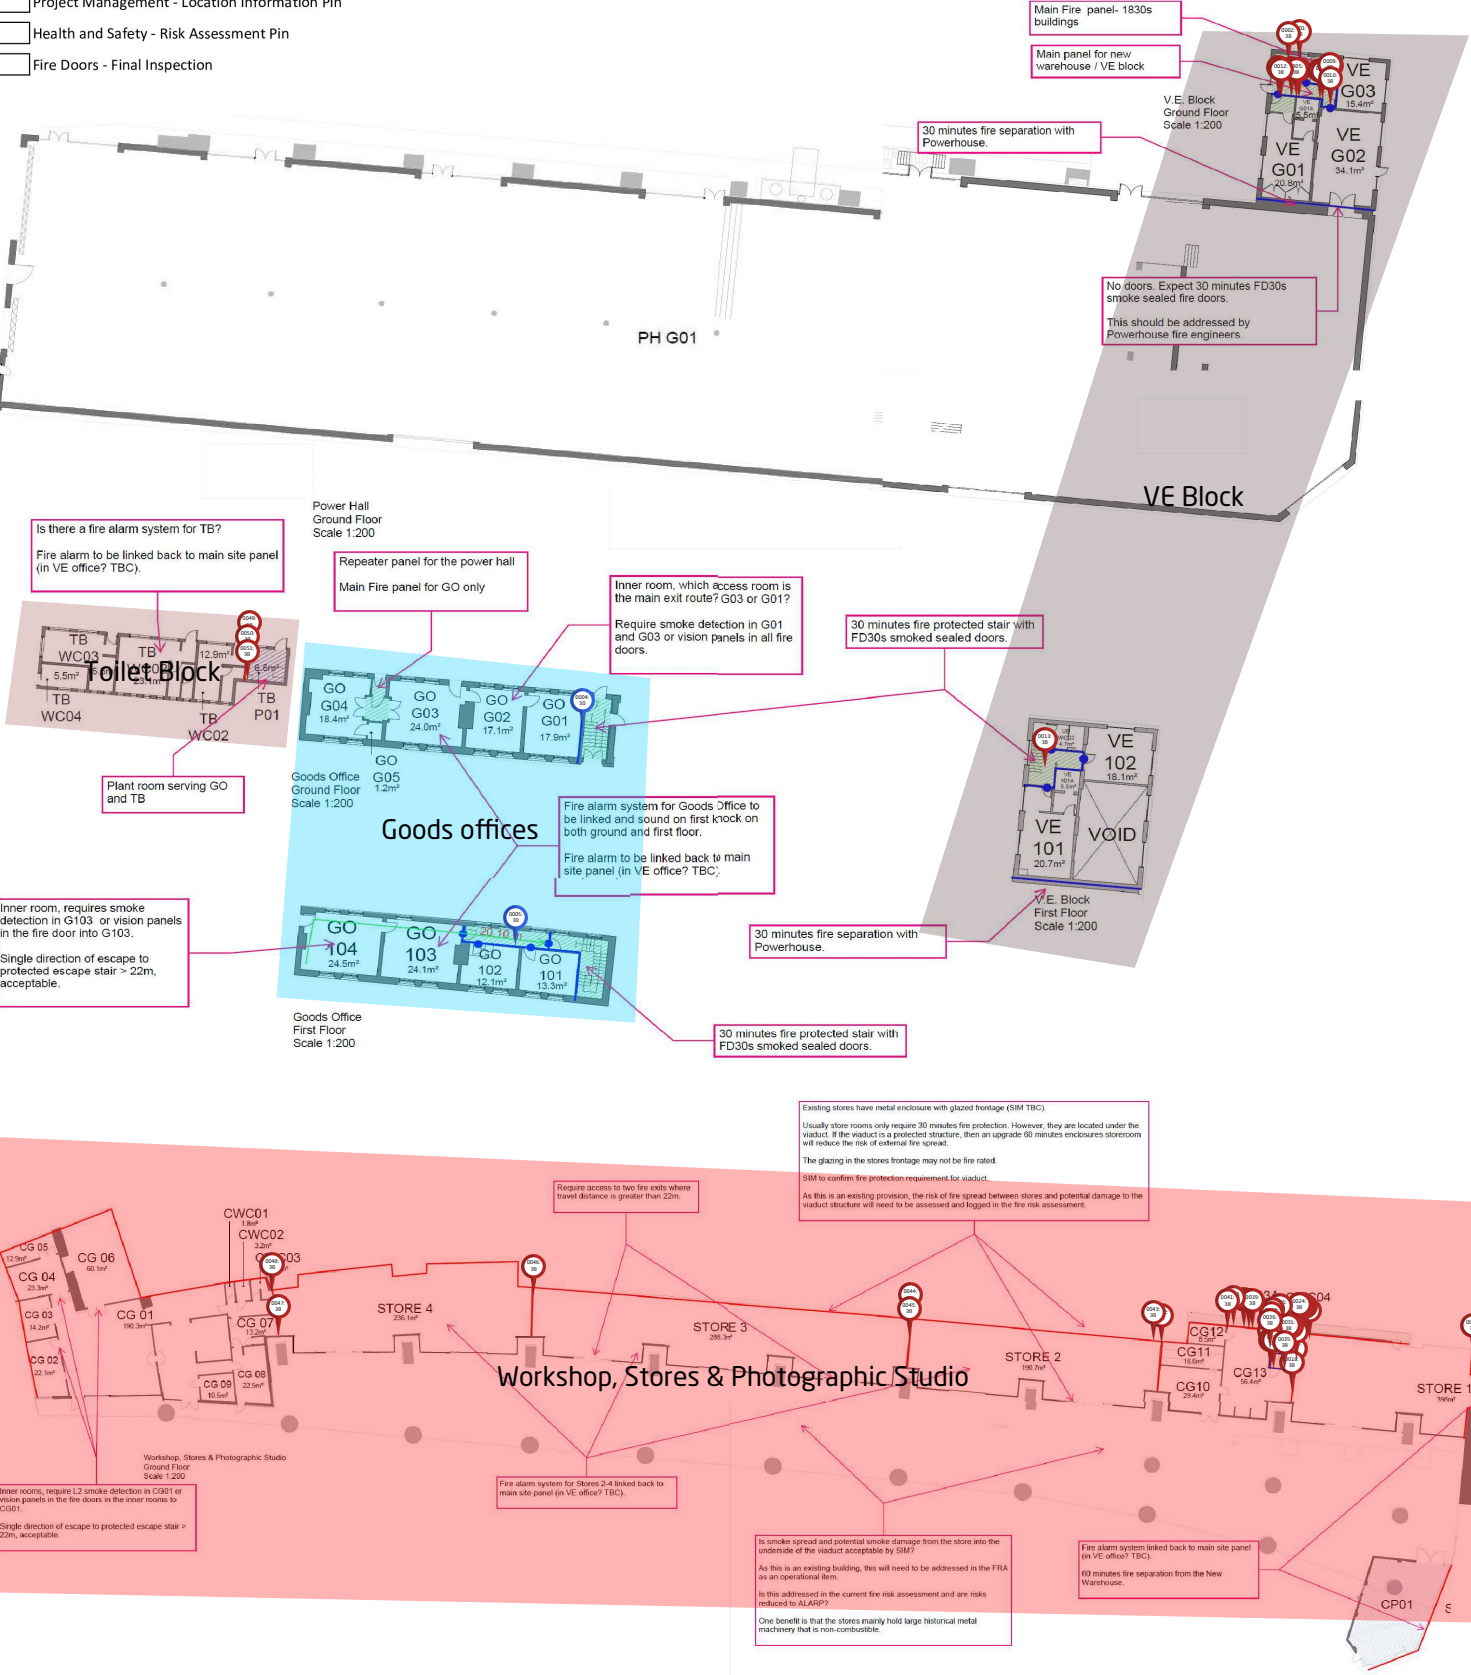
**Pin Number:** 0001:38

| Location - Room: | VE staircase |
| X3 pipes | |
| X 1 lagged pipe | |
| X 1 cable | |
| Breach identified: | Pipe x 3, Cable, Insulated metal pipes |
| Priority: | Red |

| Pull lagging back to seal top copper pipe. | |
| Installation type: | SD-128-RDW |

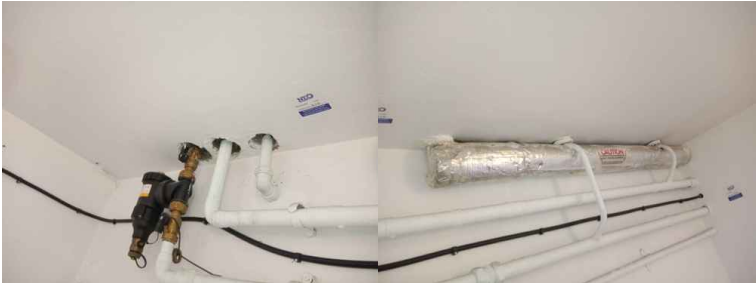
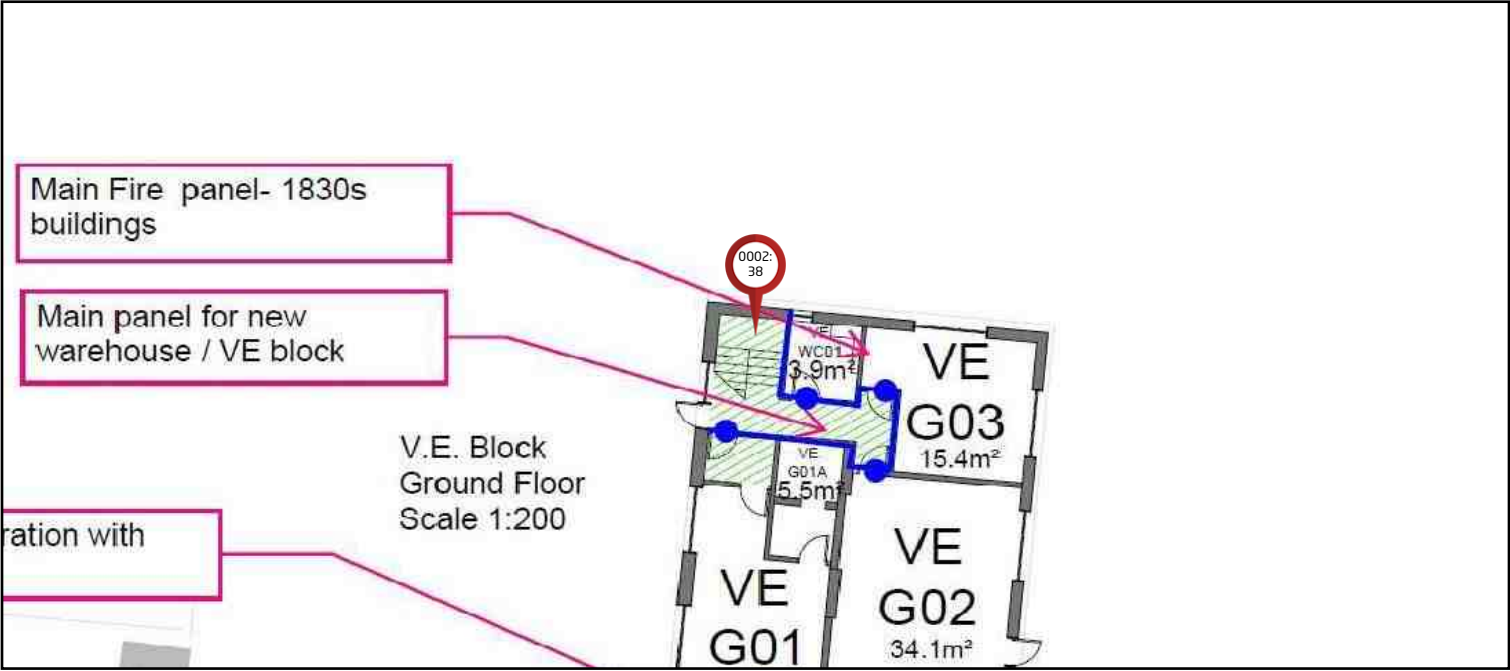
**Pin Number:** 0002:38

| Location - Room: | VE block staircase |
| Breach identified: | Pipe x 6, Cable |
| Priority: | Red |

| Installation type: | SD-128-RDW |

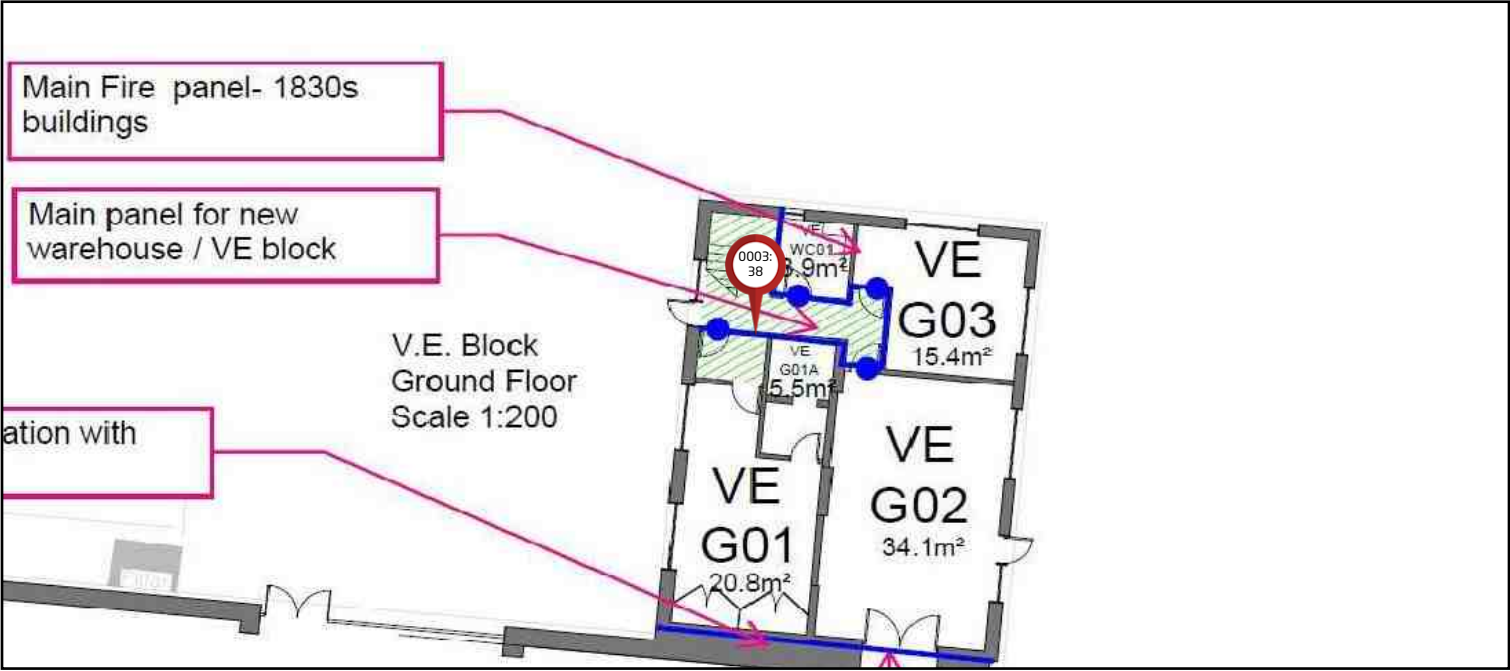
**Pin Number:** 0003:38

| Survey | |
|---|---|
| Location - Room: | VE block entrance lobby |
| Void with cables | |
| Breach identified: | Cable, Hole |
| Priority: | Red |

| Survey | |
|---|---|
| Installation type: | SD-113-RDW |

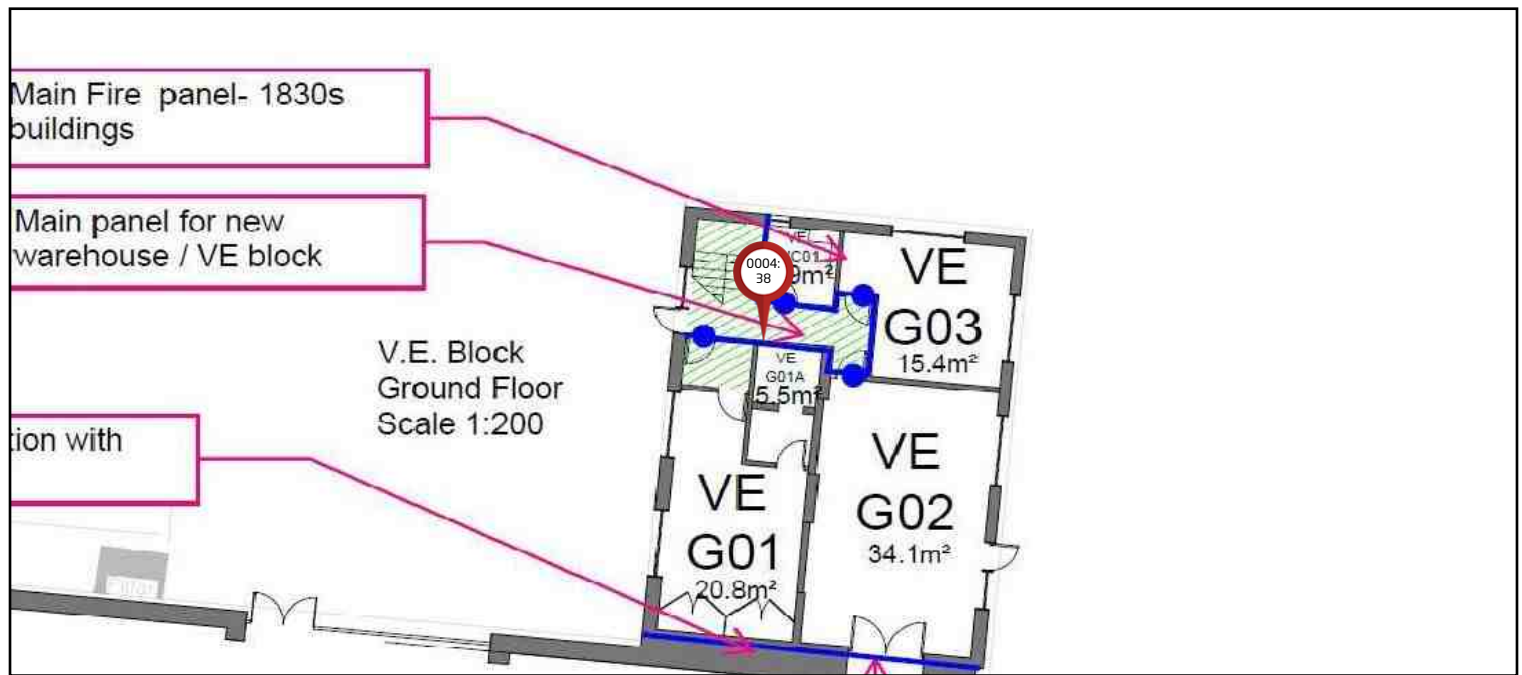
| Pin Number: | 0004:38 | Date Added: | 14/02/2022 - 12:32 |

| Location - Room: | VE block entrance lobby |
| Breach identified: | Conduit x 3 |
| Priority: | Red |

| Chip out to achieve correct annular gap for hp mastic. | |
| Installation type: | SD-170-RDW |

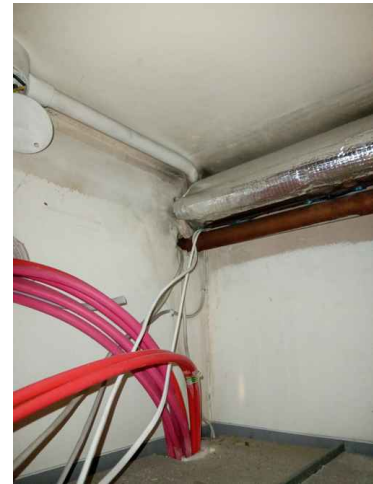
**Pin Number:** 0005:38  
**Company:** Neo Property Solutions  
**Contractor:** Matthew Brown - 38

| Survey | |
|---|---|
| Location - Room: | VE block entrance lobby |
| Copper pipes. Pull lagging back. | |
| Breach identified: | Pipe x 2, Insulated metal pipes x 2 |
| Priority: | Red |

| Survey | |
|---|---|
| Installation type: | SD-113-RDW |

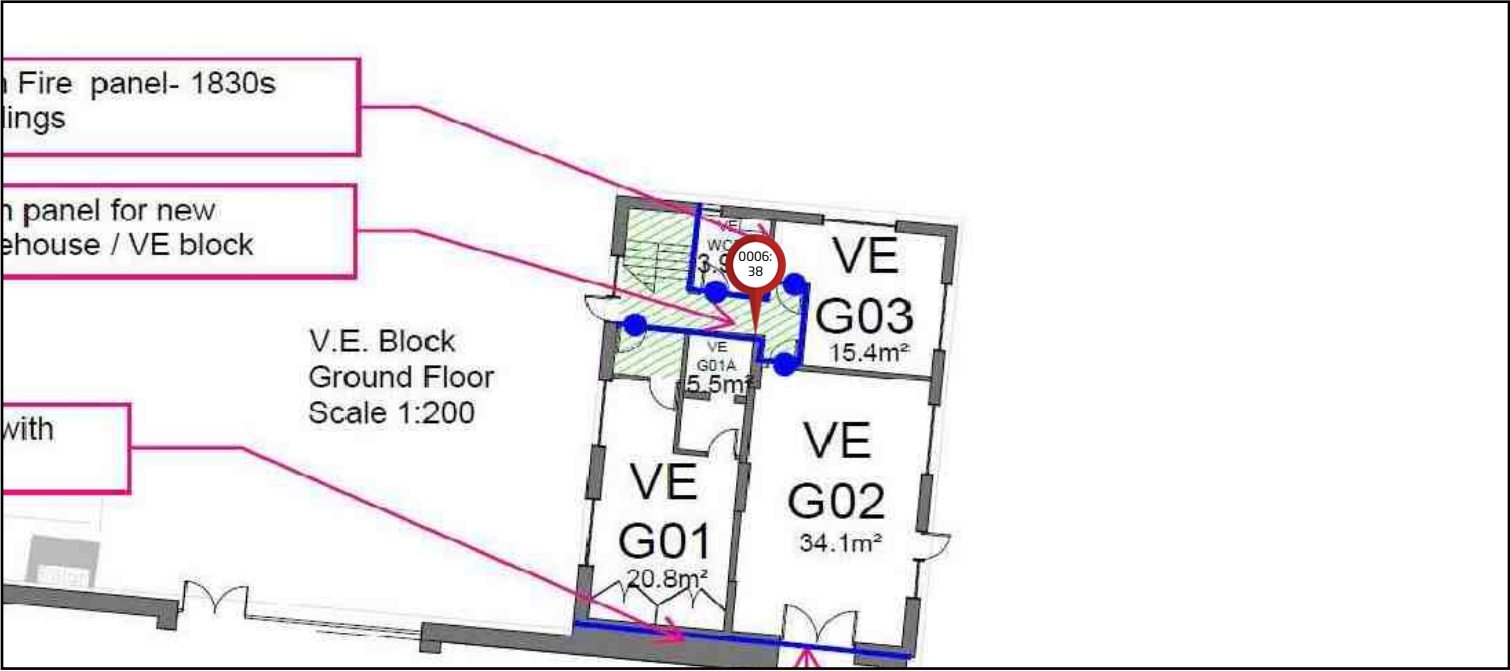
**Pin Number:** 0006:38  
**Company:** Neo Property Solutions  
**Contractor:** Tony Narkevicius - 30

| Survey | |
|---|---|
| Location - Room: | VE block entrance lobby |
| X8 cables | |
| Breach identified: | Cable x 8 |
| Priority: | Red |

| Survey | |
|---|---|
| Installation type: | SD-128-RDW |
| Once back sealed | |

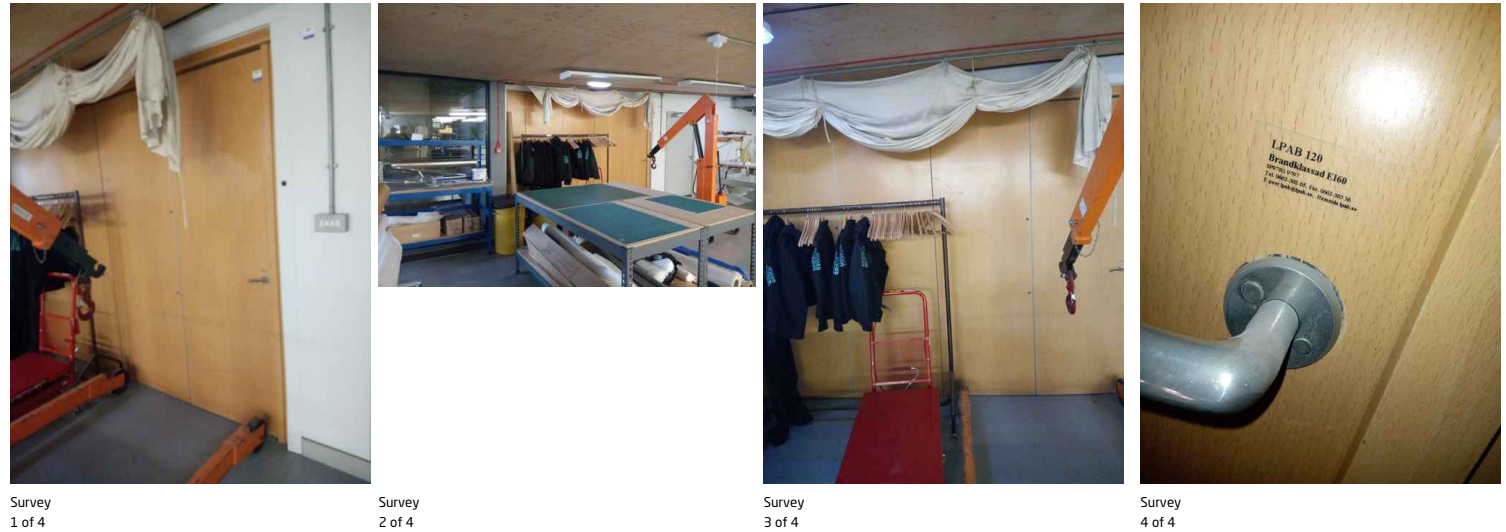
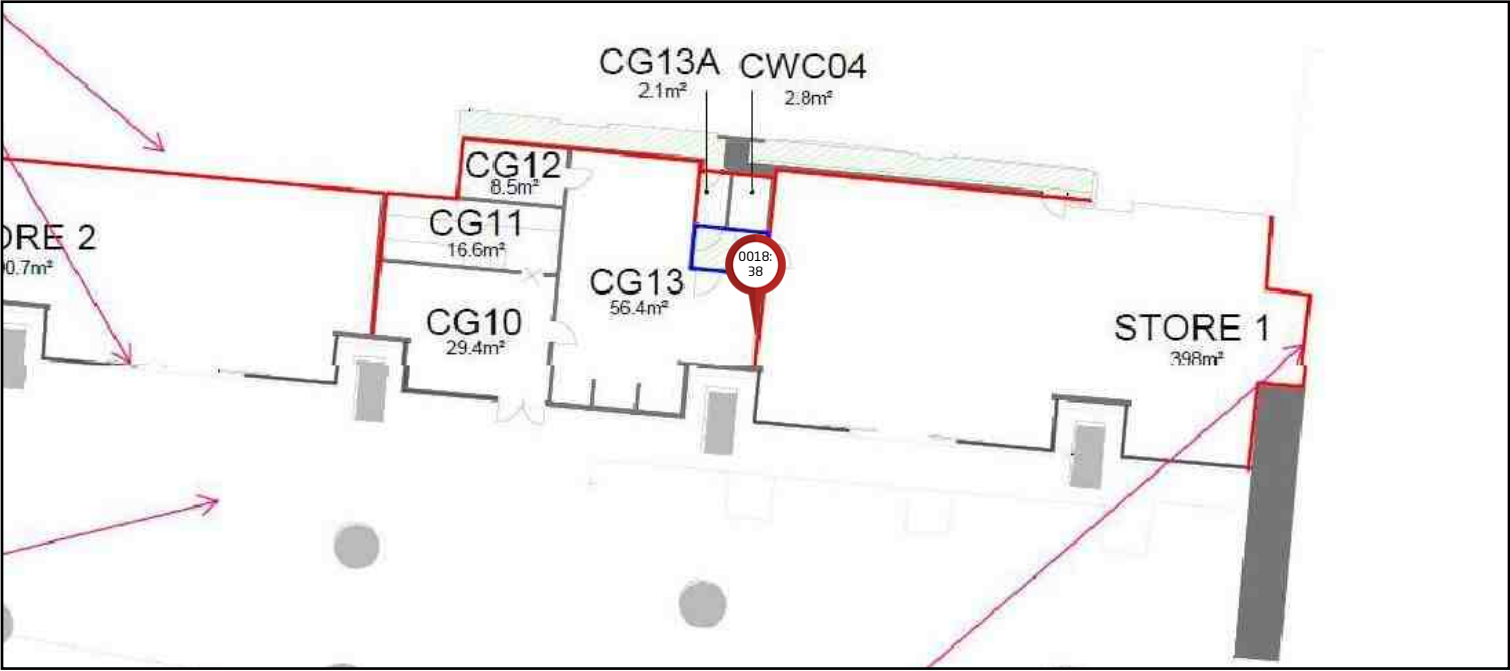
**Pin Number:** 0018:38  
**Company:** Neo Property Solutions  
**Contractor:** Tony Narkevicius - 30

| Survey | |
|---|---|
| Needs to be replaced with fire rated door | |
| Since Matthew surveyed this door i have done some investigation and it appears to be a Swedish built 60min fire rated door but this would need to be confirmed by the museum using the O&M manual | |

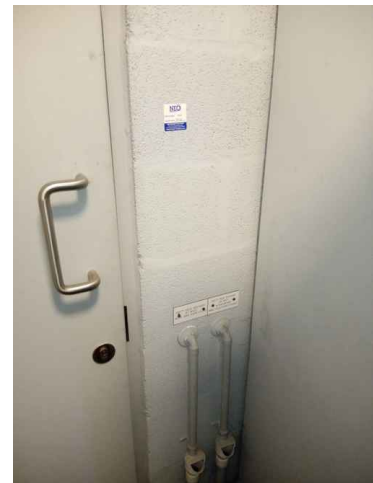
**Pin Number:** 0025:38  
**Company:** Neo Property Solutions  
**Contractor:** Tony Narkevicius - 30

| Survey | |
|---|---|
| The pipes have a plastic cover that will need to be removed and then replaced once the seal has been installed | |

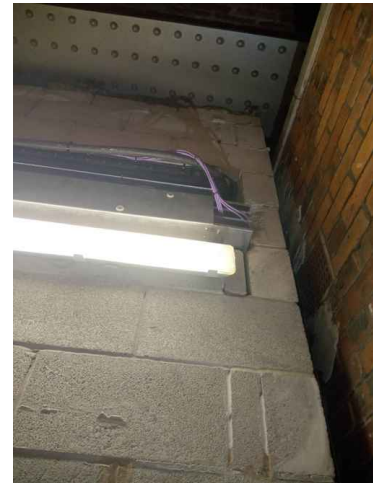
**Pin Number:** 0041:38  
**Company:** Neo Property Solutions  
**Contractor:** Matthew Brown - 38

| Survey | |
|---|---|
| Cant access other side of wall. | |
