# Appendix A

## A: Photographic Schedule

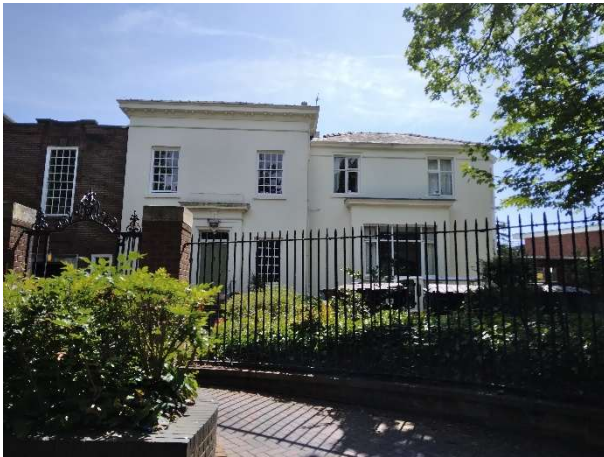
Photo 01 – Existing Front Elevation

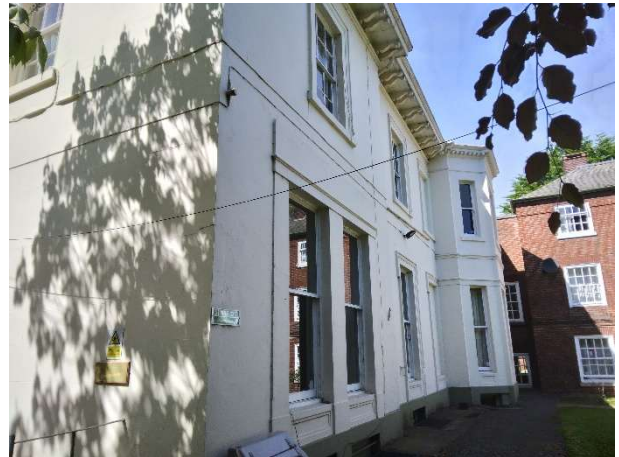
Photo 02 – Typical Side Elevation

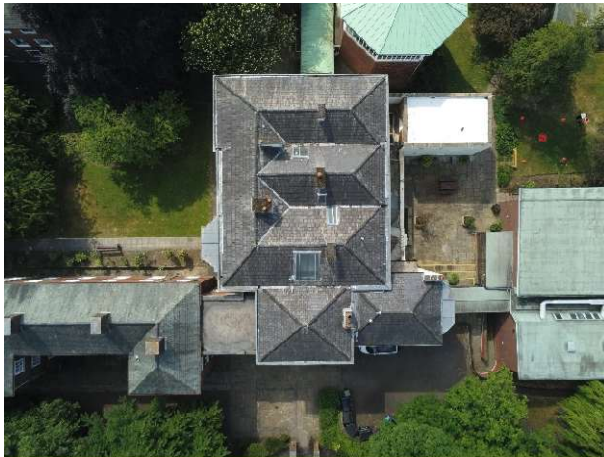
Photo 03 – Aerial Roof View

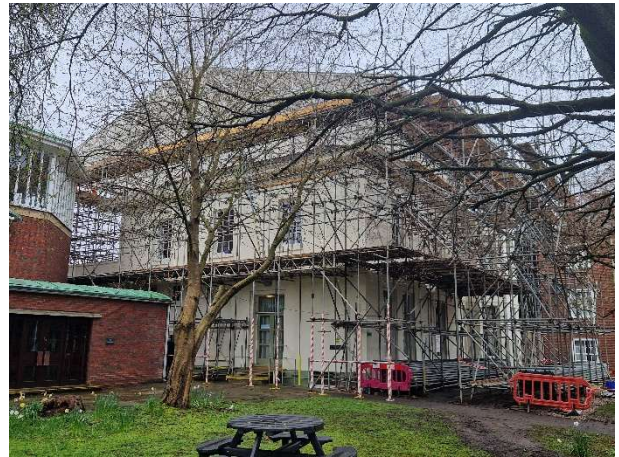
Photo 04 – Temporary Scaffold Roof to Rear Elevations

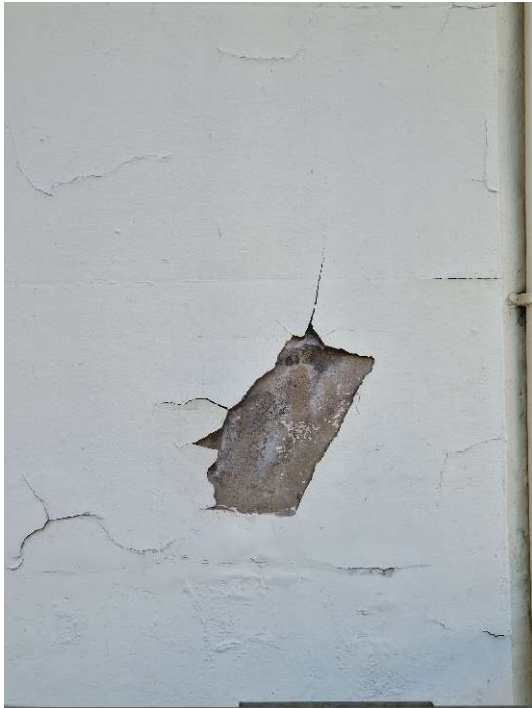
Photo 05 – Typical Section of Failed Render

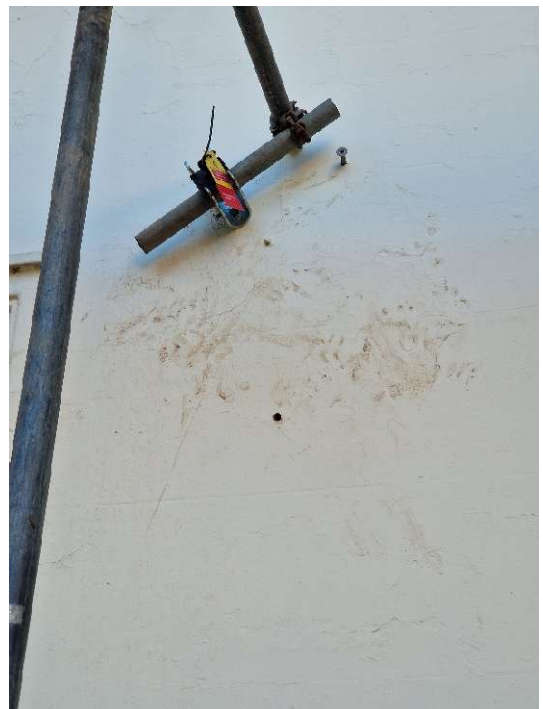
Photo 08 – Typical Scaffold Fixing

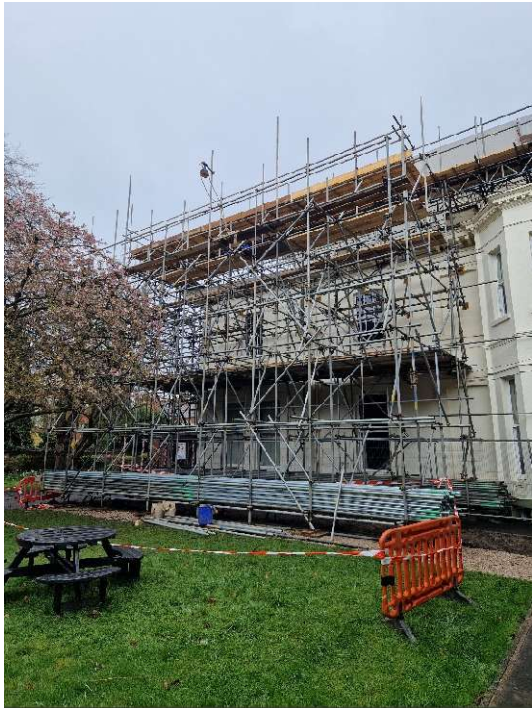
Photo 09 – Kentledge Scaffold to Rear Elevation

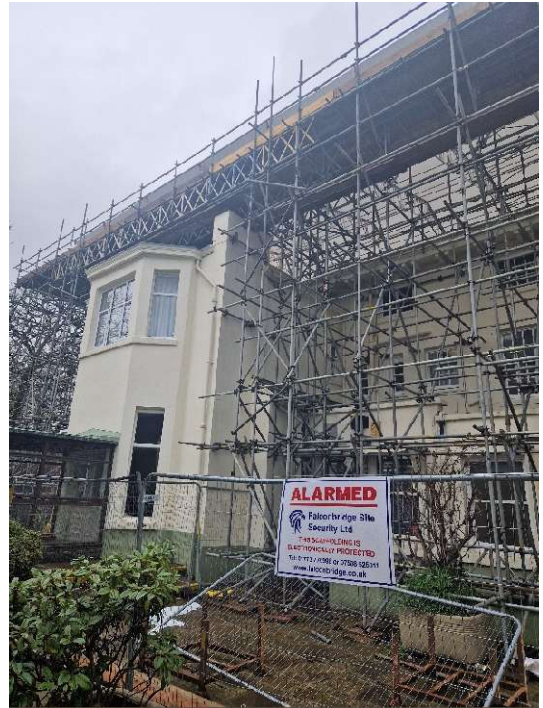
Photo 10 – Temporary Roof Scaffold to Side Elevation

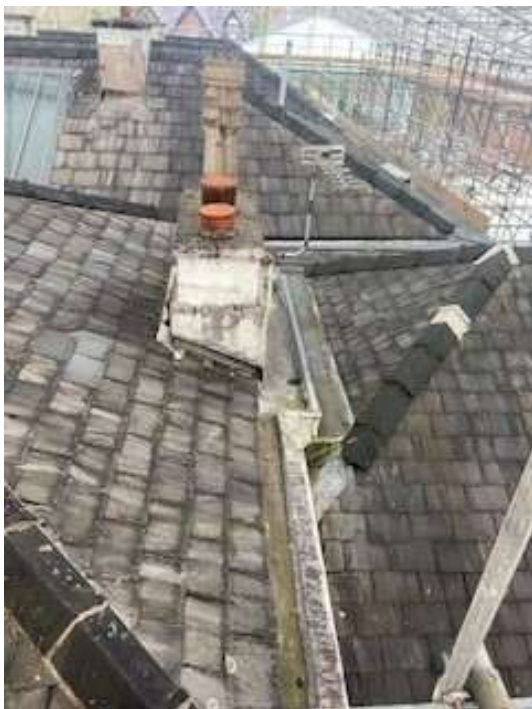
Photo 11 – Existing Roof Details

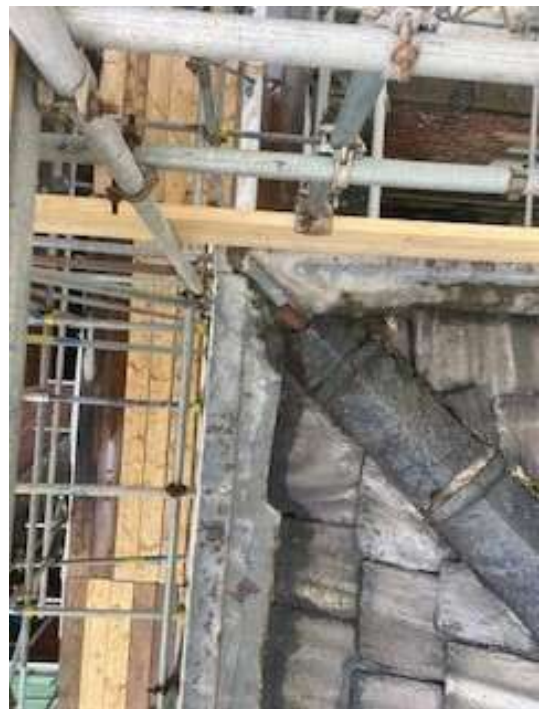
Photo 12 – Existing Gutter Details

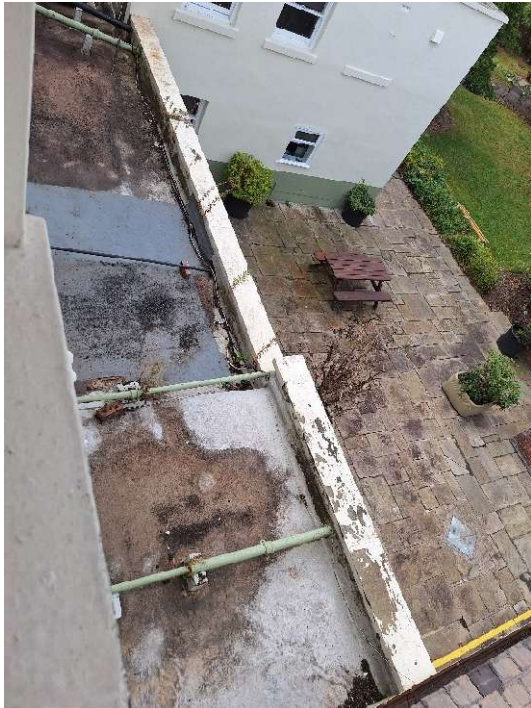
Photo 13 – Existing Flat Roof Covering (FR1)

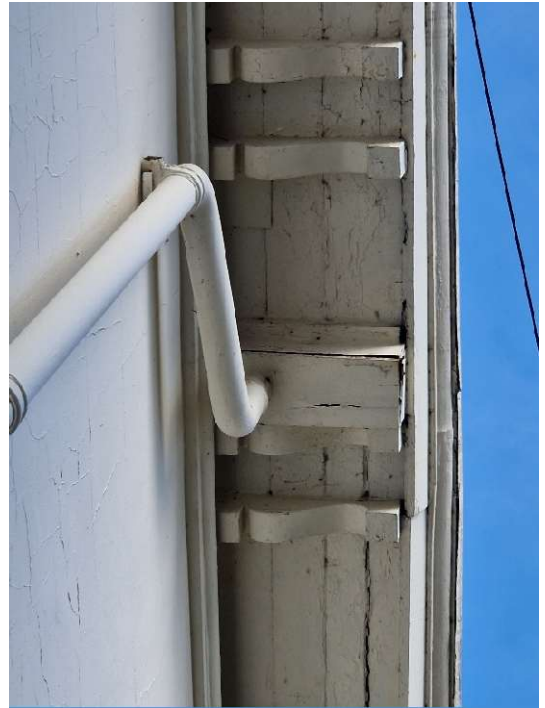
Photo 14 – Existing Projecting Eaves

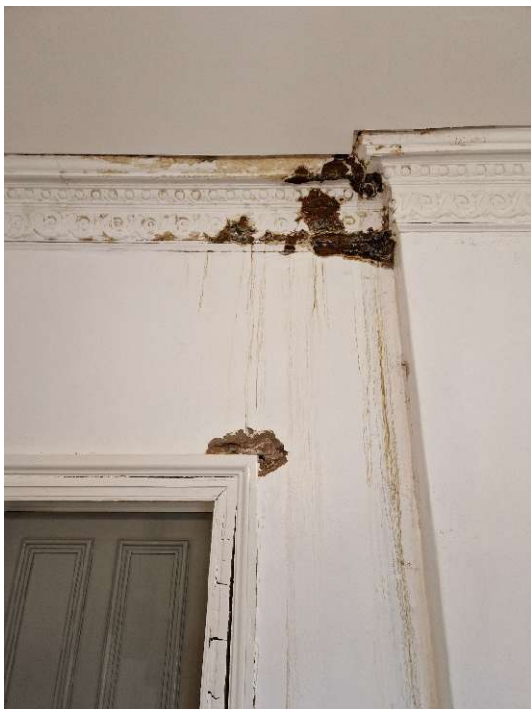
Photo 15 – Dry Rot Outbreak (Grond Floor)

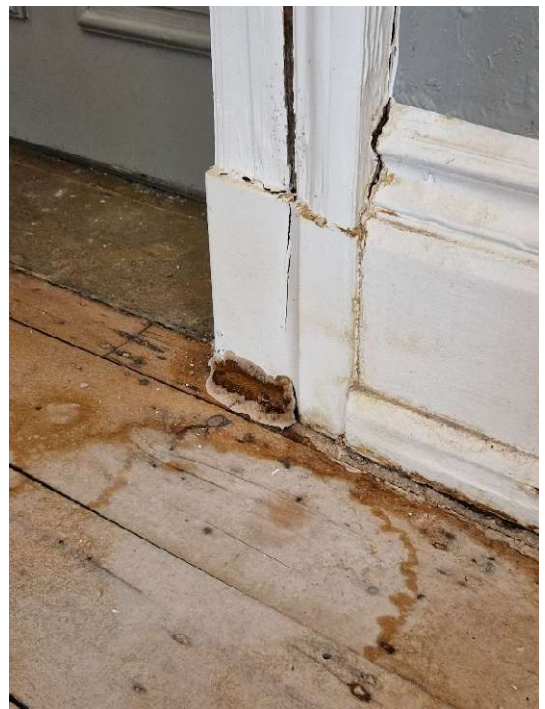
Photo 16 – Dry Rot Outbreak (Grond Floor)

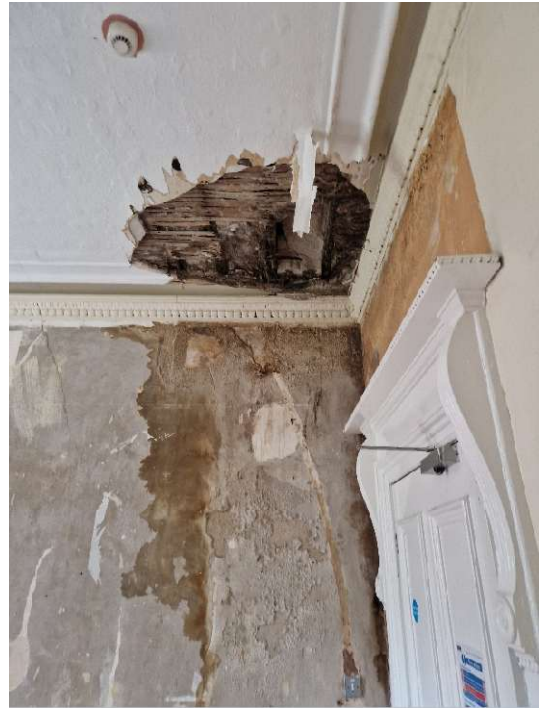
Photo 18 – Failed Plaster due to Water Ingress (First Floor)

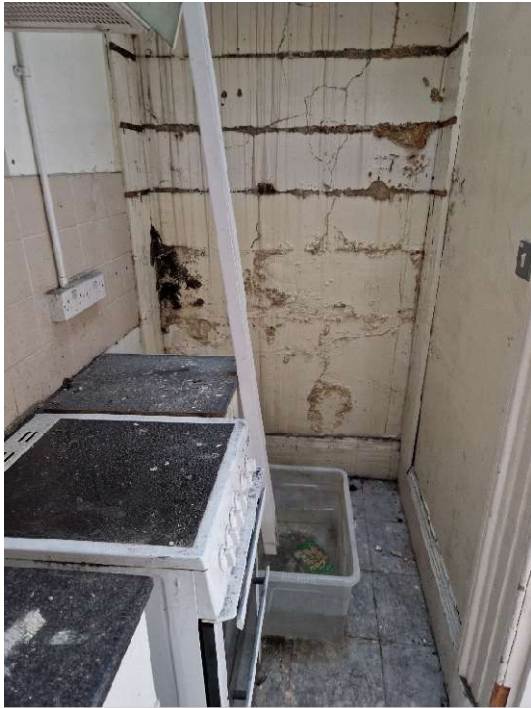
Photo 21 – Existing Kitchenette (First Floor)

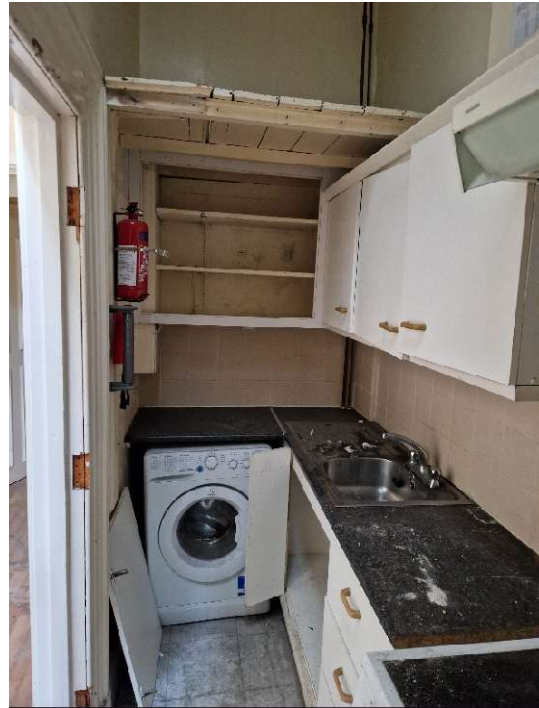
Photo 22 – Existing Kitchenette (First Floor)

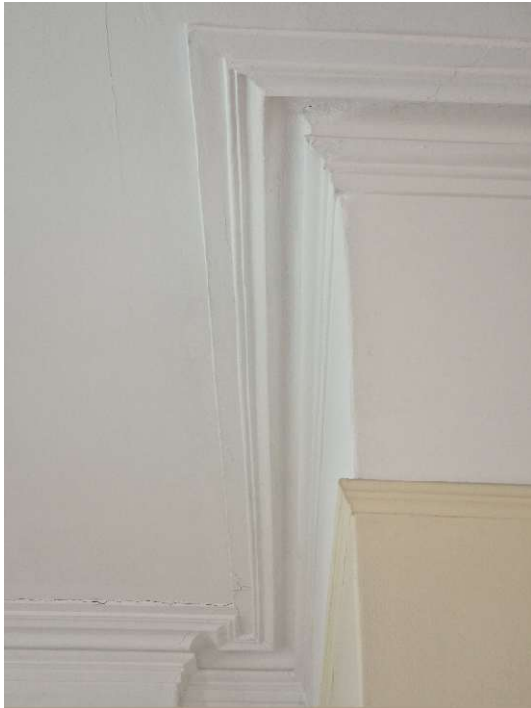
Photo 25 – Typical Ceiling Articulation

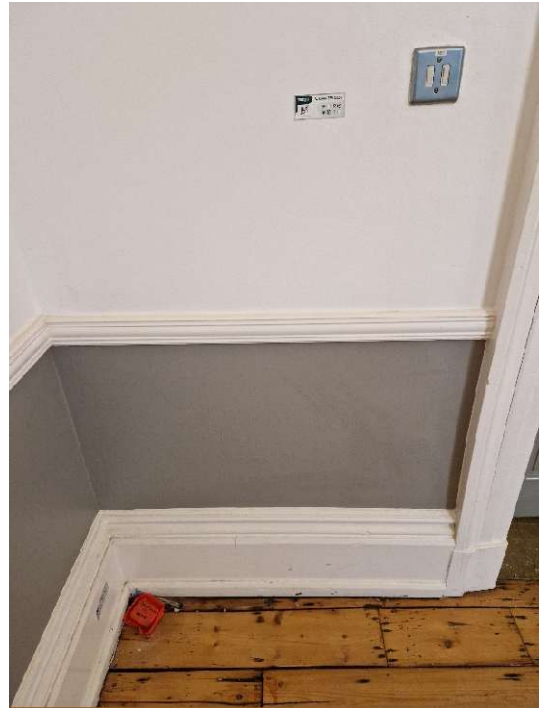
Photo 26 – Typical Wall Articulation

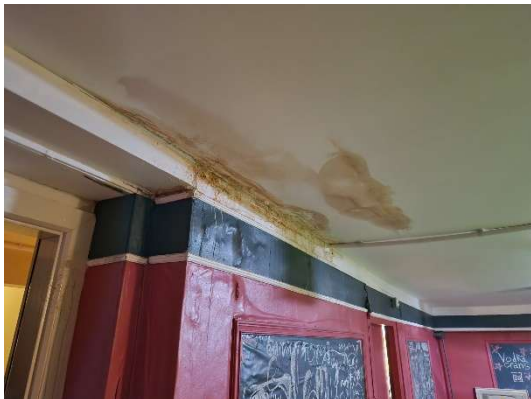
Photo 27 – Failed Ceiling Lining (Basement)

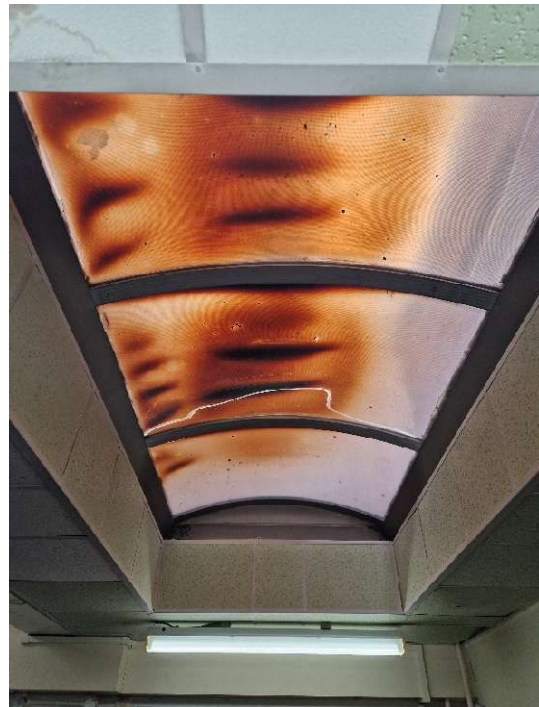
Photo 28 – Existing Rooflight (Ground Floor)
