# Design & Heritage Statement

## St Anselm Hall, University of Manchester Roof Replacement & Remedial Works

Document Ref: PN9104\_St Ansem Hall\_Design & Heritage Statement  
Revision: 00  
Date: March 2026

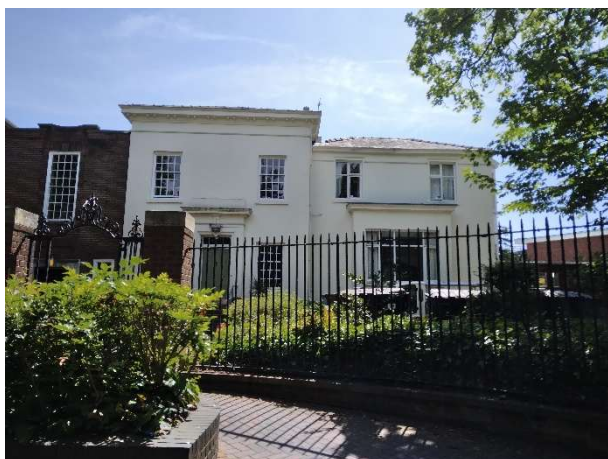
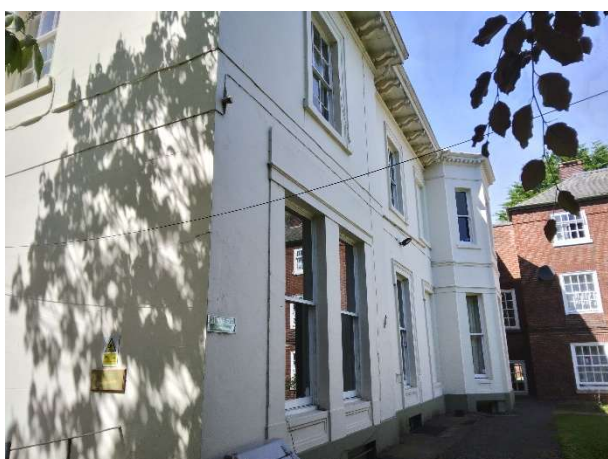
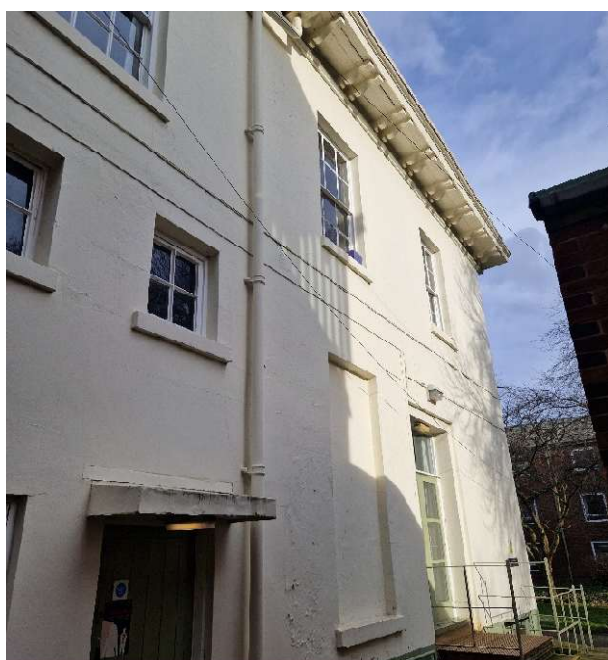
- There are numerous defects associated with the existing applied render finish to elevations and chimney stacks including crazing, cracking, de-bonding and in isolated areas complete detachment exposing the masonry substrate beneath. There is evidence of previous repairs which may have been undertaken with an inappropriate cementitious render; further analysis is required to validate.

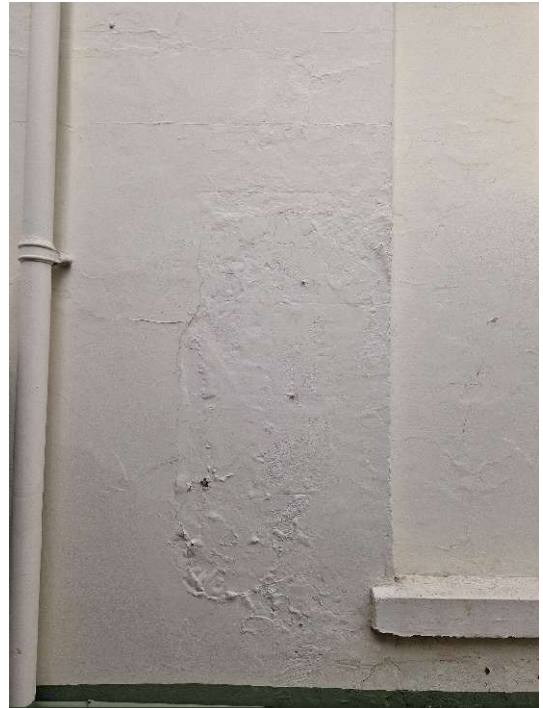
Photo 06 – Typical Section of Failed Render

- Identified failed / defective render to the four principal elevations will be further appraised once suitable access is afforded. A schedule of defective area including crazing, cracks, de-bonding has been recorded. Affected areas are to be repaired / replaced utilising a lime-based render system including commensurate breathable decoration.

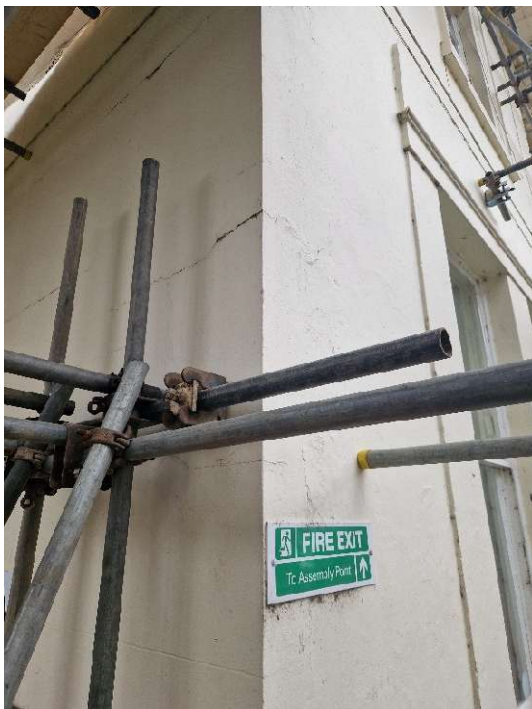
Photo 07 – Typical Cracking to External Render

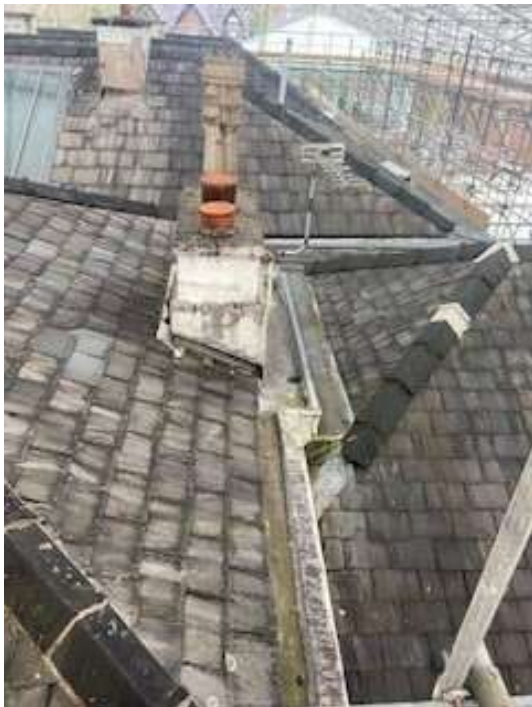
Photo 11 – Existing Roof Details

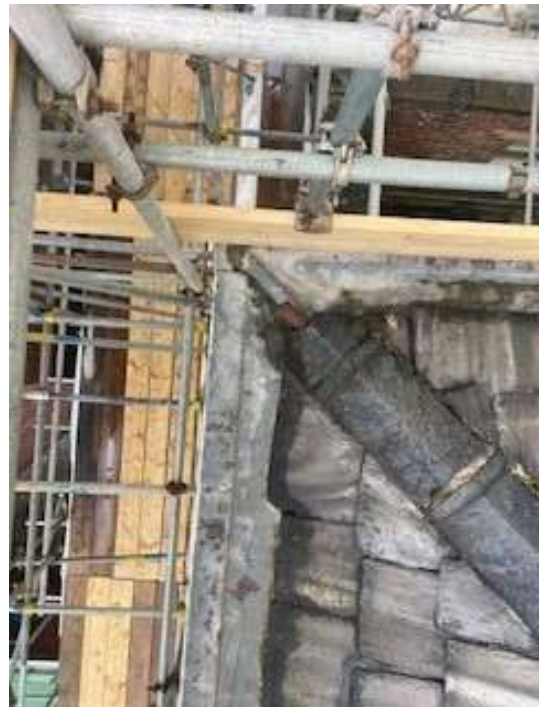
There is evidence of temporary repairs to existing lead valleys / gutter using a form of lead sealant / paint. There is also evidence of material / debris build up within valleys / gutters indicating a combination of blocked outlets and or inadequate falls. There is evidence of deterioration to the timber gutter boards and kneelers below projecting eaves gutters indicating suspected weakness or compromises to the lead linings / joints.

Photo 12 – Existing Gutter Details

- Existing weathering, apron flashings, cover flashing, soakers, step flashings, valleys, gutter etc. are to be replaced with new appropriate code lead in accordance with Lead Sheet Training Academy standards. Existing details are to be replicated.
- Existing rainwater goods including downpipes, hoppers, shoes, chutes etc. are to be replaced with commensurate cast iron matching existing configurations and locations.

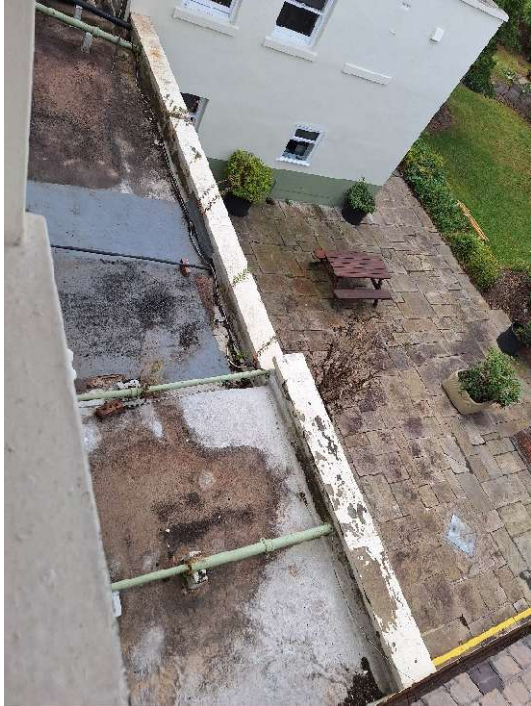
There are two further existing asphalt flat roofs identified for replacement within the scheme highlighted on drawing no. 9140\_004\_01. There is direct water penetration through Flat Roof 1 to the corresponding suspended ceiling below. The existing roof coverings are beyond their intended design life; there is evidence of blistering and cracking to the asphalt surfaces and compromised upstand details around roof light and parapets. There is also evidence of vegetation growth and isolated previous repairs with mineral felt and liquid applied coatings.

Photo 13 – Existing Flat Roof Covering (FR1)

- The asphalt flat roof coverings to 2no flat roofs as detailed on the accompanying drawings are to be replaced. The existing covering are to be removed back to the existing vapour control layer, and a new insulated built-up mineral felt system applied including associated upstand details.

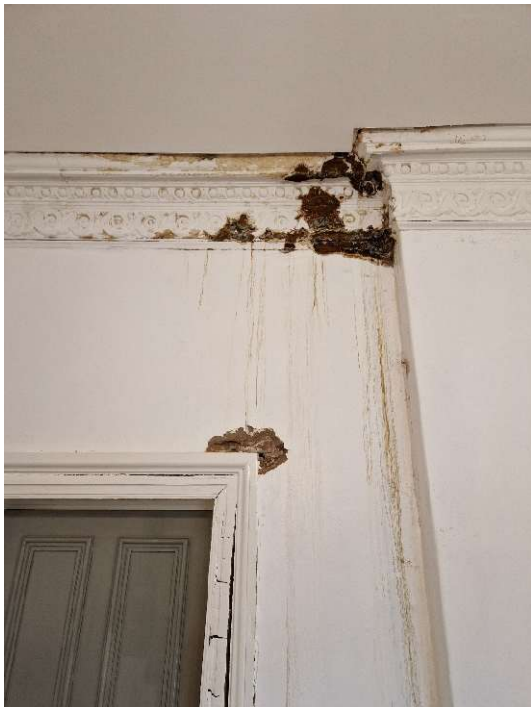
A fungal timber decay survey has been undertaken which has confirmed presence dry rot (*serpula lacrymans*) to floor joists, ceiling joists, skirting boards, stud walls, lintels, architraves and surrounding masonry. The elimination of the source of moisture feeding the decay will restrain the outbreak but there will be a required to remove decay / affected elements including floor / ceilings joints and joinery.

Photo 15 – Dry Rot Outbreak (Grond Floor)

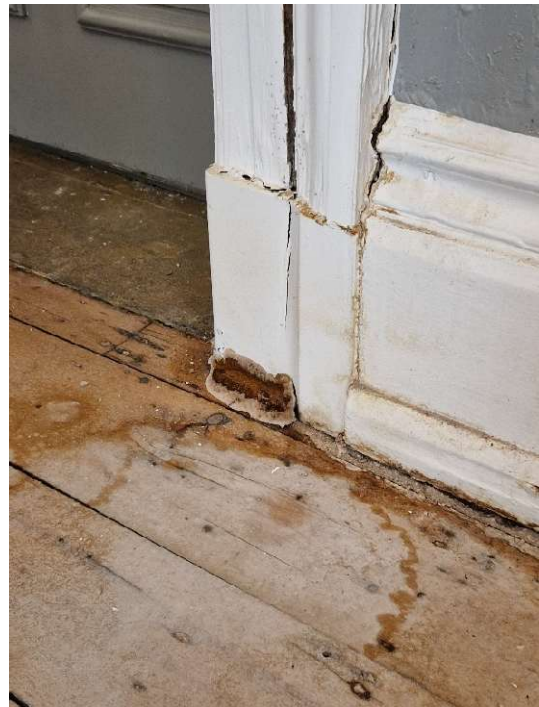
Photo 16 – Dry Rot Outbreak (Grond Floor)

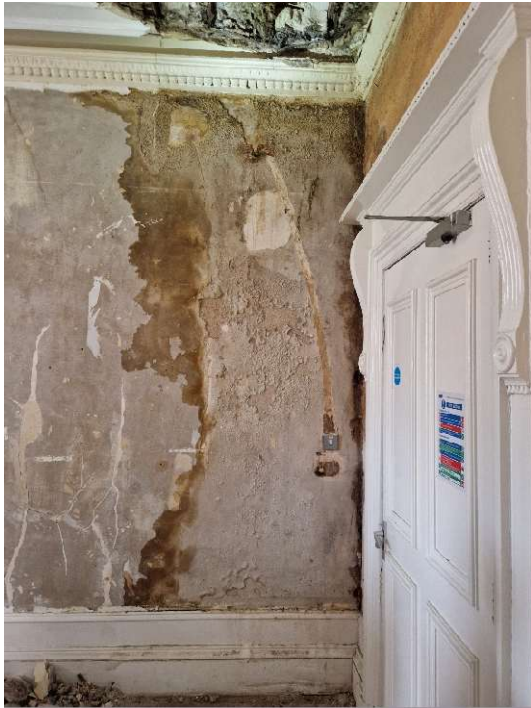
Where there has been direct water ingress existing plaster finishes have failed, cracked, addled and de-bonded. In localised areas the plaster finish has de-bonded and fallen or has been removed for precautionary measures.

Photo 17 – Failed Plaster due to Water Ingress (First Floor)

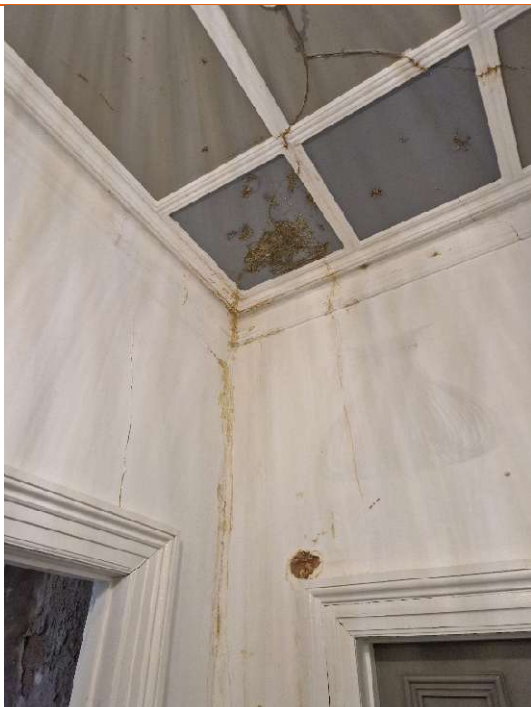
Photo 19 – Failed Internal Linings due to Water Ingress (First Floor)

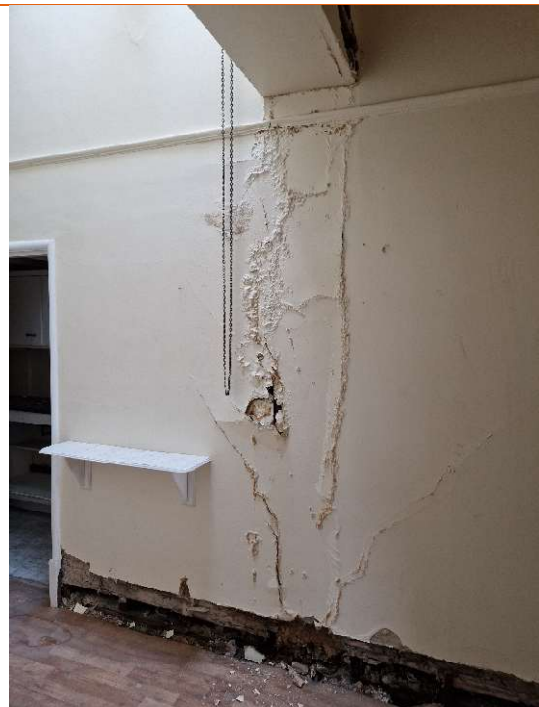
Photo 20 – Failed Internal Linings due to Water Ingress (First Floor)

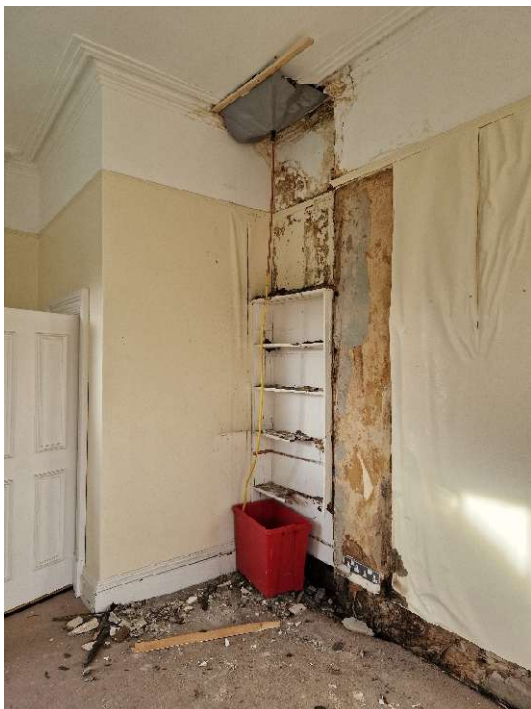
Photo 23 – Failed Internal Linings due to Water Ingress (First Floor)

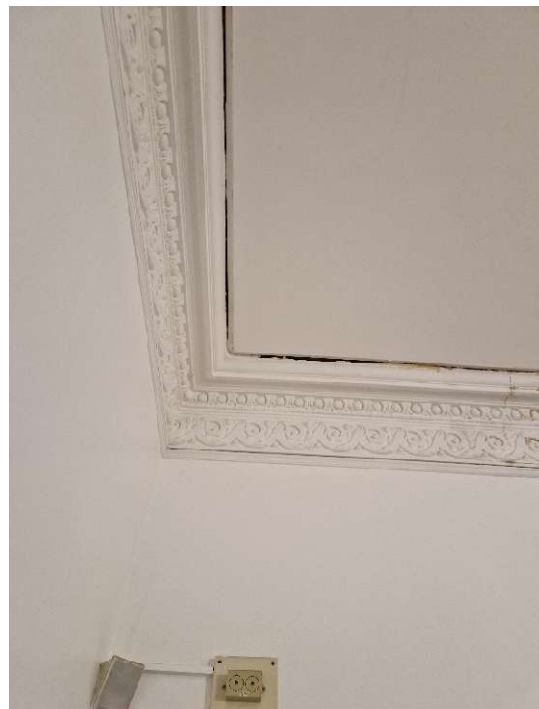
In some rooms as detailed on the accompanying drawings existing lathe and plaster ceilings have been over-boarded due to concerns over the integrity of the existing plaster. In these cases, the existing boarding will be removed and existing ceiling appraised and repaired / replaced as required to reinstate the existing ceiling line.

Photo 24 – Overboard to Lathe & Plaster Ceiling (Ground Floor)

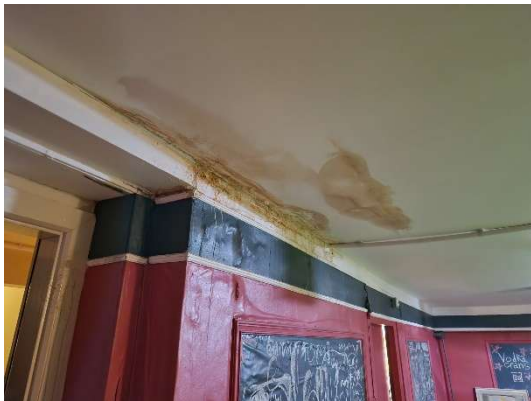
Photo 27 – Failed Ceiling Lining (Basement)
