### GAS MEMBRANE VALIDATION – BELLE VUE

| <b>Project Name: Belle Bue Stadium</b> |
| <b>Plots: 155-156</b> |

## Inspection Gas Membrane

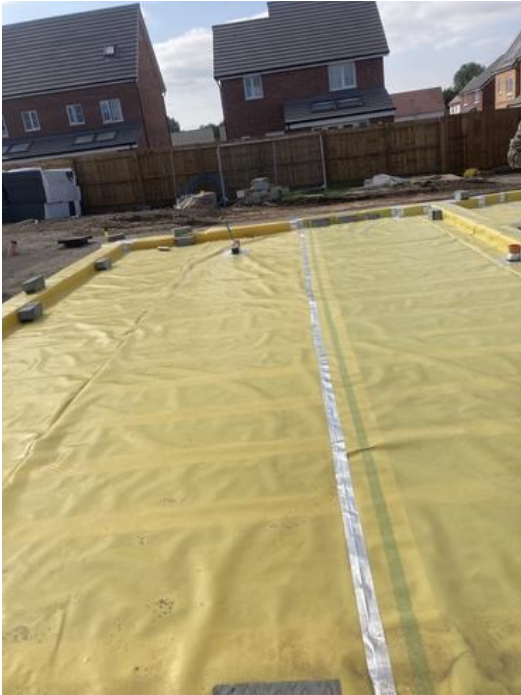
Photo 1

Gas Membrane Condition: Open punctures, tears, rips, stretching, Presence of debris, Repairs, Signs of weakness such as raised or sunken indentations, Protection plan in place to restrict access to lain gas membrane? IF FAIL DESCRIPTION IN ACTIONS AND PHOTOS REQUIRED

Pass

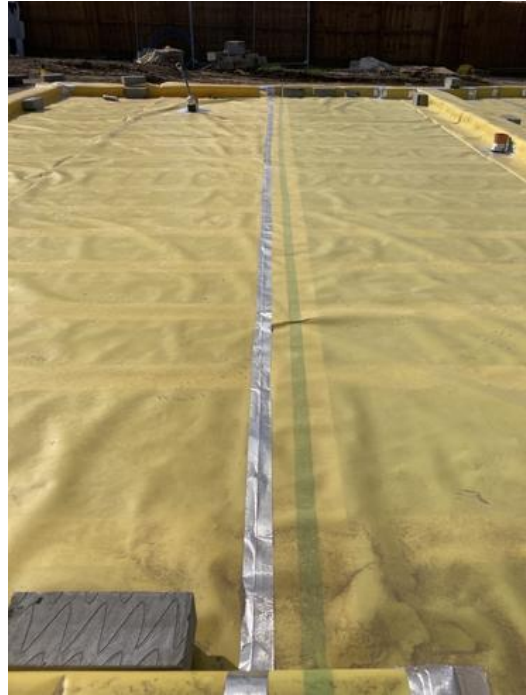
Photo 2

Laps, welds, and joints seals: Joints lapped and sealed in accordance with manufacturer's requirements/ specification? Minimum overlap insured? Sections taped twice? Are welds complete? Appropriate joining/double-sided tape used, Folds running in line with joints? (no joints cutting across folds)

Pass

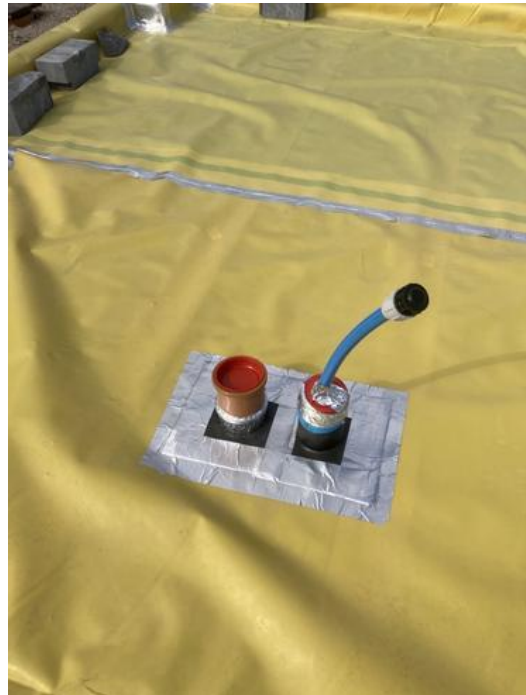
Photo 4

Service entries seals: Top hats seal arrangements fixed around service entries? Use of Jubilee clips?

Yes

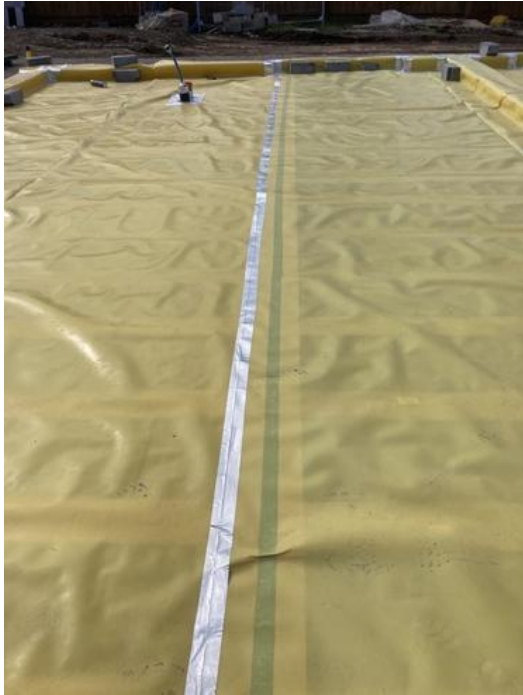
Photo 9

#### Type of joints/ Lapping

Taped

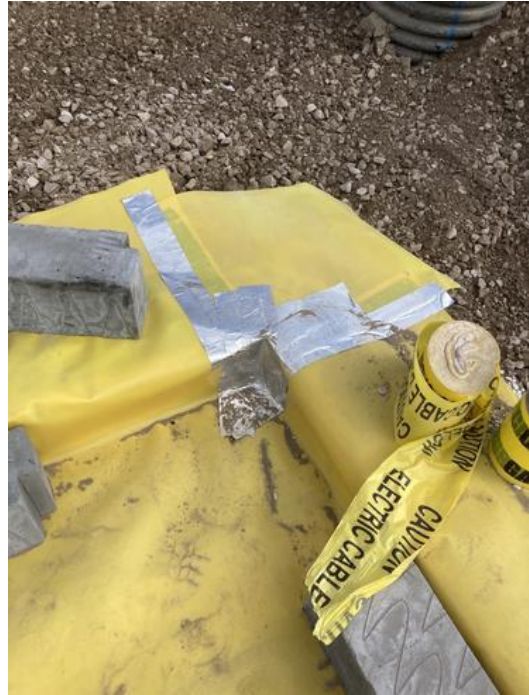
Photo 10

**Corners / Internal joints: Check all corners are correctly formed or contractor has used preformed corners.**

Pass

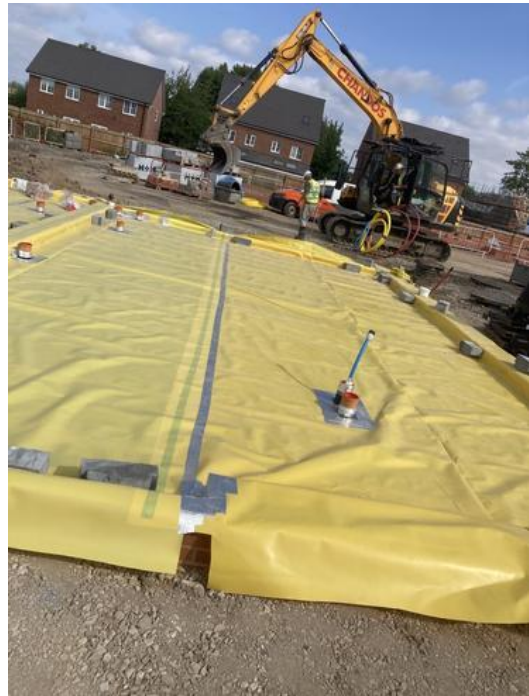
Photo 16

**Extent of Coverage: Is the membrane covering the entire plot? Does membrane span over outside walls?**

Yes

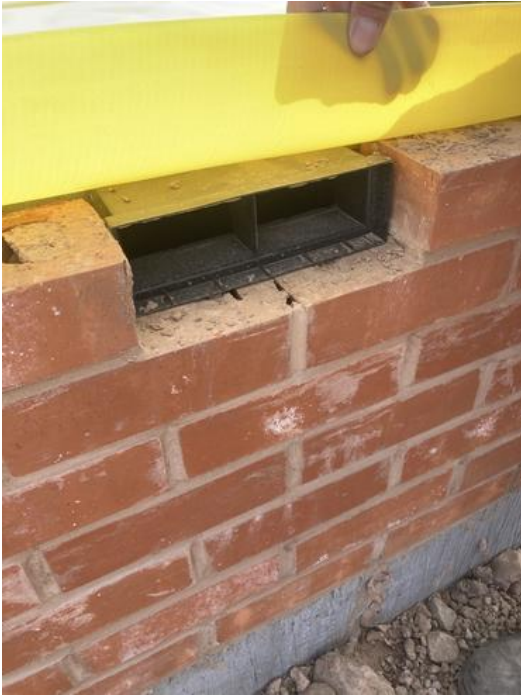
Photo 17

**External Wall Air bricks: Numbers, size. positions as design drawing? (Minimum of 3 walls)**

Pass

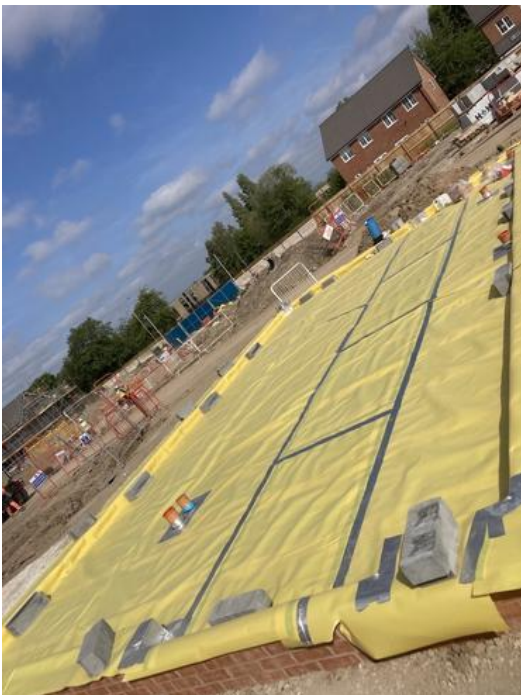
Photo 19

Gas Membrane Condition: Open punctures, tears, rips, stretching, Presence of debris, Repairs, Signs of weakness such as raised or sunken indentations, Protection plan in place to restrict access to lain gas membrane? IF FAIL DESCRIPTION IN ACTIONS AND PHOTOS REQUIRED

Pass

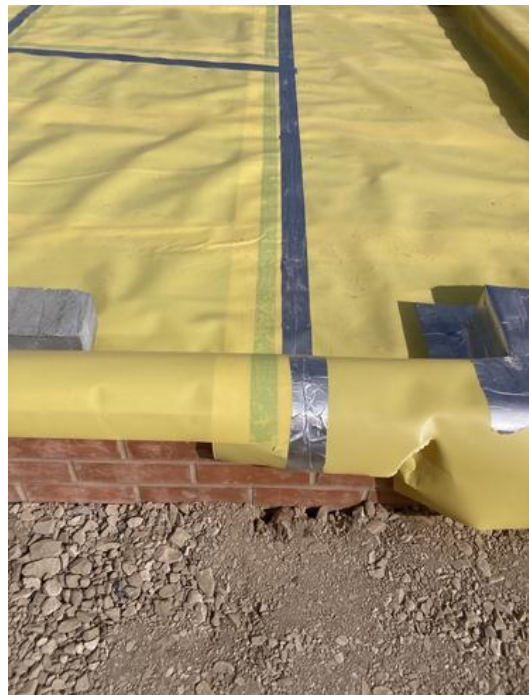
Photo 20

Laps, welds, and joints seals: Joints lapped and sealed in accordance with manufacturer's requirements/ specification? Minimum overlap insured? Sections taped twice? Are welds complete? Appropriate joining/double-sided tape used, Folds running in line with joints? (no joints cutting across folds)

Pass

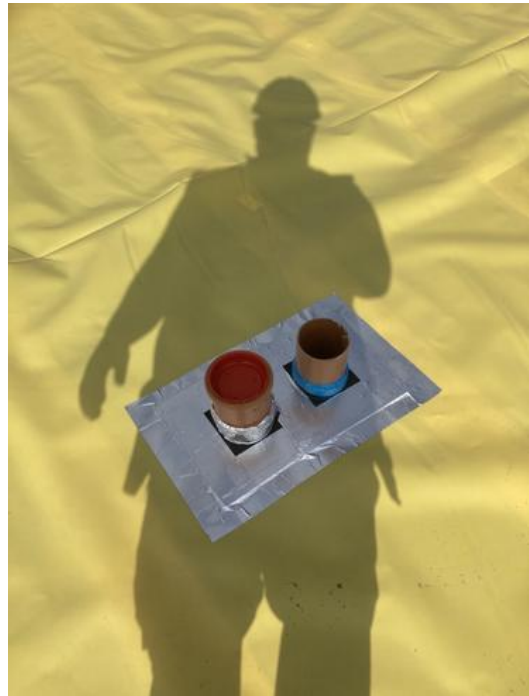
Photo 24

Service entries seals: Top hats seal arrangements fixed around service entries? Use of Jubilee clips?

Yes

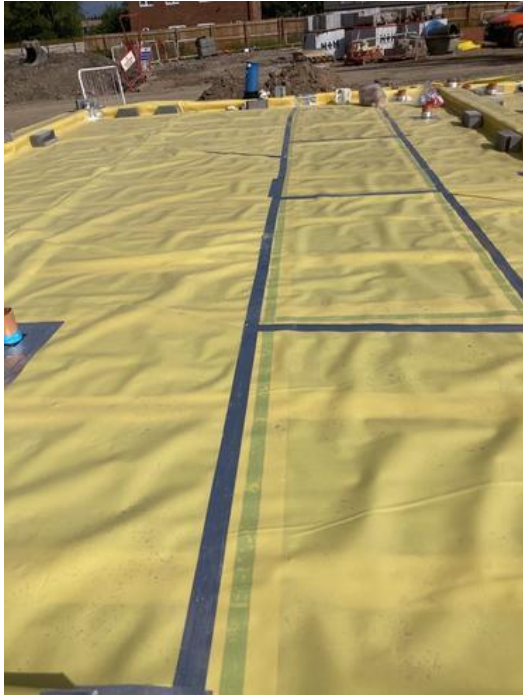
Photo 29

Type of joints/ Lapping

Taped

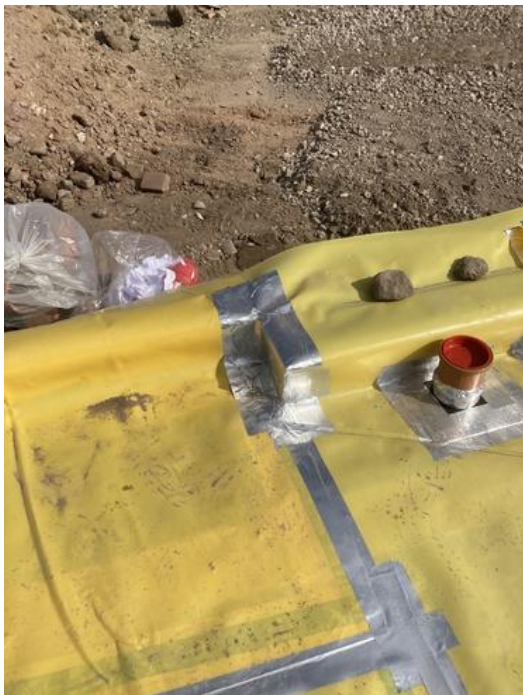
Photo 31

**Corners / Internal joints: Check all corners are correctly formed or contractor has used preformed corners.**

Pass

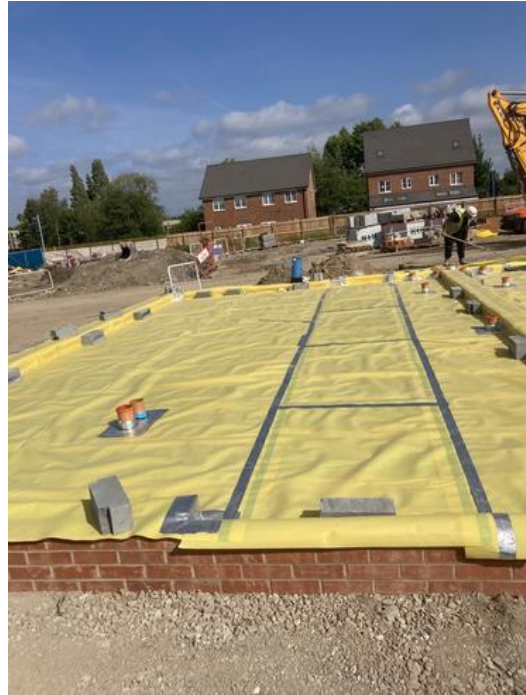
Photo 38

**Extent of Coverage: Is the membrane covering the entire plot? Does membrane span over outside walls?**

Yes

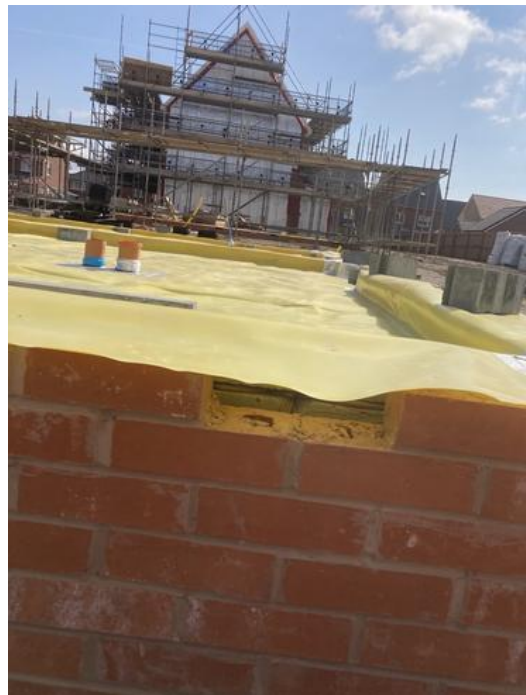
Photo 40

**External Wall Air bricks: Numbers, size. positions as design drawing? (Minimum of 3 walls)**

Pass
