## Schedule Of Condition

**Sandra Burslem & All Saints  
Library, Manchester Metropolitan  
University, Manchester**

**November 2025**

**01217**

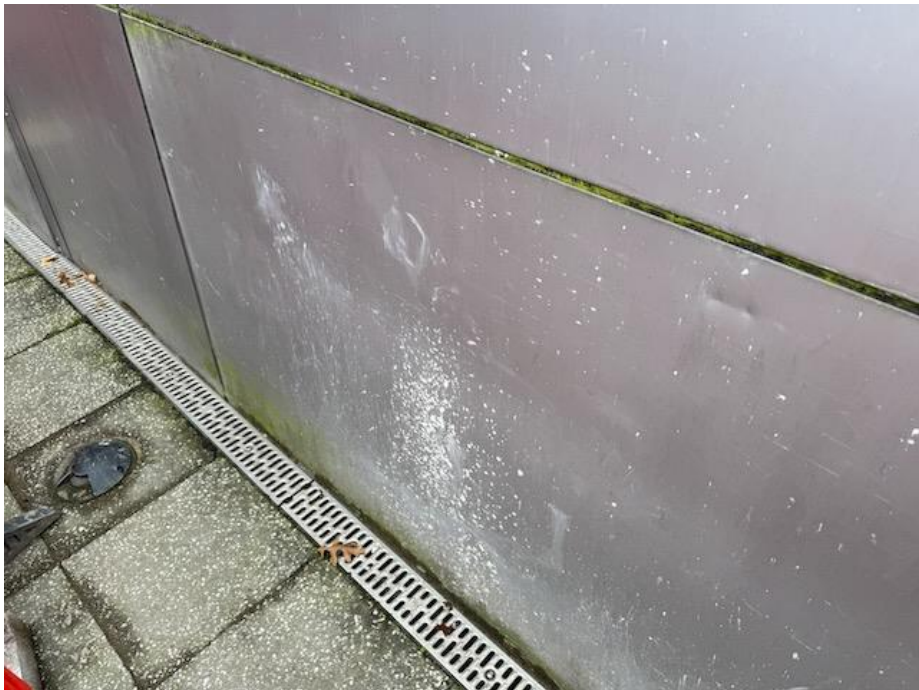
7.

| Ref | Location | Description | Condition | Photos |
|---|---|---|---|---|
| 4. | | | Localised impact damage and scratches are visible to 1 nr cladding panel at low level to the right hand side. | 7 |

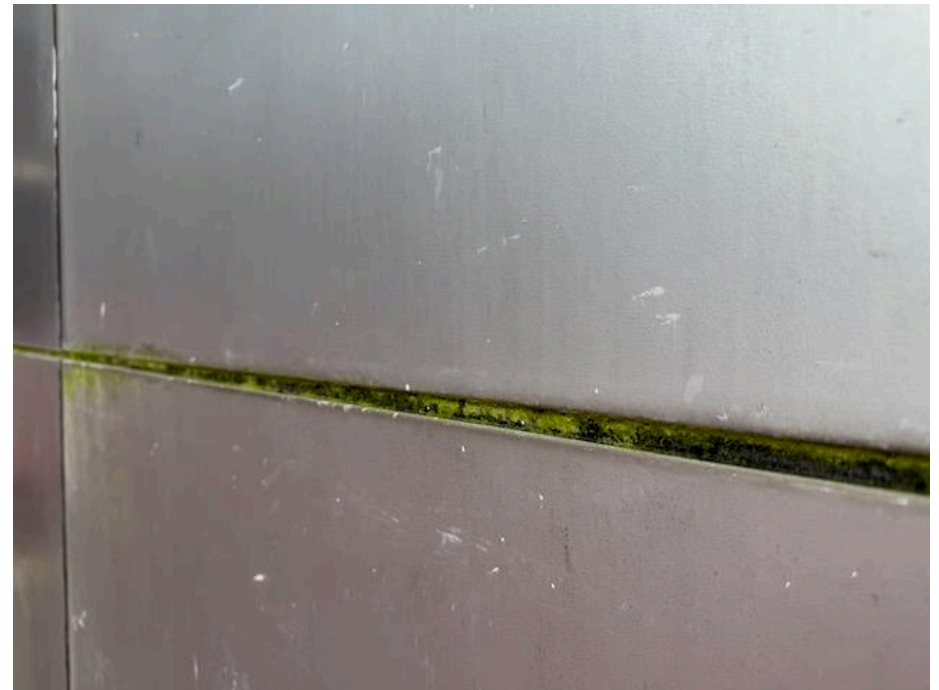
| Ref | Location | Description | Condition | Photos |
|---|---|---|---|---|
| 8. | | | The horizontal and vertical sealant between the cladding panels is degraded and soiled, wit evidence of vegetation growth in these locations. | 8 |

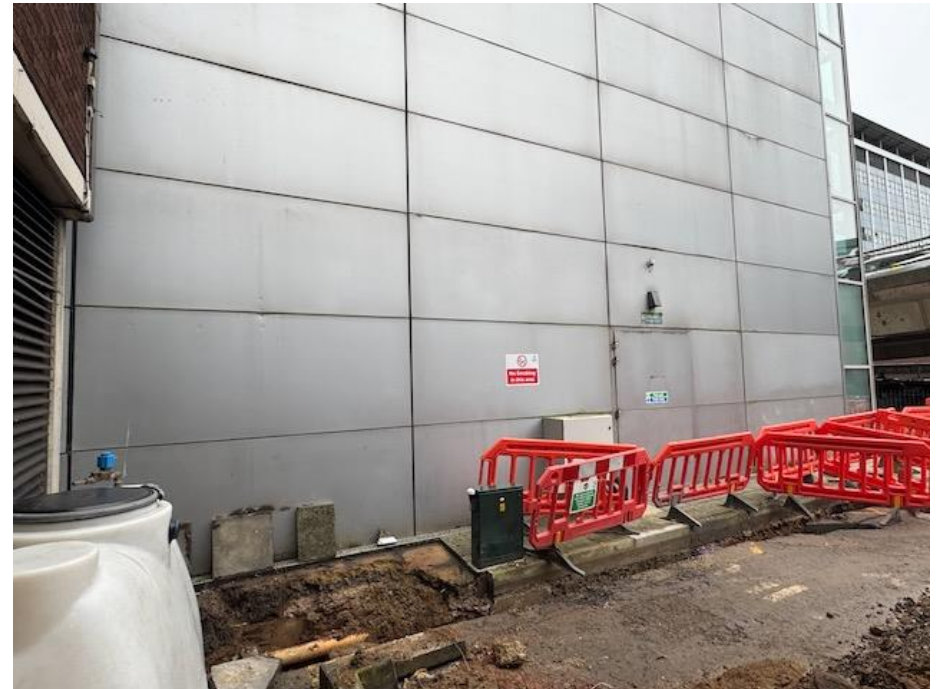
12.

| Ref | Location | Description | Condition | Photos |
|---|---|---|---|---|
| 5. | | | Minor impact damage is visible to 5 nr cladding panels at low level to the left hand side and abutment with the neighbouring building. | 12 |

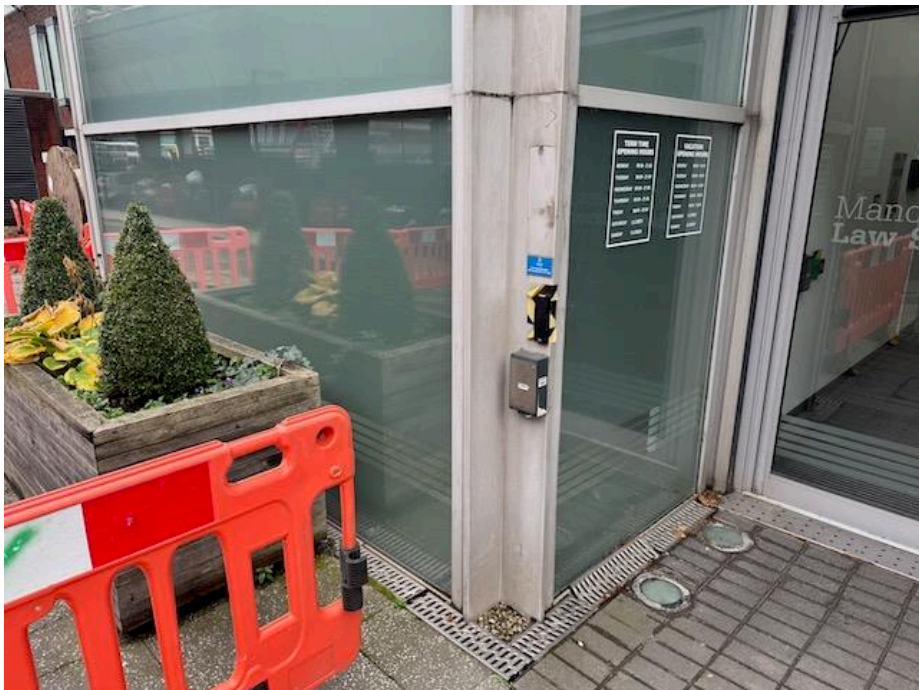
17.

| Ref | Location | Description | Condition | Photos |
|---|---|---|---|---|
| 20. | | Signage detailing opening hours is mounted to the glazing at low level adjacent to the main entrance doors. | The signage is in good condition. | 17 |

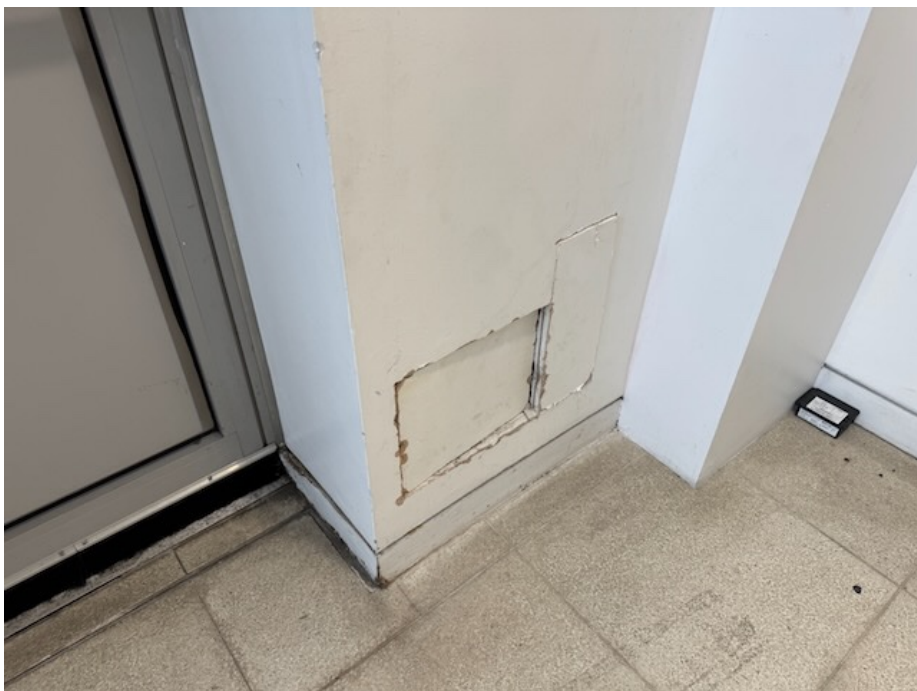
75.

| Ref | Location | Description | Condition | Photos |
|---|---|---|---|---|
| 26. | | | The plasterboard is damaged at ground floor adjacent the fire escape door where holes / access hatches have been formed. | 75 |

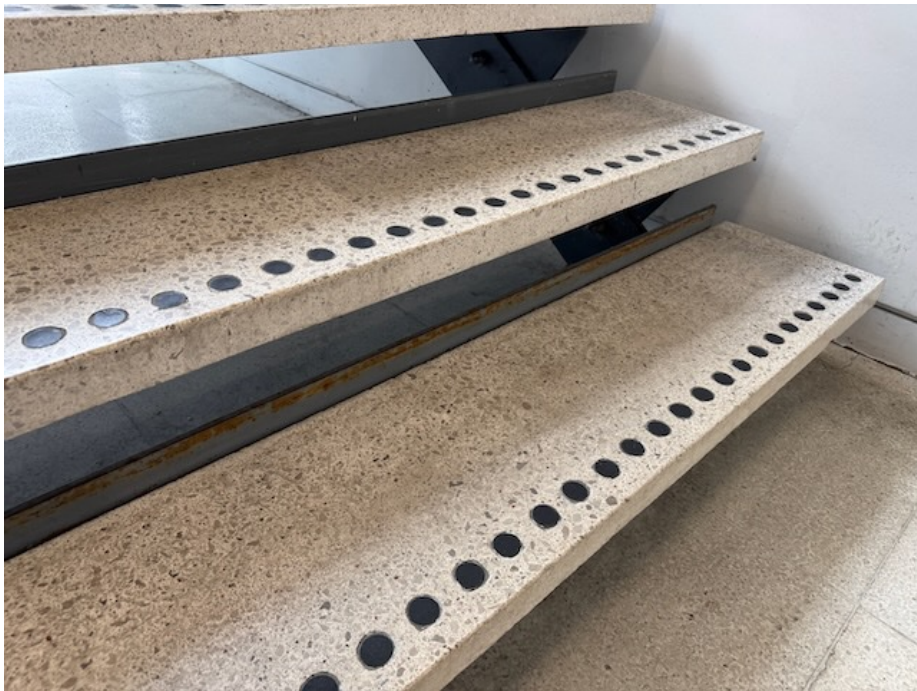
89.

| Ref | Location | Description | Condition | Photos |
|---|---|---|---|---|
| 44. | | Continuous terrazzo floor finishes are provided to the stair treads, which incorporate recessed non-slip nosings. | The terrazzo treads and recessed non slip nosings are in a satisfactory condition. | 89 |

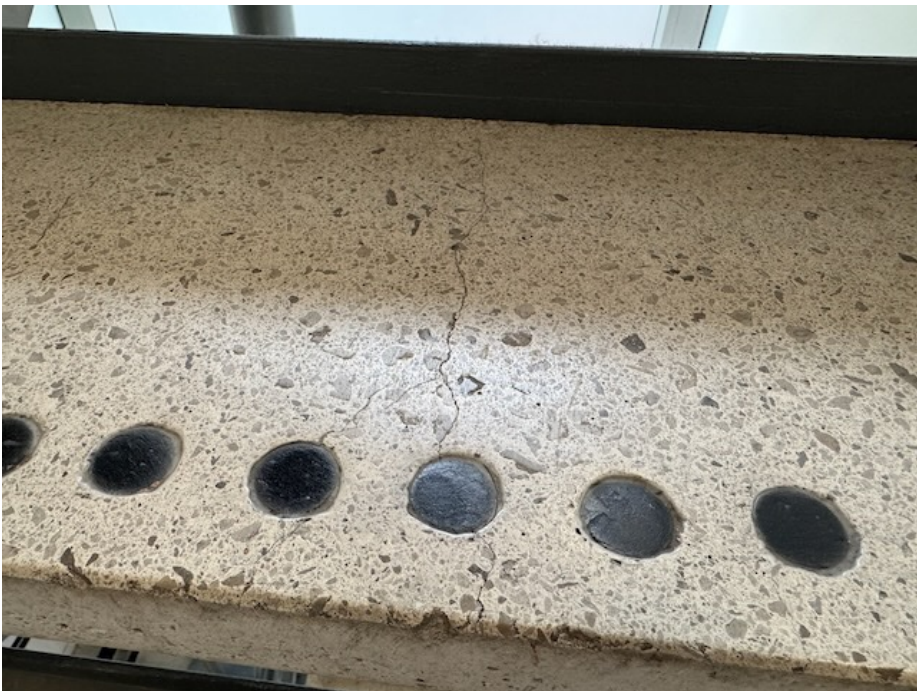
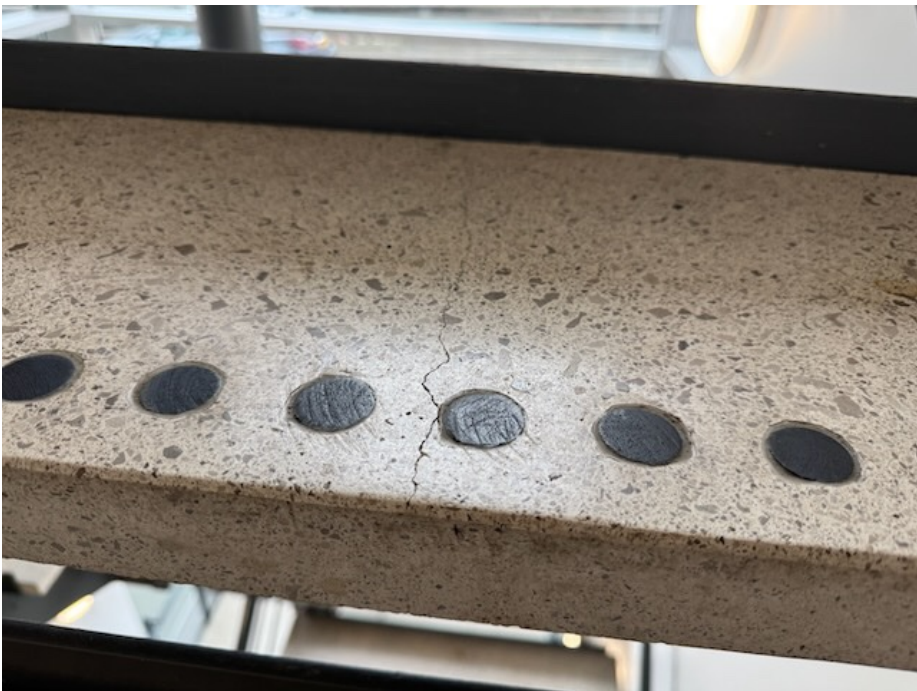
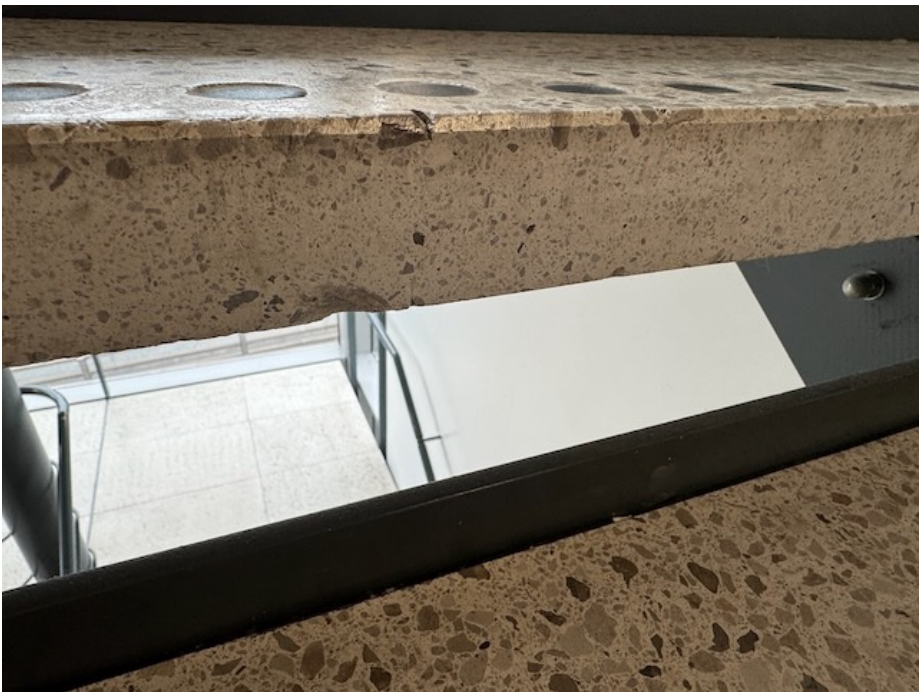
| Ref | Location | Description | Condition | Photos |
|---|---|---|---|---|
| 45. | | | There is widespread evidence of hairline cracking through the terrazzo centrally to the treads to all stair flights. | 90,<br>107,<br>120,<br>136,<br>141,<br>154,<br>169, |

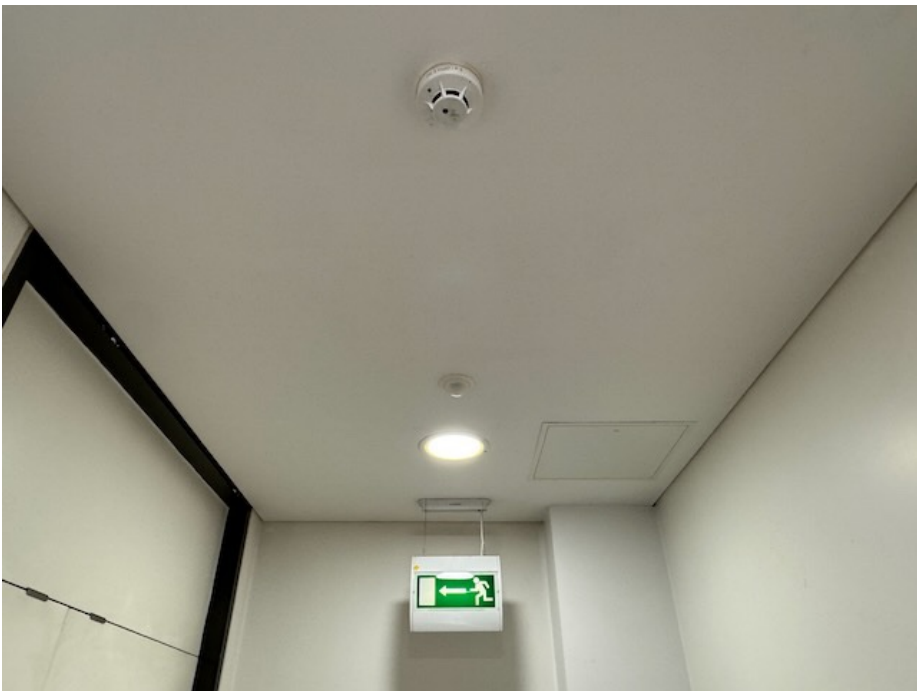
115.

| Ref | Location | Description | Condition | Photos |
|---|---|---|---|---|
| 33. | Ceilings | Painted plastered ceilings are provided within the landing / lobby areas and to the top of the stairwell. At sixth floor level a roof access hatch is incorporated within the lobby area. | The ceilings are in a satisfactory condition, subject to localised soiling and marks. | 87, 99, 100, 115, 129, 147, 163, 186, 189 |

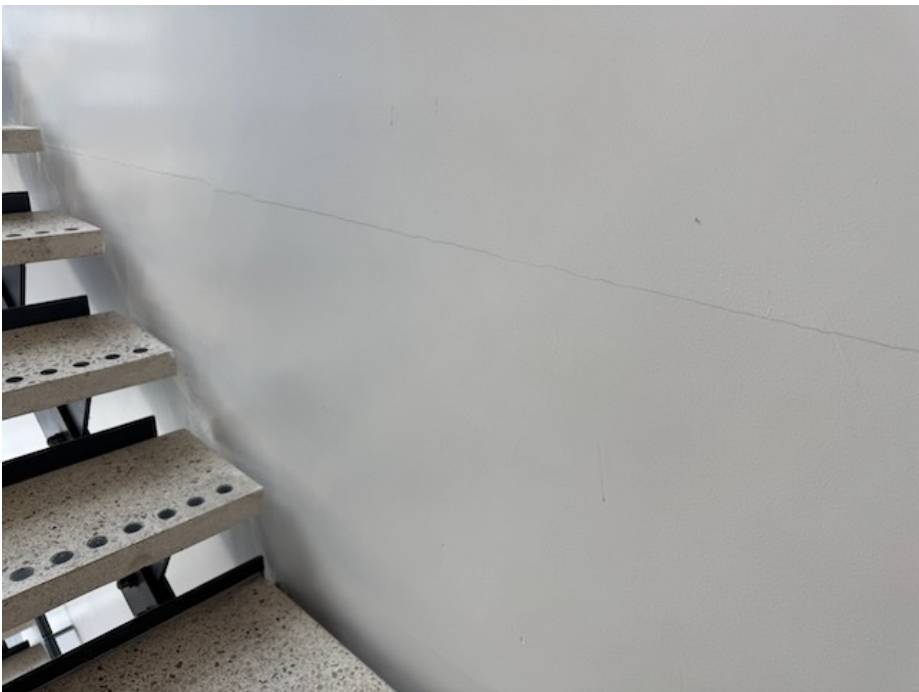
167.

| Ref | Location | Description | Condition | Photos |
|---|---|---|---|---|
| 27. | | | Consistent patterns of very slight cracking are visible to the plasterboard walls which flank the stair flights. This is most apparent between the third to sixth floor. | 125, 143, 167 |

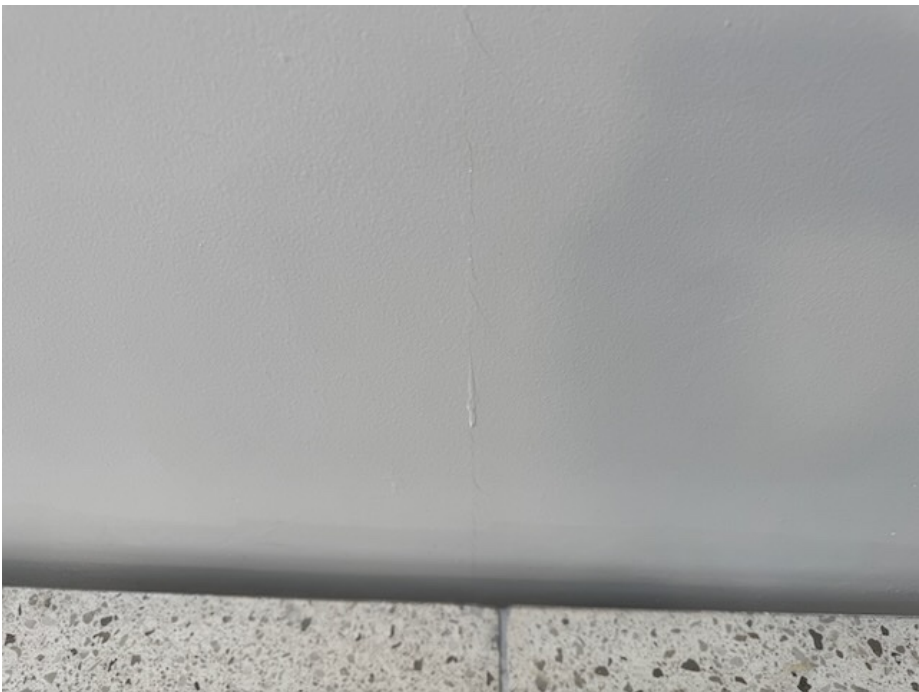
168.

| Ref | Location | Description | Condition | Photos |
|---|---|---|---|---|
| 28. | | | Isolated vertical cracking is visible through the plaster to the east of the fifth floor landing. | 168 |

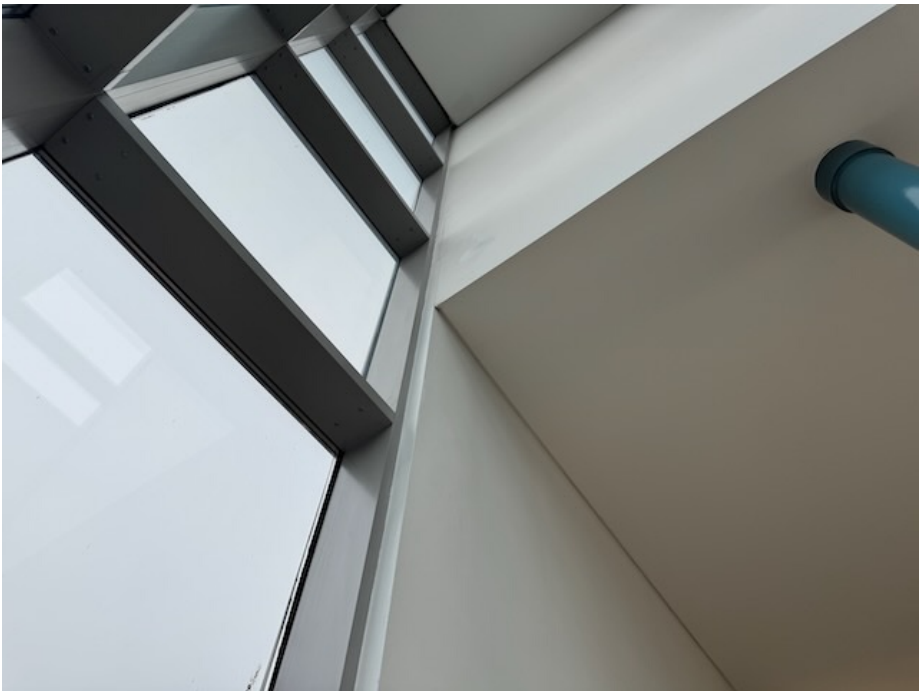
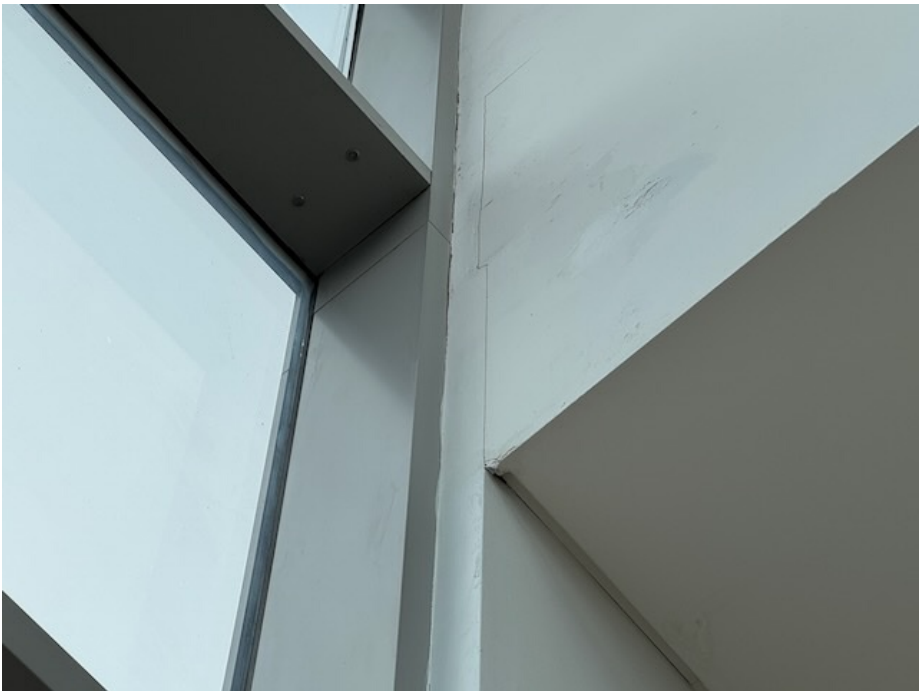
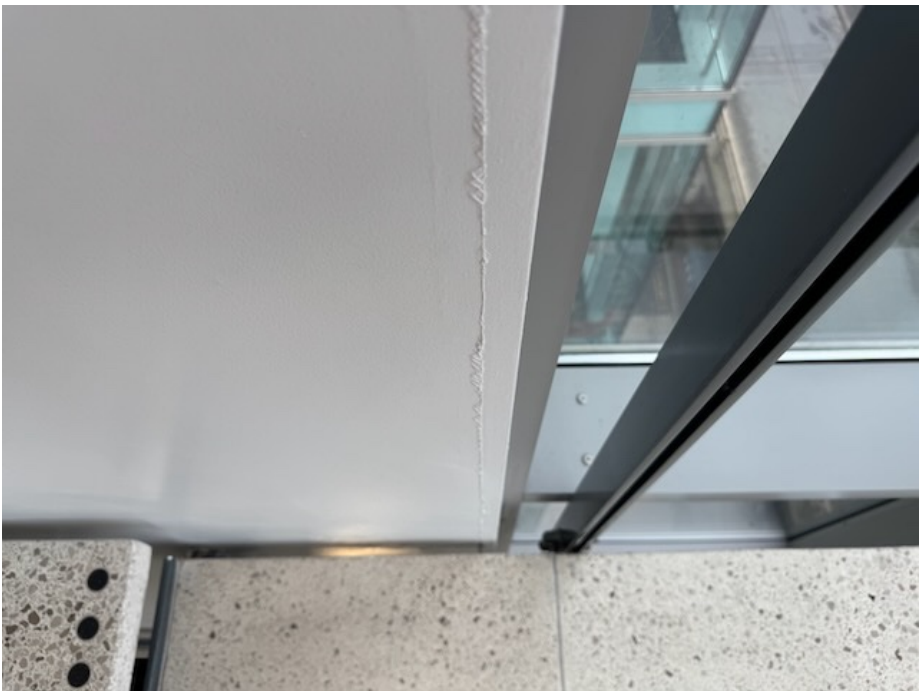
| Ref | Location | Description | Condition | Photos |
|---|---|---|---|---|
| 29. | | | Slight cracking is visible through the plastered reveals at the abutment with the curtain walling to the sixth floor areas. The paint finish is also damaged around the position of the embedded plaster angle beads | 173-174, 176-178 |

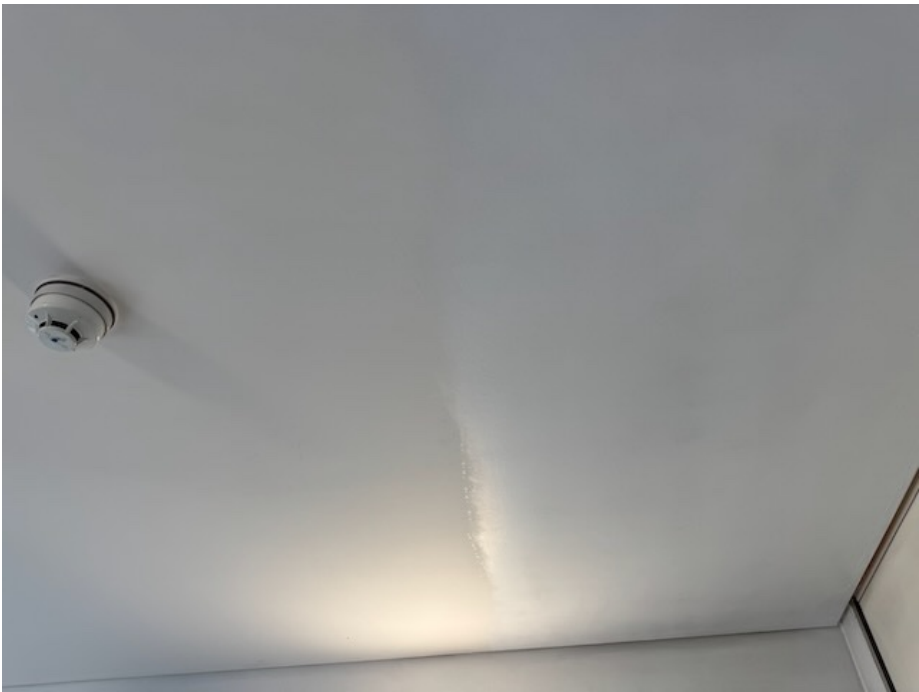
186.

| Ref | Location | Description | Condition | Photos |
|---|---|---|---|---|
| 36. | | | Decorations above the sixth floor landing are marked where a previous leak appears to have occurred. | 186 |
