## GAS MEMBRANE VALIDATION

| Site Name: Belle Vue Stadium | Project Number: 12-123 |
| Company Name: Countryside | Date: 23-08-2022 |

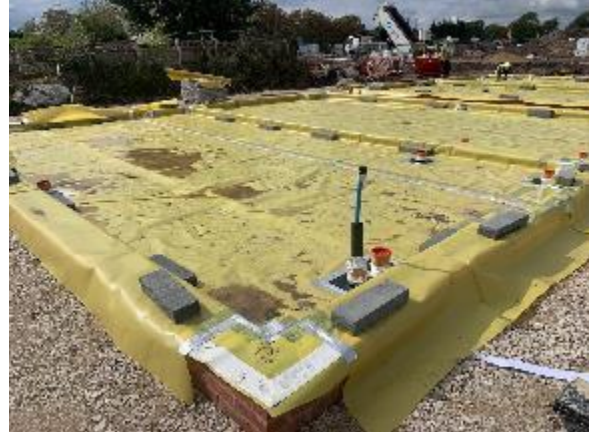
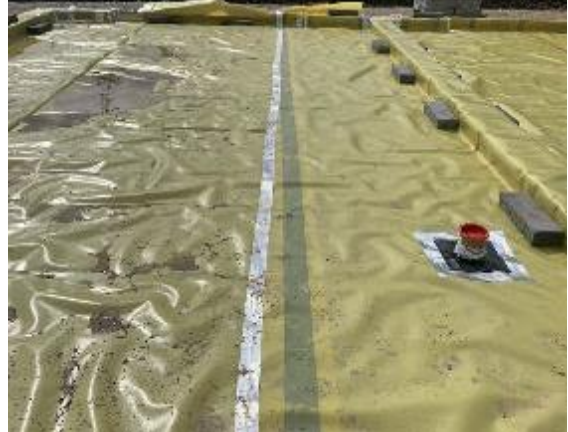
**Plot – 130**

**General Condition of Membrane-Good Condition**

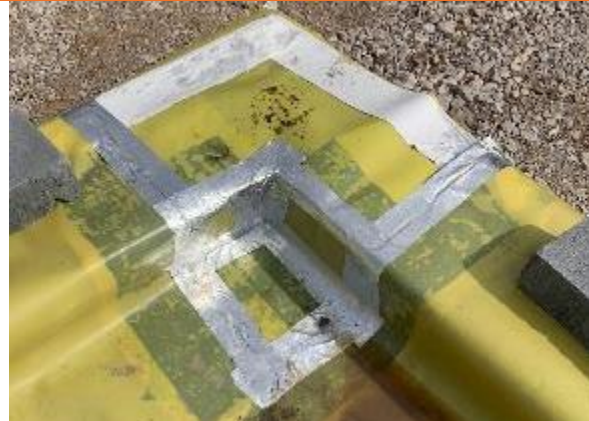
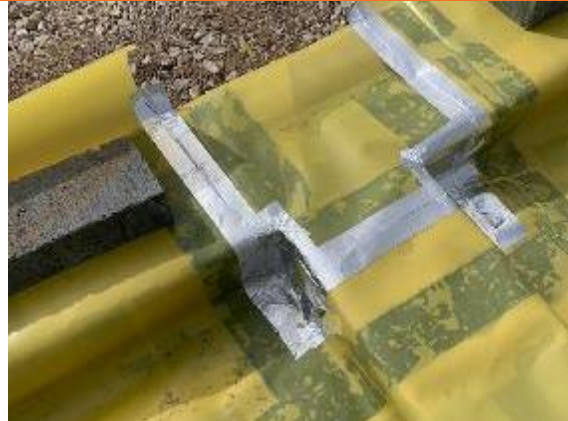
**Verification of Joints and Seals-Overlapped and sealed correctly**

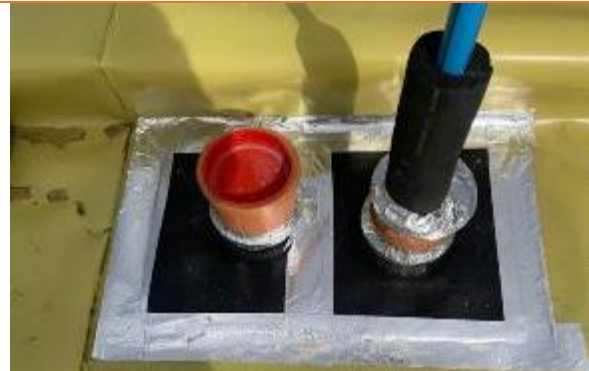
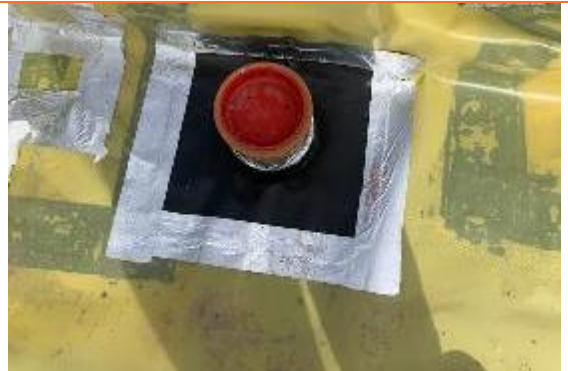
**Verification of Service Penetrations-Good Condition**

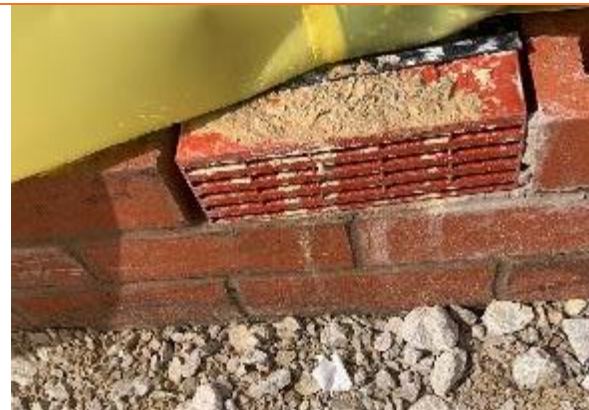
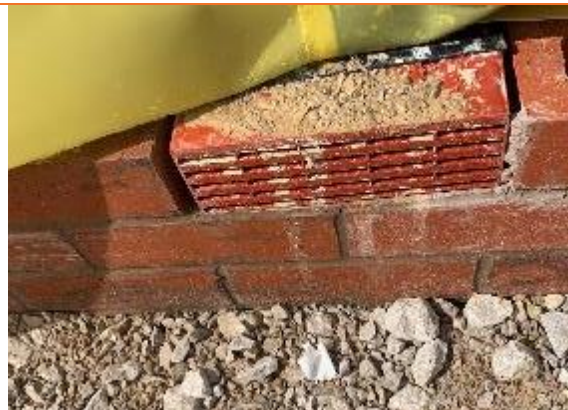
**Verification of Ventilation-Good Condition**

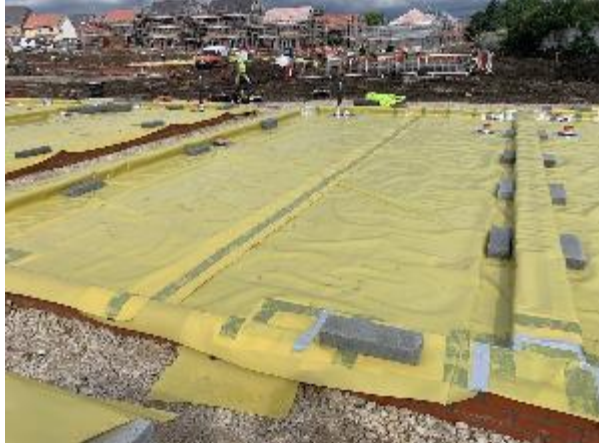
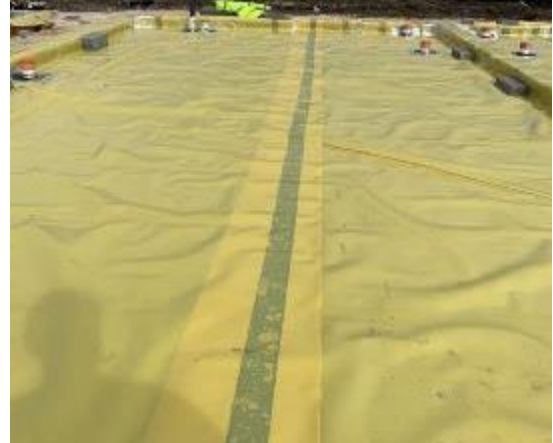
**Plot – 131**

**General Condition of Membrane-Good Condition**

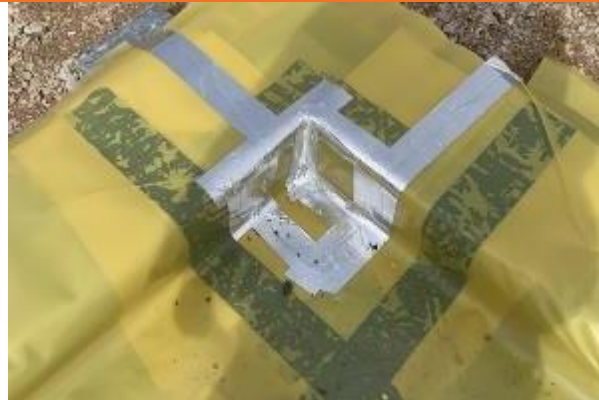
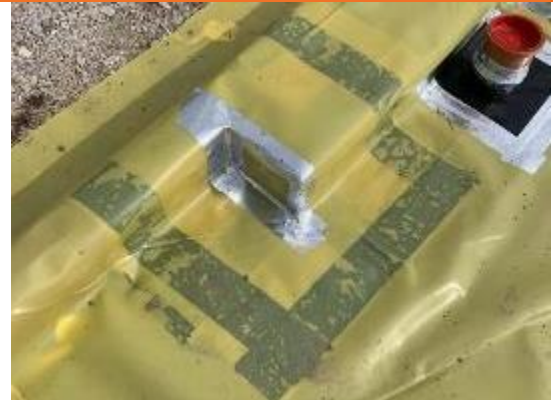
**Verification of Joints and Seals-Overlapped and sealed correctly**

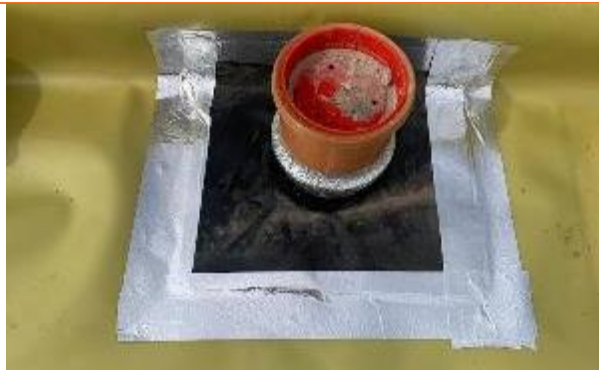
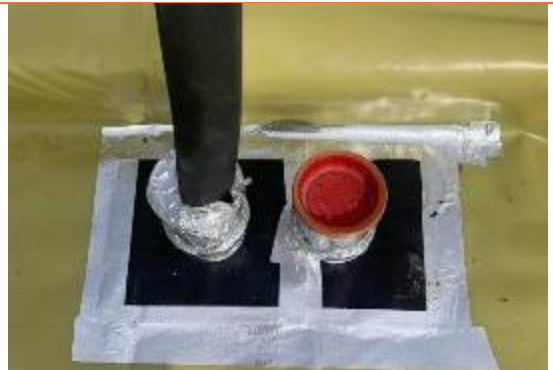
**Verification of Service Penetrations-Good Condition**

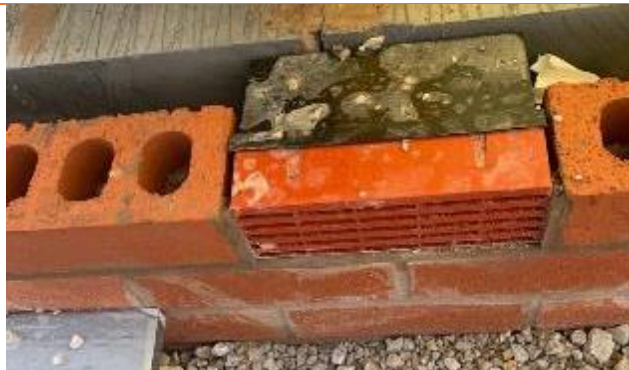
**Verification of Ventilation-Good Condition**

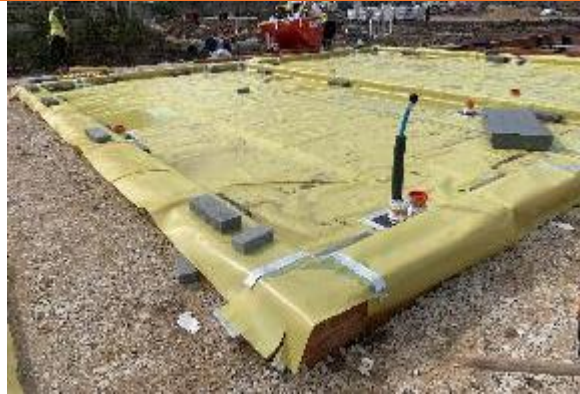
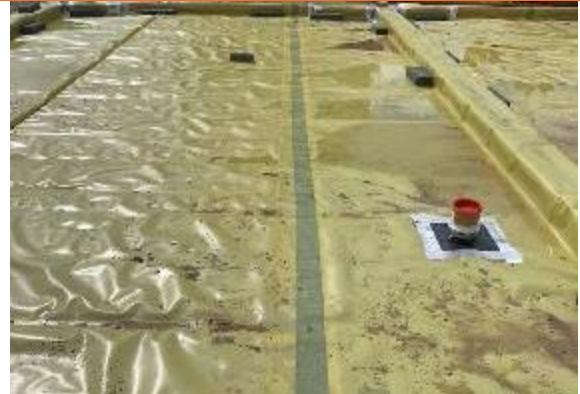
**Plot – 132**

**General Condition of Membrane-Good Condition**

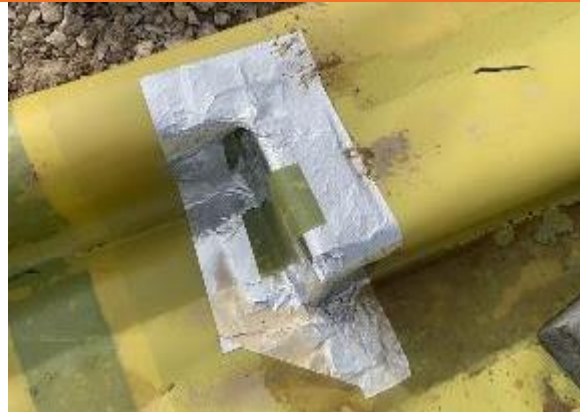
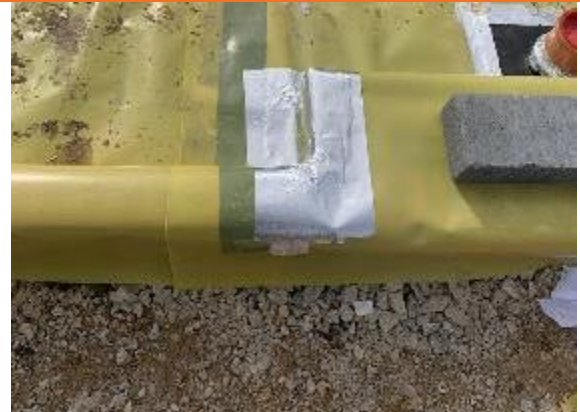
**Verification of Joints and Seals-Overlapped and sealed correctly**

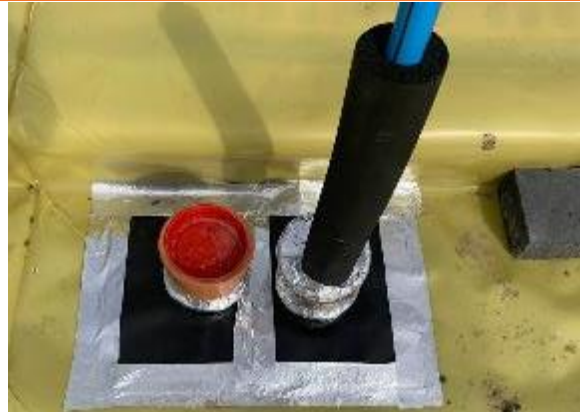
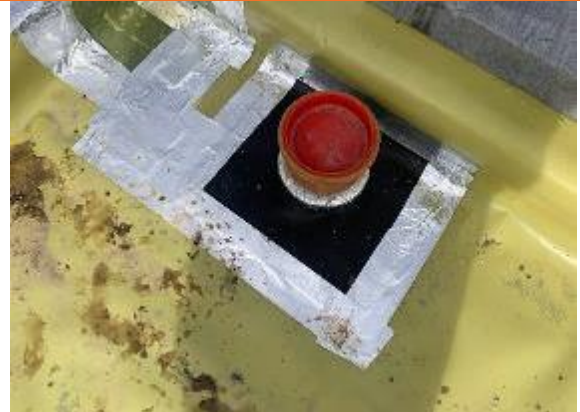
**Verification of Service Penetrations-Good Condition**

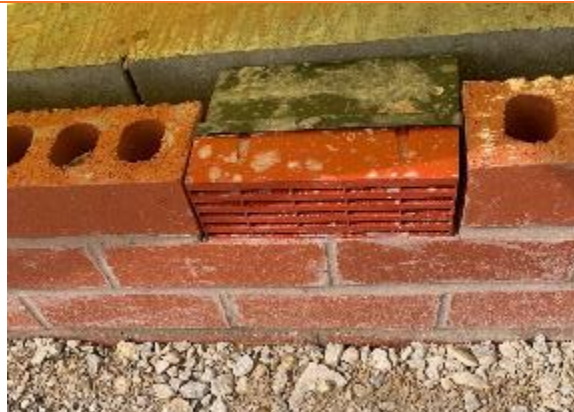
**Verification of Ventilation-Good Condition**

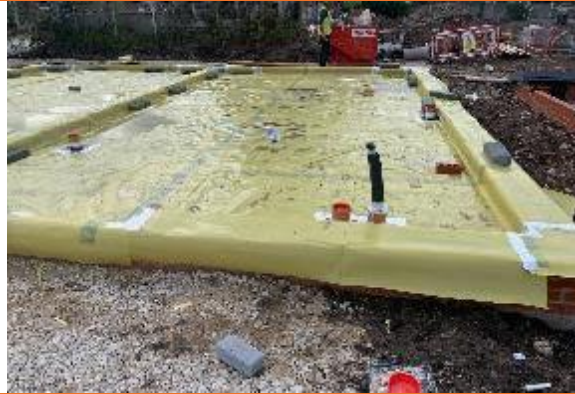
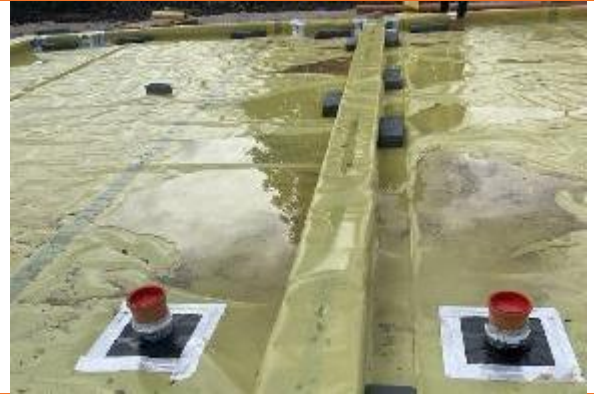
**Plot – 133**

**General Condition of Membrane-Good Condition**

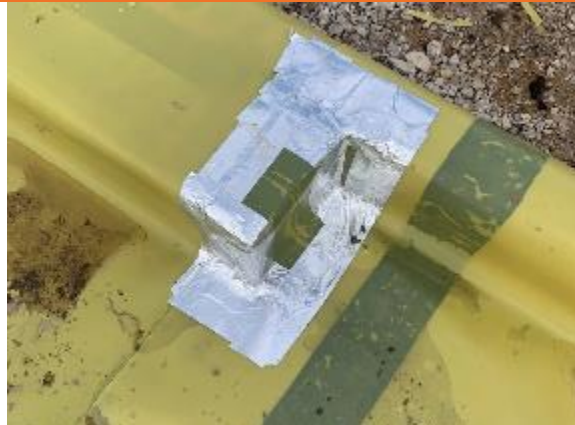
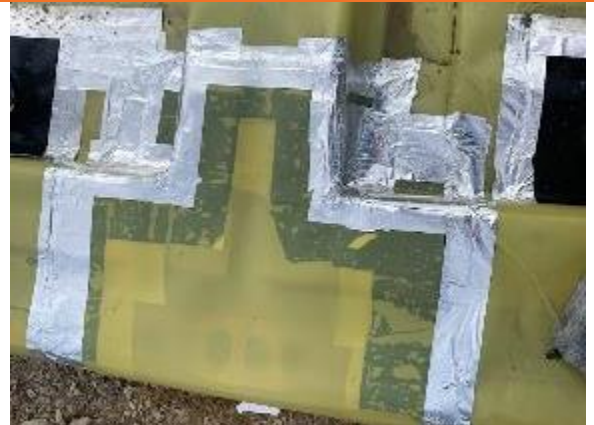
**Verification of Joints and Seals-Overlapped and sealed correctly**

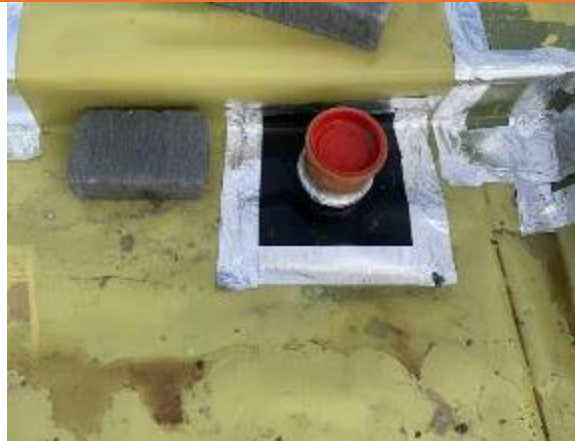
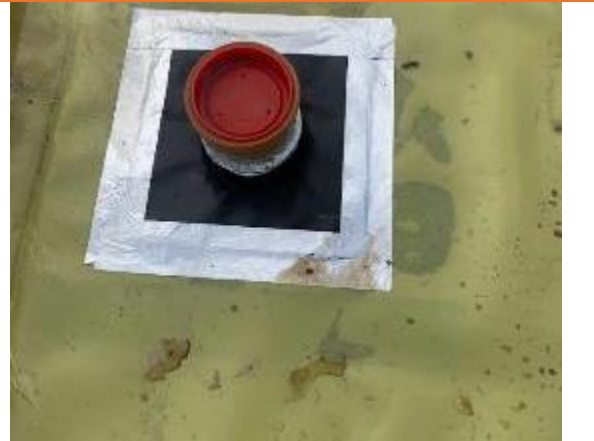
**Verification of Service Penetrations-Good Condition**

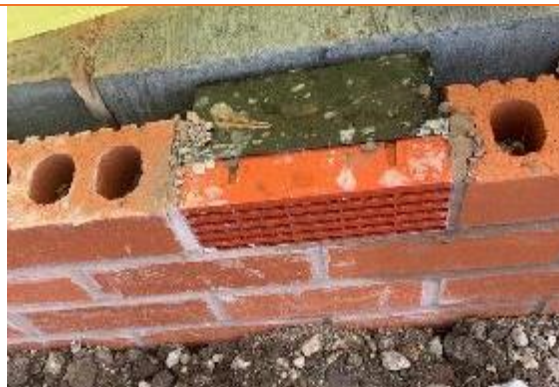
**Verification of Ventilation-Good Condition**

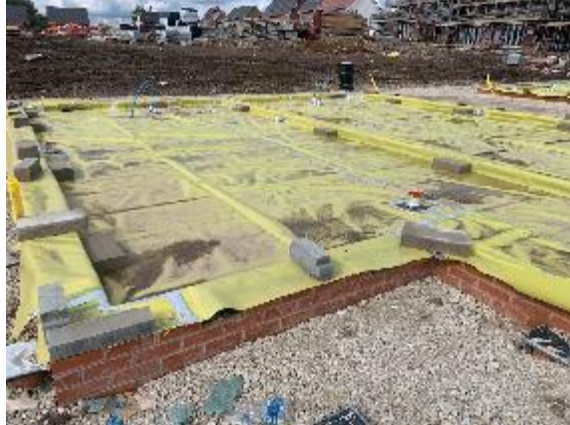
**Plot – 136**

**General Condition of Membrane-Good Condition**

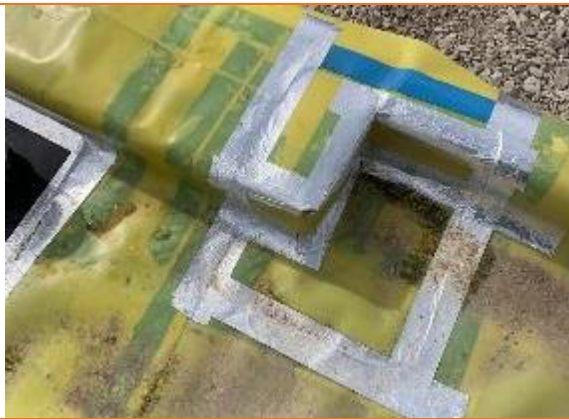
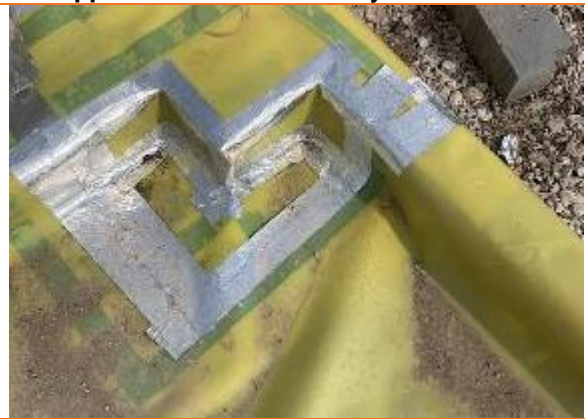
**Verification of Joints and Seals-Overlapped and sealed correctly**

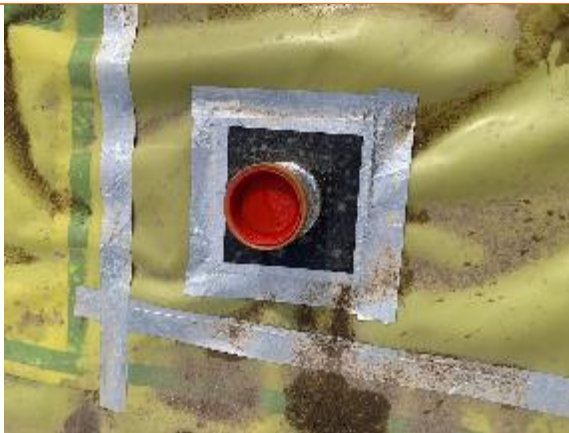
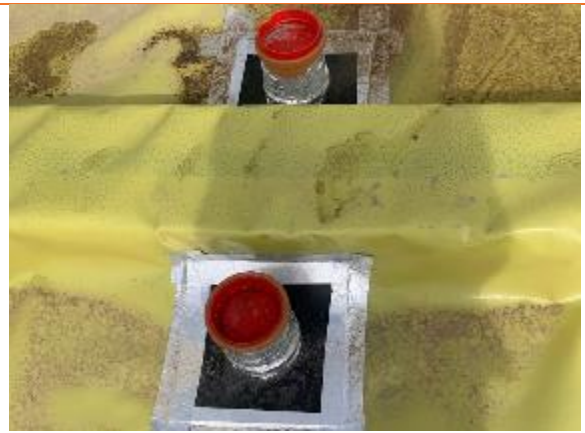
**Verification of Service Penetrations-Good Condition**

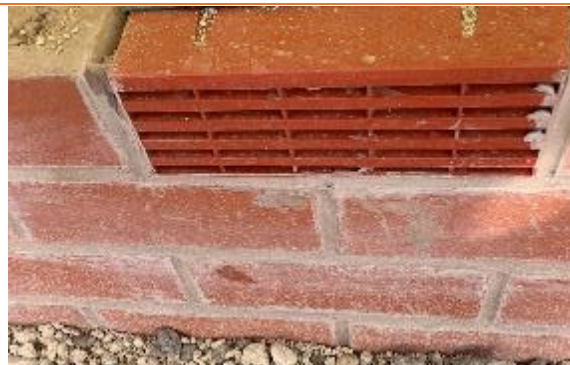
**Verification of Ventilation-Good Condition**

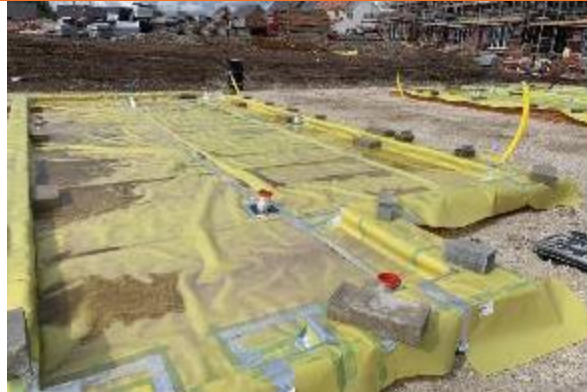
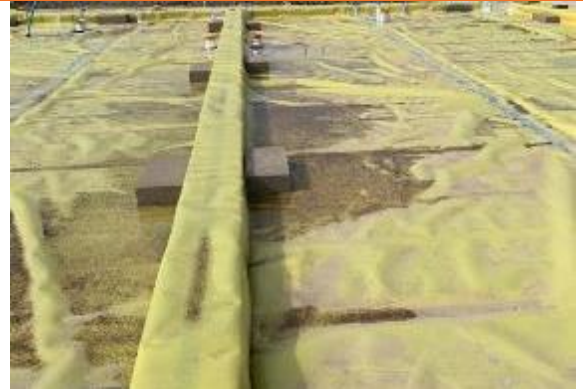
**Plot – 137**

**General Condition of Membrane-Good Condition**

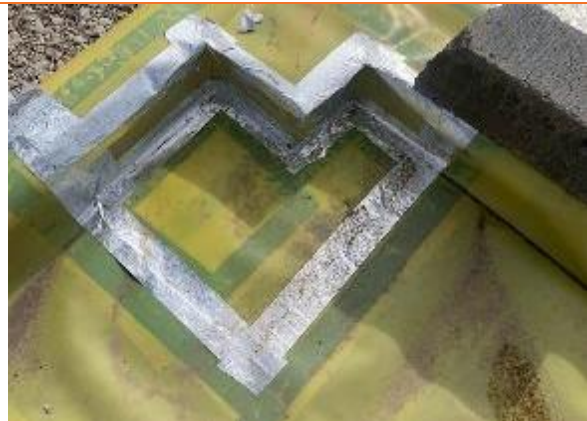
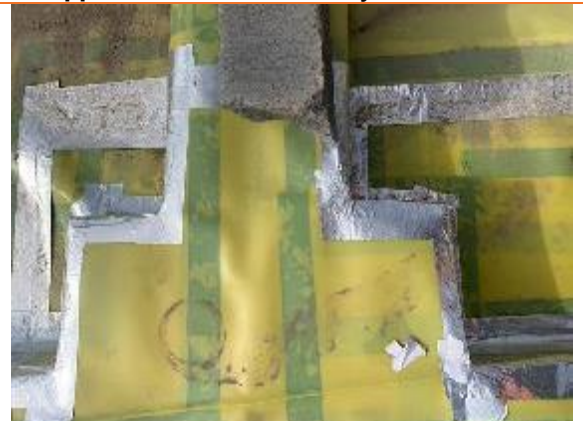
**Verification of Joints and Seals-Overlapped and sealed correctly**

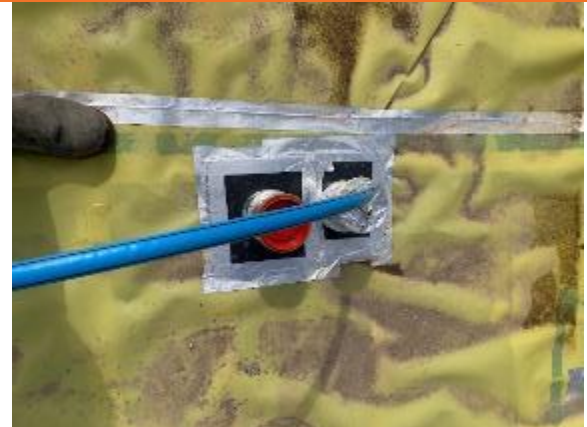
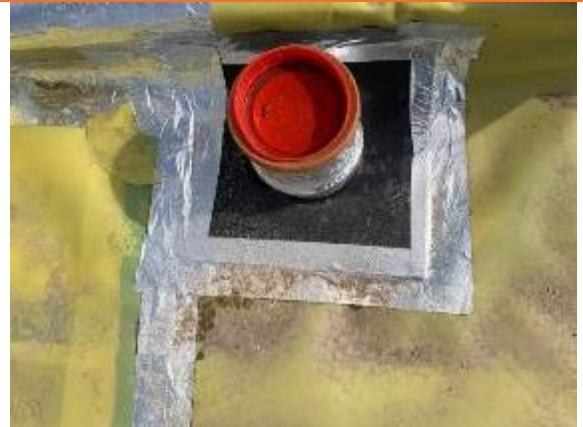
**Verification of Service Penetrations-Good Condition**

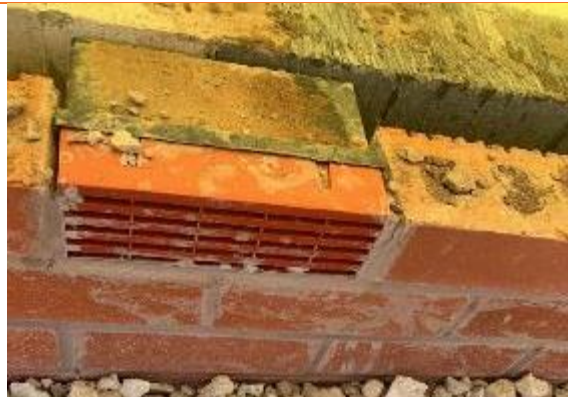
**Verification of Ventilation-Good Condition**

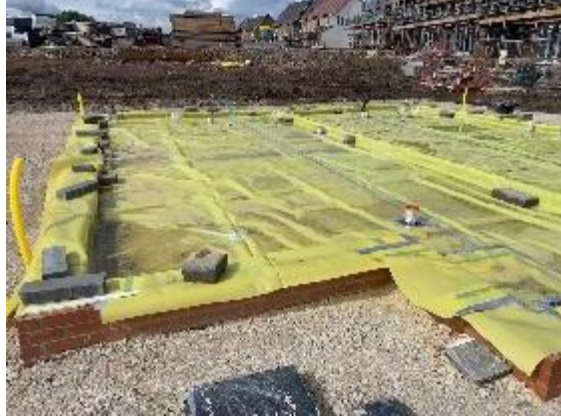
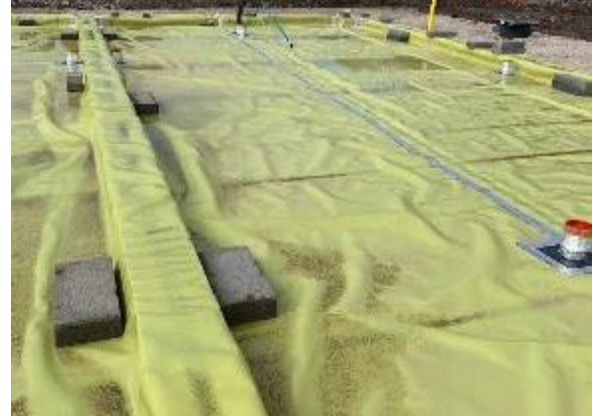
**Plot – 138**

**General Condition of Membrane-Good Condition**

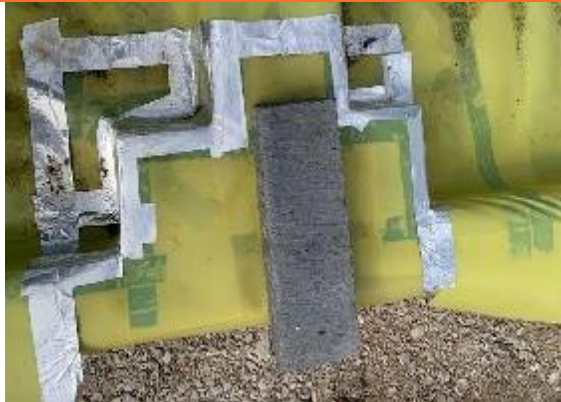
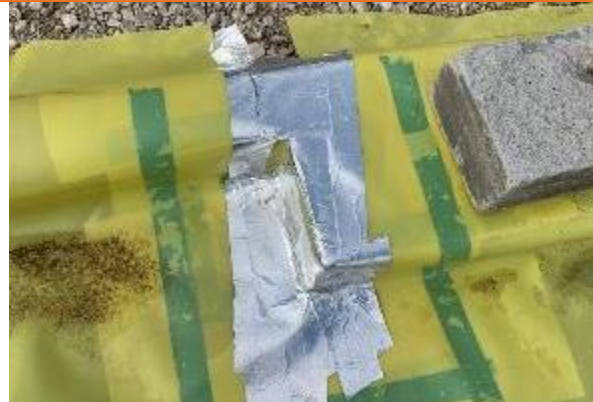
**Verification of Joints and Seals-Overlapped and sealed correctly**

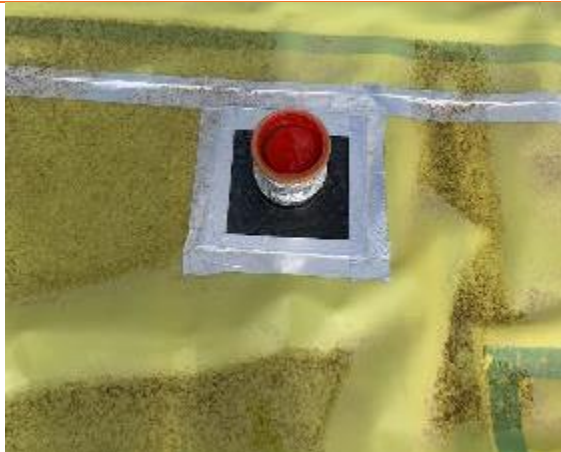
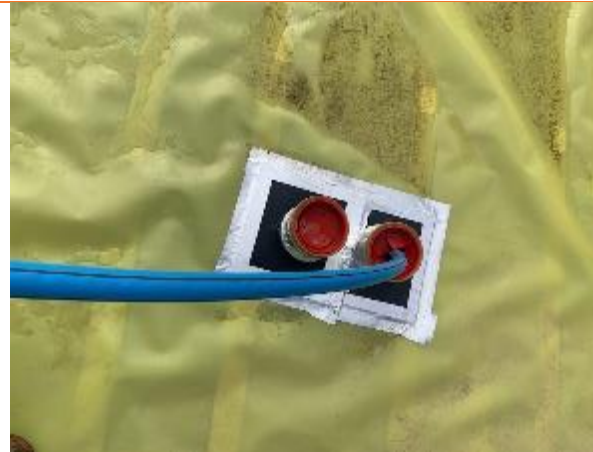
**Verification of Service Penetrations-Good Condition**

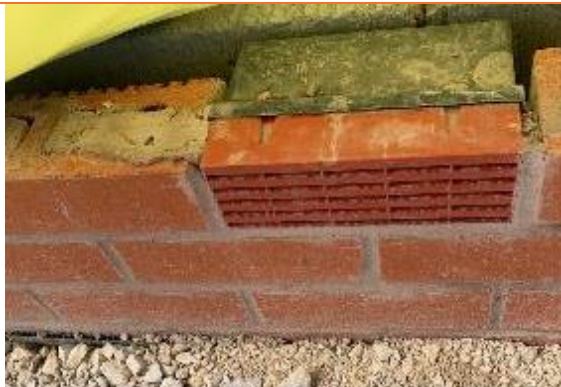
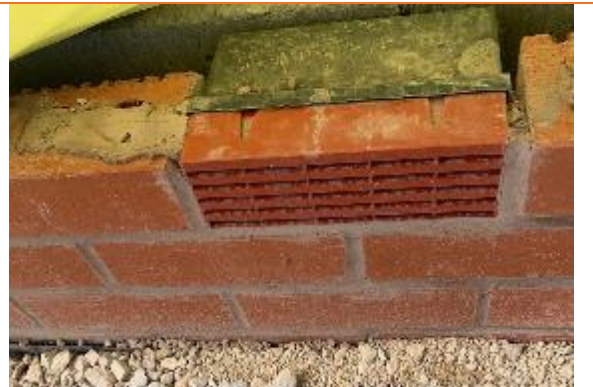
**Verification of Ventilation-Good Condition**

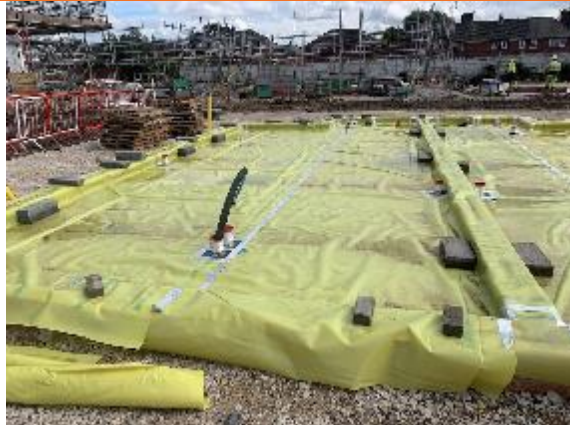
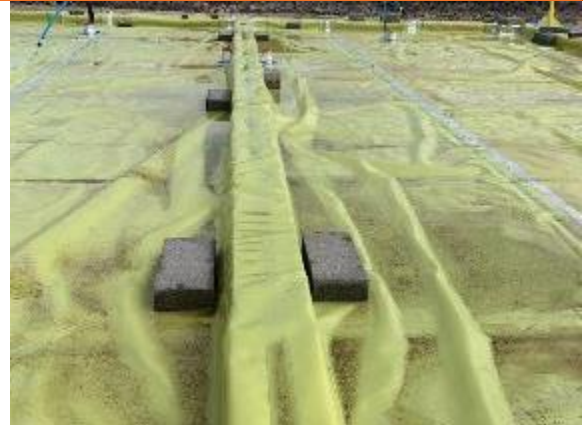
**Plot – 139**

**General Condition of Membrane-Good Condition**

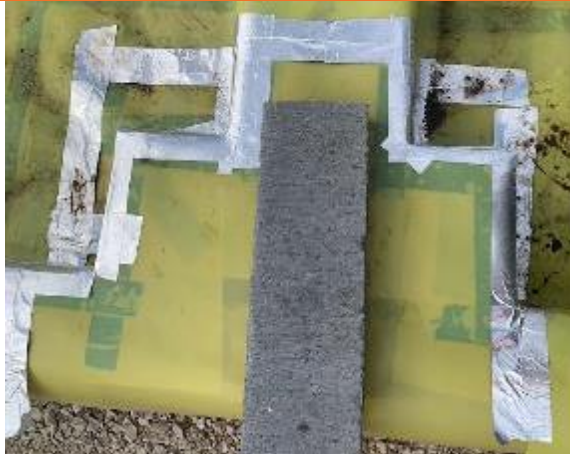
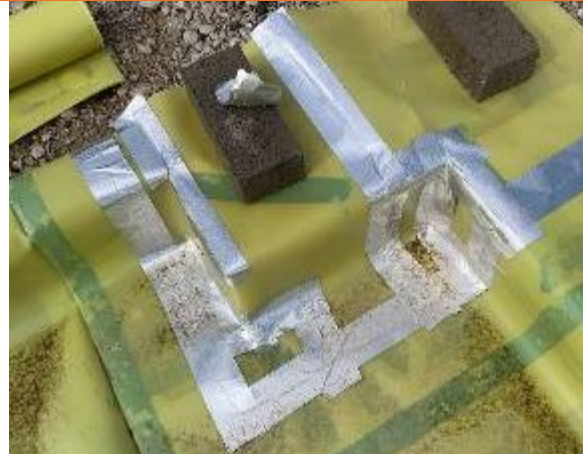
**Verification of Joints and Seals-Overlapped and sealed correctly**

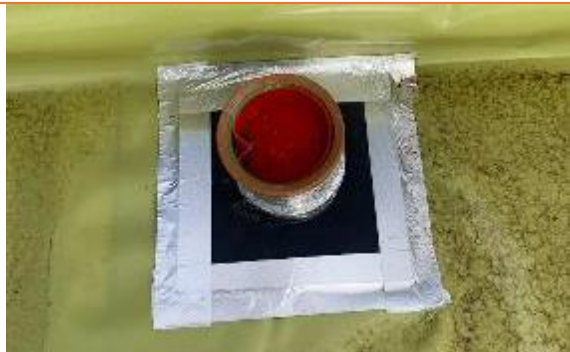
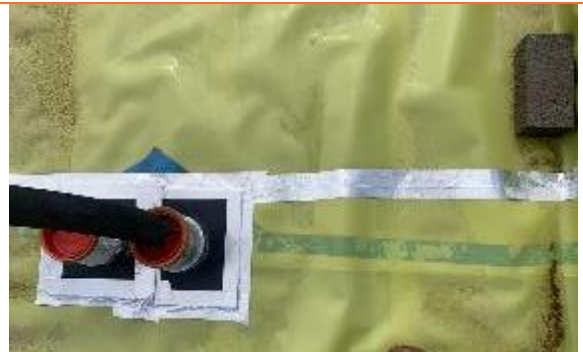
**Verification of Service Penetrations-Good Condition**

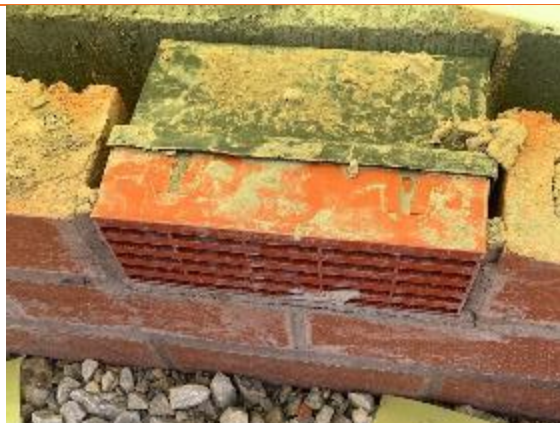
**Verification of Ventilation-Good Condition**
