## CCTV Inspection Report

**Bennett Street, Ardwick**

**01/05/2025**

**Job Number: Kellen Homes, Bennett Street, 01.05.25**

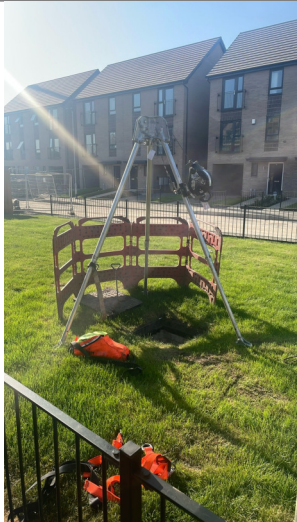
**Other Site Photos:** SW3 - All CCTV works carried out from this MH.

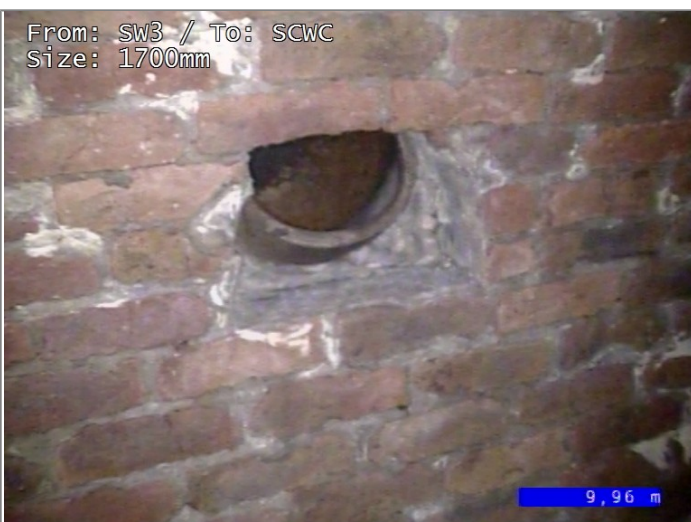
Connection other than junction, closed, at 10 o'clock, diameter 225mm

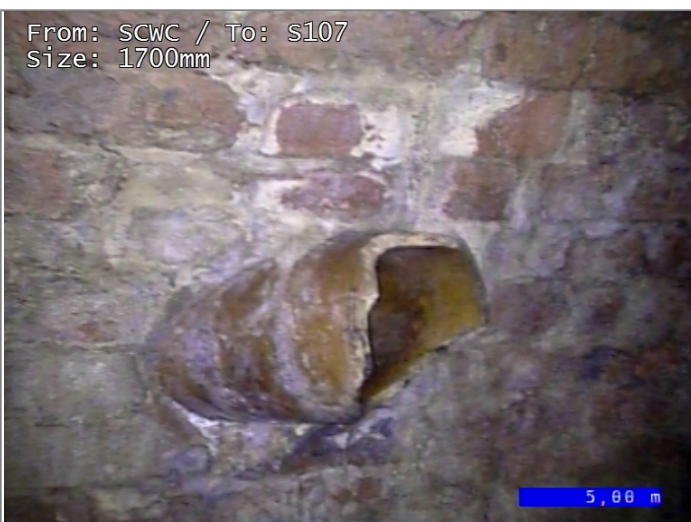
| Start Node Ref:SCWC I/L : metres | | | | | Photo | Type/Grade |
|---|---|---|--|--|---|---|
| 5.00 | CXI | Connection intruding at 9 o'clock, diameter 150mm, intrusion 5% | | | 12105083 | Structural / 4 |

Connection intruding at 9 o'clock, diameter 150mm, intrusion 5%

**REHABILITATION PROCEDURE IS URGENT AND HAS TO BE COMPLETED WITHIN 1 TO 2 YEARS.  
NECESSITY FOR EMERGENCY OPERATIONS HAS TO BE EXAMINED.**

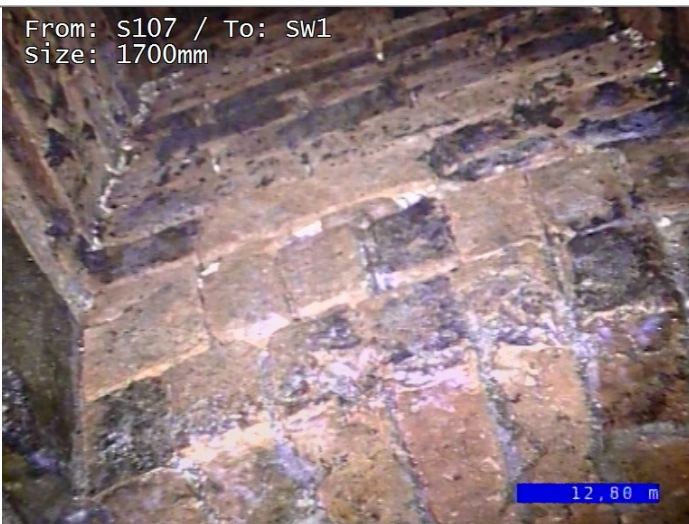
UNCHARTED CHAMBER

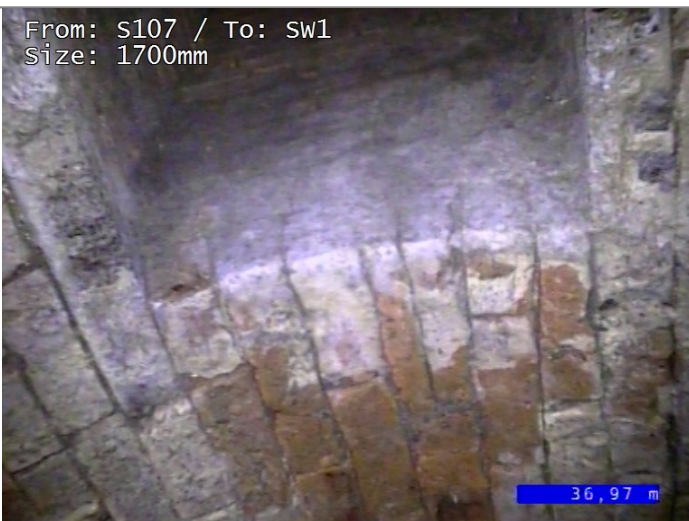
UNCHARTED CHAMBER

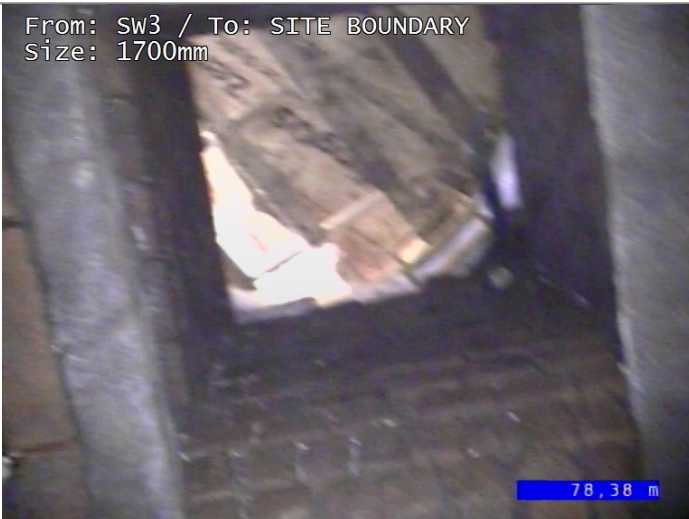
| Start Node Ref:SW3 I/L : metres | | | | Photo | Type/Grade |
|---|---|---|--|---|---|
| 78.38 | REM | UNCHARTED CHAMBER | | 12105499 | Comment / 0 |

UNCHARTED CHAMBER

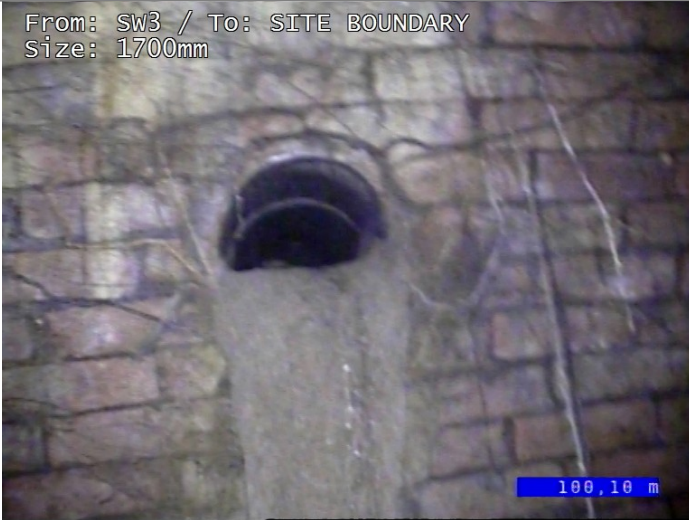
Junction, closed at 9 o'clock, diameter 225mm

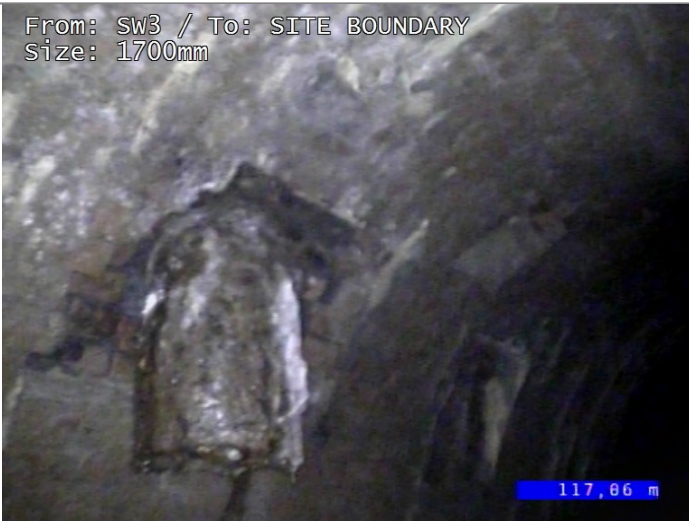
| Start Node Ref:SW3 I/L : metres | | | | Photo | Type/Grade |
|---|---|---|--|---|---|
| 117.06 | CXI | Connection intruding at 9 o'clock, diameter 225mm, intrusion 10% | | 12105535 | Structural / 4 |

Connection intruding at 9 o'clock, diameter 225mm, intrusion 10%
