**Apartments 402 & 404 Middle Warehouse, Castle Quay  
Independent Report & Advice on Rainwater Incursion Experienced**

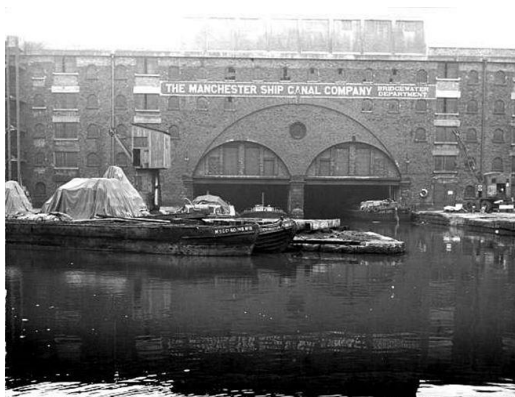
Initial query as to the age of the parapet now answered.

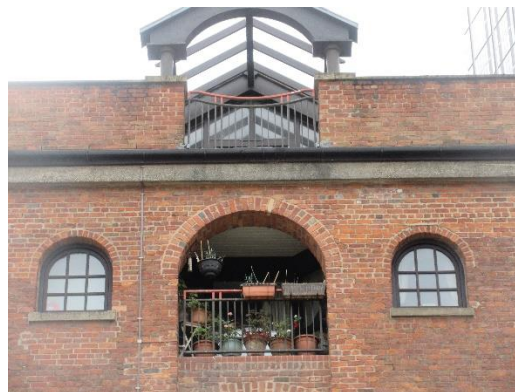
New build (1990s) construction above concrete ring beam.

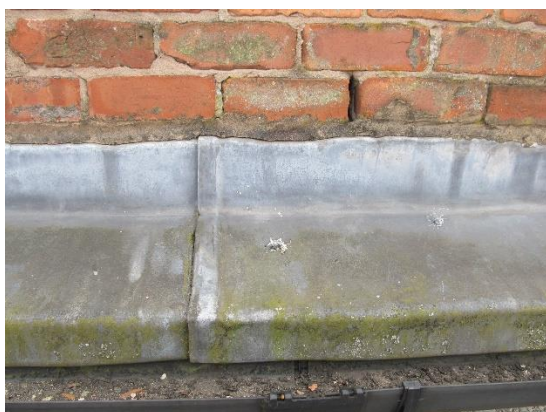
Open perpend (weep holes) commensurate with cavity wall construction i.e. cavity wall tray and drainage.

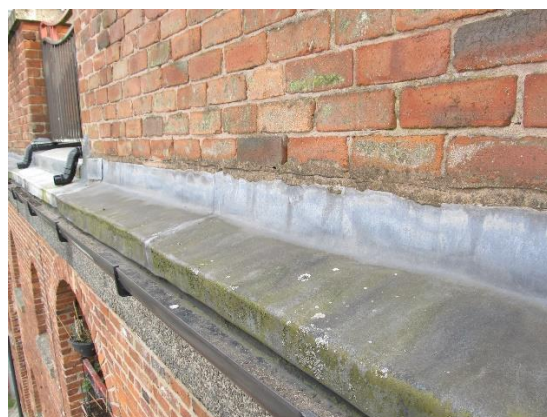
Leading edge to modern polymer polyethylene dpc / tray visible above the lead cover flashing.

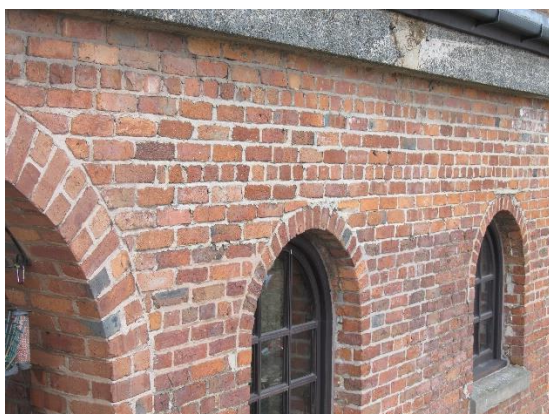
Solid masonry (English Garden Wall Bond) below concrete ring beam – note old rusted fixing bolt holes to former hopper head.

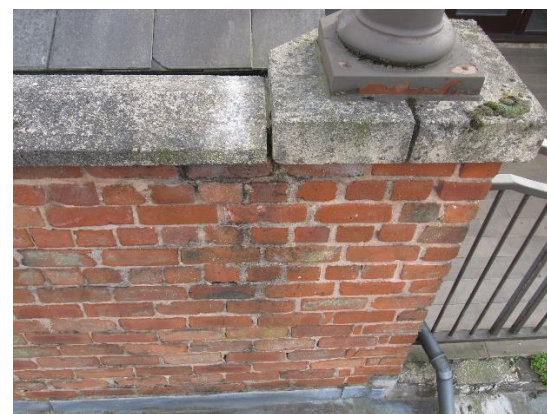
Assumed cavity wall parapet reliant on coping / dpc beneath to keep out rainwater and tray at base drain the cavity.

If this is indeed how the wall has been constructed at this point, then potentially any movement or poor installation of the cavity tray at the base of this section of cavity wall will give rise to water incursion. On that basis we have highlighted the base of the parapet and indeed, the head of the

wall for further intrusive investigations. The integrity of the trays and the damp proof course beneath the coping need to be checked.

| Flat 402 & 404 | Investigate parapet wall cavity trays and below coping dpcs – repairs if required. |

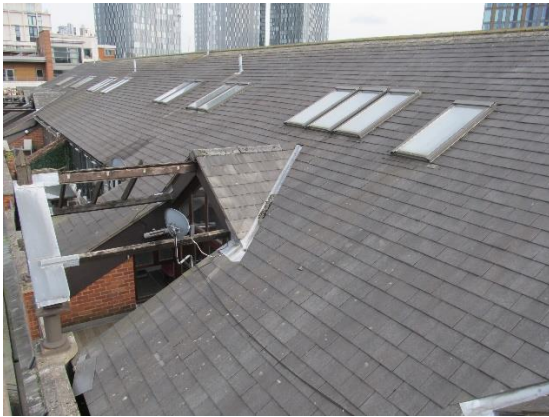
The rear roof slope drains to eaves guttering where cut-back to form the roof terraces.

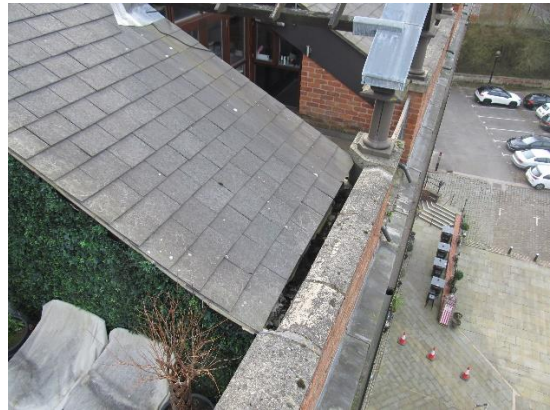
And to the hidden parapet gutters.

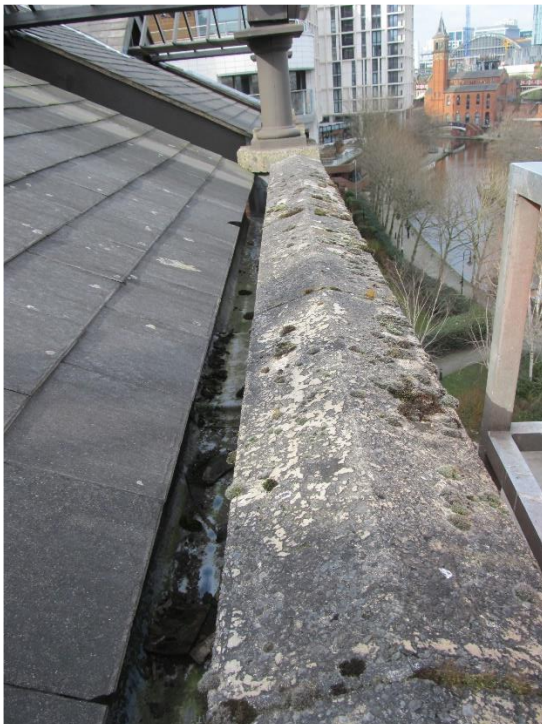
General arrangement of the back gutter.

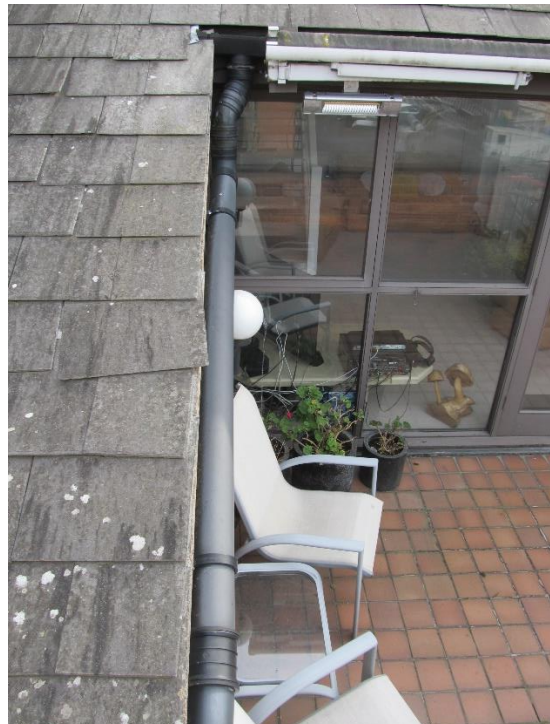
Drainage redirected from the eaves guttering to 503 roof terrace to the back gutter of 502.

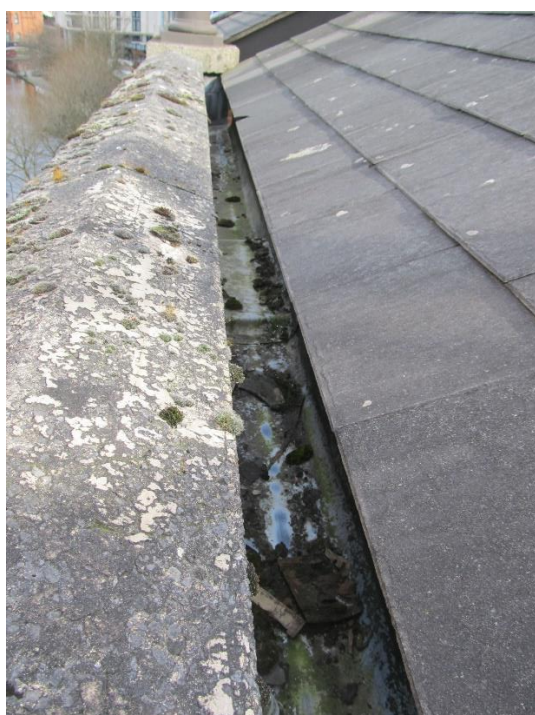
Given the length of the guttering the sections of lead have been jointed to prevent splitting.

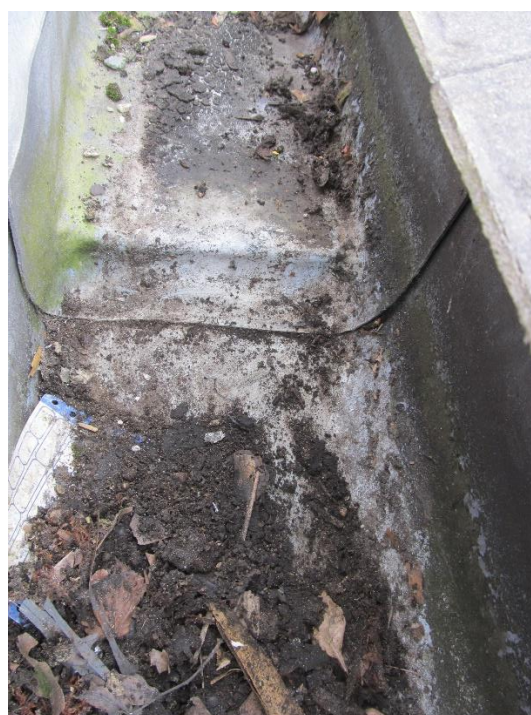
Lap joint to sheet lead designed to accommodate thermal expansion and contraction in the material.

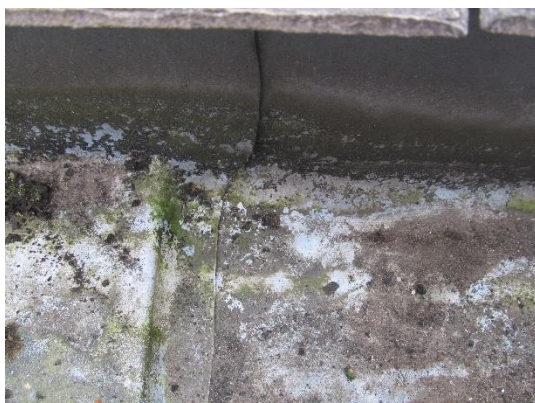
Standard joints to lengths of leadwork, sole and walls.

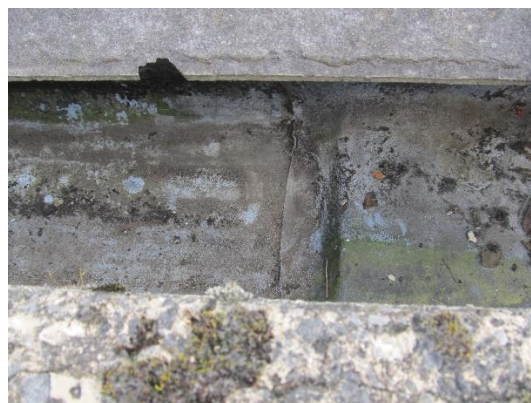
Potential for rainwater ingress to exploit the jointing to the lead sheet when the gutter is holding water.

This is another element of construction that has been flagged for further investigation. If water builds-up within these gutters during heavy rainfall, which I suspect it does (evidence points to this), the lead weathering details will allow water to penetrate the fabric, unless there is a secondary weather-proofing barrier beneath this, which I doubt.

A simple solution in this case might be to cover the lead with a fleece and built-up liquid plastic waterproofing to form a seamless gutter, to eliminate the reliance on jointed sheet lead.

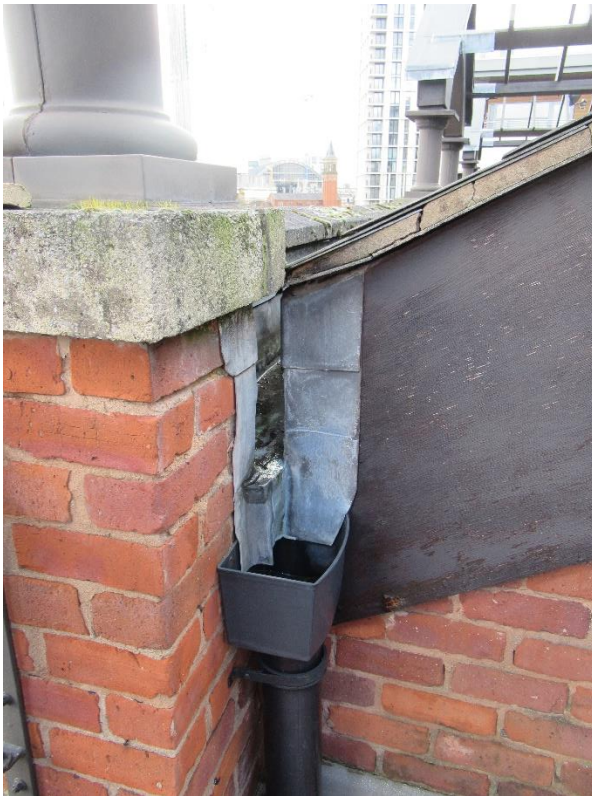
Hopper to open end of parapet gutter.

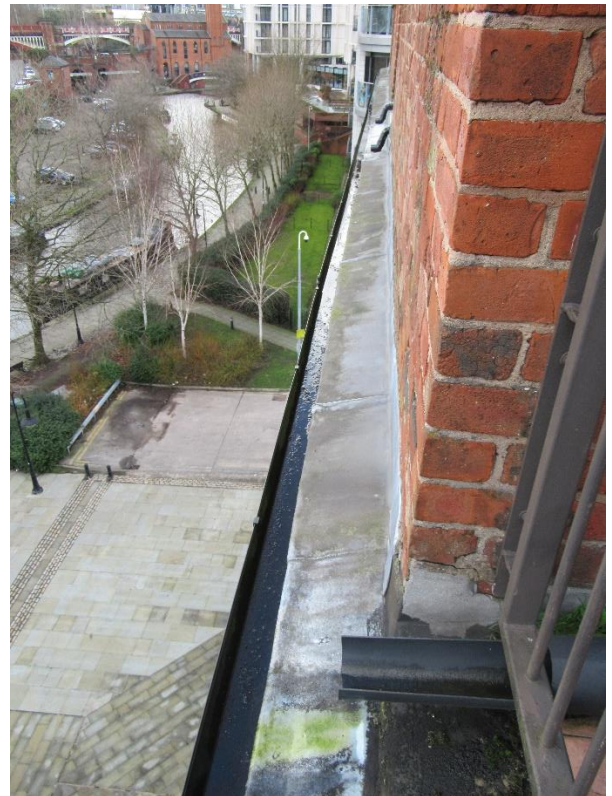
Drainage from hopper downspout onto ring beam.

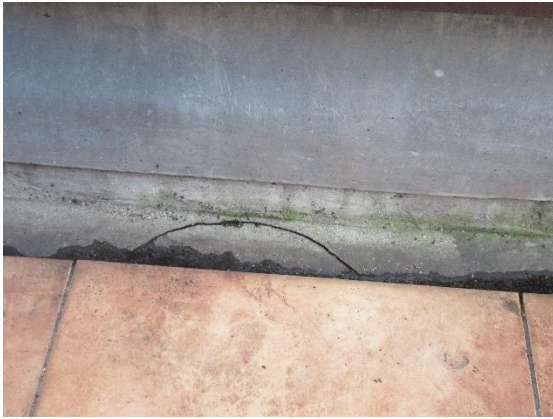
Typical example of cracked / fissured asphalt to the upstand skirting to 502 roof terrace.

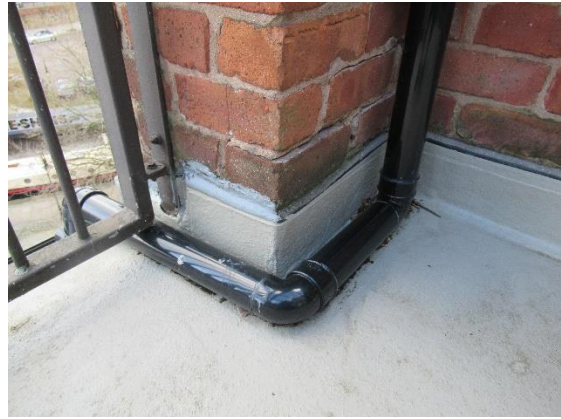
New liquid plastic overlay completed to a good standard and providing a watertight deck.

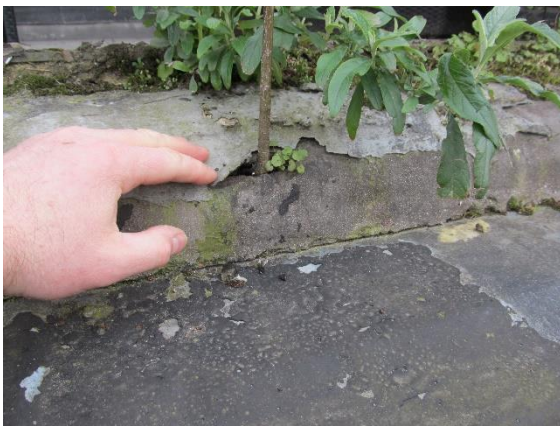
Obvious splits and defects to the asphalt to 505 terrace – remote from both 402 and 404 but included for context.

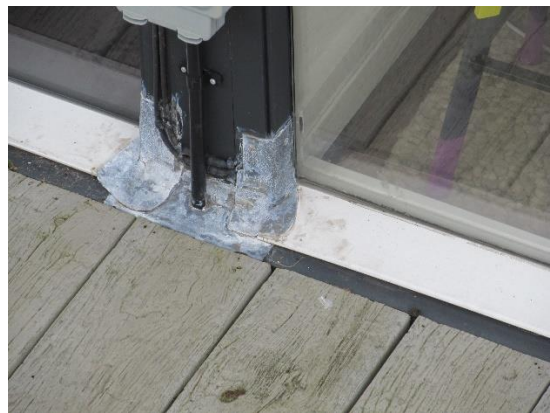
Retrospective lead saddle / bandage repair where electrical cables pass through the waterproofing to 504 Terrace.

In respect of the ingress to 404, I cannot eliminate the roof terrace weathering details to 504 as a potential cause and certainly the repairs affected to the patio screen base rail with lead should be further investigated.

| Flat 404 | Investigate temporary waterproofing repairs to 504 Terrace – flood test and undertake repairs. |

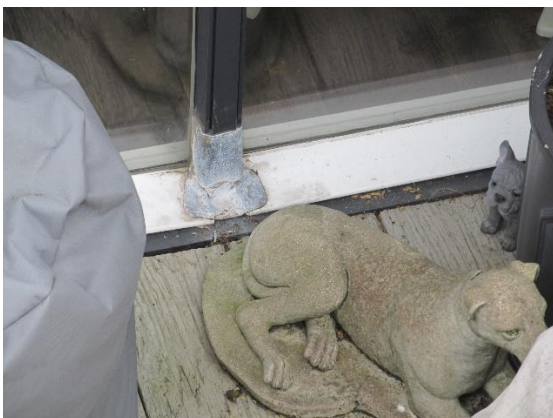
Further example of patch repairs to 504 Terrace.

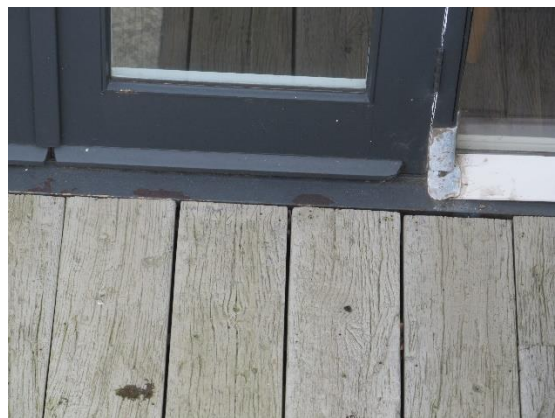
As above and opposite - 504 Terrace.

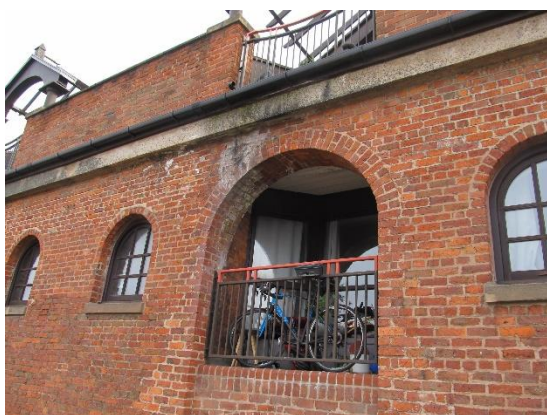
I have not carried out any calculations to determine the surface area and volume of rainwater that the eaves gutter planted to the rear wall drains, but I have seen several giveaway stains and deterioration to the brickwork beneath the guttering that convinces me that this gutter is undersized and during heavy rainfall will overspill or surcharge.

Evidence of prolonged surcharges from the eaves guttering affecting the brickwork below.

Again, the guttering is something that should be replaced and correctly sized. On the basis that the existing guttering is fabricated from PVCu and of nothing of great architectural importance, there should not be any issue in replacing this with the Conservation Officer.

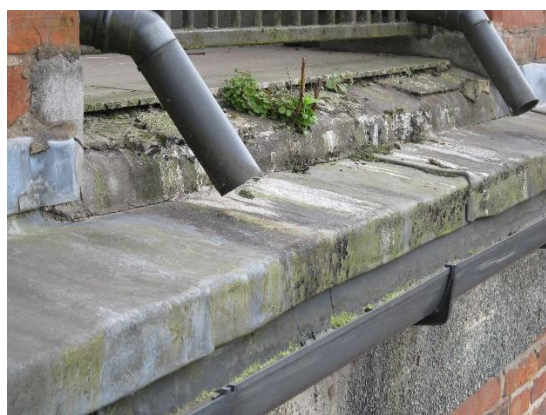
Downspouts serving the rear roof slopes and hidden parapet gutters.

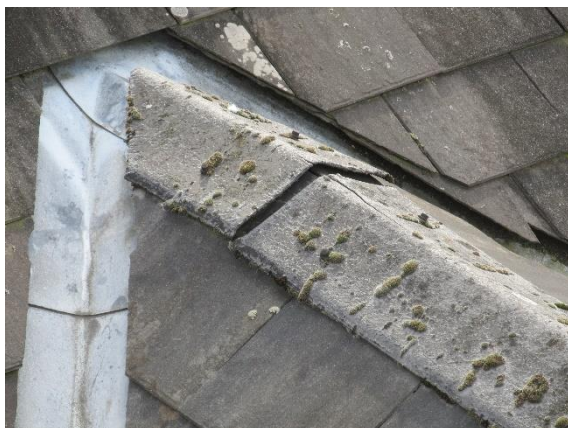
Split cement fibre ridge tiles and evidence elsewhere of slipped and missing slates to the rear roof slopes.

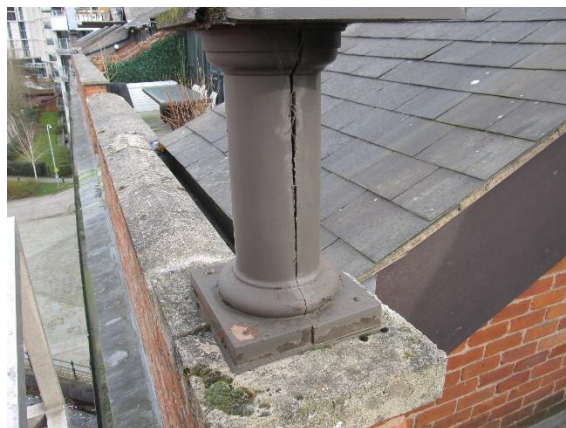
The split GRP casings to the pergola stanchions, might, dependent upon the base detail to the steel, allow rainwater to run in and bypass the parapet wall weathering details, leading to rainwater to the 4th Floor apartments.

Open joints (typical) to GRP casings – potential source of rainwater to the parapet wall.

| Flat 402 & 404 | Seal GRP casings to pergola stanchions. |
