Our reference: 895-ACE-ZZ-XX-CP-S-0001

**Statement on as-built drainage for the residential scheme at Portugal Street East, Manchester**

**Project Name:** GR71573\_CCTV\_Site  
**Project Description:** Cleansing & CCTV Inspection  
**Project Number:** Site Drainage  
**Project Status:** Complete  
**Project Date:** 19/06/2024  
**Inspection Standard:** MSCC5 Sewers & Drainage GB (SRM5 Scoring)

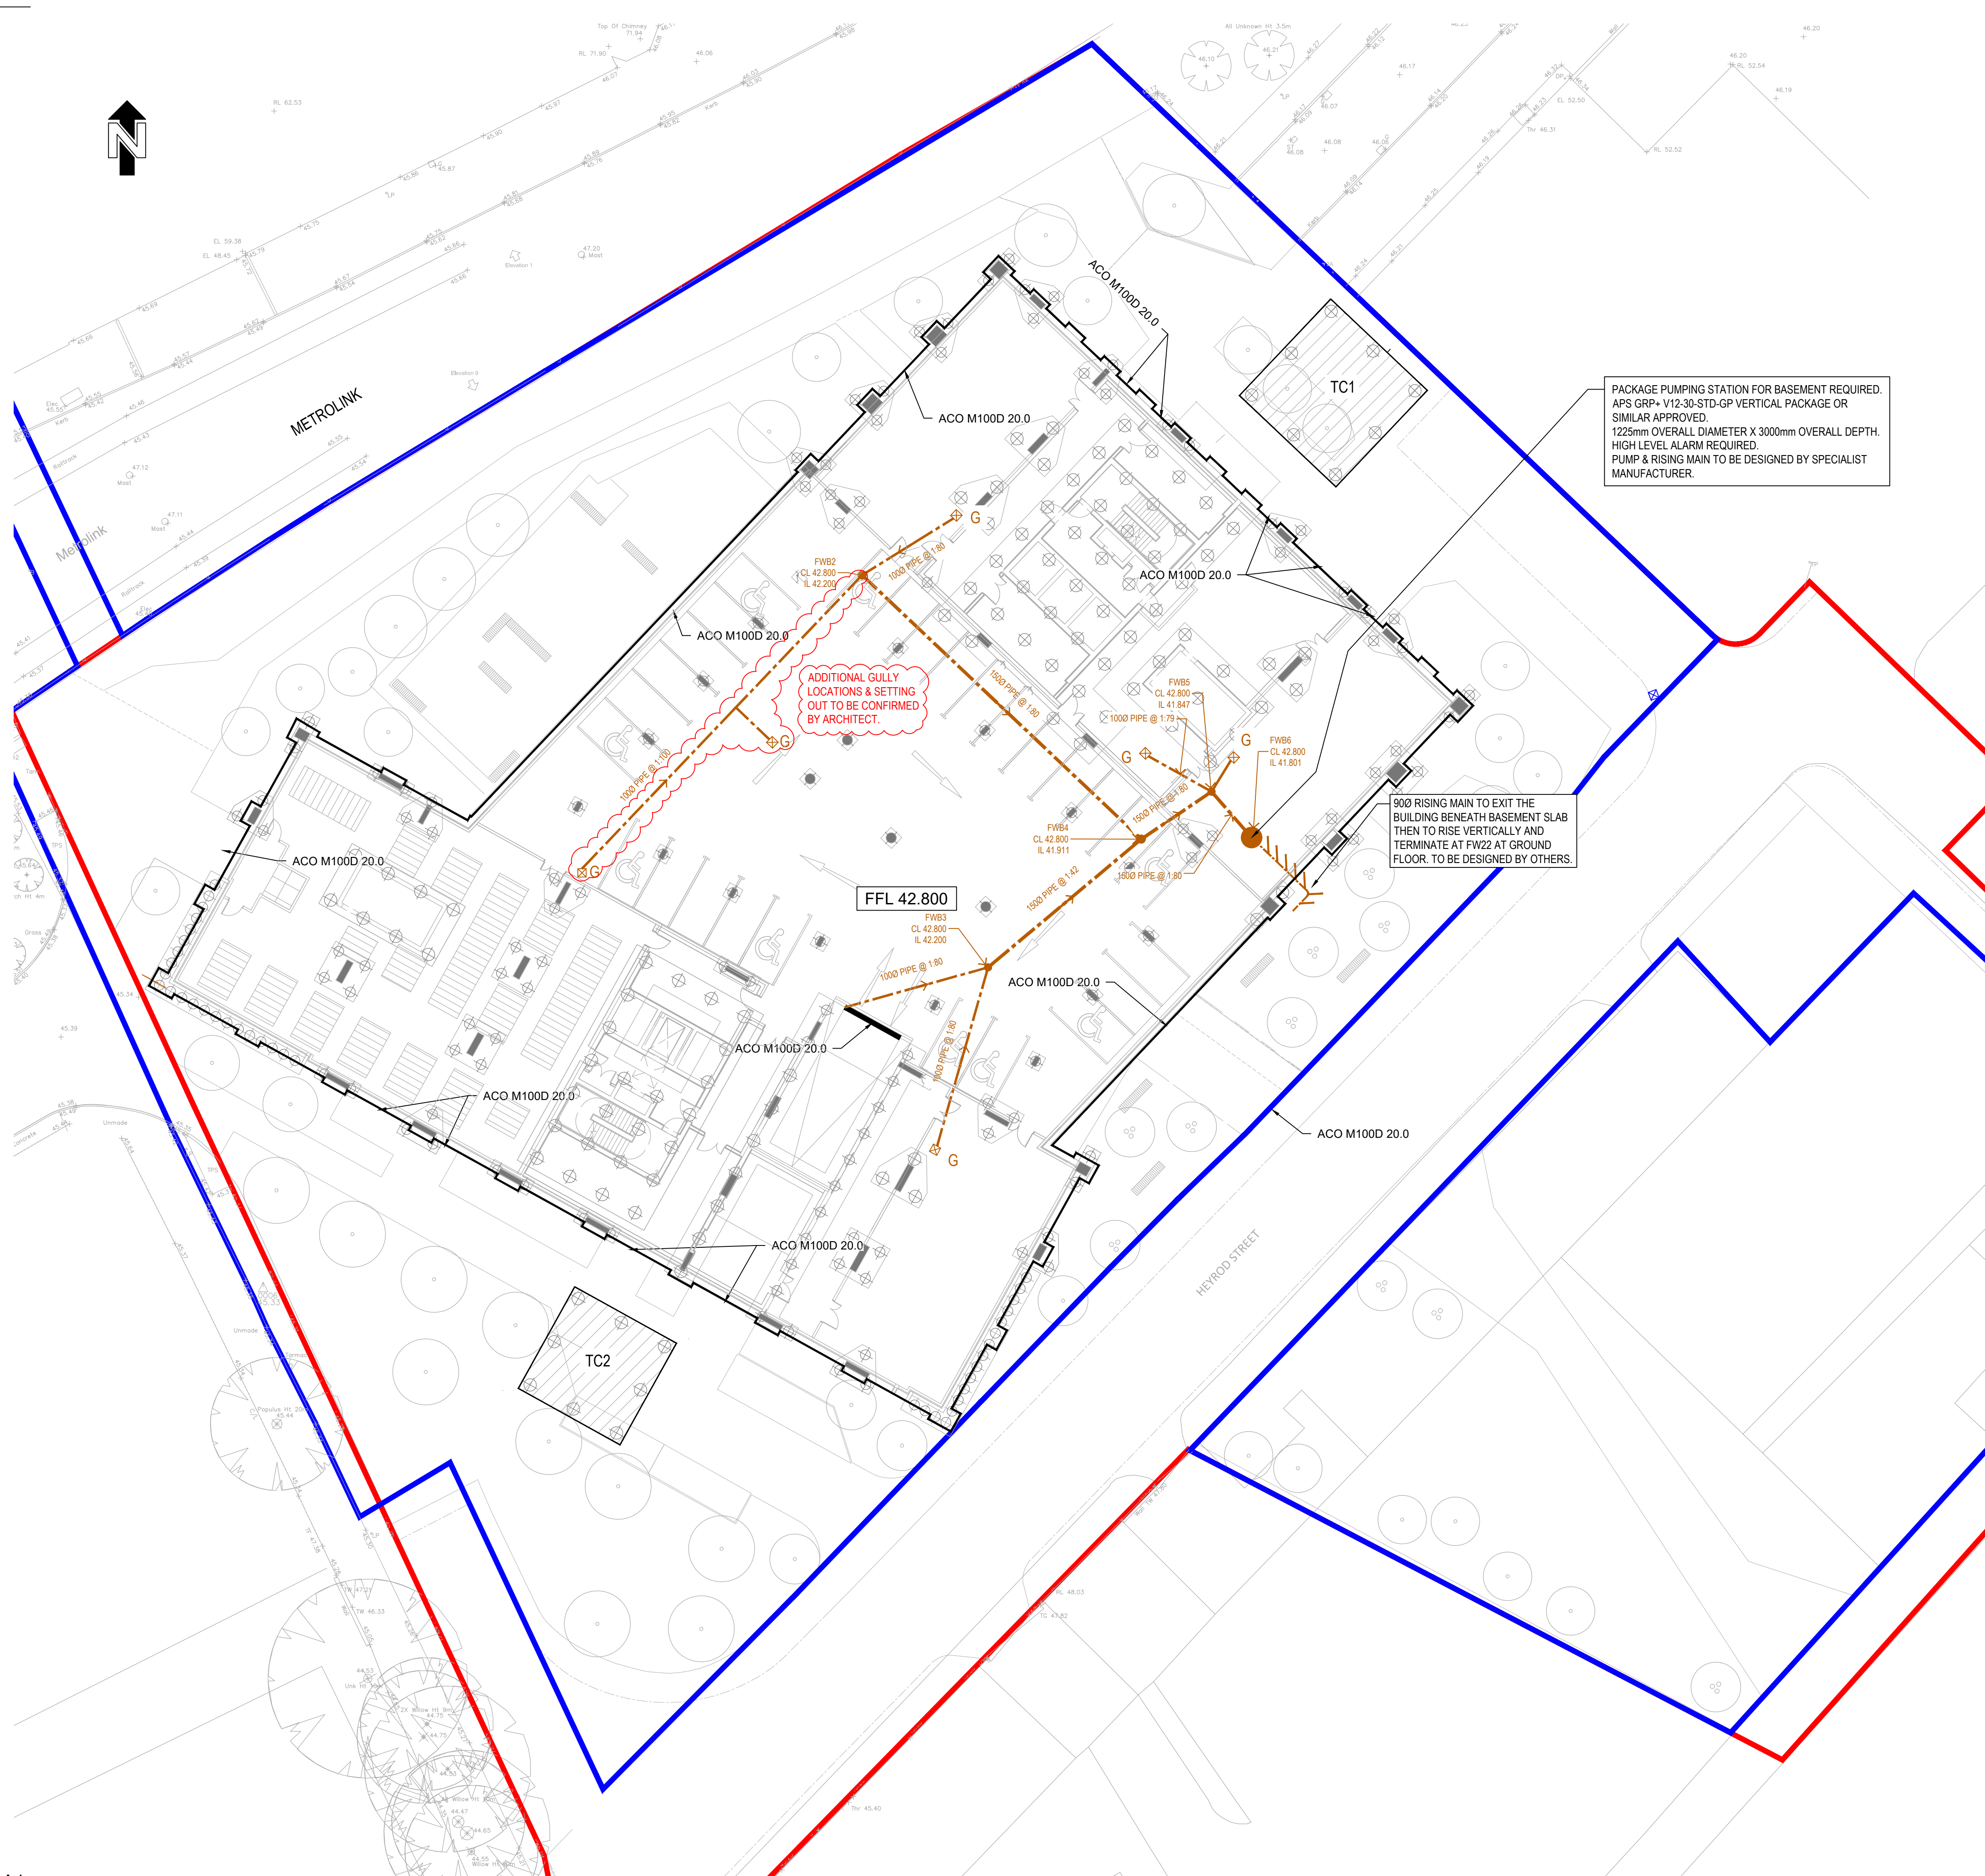
While there are some discrepancies between the as-built system's invert levels and the proposed drainage design, a comprehensive review of the constructed levels and gradients confirms that the system is acceptable and functions as intended. Our design comments are included within this report and are highlighted in green for clarity.

Additionally, several channel drains and associated pipework, highlighted in purple, appear to be missing. Although these elements do not directly impact the operation of the overall system and may not have been installed at the time of survey, we recommend they be installed in line with the approved drainage design.

- PLANNING BOUNDARY
- INSTALLED SURFACE WATER DRAINAGE
- INSTALLED FOUL WATER DRAINAGE
- INSTALLED COMBINED WATER DRAINAGE
- INSTALLED SURFACE WATER CHANNEL DRAIN
- MISSING DRAINAGE

We also recommend that all maintenance and remedial works identified in the Subscan CCTV Report (Ref: GR71573\_CCTV) be undertaken to ensure the drainage system continues to function as intended.

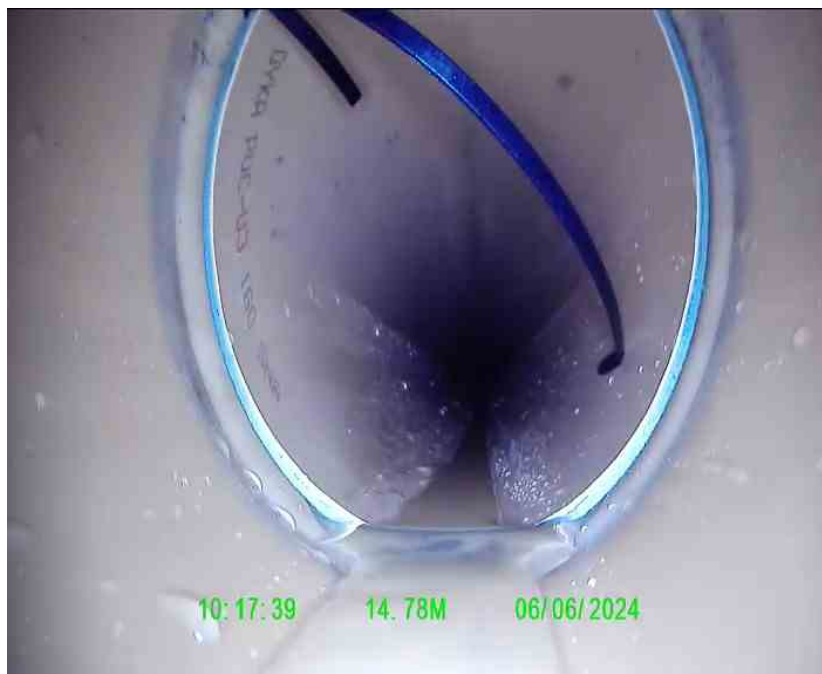
FWB2X\_050d34d7-1ffa-4e1f-a1ee-d5562d979041\_20240617\_154520\_019.jpg, 00:01:08, 14.80 m

Other obstacles from 10 o'clock to 11 o'clock, 10% cross-sectional area loss, Tie Wrap stuck in joint (not affecting flow)
