## **SITE ADJACENT TO DALTON AVENUE**

**FALLOWFIELD  
MANCHESTER M14 7NR**

## **VALIDATION REPORT *UNDERTAKEN FOR* DENTON CONSTRUCTION**

**Ref:26-B-13509/Dalton Avenue**

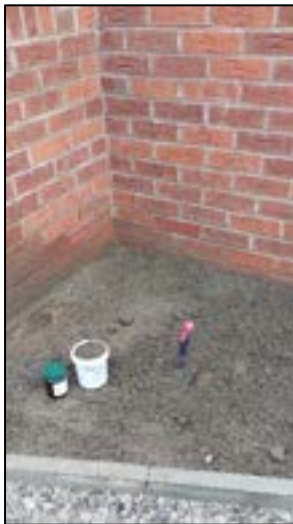
Photo 1: Plot 5 Planter

Consequently, on 27<sup>th</sup> February 2026, we attended site to collect 3no. topsoil samples and deliver them to the laboratory for a suitable test suite. It is understood that 10 tonnes of topsoil had been delivered (from a greenfield source), but only 5 tonnes had in fact been required to provide a growing medium in the 'planters.' At this time the build was still incomplete and the planters were observed as bare soil.

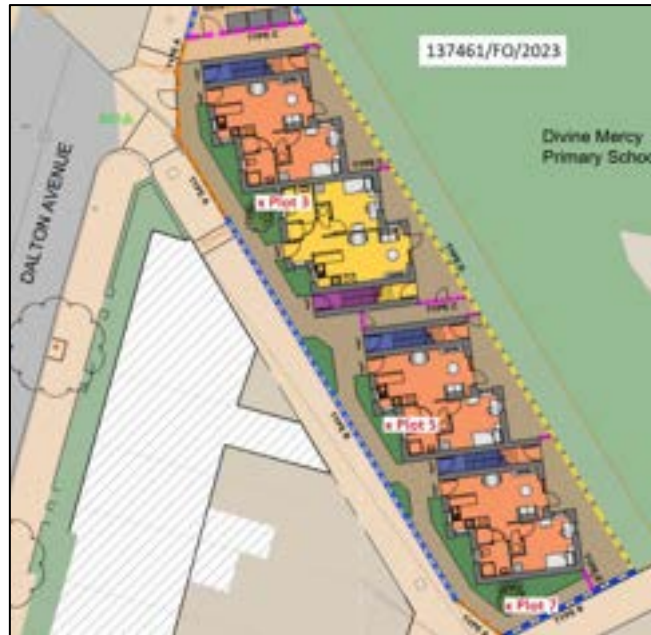
Figure 1. Location of Soil Sampling 27/2/2026

A trial pit was hand dug in 3 areas to a depth of approximately 200mm, at the locations shown below in Figure 1, and a sample was recovered at each.

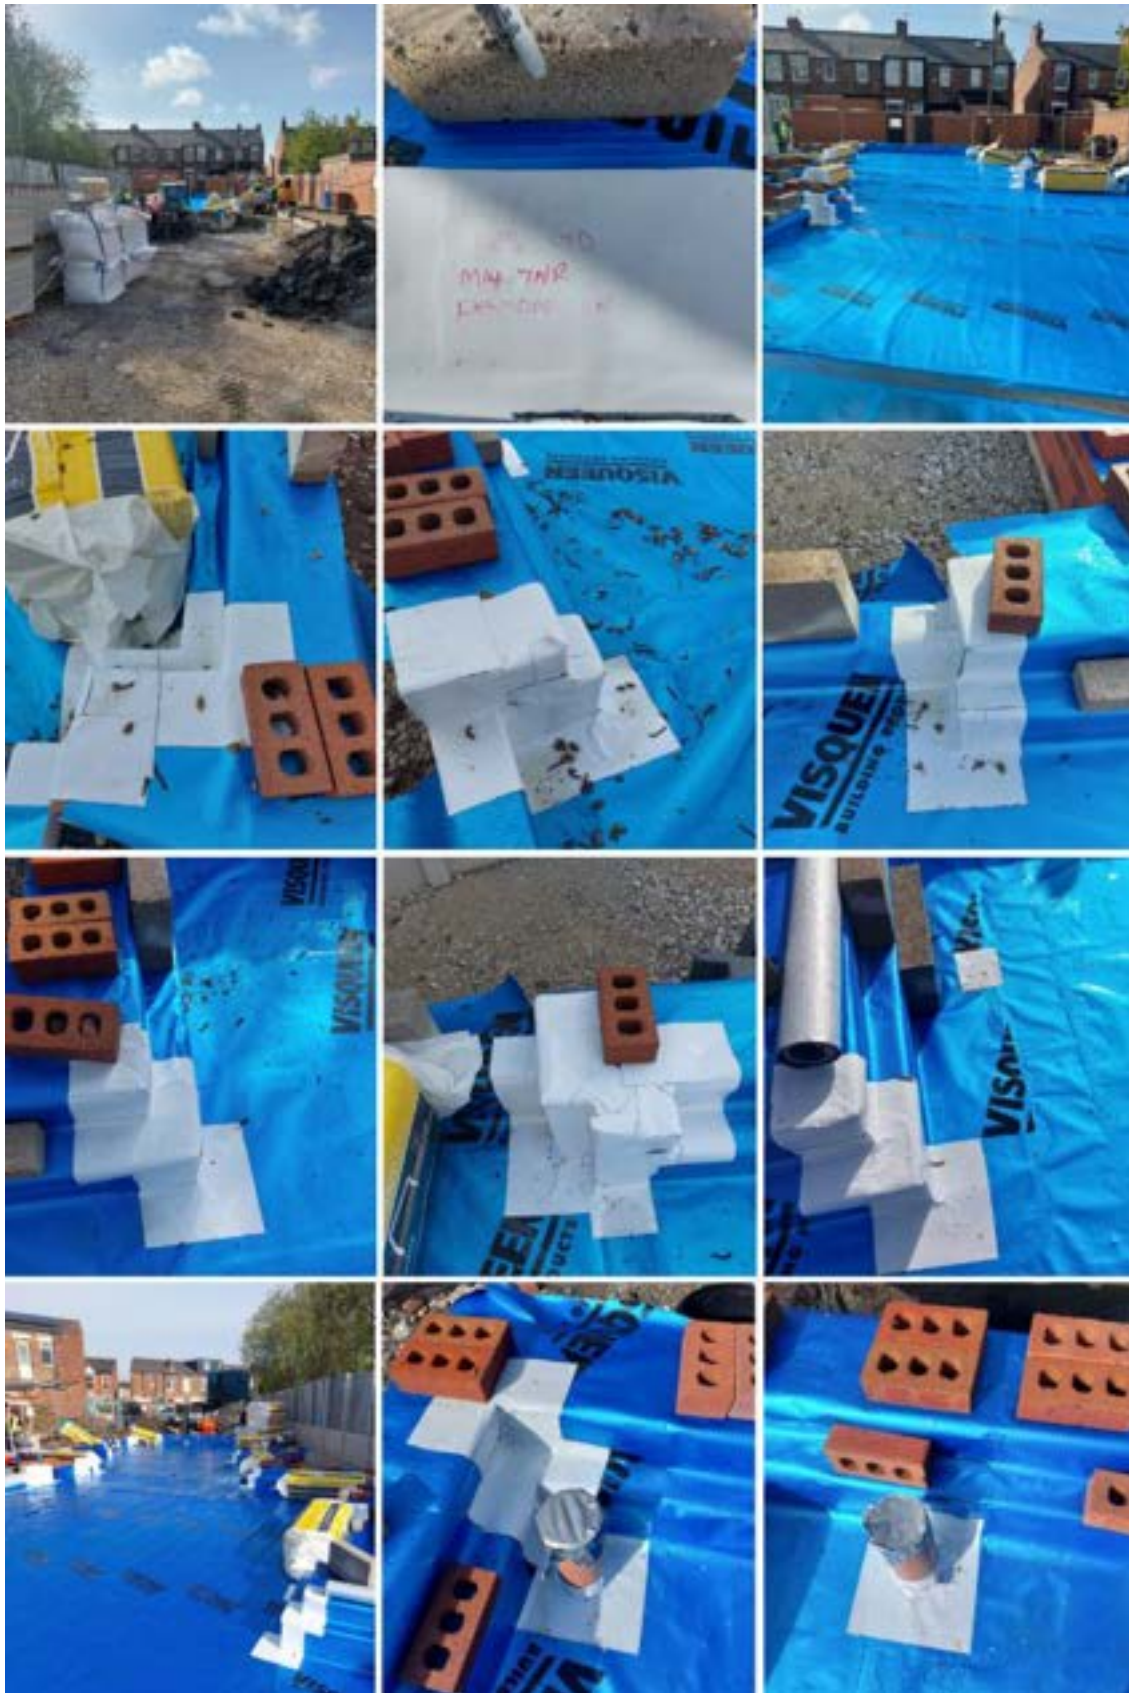
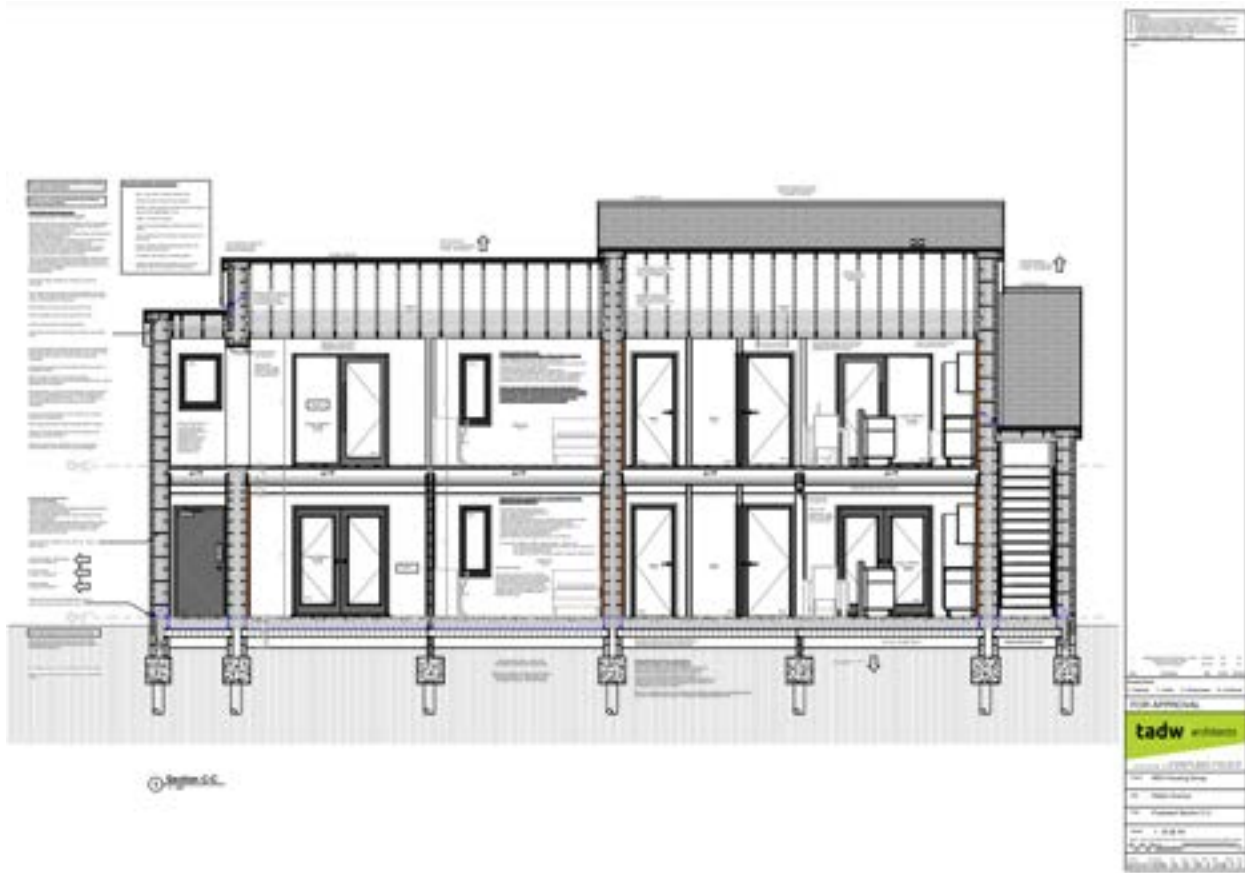
Please see photographs.

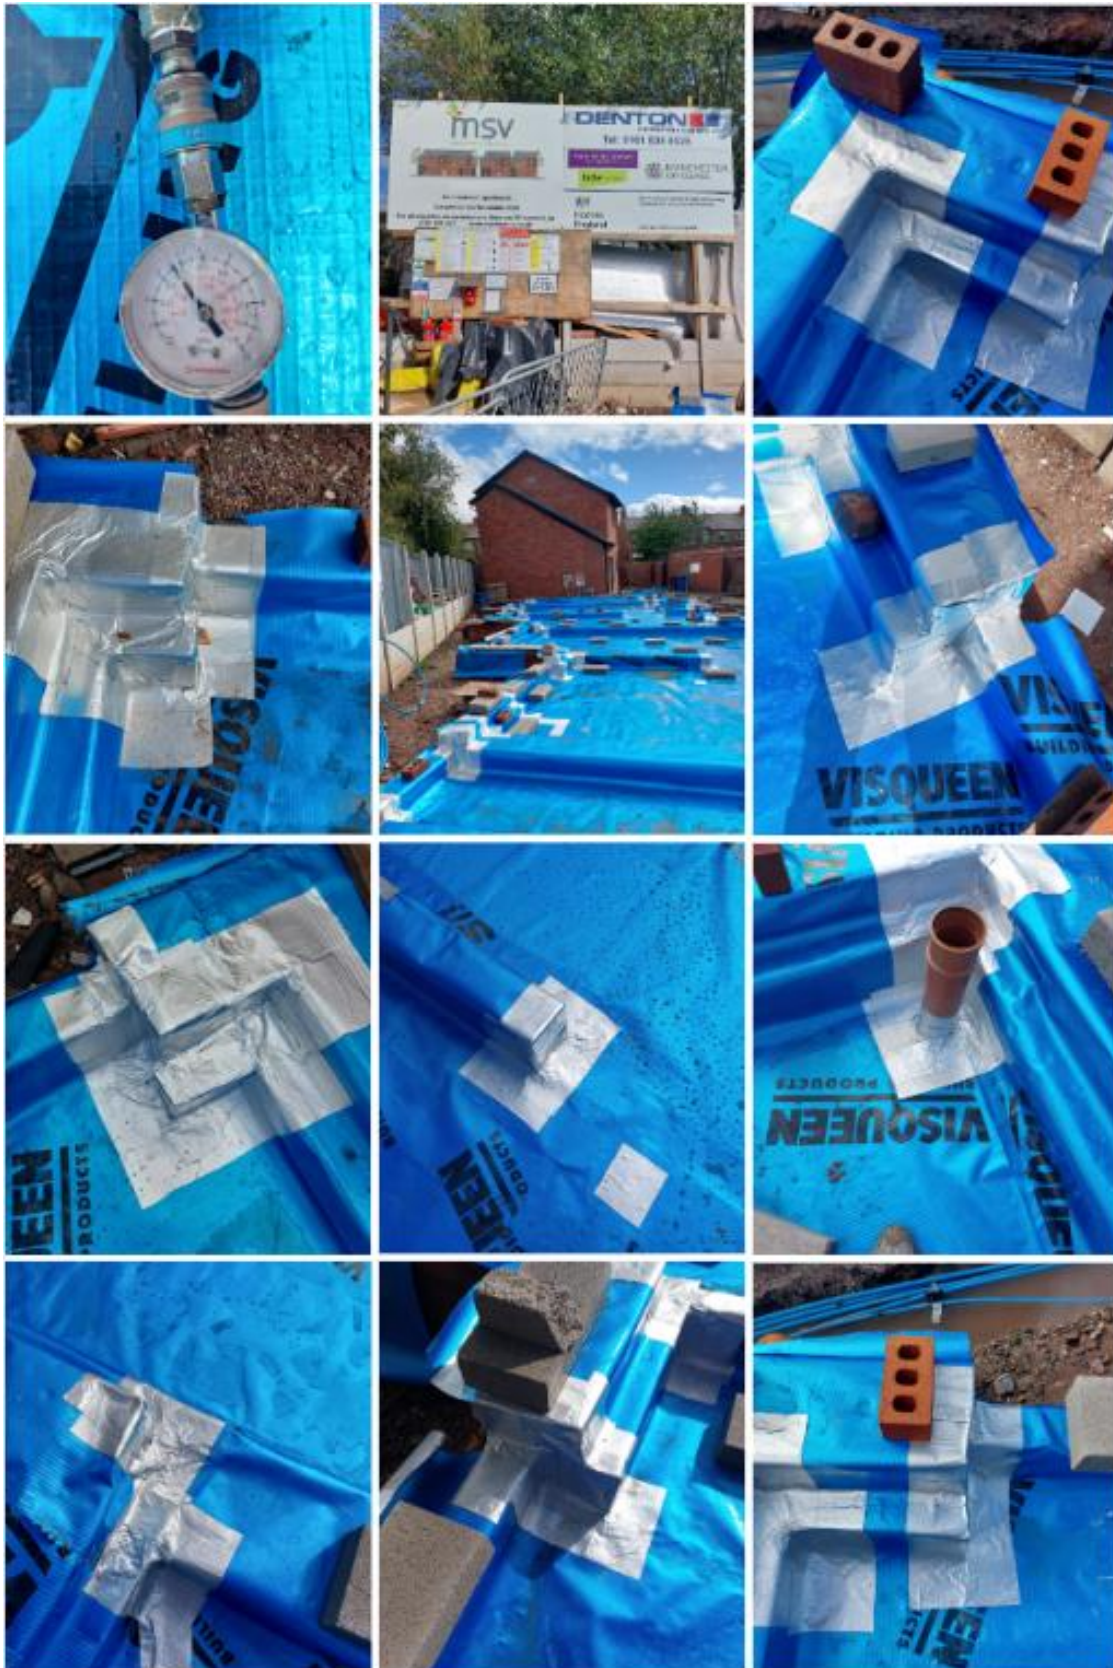
Overall, the gas membrane had been installed to a good standard, with only a few minor repairs required around the columns.
