## Castlefield Viaduct – Phase 2

Truss End Support Boxes – Remedial Options Appraisal

| Document verification | | | | | | |
|---|---|---|---|---|---|--|
| Document title | | Truss End Support Boxes – Options Appraisal | | | 282210 | |
| Revision | Date | Filename | CVI-ARUP-ZZ-ZZ-RP-S-000003 | | | |

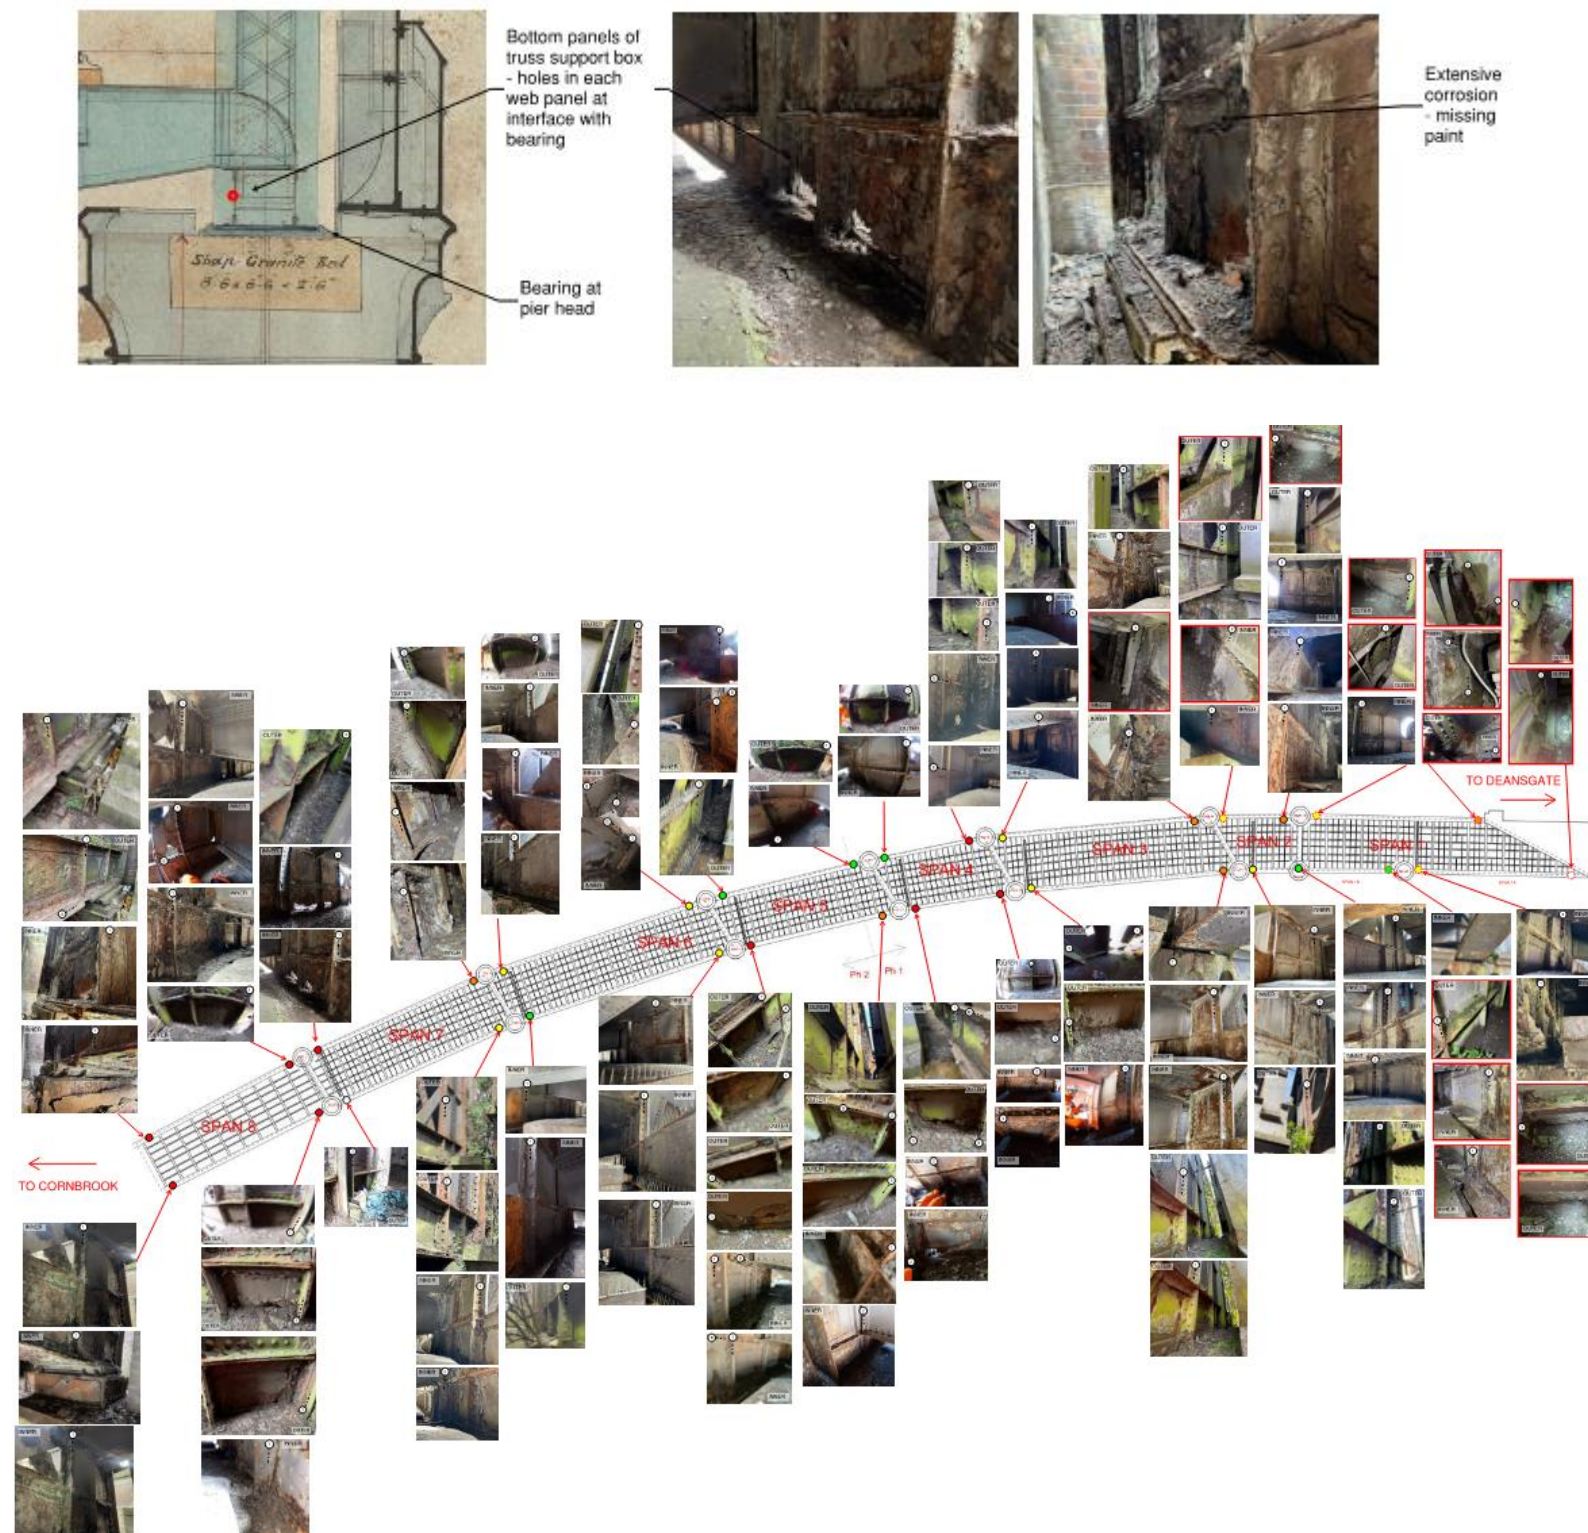
- The surveys found the **bottom panels of the support boxes, below the deck, to be in a very poor condition**. These areas are prone to water attack from driven rain running down the outside of the outer plane. Some will also collect water overflowing from the truss bottom chords, which acts as gutters and are unable to discharge in some locations. Maintenance may also have been neglected through the life of the structure given the challenging access to both support box planes.

- An end-by-end survey was carried out for all trusses, for both the inner and outer planes. Significant corrosion was found at several locations, with complete paint absence and loss of thickness to the 5/8" steel web plate. Some panels were found to be deteriorated such that large holes were evident. At other locations, however, the condition was found to be more acceptable, with paint present and negligible corrosion.

- A qualitative rating was ascribed to each truss end in Appendix B.2 of the Principal Inspection (CVI-ARUP-ZZ-ZZ-RP-S-000001), extracted opposite. The ratings are coloured red, amber, yellow, green (RAYG) in decreasing order of deterioration. This Condition Summary helps to show spatially where the defects occur.

- The Arup Principal Inspection + Assessment recommended that the most deteriorated support boxes should be remediated. These are those rated ‘red’ in the Condition Summary: there are 9No. ‘red’ truss ends across the viaduct.

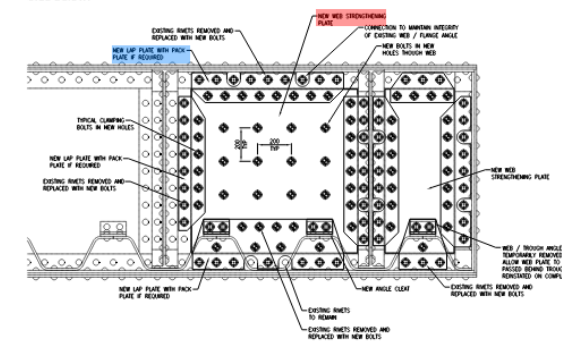
The designer is to confirm the existing condition / thickness of remaining web plate in order to size the strengthening plate accordingly, taking account of any corrosion or holing that may exist. Particular attention should be made to avoid having bolted connections where holing or thinning of plates exist as the integrity of the connection may be in doubt.

A typical example of a proposed bolted web plate strengthening arrangement can be seen in Figure 0.18 below.

New web plates either side of existing  
- provides symmetric remedial  
with no eccentricities

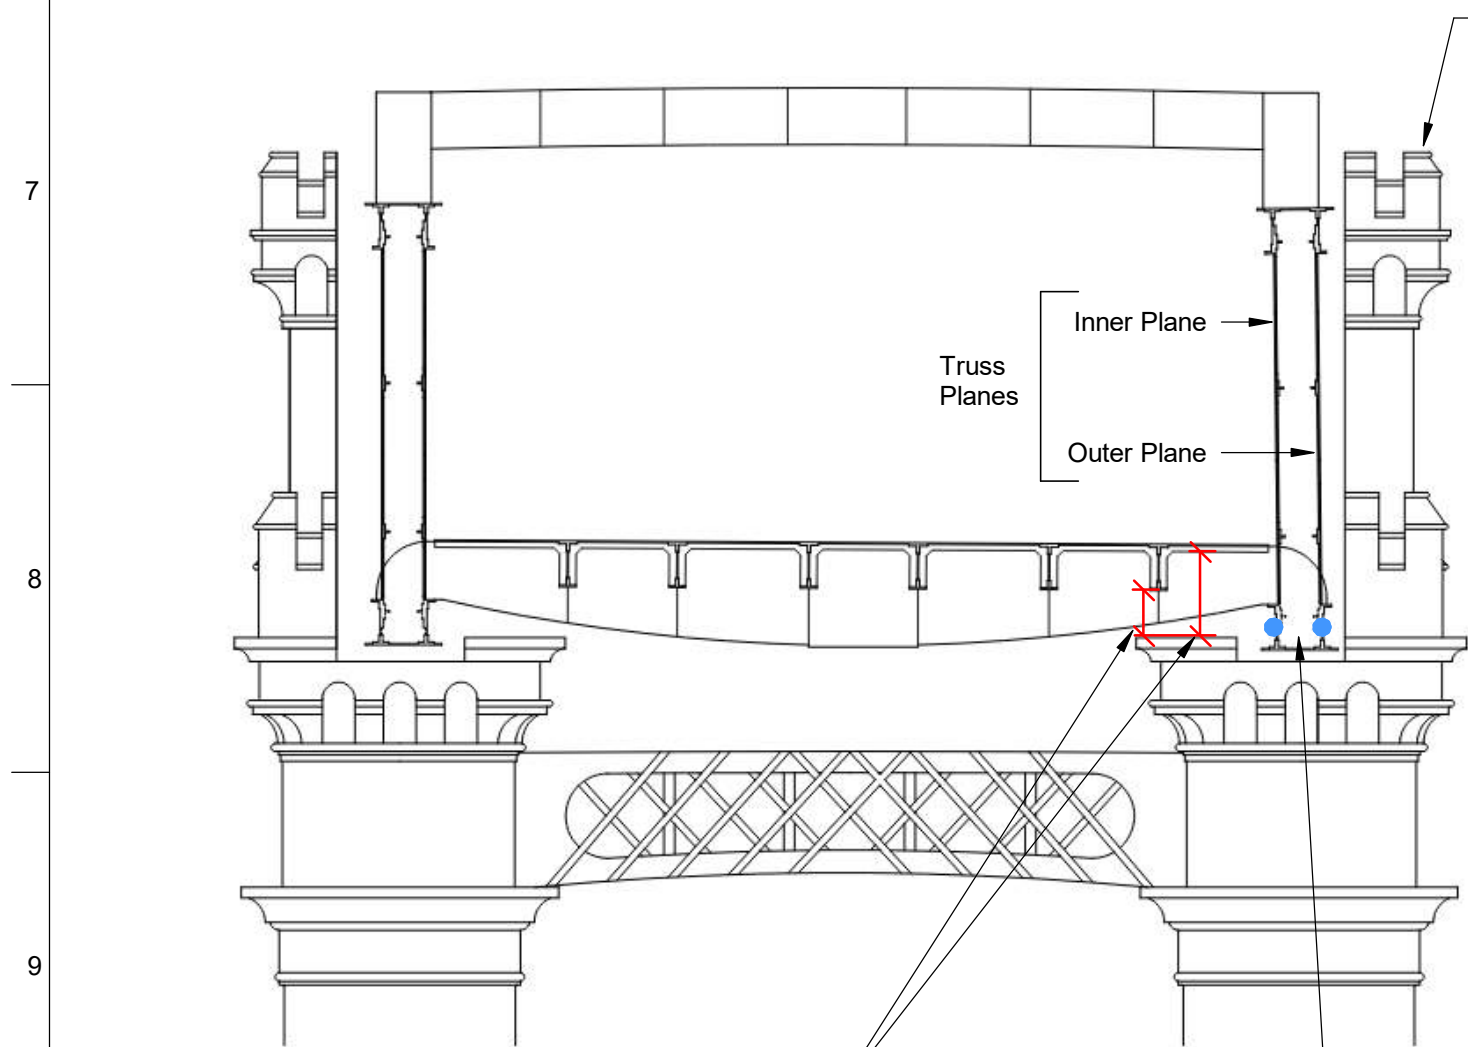
Clearance to pier head castellated head - varies per pier - indicatively 650mm below longitudinal beam, 1200mm below deck plate

Lower web panels - area of worst case corrosion

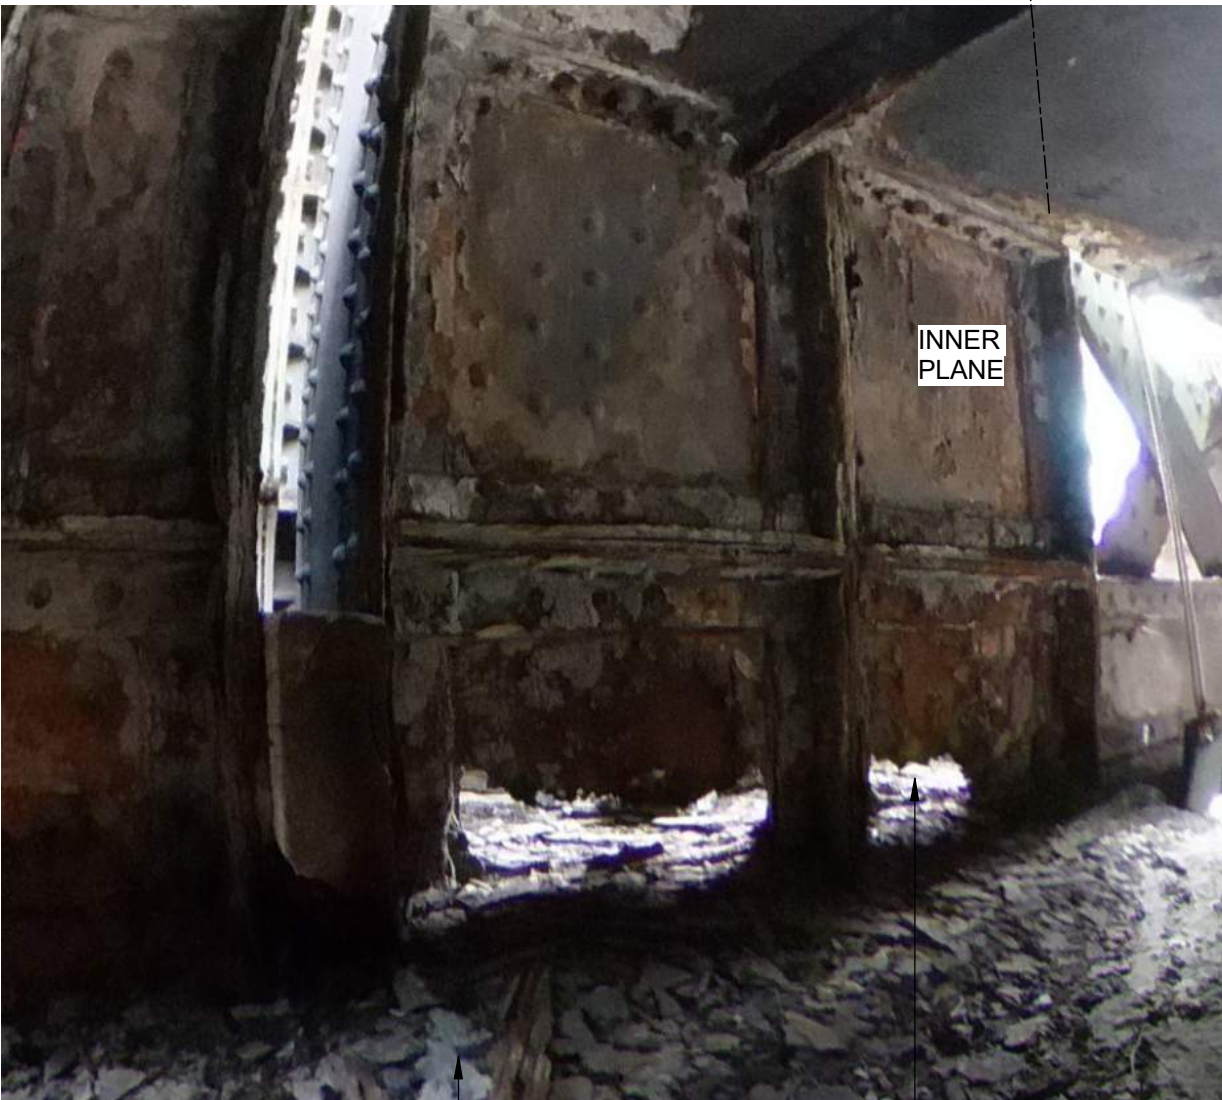
Span 7 North Elevation, Cornbrook End

Debris at pier head to be cleared to confirm extents/condition of bottom horizontal stiffener on GL A

Holes on both lower web panels, inner plane

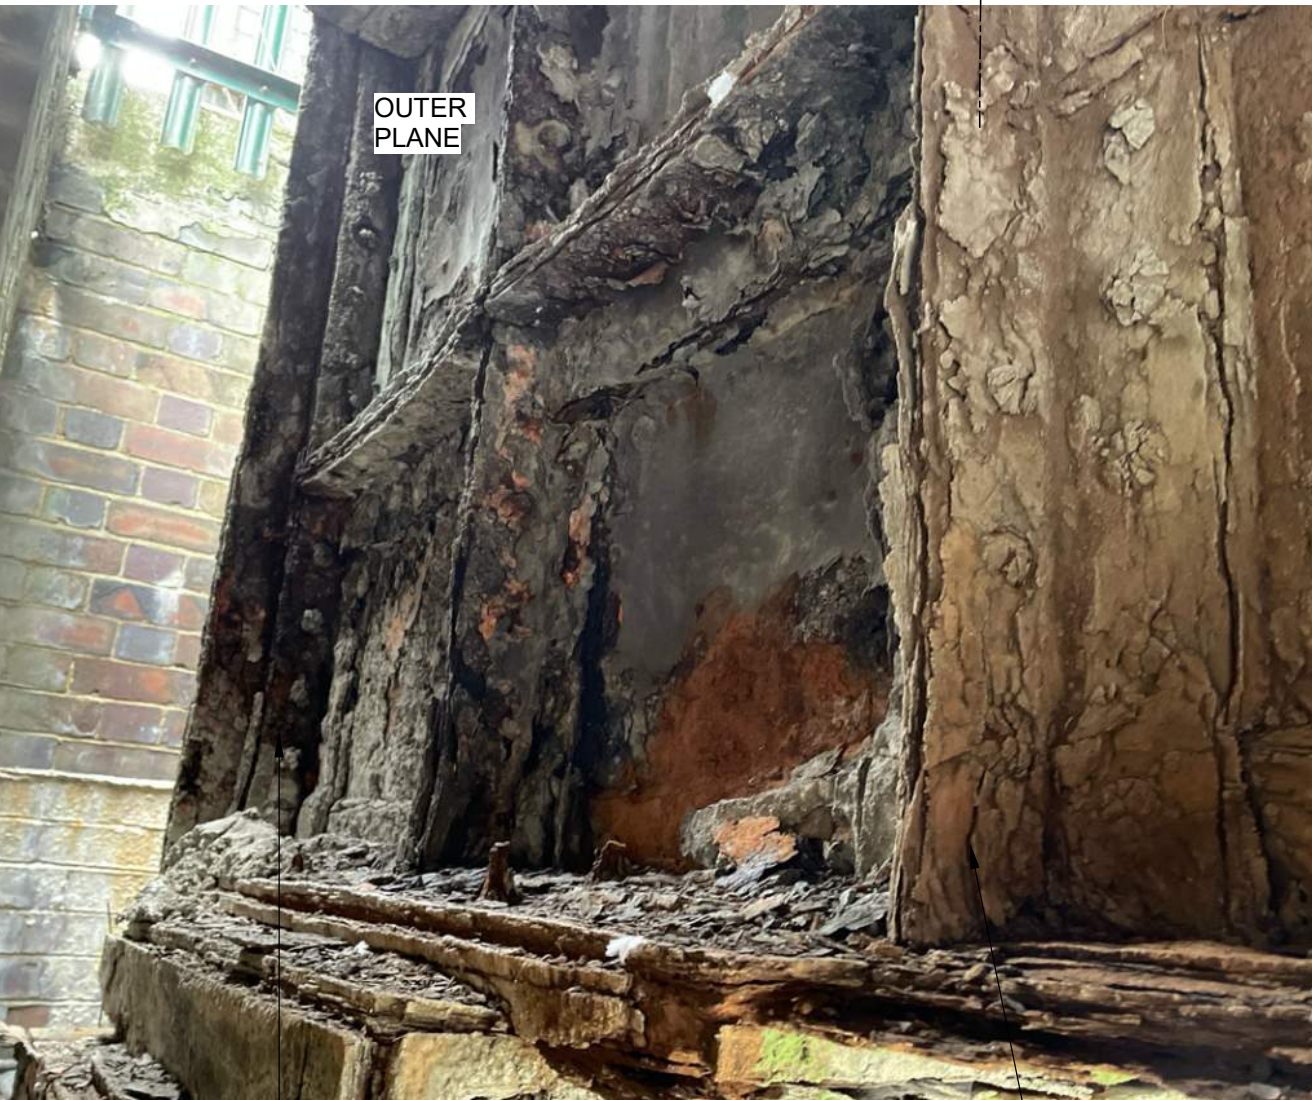
Span 8 North Elevation, Cornbrook End

Note: this is at the Cornbrook abutment; access further constrained by surrounding masonry bearing gallery

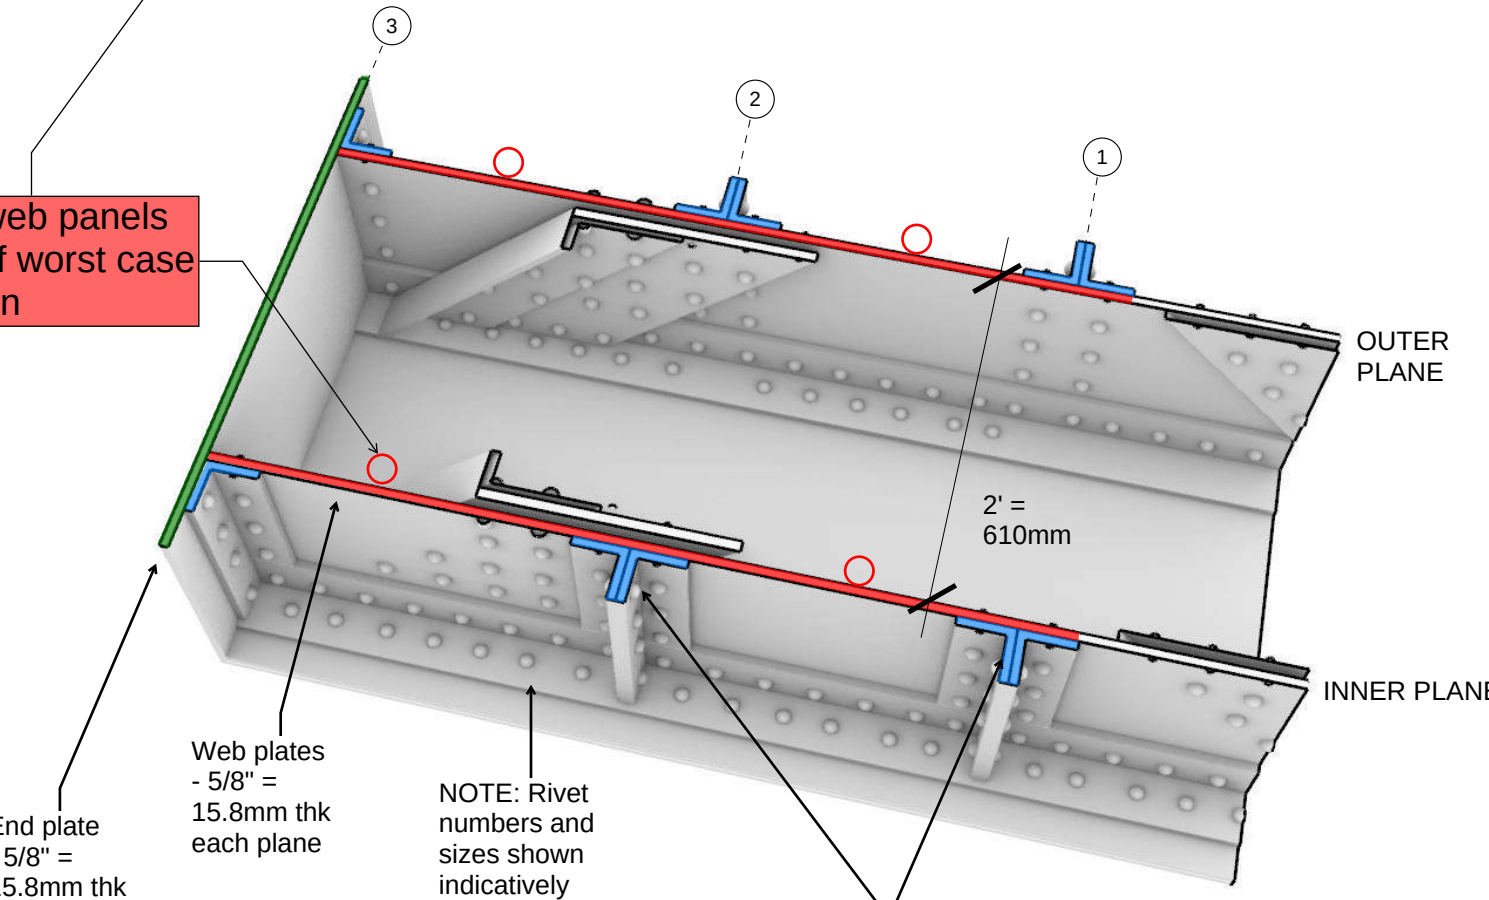
Lower web panels - area of worst case corrosion

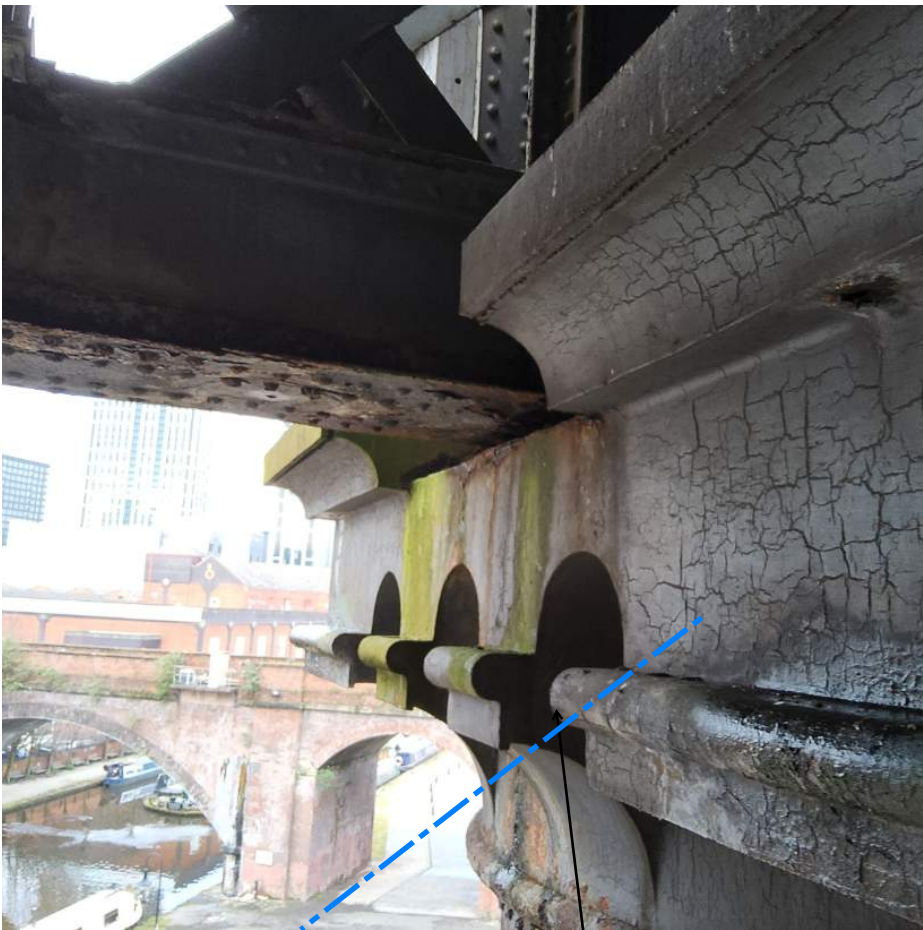
Clearance to pier head castellated head - varies per pier - indicatively 650mm below longitudinal beam, 1200mm below deck plate

Lower web panels - area of worst case corrosion

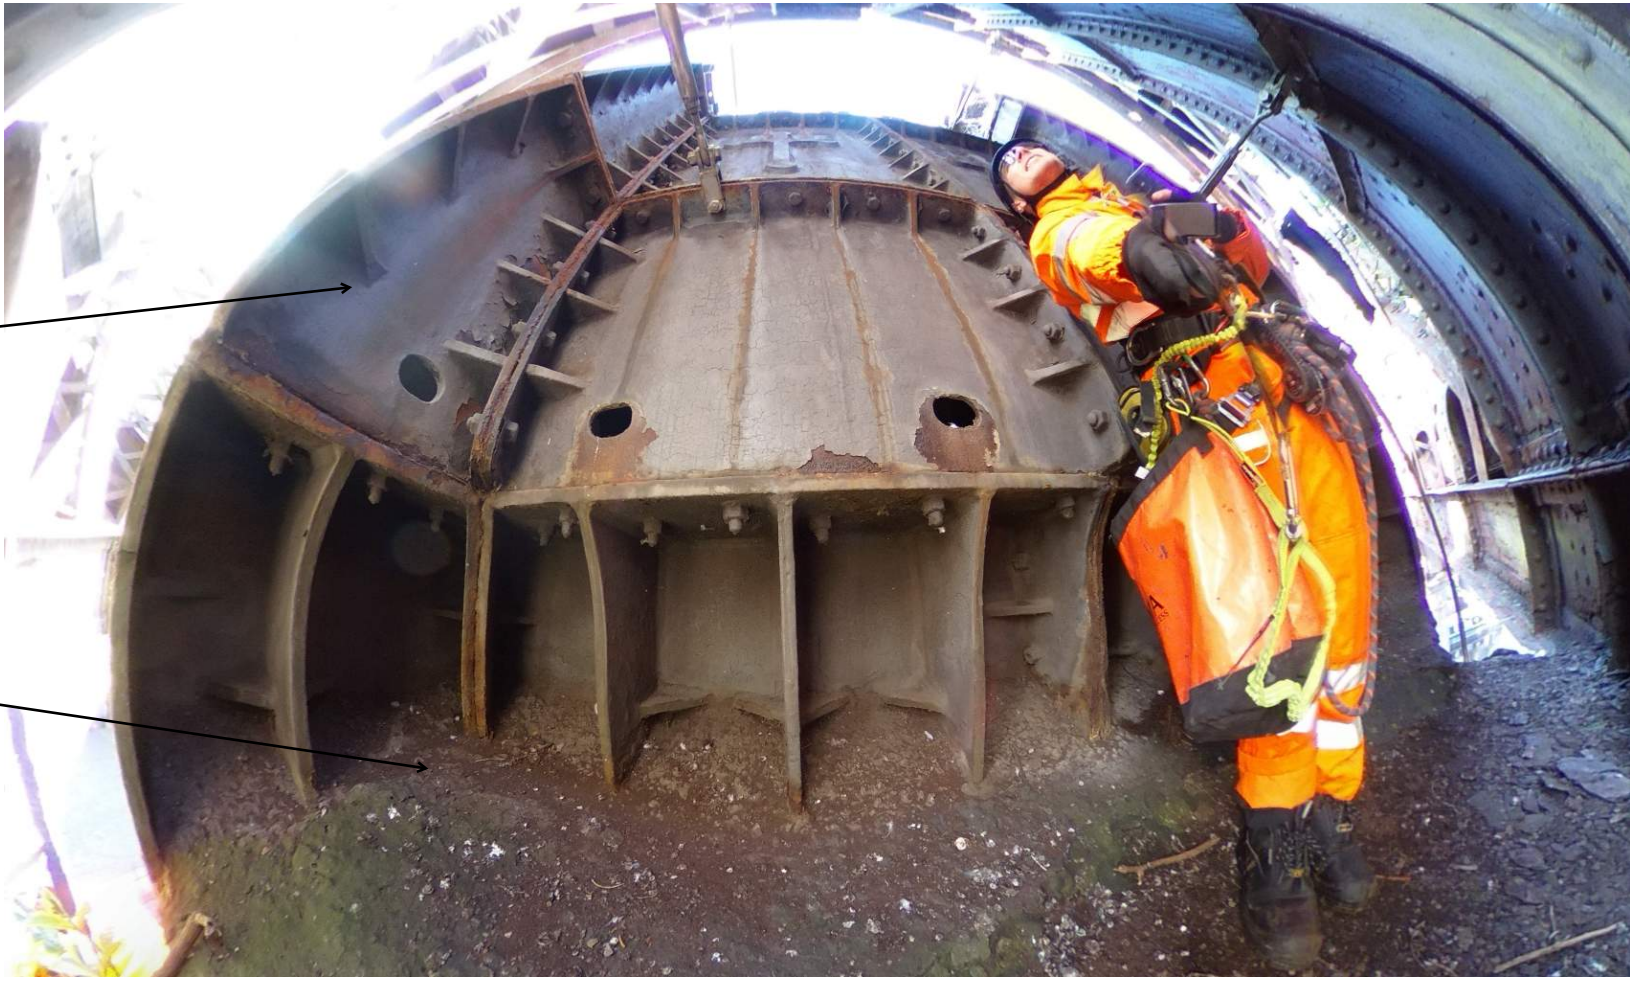
Connection into pier head unknown - buried within debris

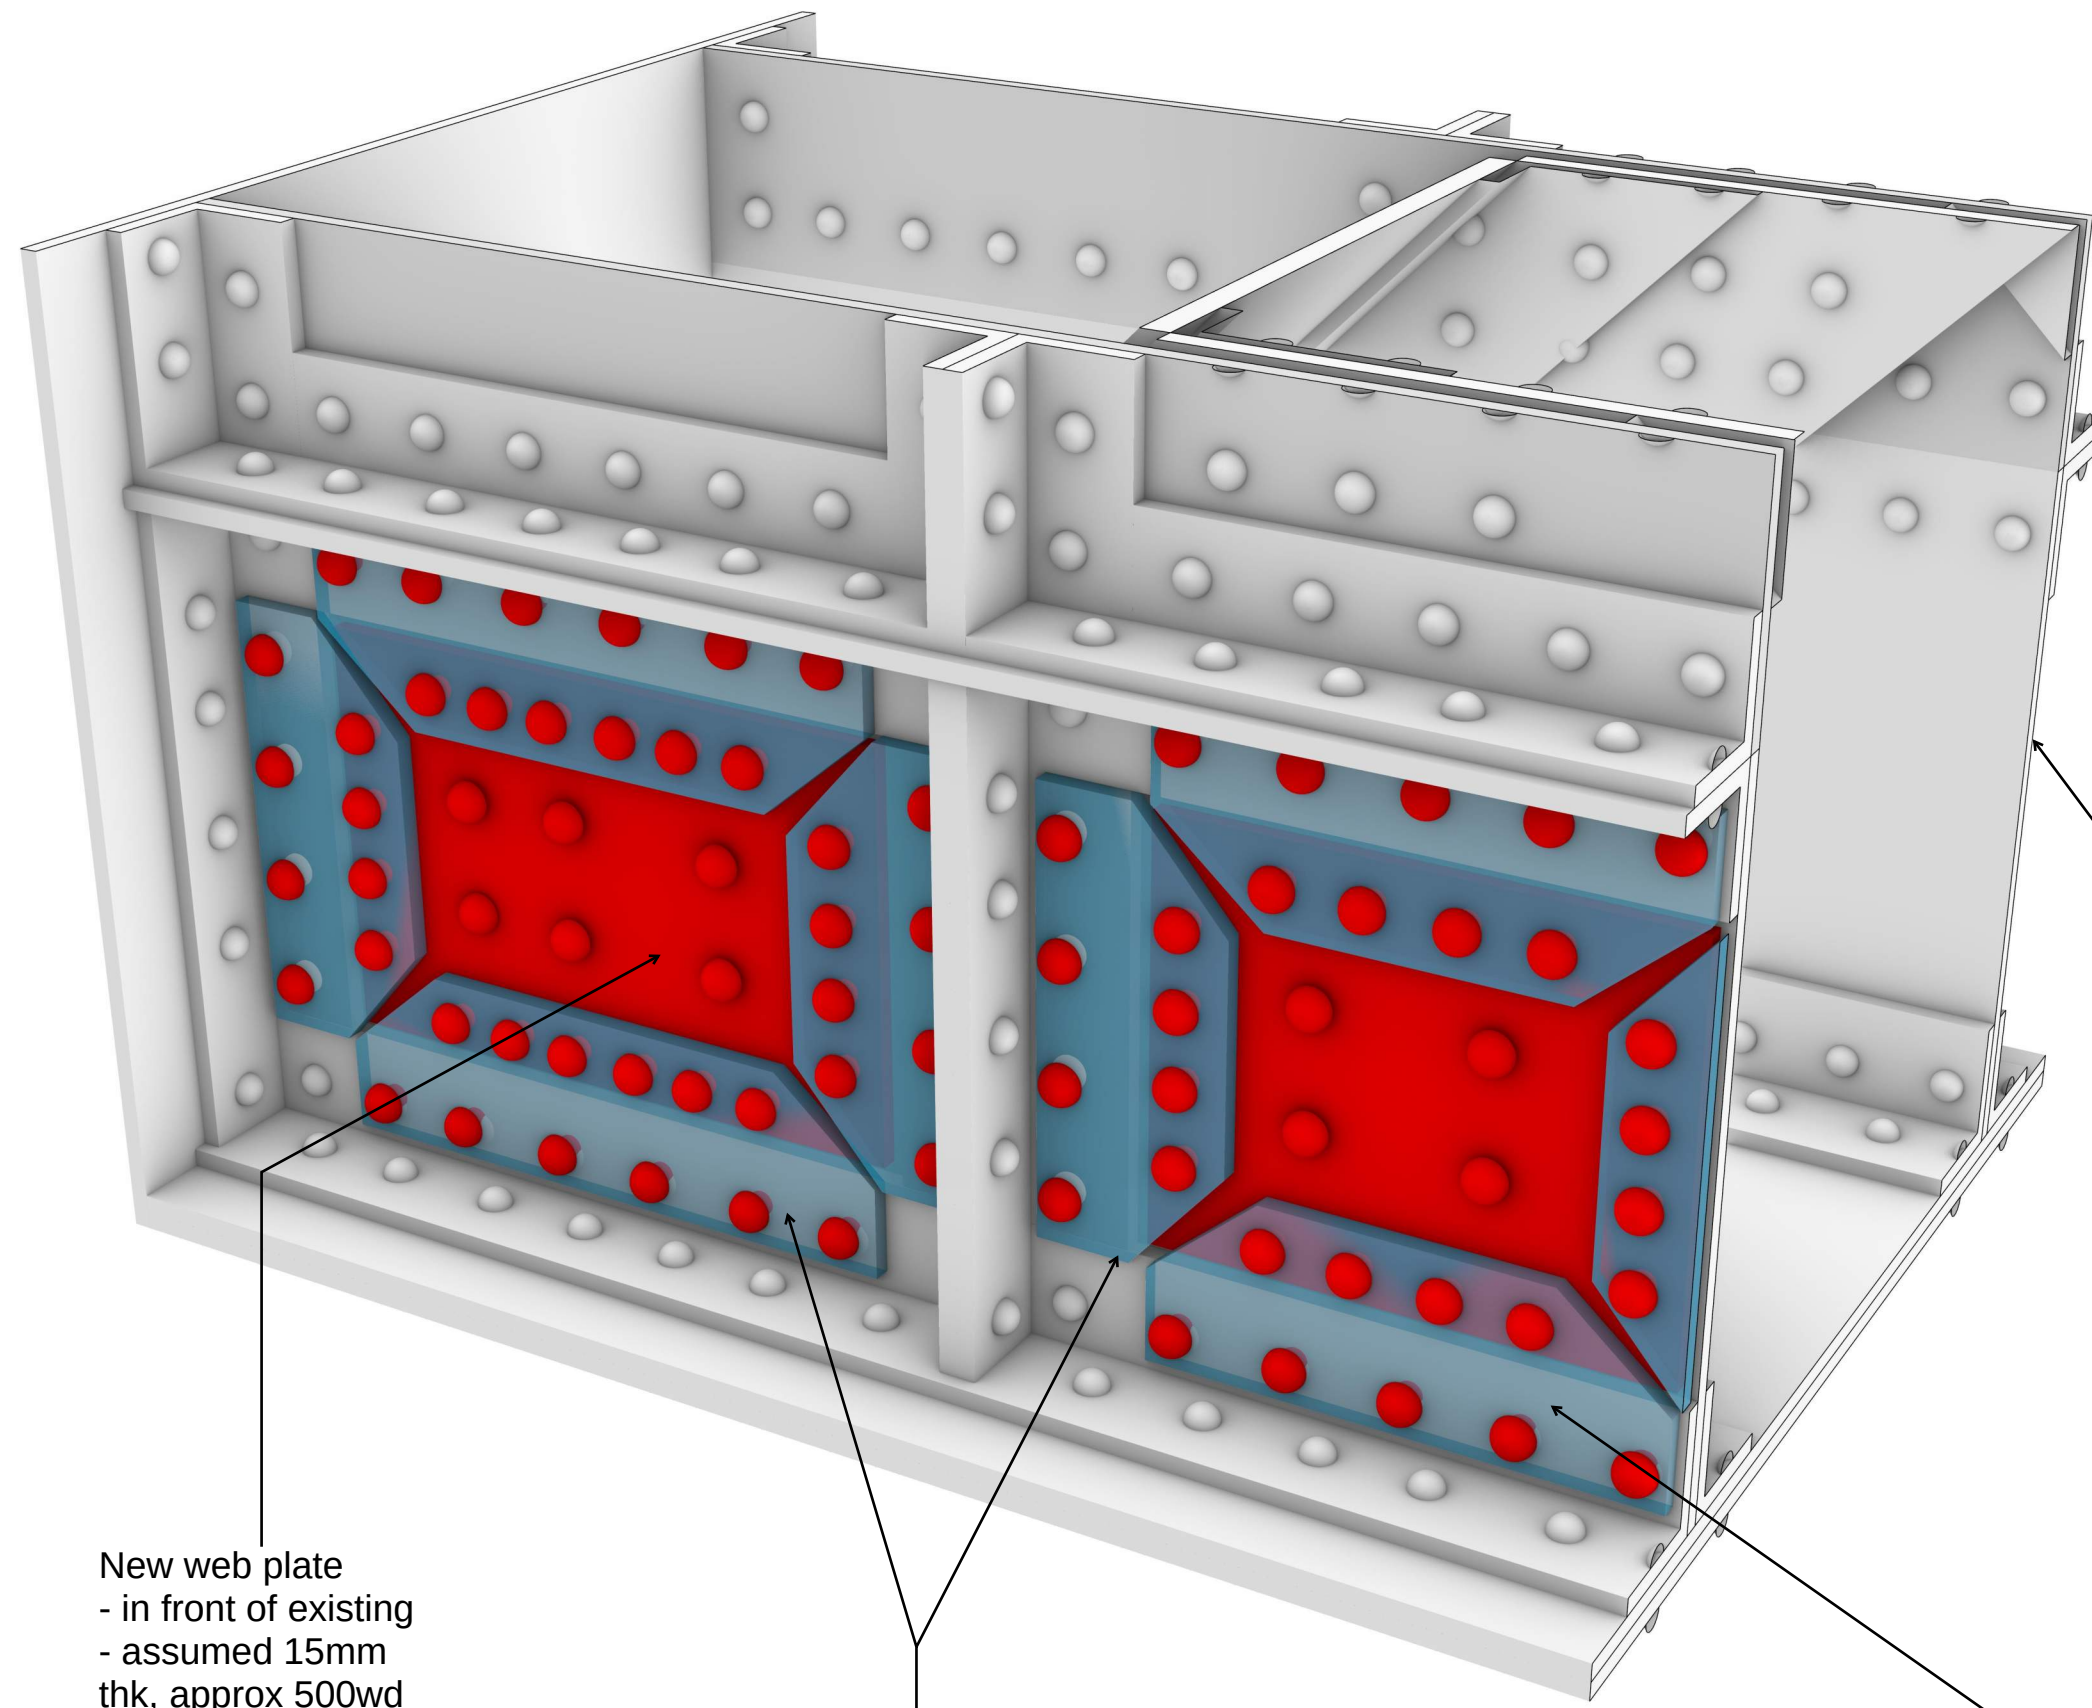
Holes to bottom of lower panels

New web plate  
- in front of existing  
- assumed 15mm  
thk, approx 500wd  
x 400dp
