Gas Membrane Installation  
Validation Report  
Kier  
Nelson Street  
Miles Platting  
Manchester  
M40 8BB

## Appendix 1 – Site Survey Sheets

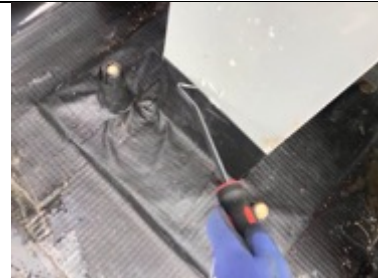
Pick testing stanchion sealing

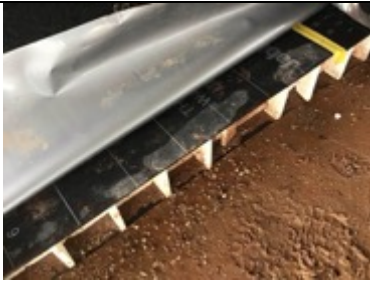
Heave board installed which the membrane is installed above

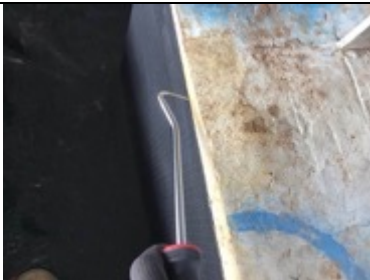
Internal perimeter concrete column retro fit detail testing

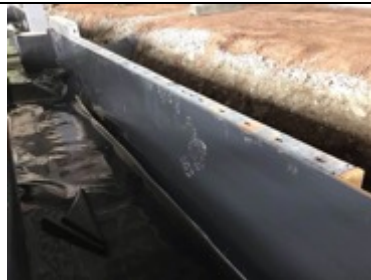
Membrane extended up the perimeter shuttering

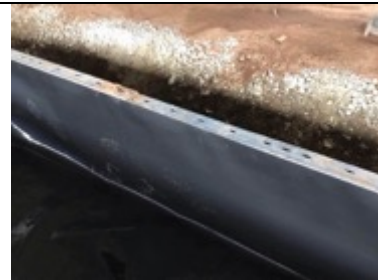
Membrane extended up the perimeter shuttering

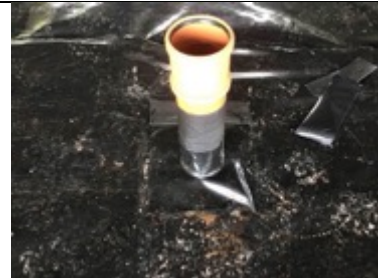
Pipe penetration sealed using hand welded preformed top hat and Juta GP1 SAM

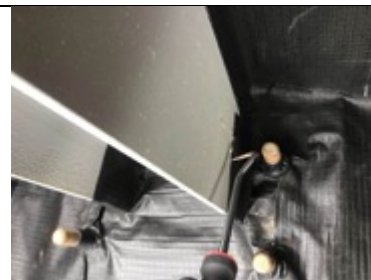
Testing stanchion detailing

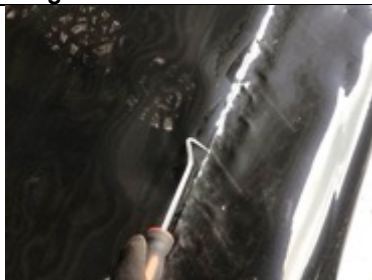
Testing sealed hand welded  
membrane lap joint

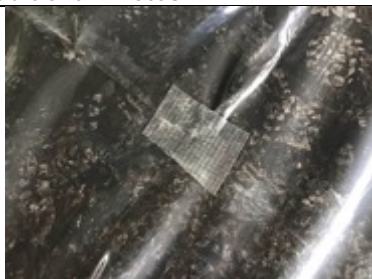
Defect repaired sealed using Juta  
GP1 SAM

| 4no weld defects were recorded by MEC. These areas were re welded by the installers during the inspection with an additional patch of Juta GP1 SAM placed over the weld. | | No Action Required all Defects rectified at time of inspection |

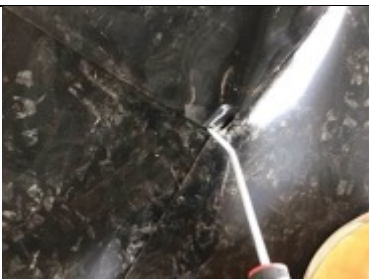
Recorded weld defect

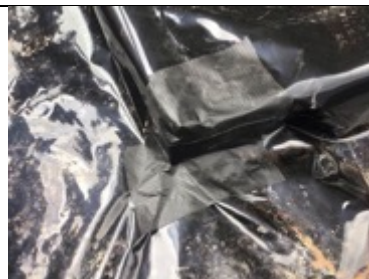
Corner detailing sealed sealed  
using Juta GP1 SAM

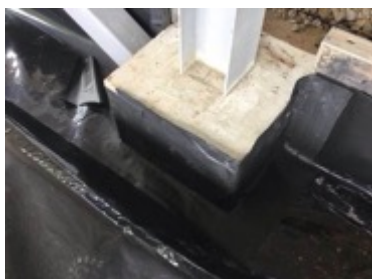
Stanchion concrete surround  
sealed sealed using Juta GP1  
SAM

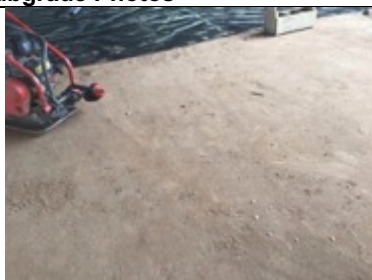
Blinding prior to the membrane installation

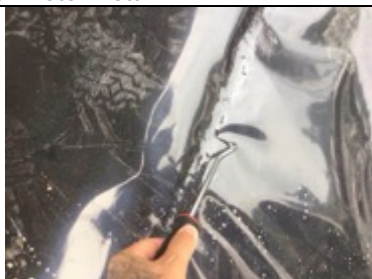
Testing perimeter membrane hand welded lap joint

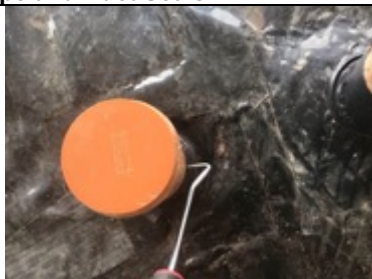
Probe testing pipe sealing

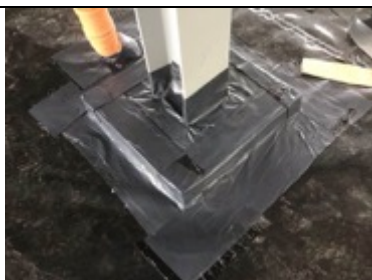
Sealed stanchion detailing

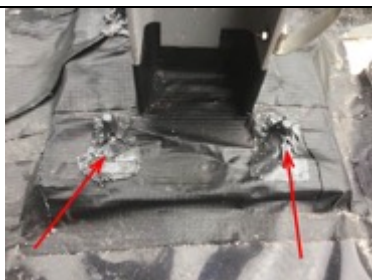
Butyl tape used to seal bolts

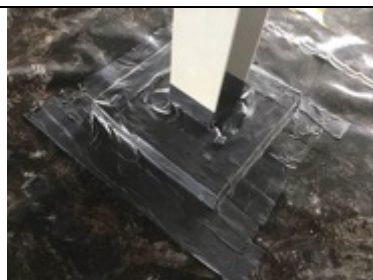
Sealed stanchion detailing

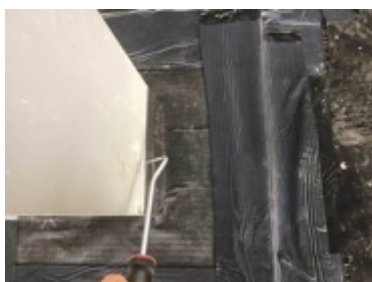
Probe testing stanchion detailing

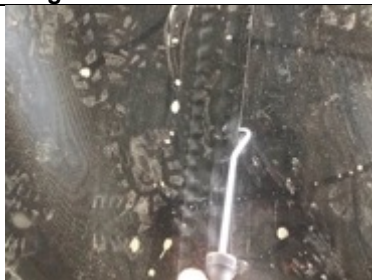
Probe testing auto welded  
membrane lap joint

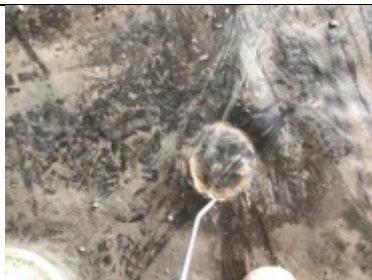
| (Section 2, Testing and Inspection Method) | |
|---|---|
| 3no recorded defects repaired by the installers during the inspection using Juta WP SAM. | No Action Required all Defects rectified at time of inspection |

Recorded defect

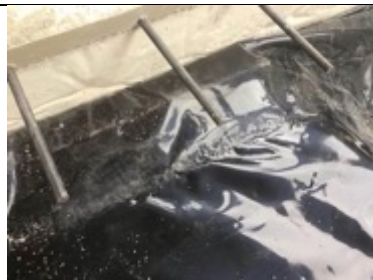
Membrane hand welded to the  
existing membrane from pour 1b

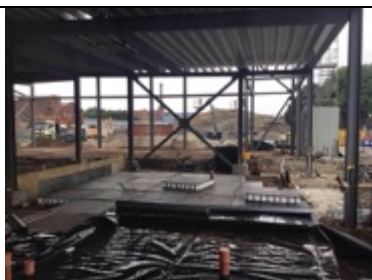
Remaining area of pour 3 yet to be installed

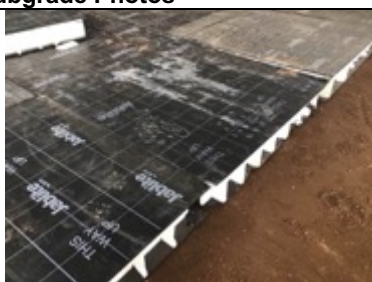
Heave board installed prior to the membrane installed above

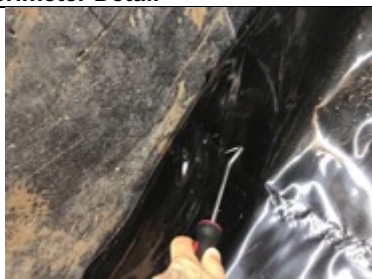
Testing perimeter hand weld

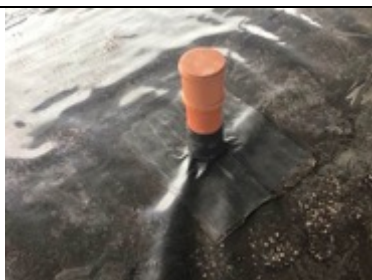
Sealed pipe penetration

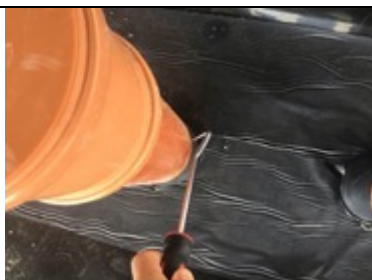
Probe testing pipe sealing

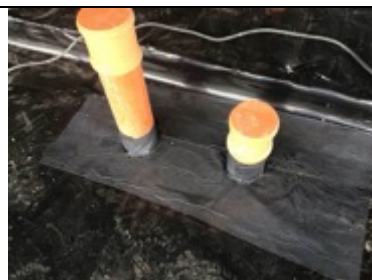
Sealed pipe penetrations

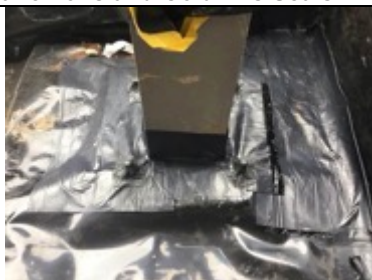
Sealed stanchion detailing

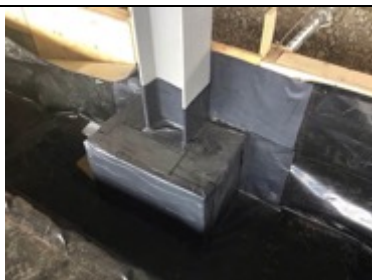
Sealed internal stanchion and  
concrete surround detailing

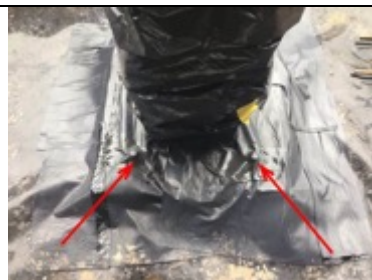
Double sided butyl tape used on  
the stanchion bolts

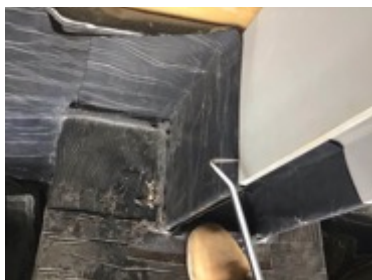
Probe testing stanchion sealing

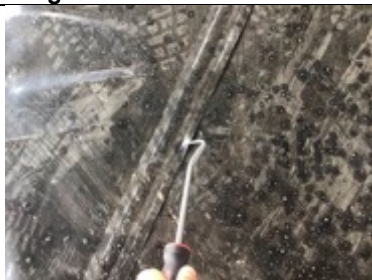
Testing auto welded membrane  
lap joint

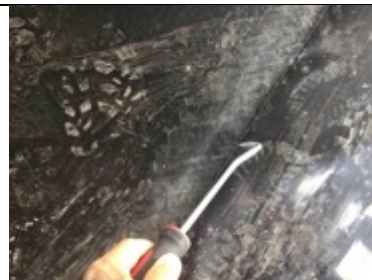
Testing hand welded membrane  
lap joint

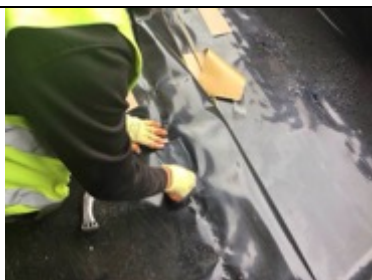
| <p>3no recorded weld defects were repaired by the installers during the inspection using Juta WP SAM.</p> <p>Due to groundworks not complete, the membrane could not be fully installed across the whole base of pour 3 at the time of our inspection. A return visit is required to inspect the membrane between Gridlines 21-23 / O-Q.</p> | <b>Action Required</b><br>No Action Required all Defects rectified at time of inspection |

Installer repairing weld defect during the inspection

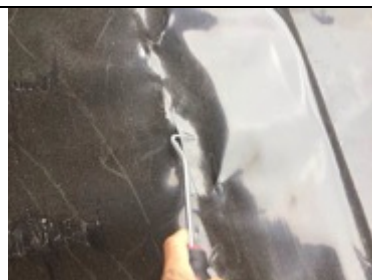
Recorded hand weld defect

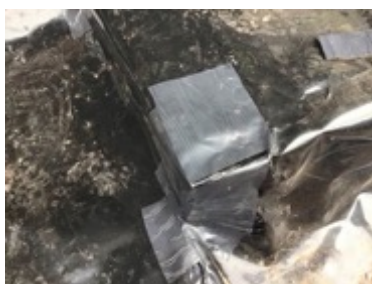
Sealed corner detailing

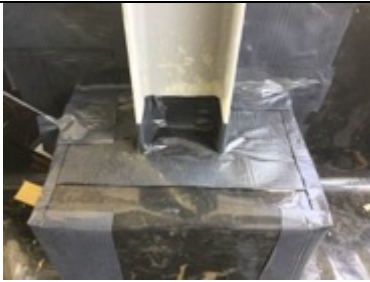
Sealed steel stanchion detail within pour area 3.

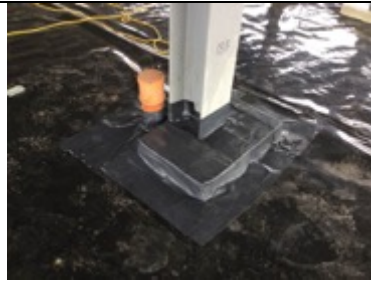
Steel stanchion detailing sealed within pour area 5.

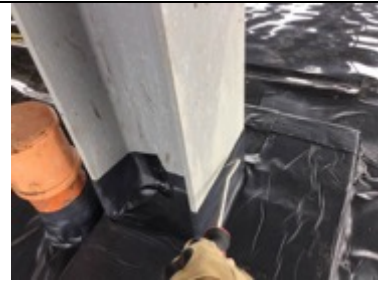
Pick testing to the stanchion detail within pour area 5.

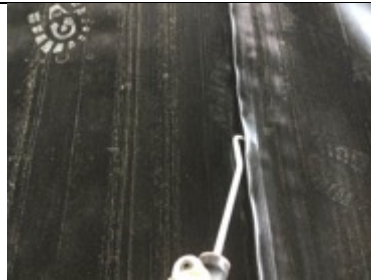
Pick testing along the auto welded lap joint within Pour area 5.

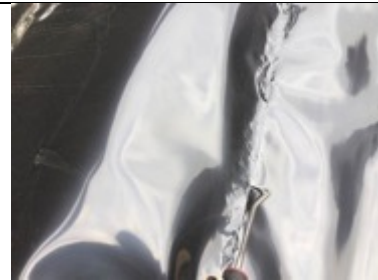
Pick testing carried out along the hand welded lap joint to pour area 5.

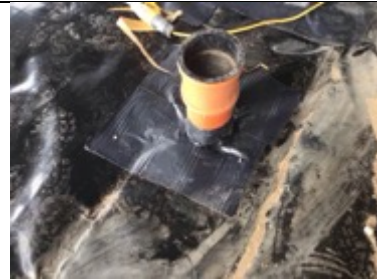
Sealed pipe penetrations

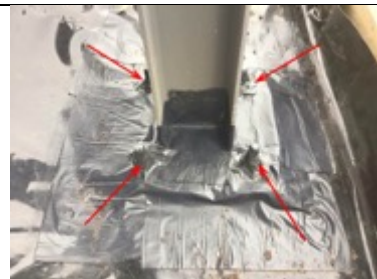
Double sided butyl tape used on the stanchion bolts

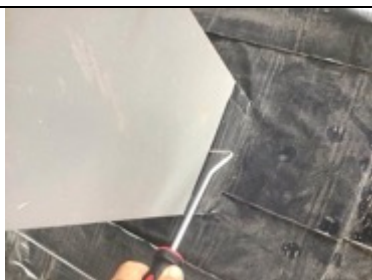
Probe testing stanchion detailing

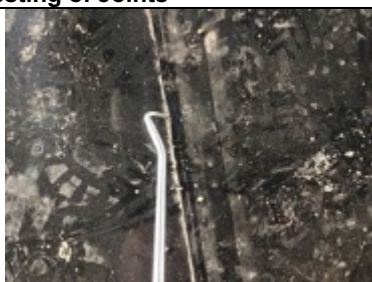
Probe test to auto welded  
membrane lap joint

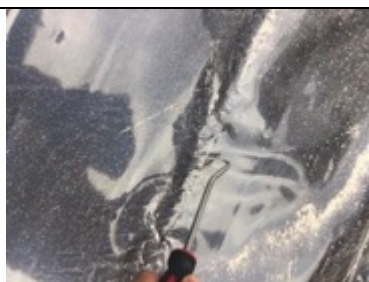
Probe test to hand welded  
membrane lap joint

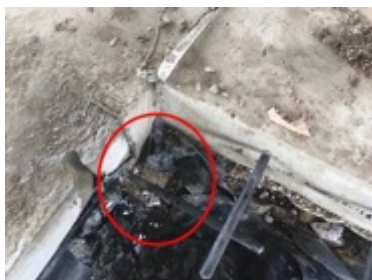
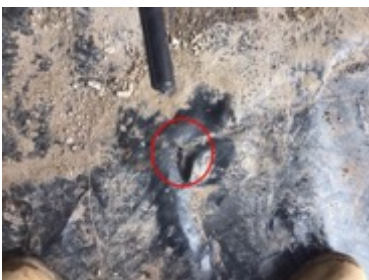
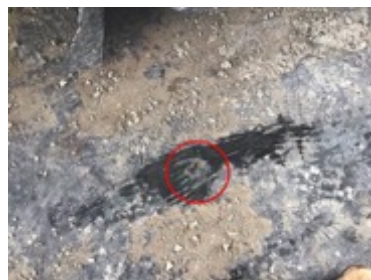
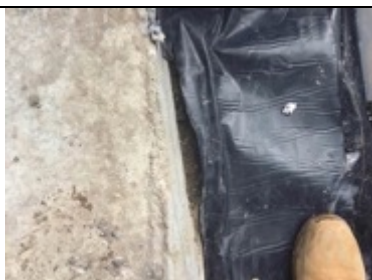
| <b>Leak/Hole Detection</b> | MEC Environmental Ltd carried out a thorough Visual Inspection to the available area at the time of our inspection | |
|---|---|---|
| MEC recorded 17no defects largely throughout the existing membrane from previous pours. During the inspection the installers repaired the recorded defects using Juta GP SAM. Sections of detailing work required additional heat to adhere sufficiently which the installers did during the inspection to the areas noted by MEC | | No Action Required all Defects rectified at time of inspection |

Recorded defect
