4891M

# NXQ Lever Street, Manchester Façade Retention Strategy & Methodology

December 2025

# 4891M | Lever Street Façade Retention Strategy & Methodology

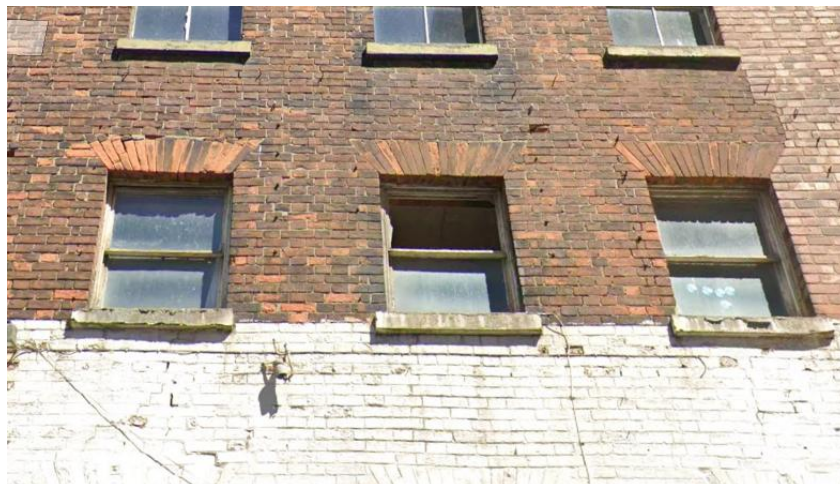
Given the age of the existing buildings, there are many examples of embedded metal fixings within the external façade. The embedded fixings are likely to be present internally too although given the unsafe nature of the building, the extents of such fixings cannot be quantified.

There are signs of localised cracking to the external façade due to the presence of embedded fixings and in areas, broken bricks are present.

**Photo showing embedded metalwork within elevation (small black shadows on regular grid between windows)**

The fixing details of these to the existing façade are not clear but is likely to consist of embedded metal fixings. Given the extent of these services, inspection of the masonry behind cannot be determined. As covered in 5.1.1 it is of paramount importance that embedded metal work is removed and masonry locally repaired.

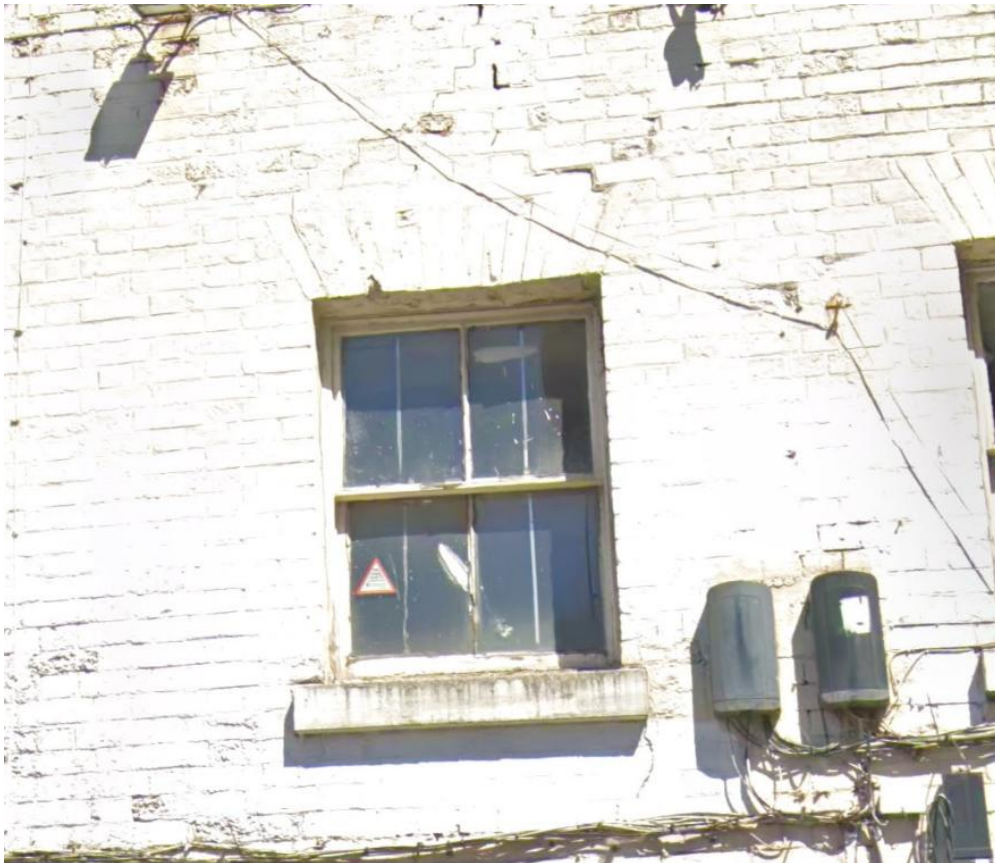
The external flat arch lintels show signs of settlement, mortar deterioration, and minor deformation consistent with the age of the building. Continued exposure risks progressive joint failure or arch instability. There are many examples of blown brick faces particularly on the Lever Street elevation which if left untreated would lead to further deterioration and localised collapse of the arch. If left, this can lead to further deterioration and potential for a more progressive collapse of masonry.

There is evidence of settlement of a flat arch lintel settlement on the Houldsworth Street elevation with cracking present above the lintel in a triangular pattern suggesting excessive deflection at midspan of the lintel. It is considered that the floor joists span on to the Houldsworth Street elevation and provide restraint to the façade. Any failure of lintels could lead to localised failure of support of the existing floor joists and a loss in restraint of the façade.

**Photo showing failed lintel and diagonal triangular cracking above window**

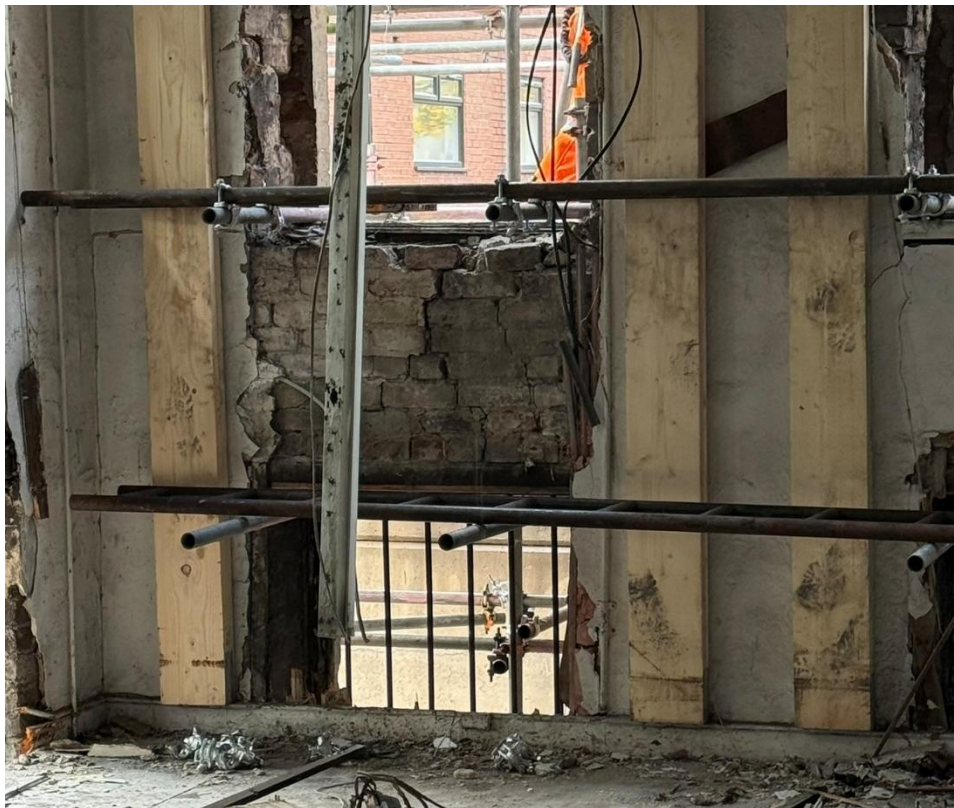
There are signs within the building that some internal lintels have failed evidenced by large cracks within spandrel panels between windows (see 5.1.7) this may also have resulted in split header courses. If left, this can lead to further deterioration and potential for a more progressive collapse of masonry.

Linked to the internal lintels, there is an example within 56 Lever Street of a failed spandrel panel between the lower ground floor and upper ground floor window local to the corner of Lever Street and Houldsworth Street. This is not expressed externally suggesting that an internal lintel failure has led to partial inner leaf collapse.

**Photo showing failed spandrel panel between lower and upper ground windows**

It is of paramount importance that any lintels are repaired and replaced as necessary with materials suitable for an external environment – i.e. any timber lintels should be replaced with concrete equivalents.
