**GAS MEMBRANE VALIDATION**

| <b>Site Name: Belle Vue Stadium</b> | <b>Project Number: 12-123</b> |
| <b>Company Name: Countryside</b> | <b>Date: 30-05-2022</b> |

**Plot - 99**

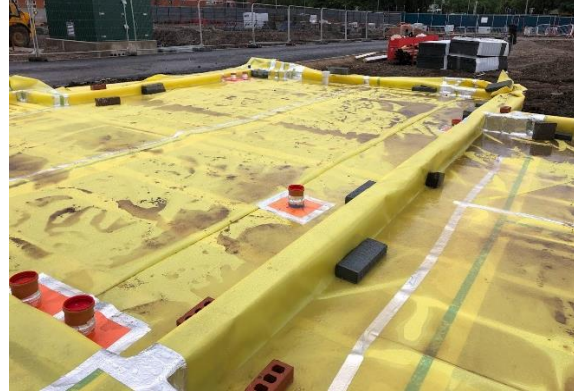
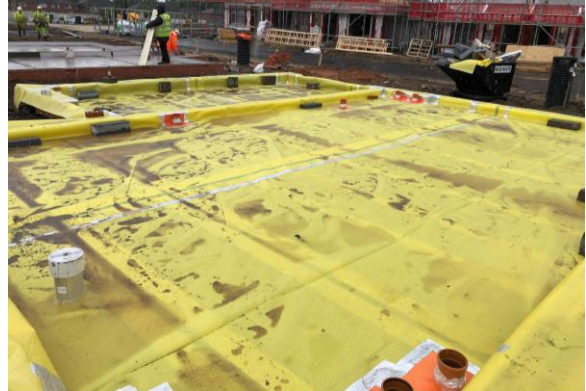
**General Condition of Membrane-Good Condition**

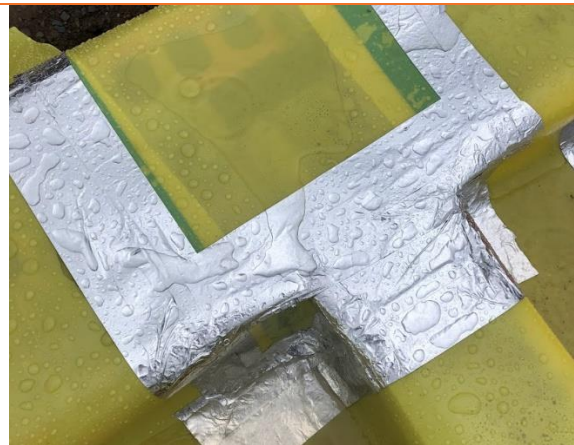
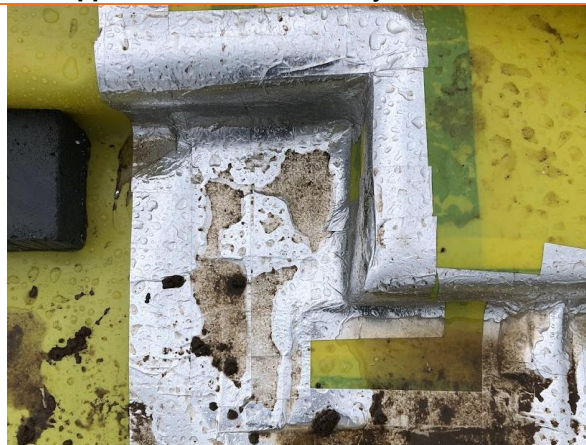
**Verification of Joints and Seals-Overlapped and sealed correctly**

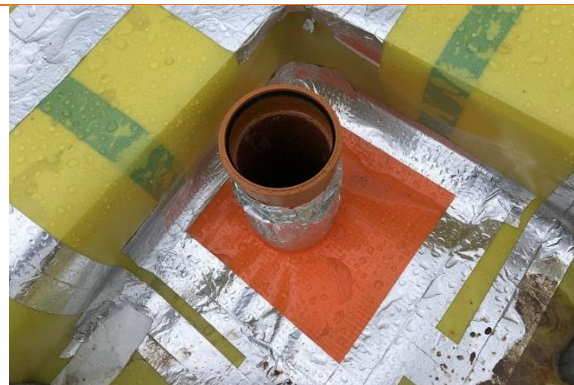
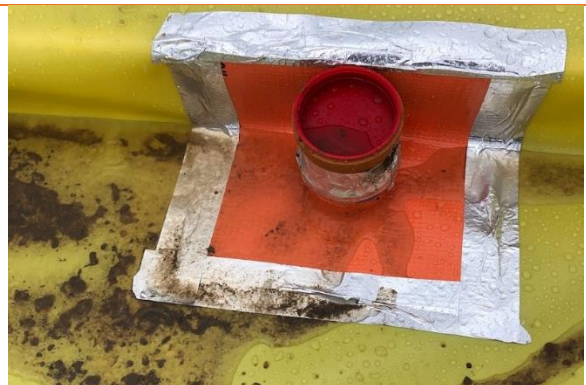
**Verification of Service Penetrations-Good Condition**

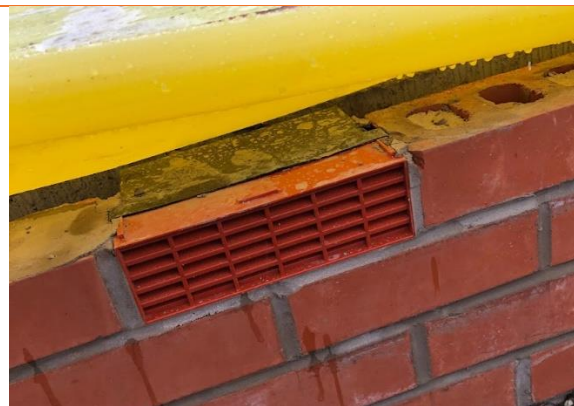
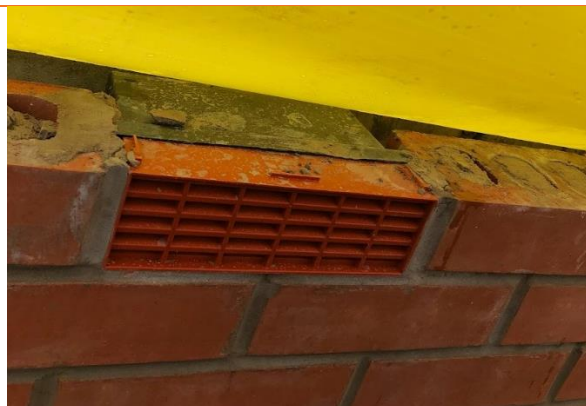
**Verification of Ventilation-Good Condition**
