**GAS MEMBRANE VALIDATION**

| <b>Site Name: Belle Vue Stadium</b> | <b>Project Number: 12-123</b> |
| <b>Company Name: Countryside</b> | <b>Date: 09-05-2022</b> |

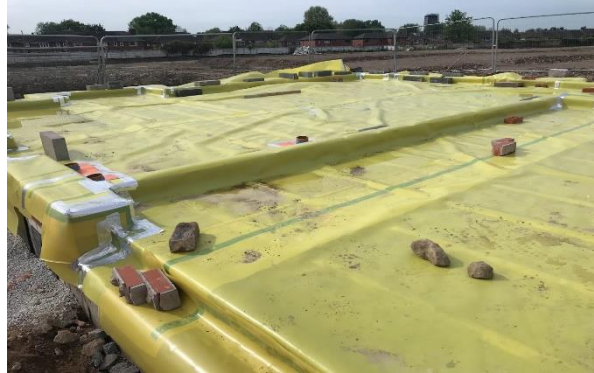
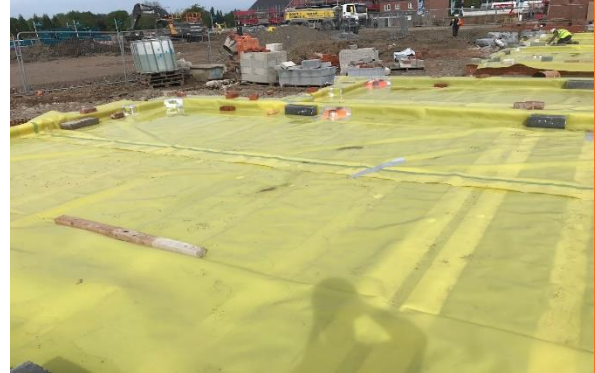
**Plot - 146**

**General Condition of Membrane-Good Condition**

| Slab / membrane condition (is membrane clear of debris or insulation) | Good |

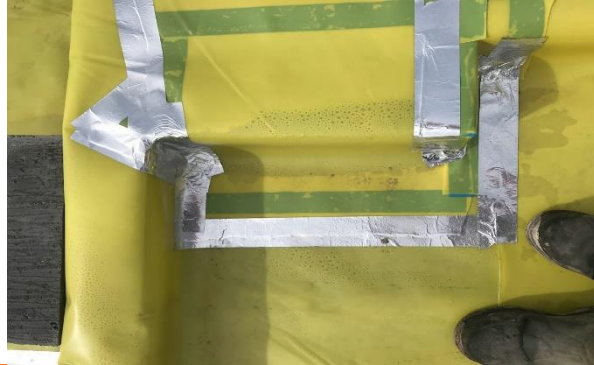
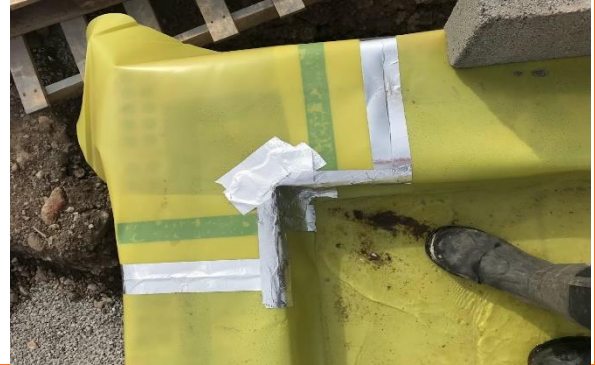
**Verification of Joints and Seals-Overlapped and sealed correctly**

| Membrane joints inspected has Double –sided butyl tape been used? | yes |

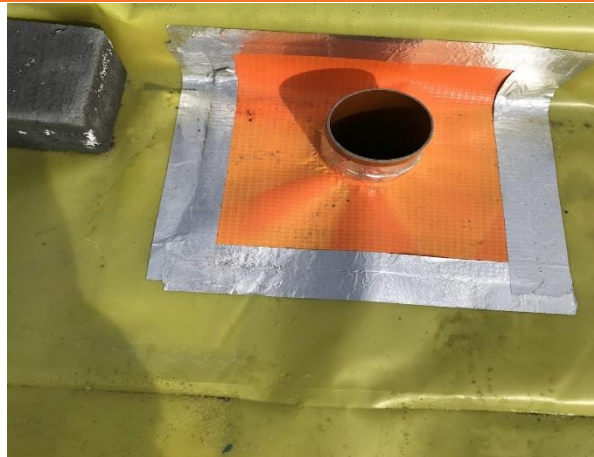
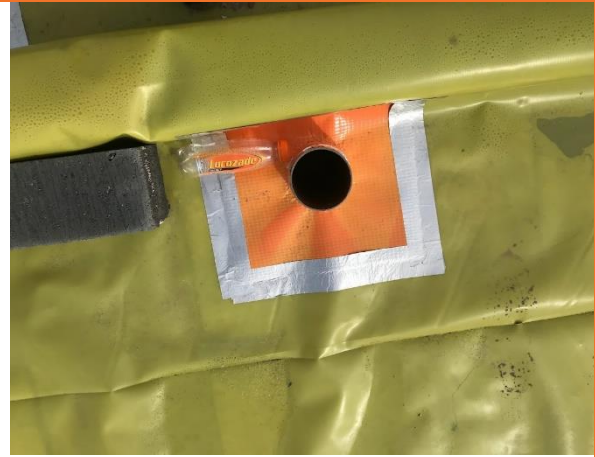
**Verification of Service Penetrations-Good Condition**

| Service entries – Jubilee clips, Top hats installed correctly | yes |

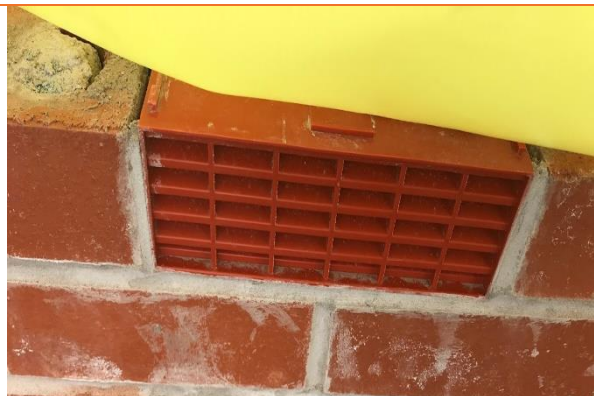
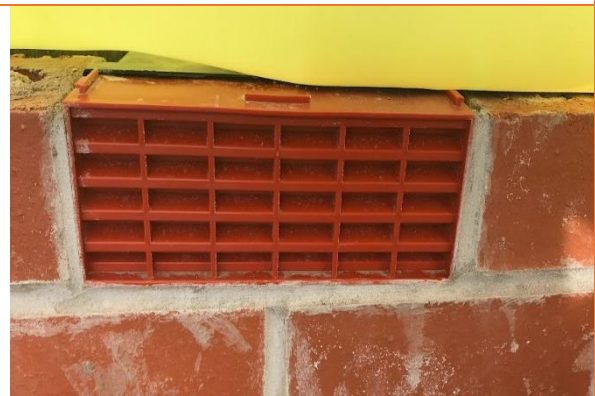
**Verification of Ventilation-Good Condition**

| External Wall Air bricks Present? | yes |

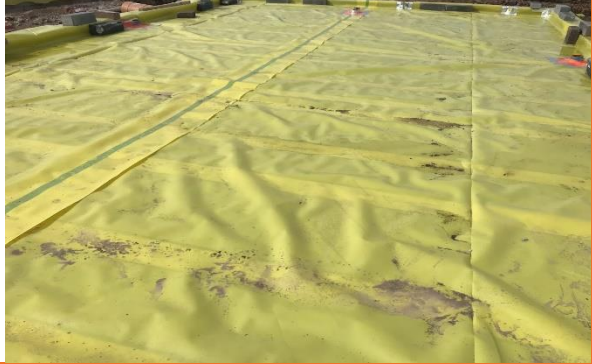
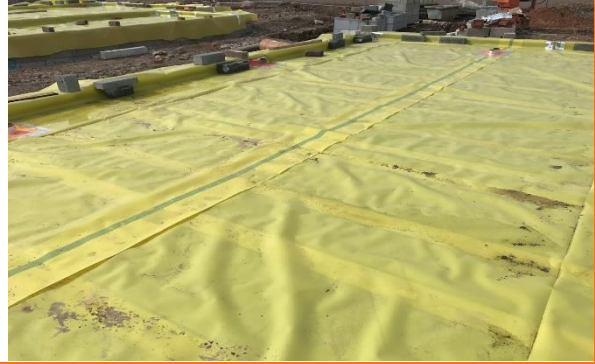
**Plot - 147**

**General Condition of Membrane-Good Condition**

| Notes/recommendations | Comments |
|---|---|
| Slab / membrane condition (is membrane clear of debris or insulation) | Good |

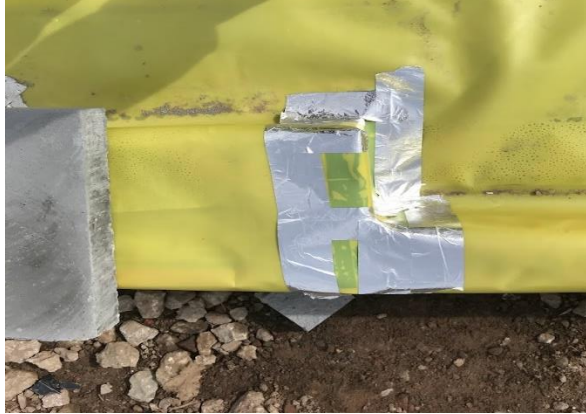
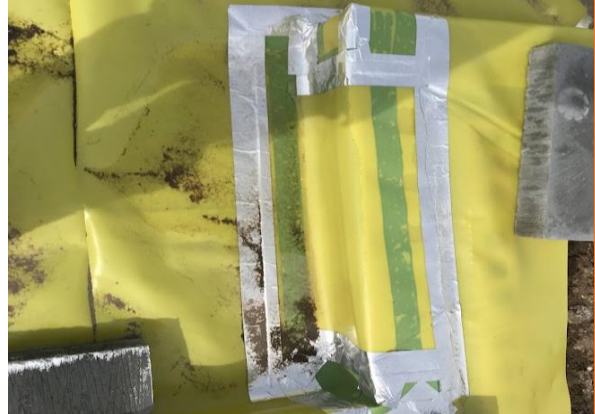
**Verification of Joints and Seals-Overlapped and sealed correctly**

| Notes/recommendations | Comments |
|---|---|
| Membrane joints inspected has Double –sided butyl tape been used? | yes |

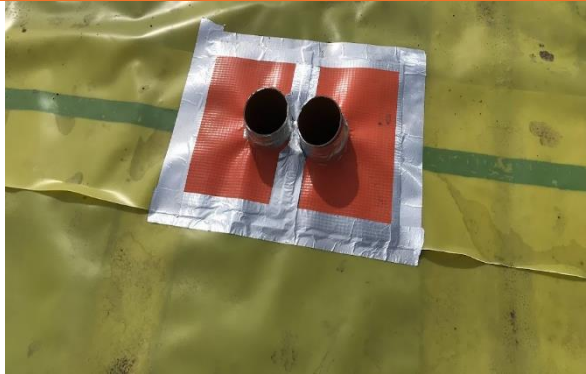
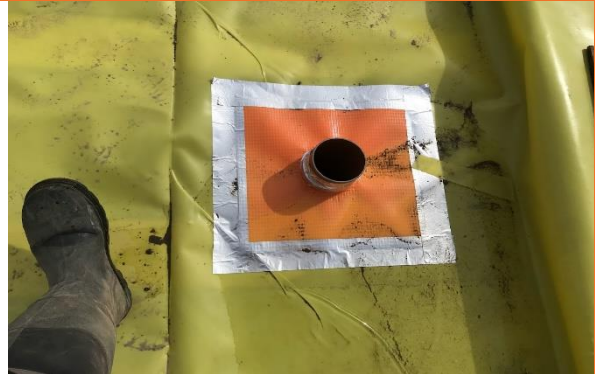
**Verification of Service Penetrations-Good Condition**

| Notes/recommendations | Comments |
|---|---|
| Service entries – Jubilee clips, Top hats installed correctly | yes |

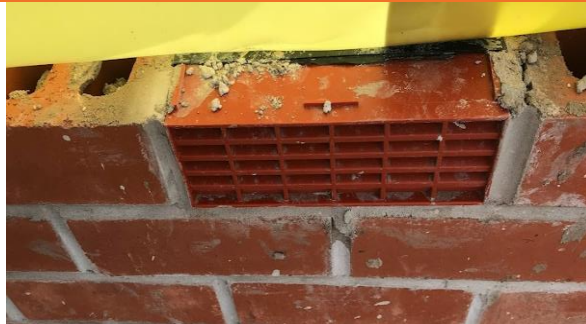
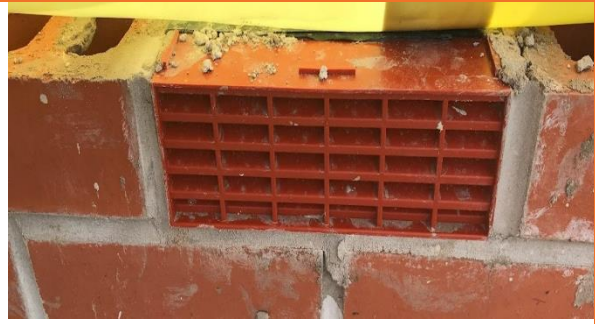
**Verification of Ventilation-Good Condition**

| Notes/recommendations | Comments |
|---|---|
| External Wall Air bricks Present? | yes |

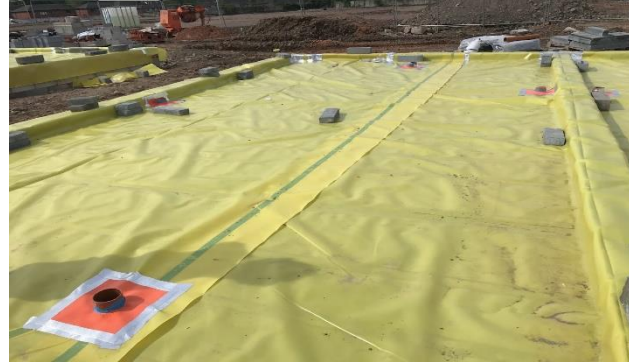
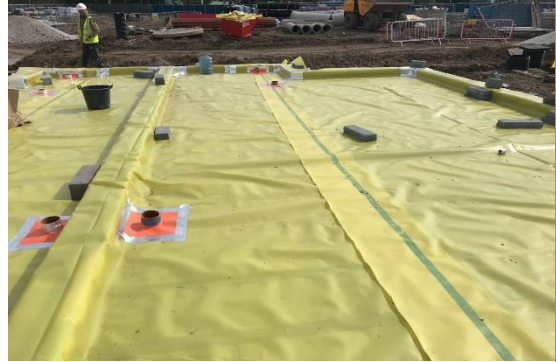
**Plot - 148**

**General Condition of Membrane-Good Condition**

| Notes/recommendations | Comments |
|---|---|
| Slab / membrane condition (is membrane clear of debris or insulation) | Good |

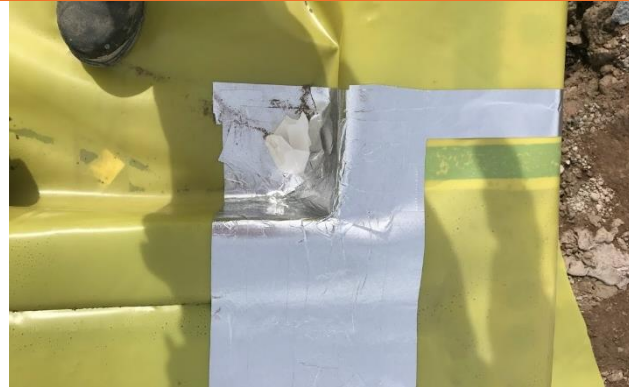
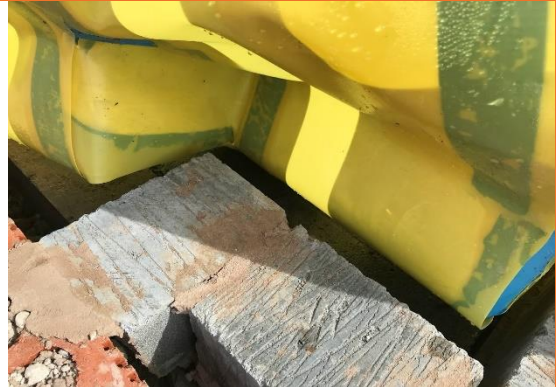
**Verification of Joints and Seals-Overlapped and sealed correctly**

| Notes/recommendations | Comments |
|---|---|
| Membrane joints inspected has Double –sided butyl tape been used? | yes |

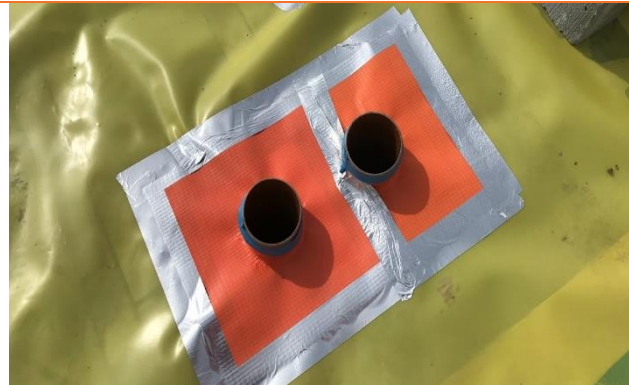
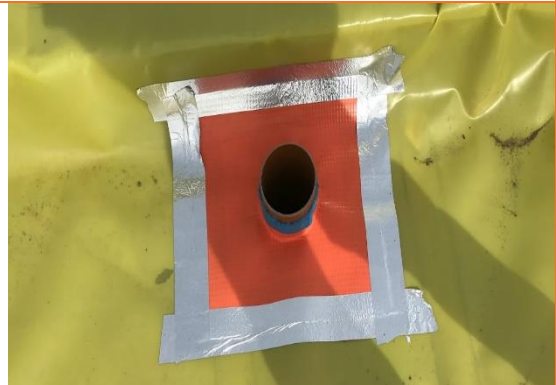
**Verification of Service Penetrations-Good Condition**

| Notes/recommendations | Comments |
|---|---|
| Service entries – Jubilee clips, Top hats installed correctly | yes |

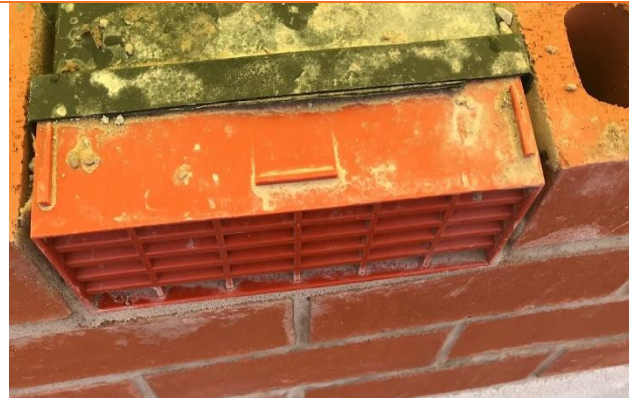
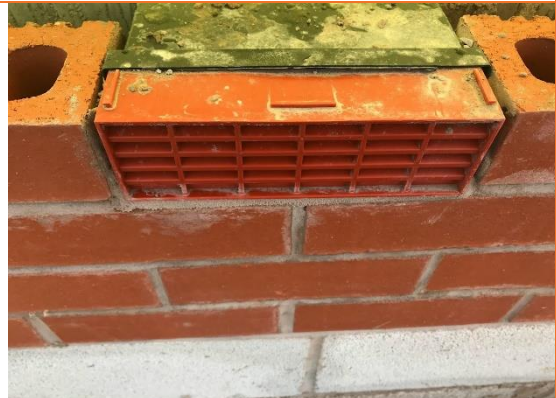
**Verification of Ventilation-Good Condition**

| Notes/recommendations | Comments |
|---|---|
| External Wall Air bricks Present? | yes |

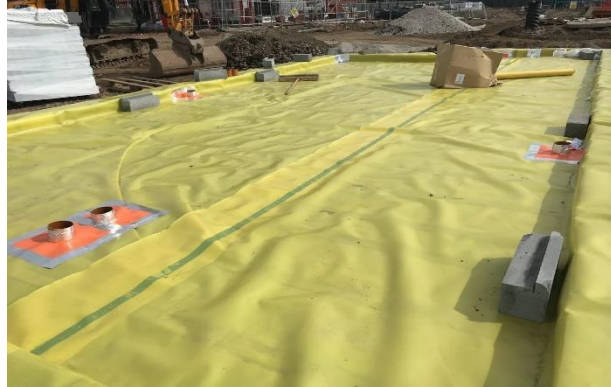
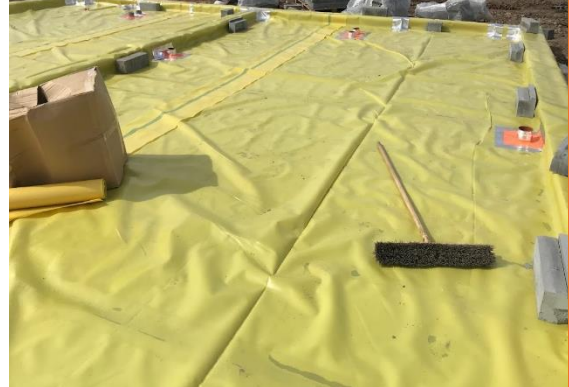
**Plot - 149**

**General Condition of Membrane-Good Condition**

| Notes/recommendations | Comments |
|---|---|
| Slab / membrane condition (is membrane clear of debris or insulation) | Good |

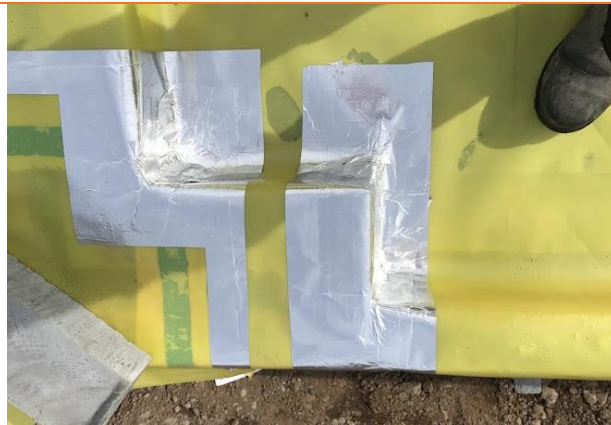
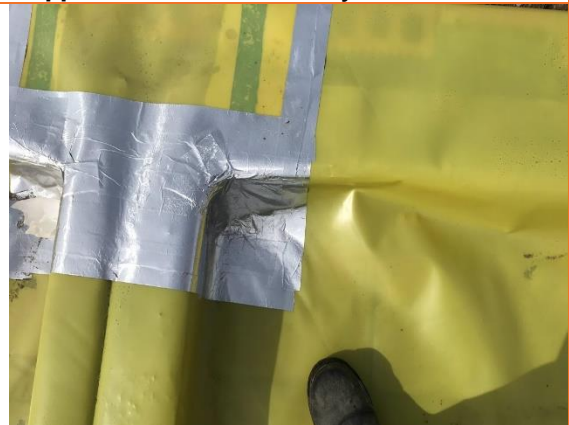
**Verification of Joints and Seals-Overlapped and sealed correctly**

| Notes/recommendations | Comments |
|---|---|
| Membrane joints inspected has Double -sided butyl tape been used? | yes |

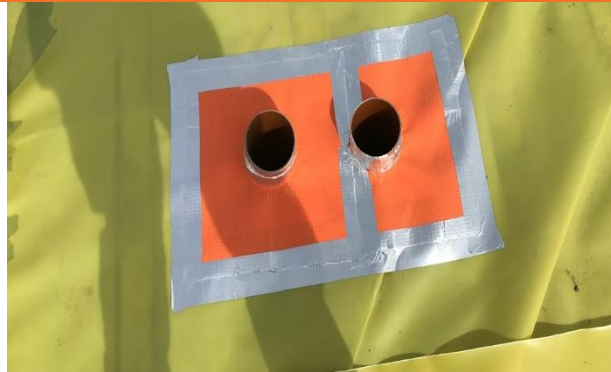
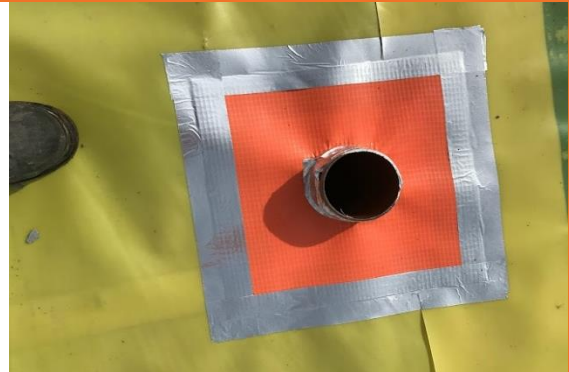
**Verification of Service Penetrations-Good Condition**

| Notes/recommendations | Comments |
|---|---|
| Service entries - Jubilee clips, Top hats installed correctly | yes |

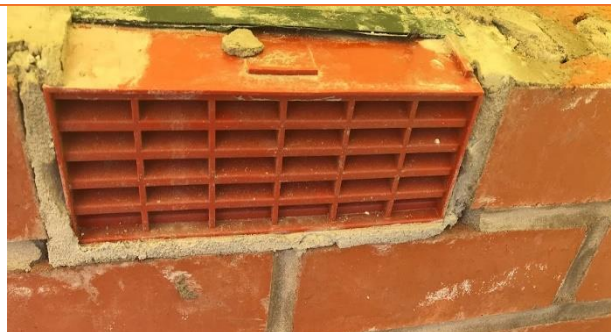
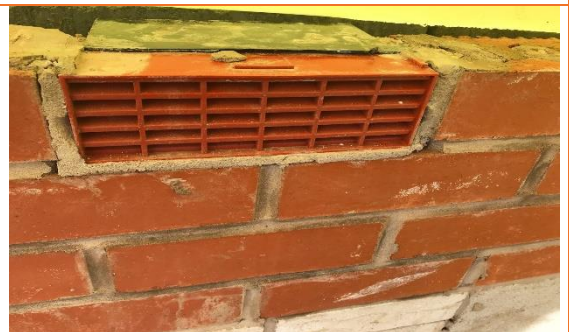
**Verification of Ventilation-Good Condition**

| Notes/recommendations | Comments |
|---|---|
| External Wall Air bricks Present? | yes |
