**LAYER SURVEYS LTD**

Job Number  
**LS6501**

Manchester Business Park,  
Aviator Way,  
Manchester,  
M22 5TG

Purpose of Survey:

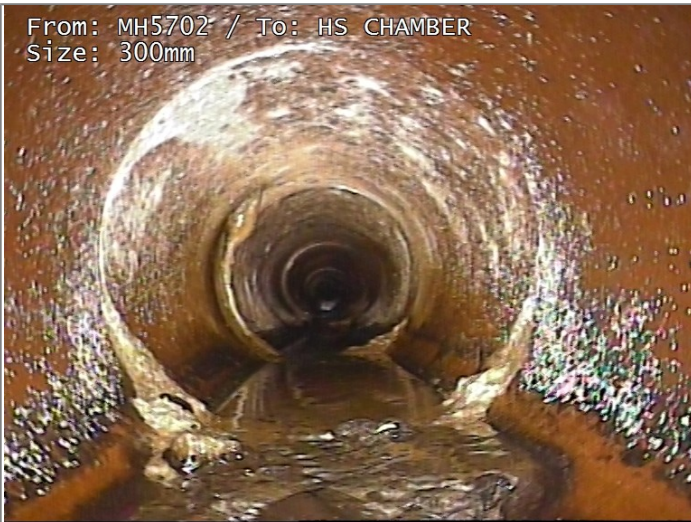
| Start Node Ref:MH5702 I/L : metres | | | | | Photo | Type/Grade |
|---|---|---|---|--|---|---|
| | 1.49 | DEC | Settled deposits hard or compacted 10% cross-sectional area loss | | | 14284983 Service / 3 |

Settled deposits hard or compacted 10% cross-sectional area loss

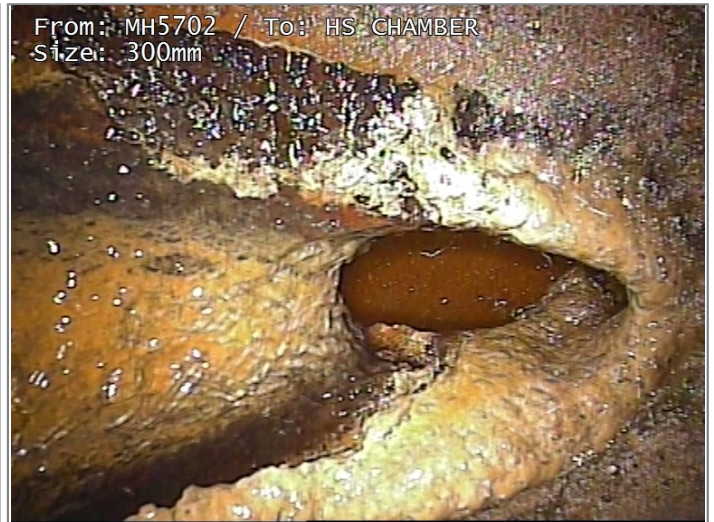
Junction at 11 o'clock, diameter 100mm - Remark: ENCRUSTATION AROUND JUNCTION

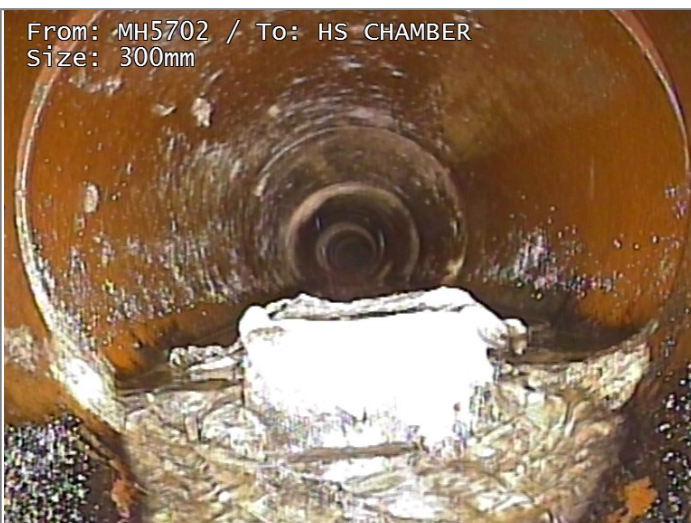
| Start Node Ref:MH5702 I/L : metres | | | | | Photo | Type/Grade |
|---|---|---|---|--|---|---|
| | 6.36 | DEC | Settled deposits hard or compacted 30% cross-sectional area loss | | | 14284986 Service / 4 |

Settled deposits hard or compacted 30% cross-sectional area loss

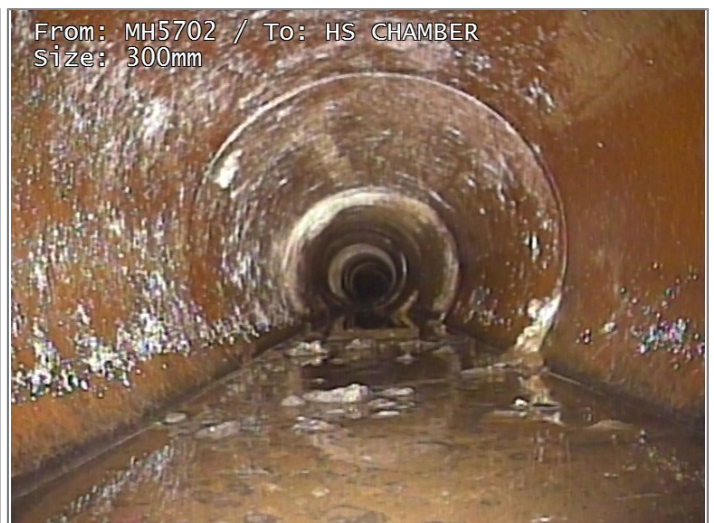
| Start Node Ref:MH5702 I/L : metres | | | | | Photo | Type/Grade |
|---|---|---|---|--|---|---|
| | 6.66 | SA | Survey abandoned - Remark: UNABLE TO PASS DEBRIS CLEANSE REQUIRED | | | 14284988 Comment / 0 |

Survey abandoned - Remark: UNABLE TO PASS DEBRIS CLEANSE REQUIRED

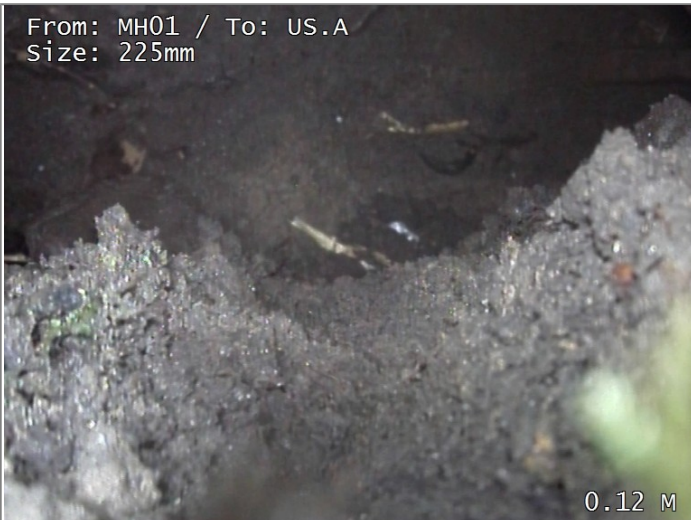
| Position | Code | Description | Photo | Type/Grade |
|---|---|---|---|---|
| 0.12 | DES | Settled deposits fine 70% cross-sectional area loss | 14286797 | Service / 4 |

Settled deposits fine 70% cross-sectional area loss

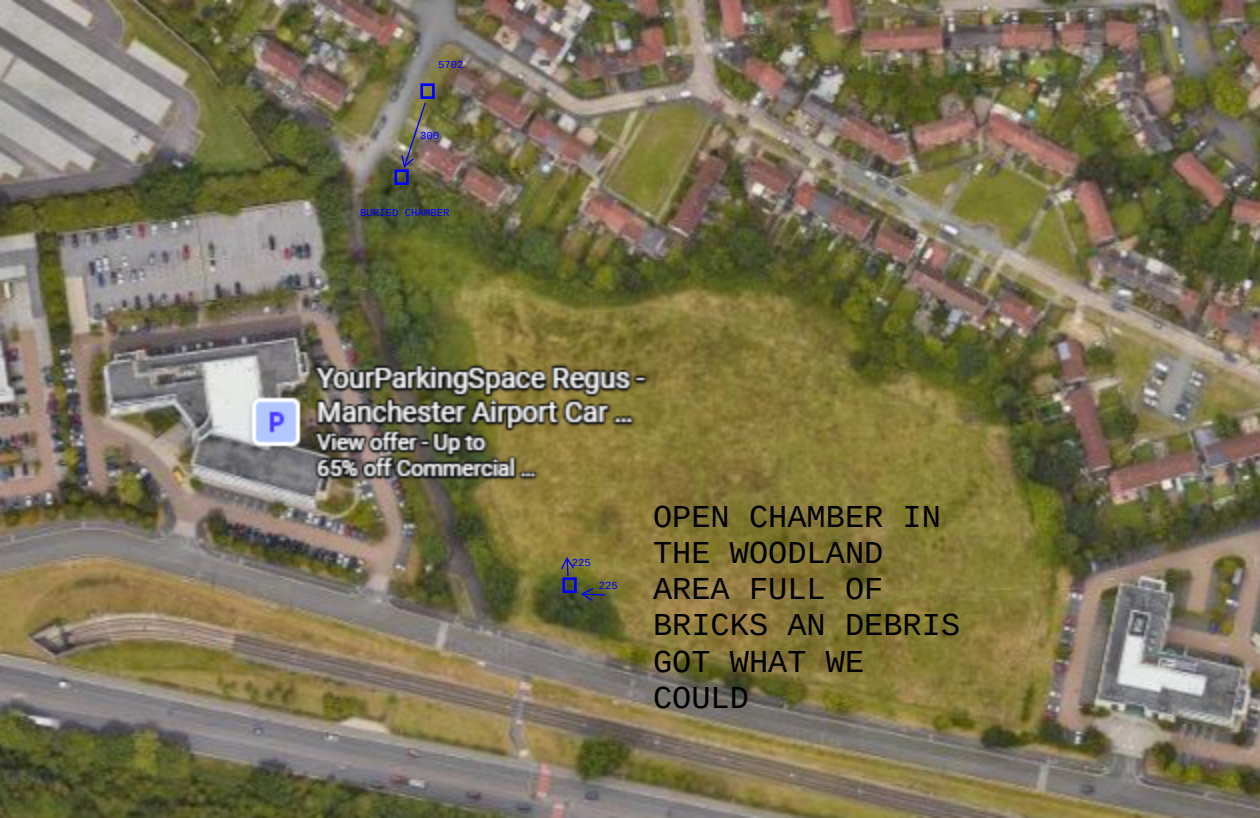
WOODLAND CHAMBER

OPEN CHAMBER IN  
THE WOODLAND  
AREA FULL OF  
BRICKS AND DEBRIS  
GOT WHAT WE  
COULD

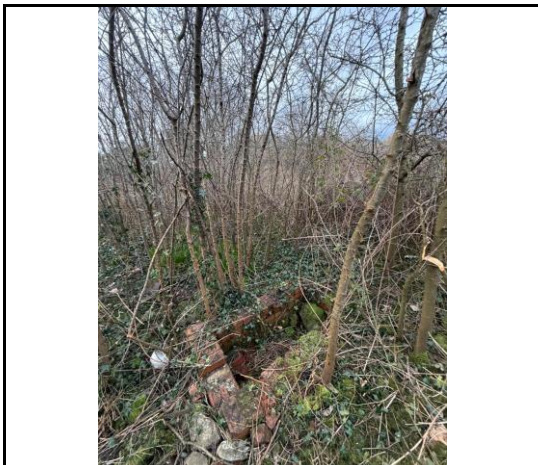
## LOCATION PHOTO

| | Cover | Shaft | Irons / Ladders | Chamber | Benching | Channel |
|---|---|---|---|---|---|---|
| Urgent attention | <input type="checkbox"/> | <input type="checkbox"/> | <input type="checkbox"/> | <input checked="" type="checkbox"/> | <input type="checkbox"/> | <input type="checkbox"/> |
