# KEYSTONE

## BUILDING SURVEY

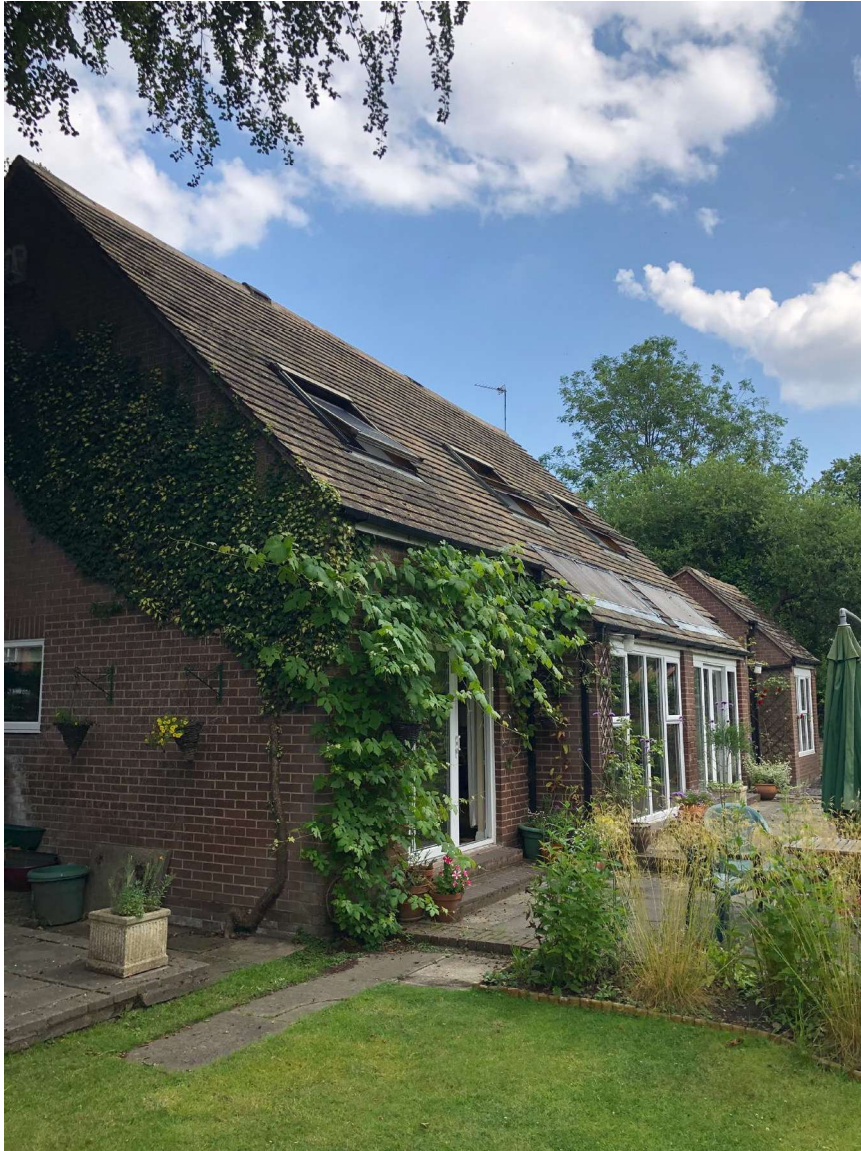
### Photo 1

The roof edge is in **ageing** condition with evidence of isolated deterioration. You should instruct a suitably competent roofing contractor to repair it with an appropriately specified material soon.

Extensive **vegetation** growth is noted to the **front and right-hand wall**. This can create a route for moisture ingress and vermin to enter the building. If not managed, this can also significantly affect the structural and thermal performance of the wall. It can also exacerbate internal damp and condensation issues. We recommend engaging a suitably competent contractor to carefully remove the vegetation and make good to the affected areas.

Description: Typical view or right/rear [when facing the front door] of property – note ivy growth and deterioration to the roof edge.

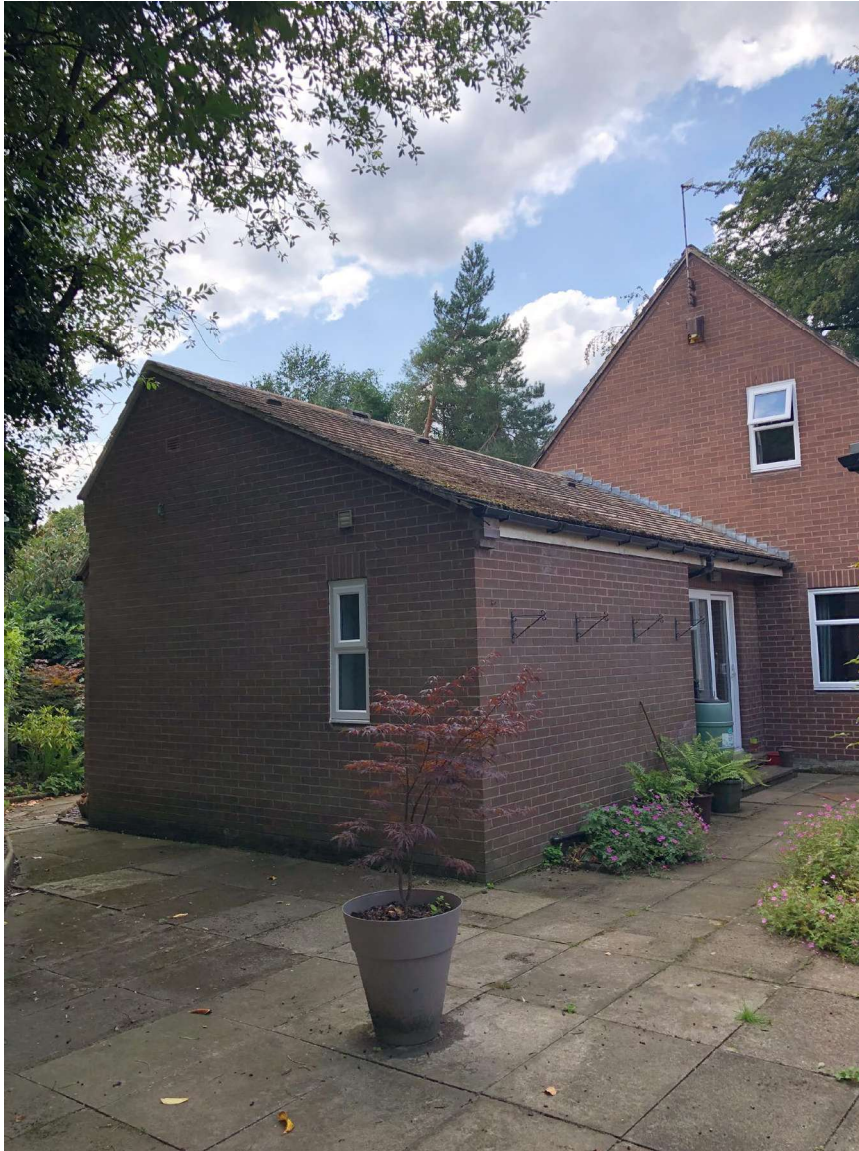
**Photo 2**

**Extensive moss**/lichen is on to the roof surfaces; it tends to retain moisture, which can cause damage to roof coverings over a period. It can also attract vermin such as birds which can exacerbate the deterioration of the building fabric and pose a health and safety risk. This should be cleaned now.

Description: Typical front left-hand view of the property [when facing front door.]  
– note lateral extension added around 1993 – extensive moss to roof covering.

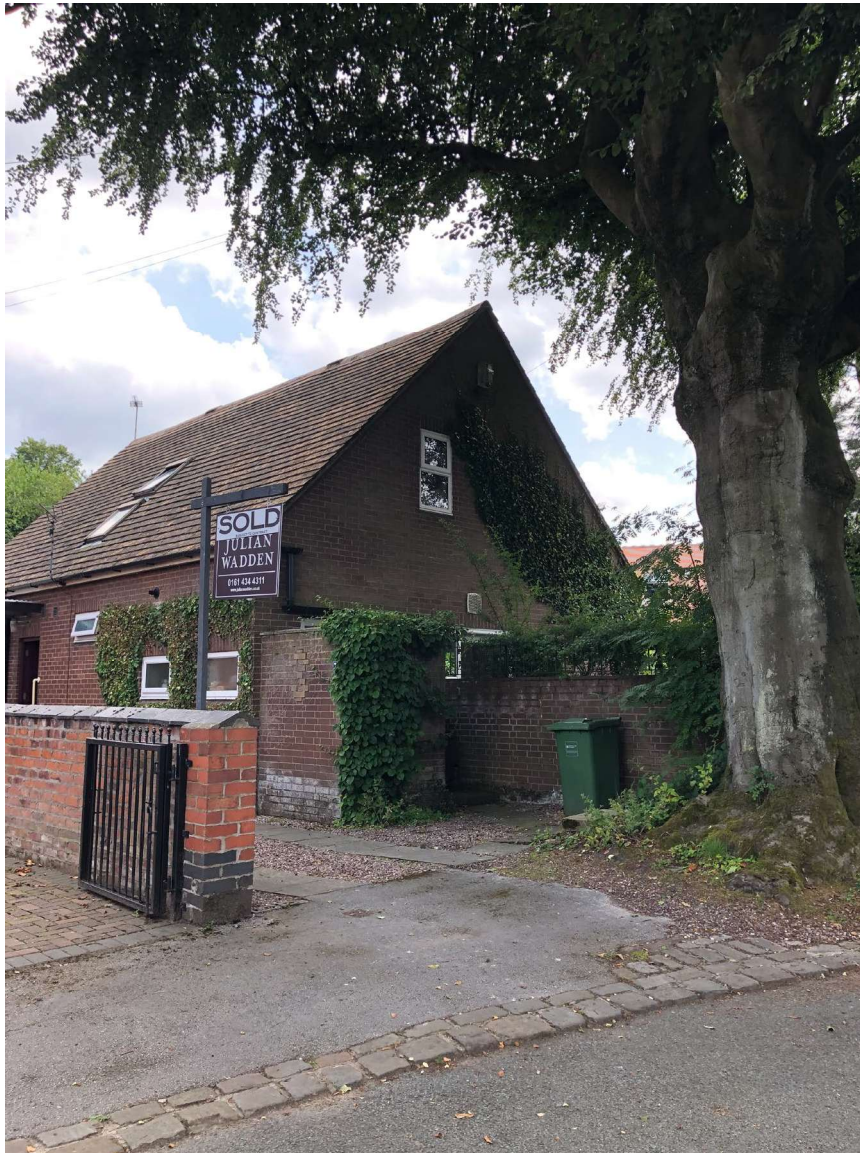
**Photo 3**

The **tree** located to the **7m** is within influencing distance of the property. It is of the Beech species and the vendor advised that it is protected under the **Tree Preservation Order** and regularly maintained. Whilst there is always a risk of damage to the foundations, this is significantly reduced provided that the tree is regularly pruned and maintained. Provided, it is continually maintained it is unlikely to affect the property.

Description: Typical front right-hand view – Note protected Beech tree approx. 7m distance from property and drive way entrance.

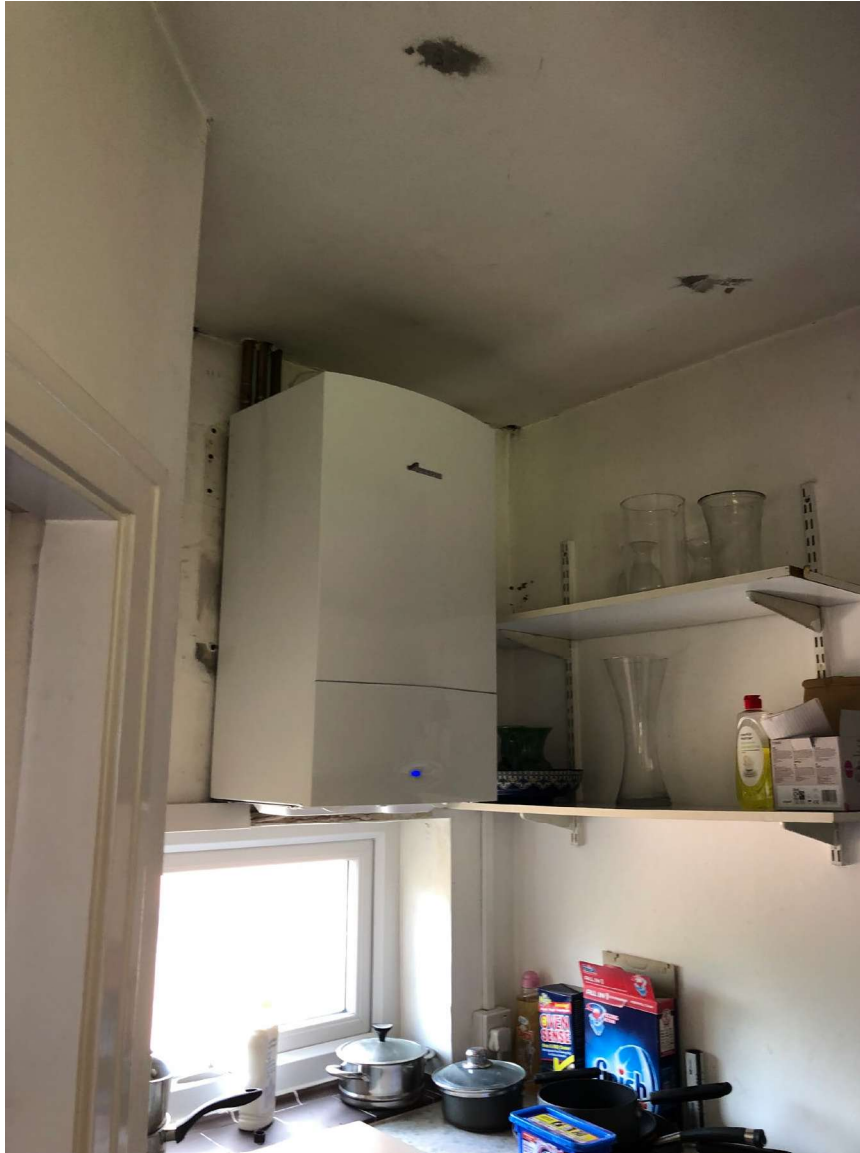
**Photo 4**

Description: Newly installed gas combination boiler to original building.

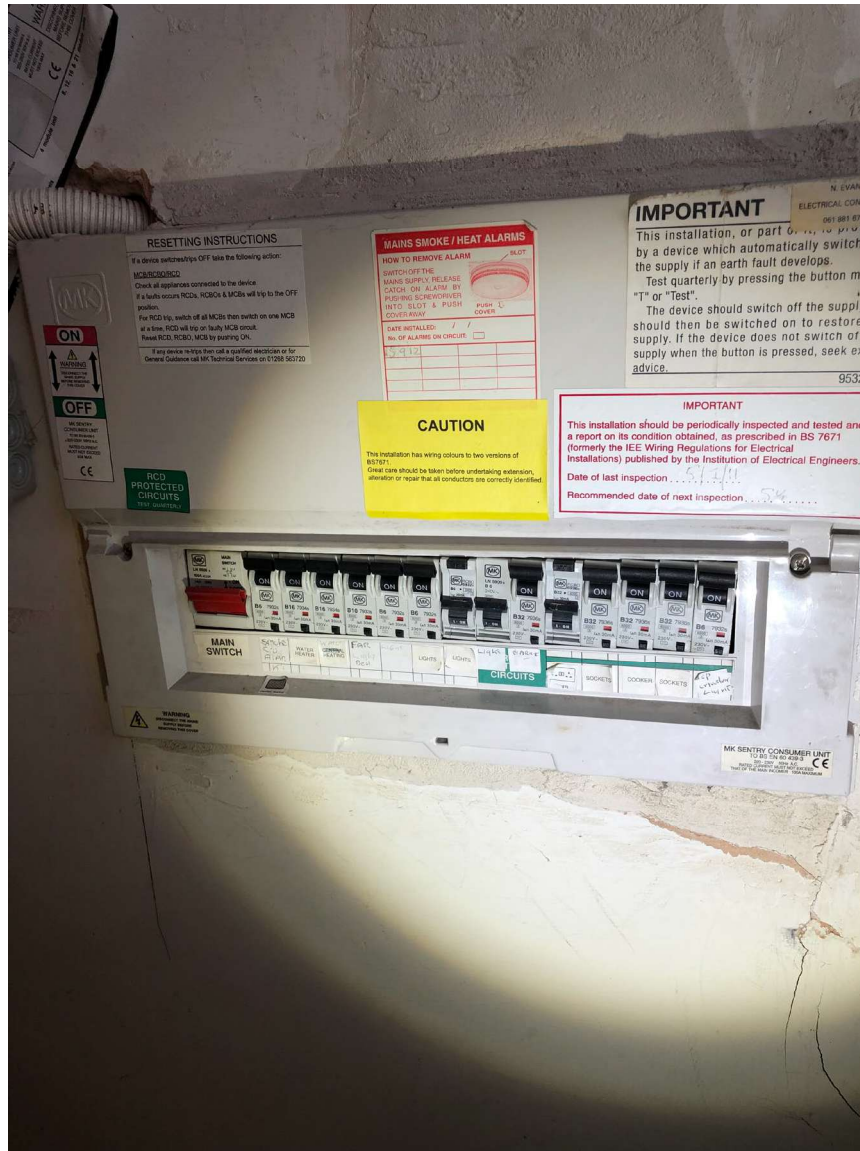
## Photo 5

Description: Electrical distribution board.

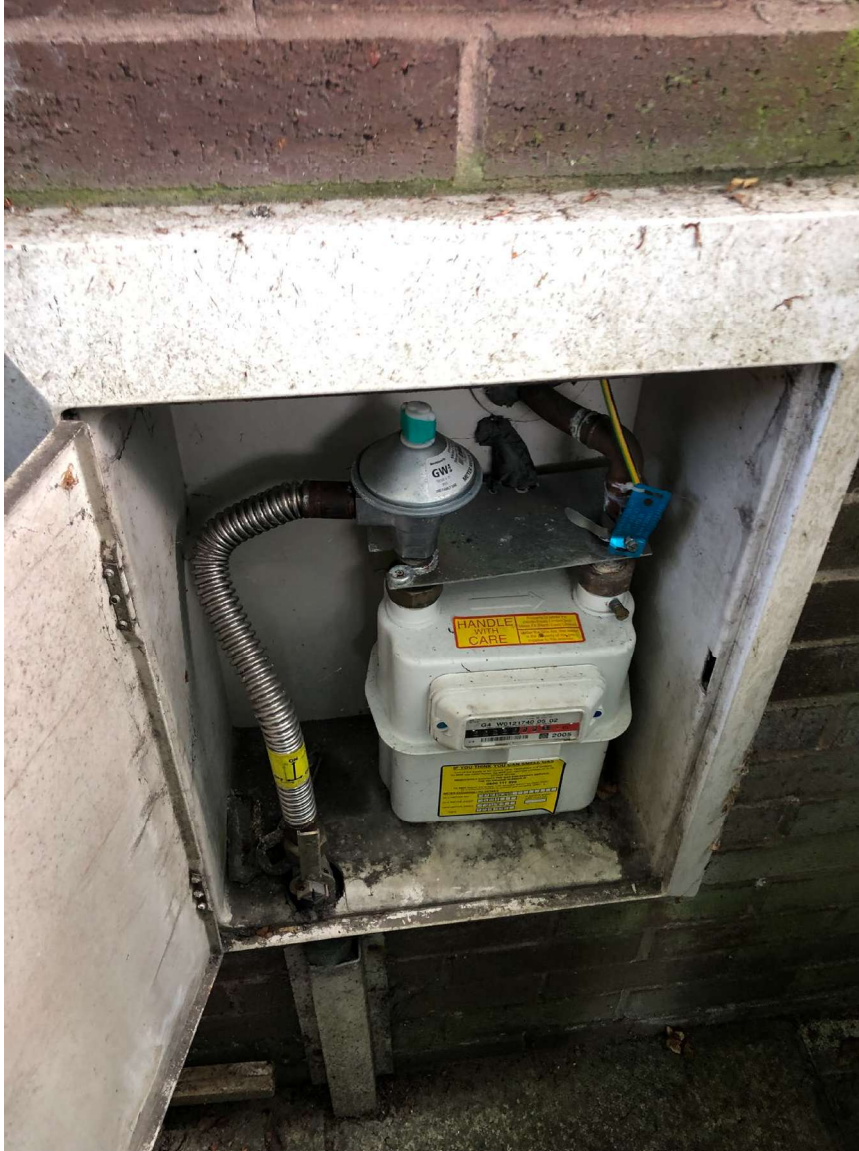
**Photo 6**

Description: External gas meter.

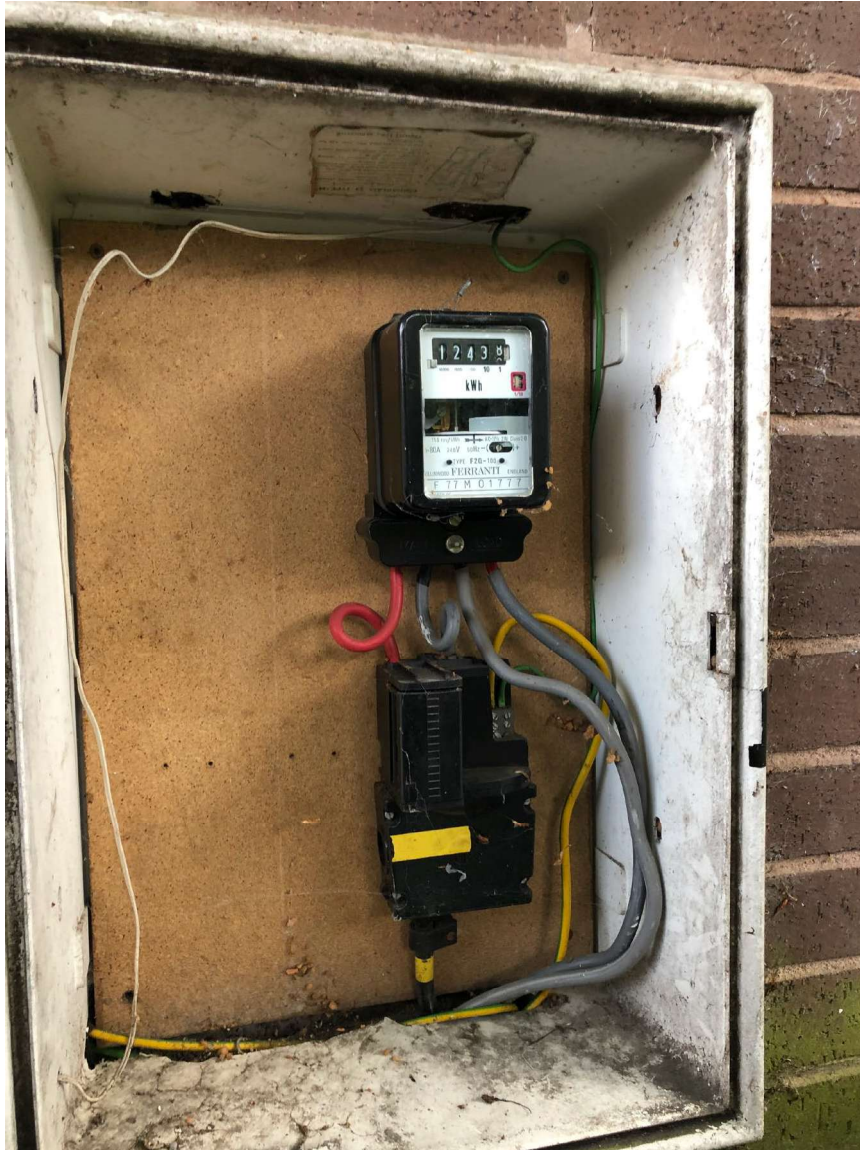
**Photo 7**

Description: External electrical meter.

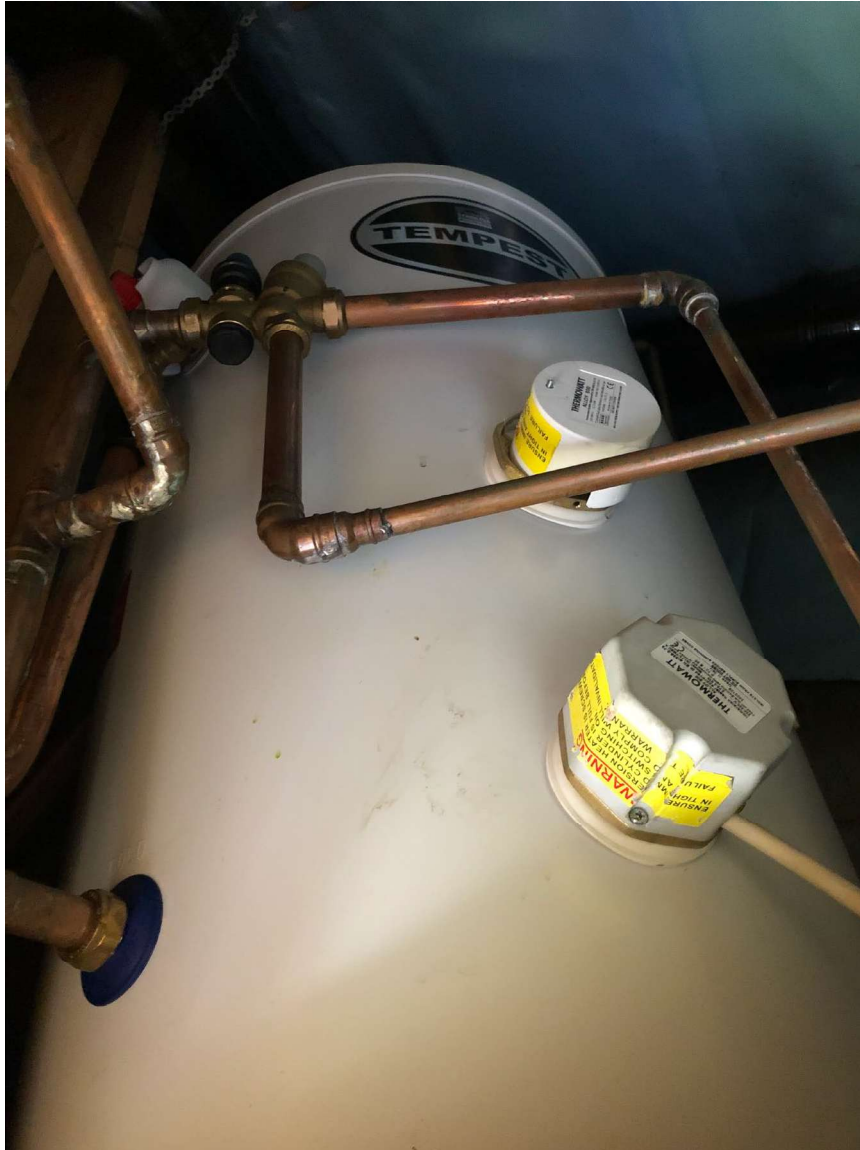
**Photo 8**

Description: Hot water immersion heater feeding lateral extension.

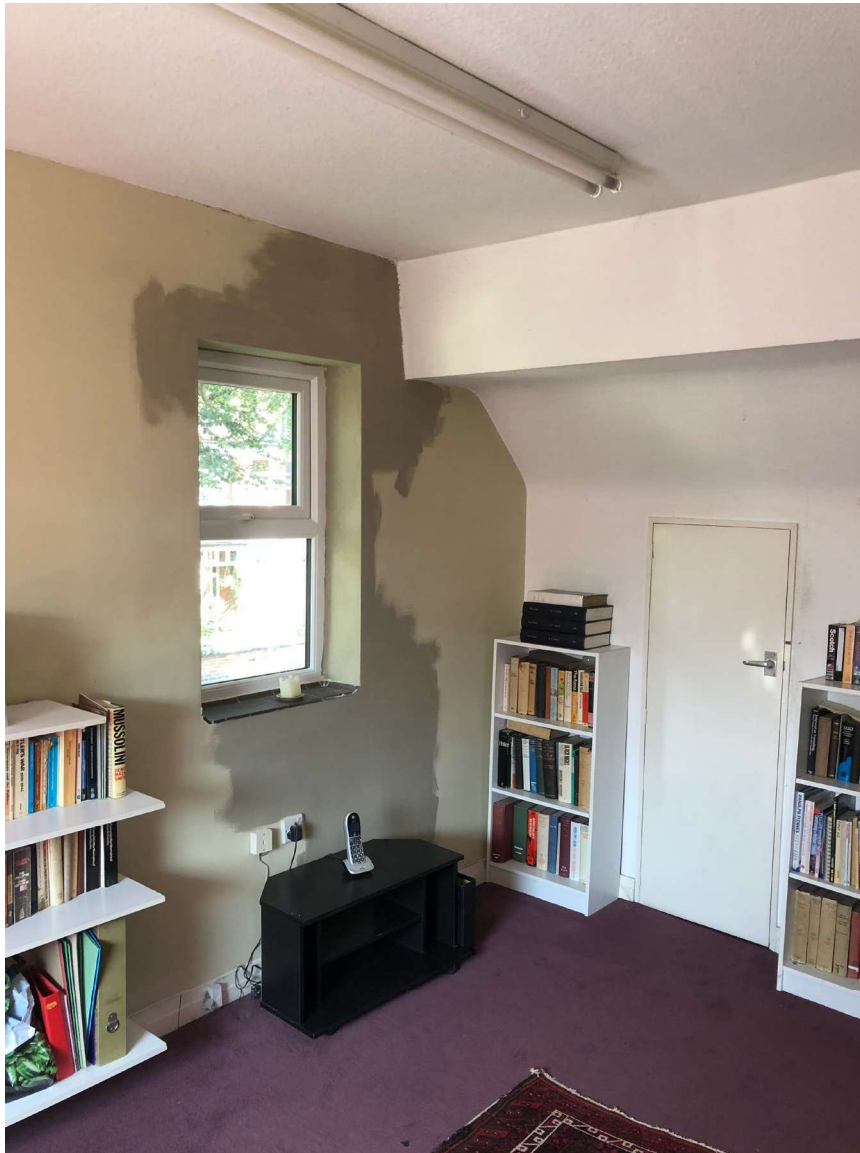
**Photo 10**

**Some movement** was noted to the right-hand wall, which has been recently plastered. Since the plastering, there are small hair line cracks which have formed around the window opening. In the absence of long-term monitoring, the movement appears to be minor in nature and due to the expected movement, you see of timber roof structure above. You should therefore follow the advice provided in section F1.

Description: Historic repair to righting hand wall – establish if deterioration of roof structure is attributed to movement.

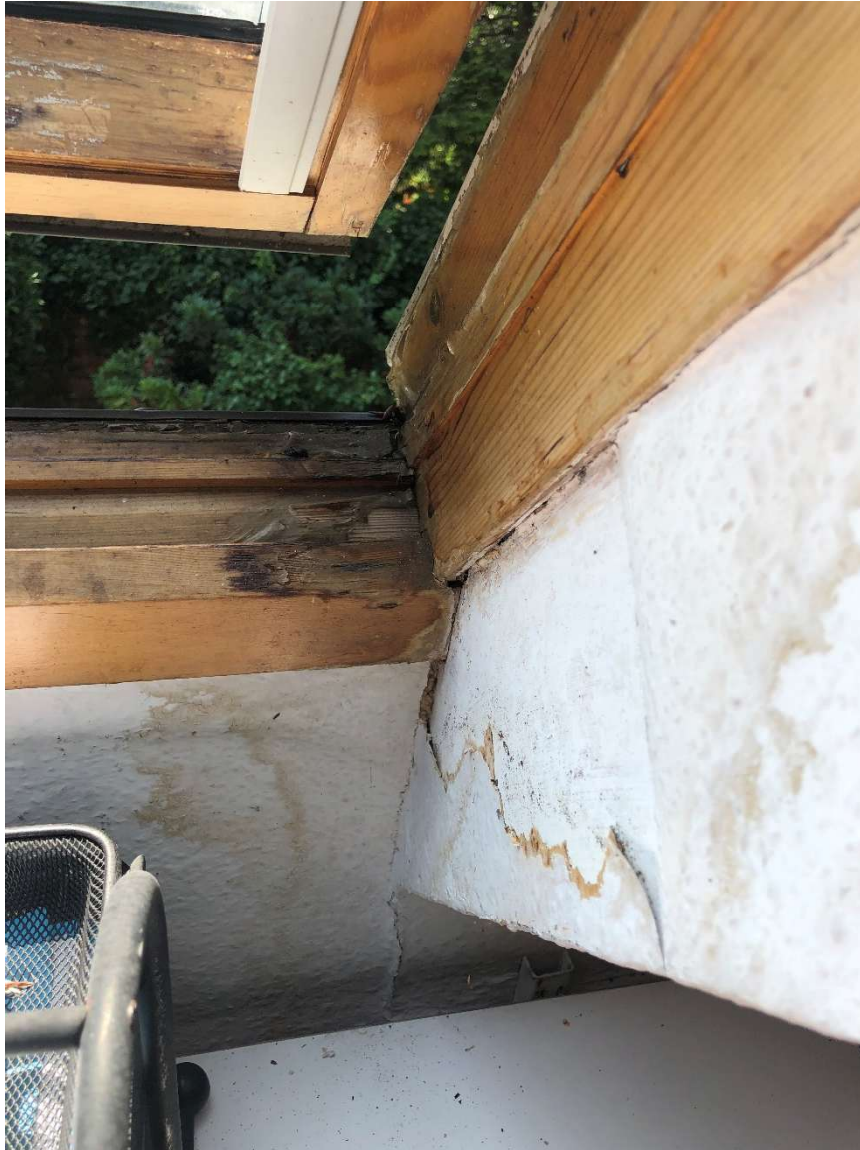
**Photo 11**

Description: Historic damp stains around window, may come during wet weather.

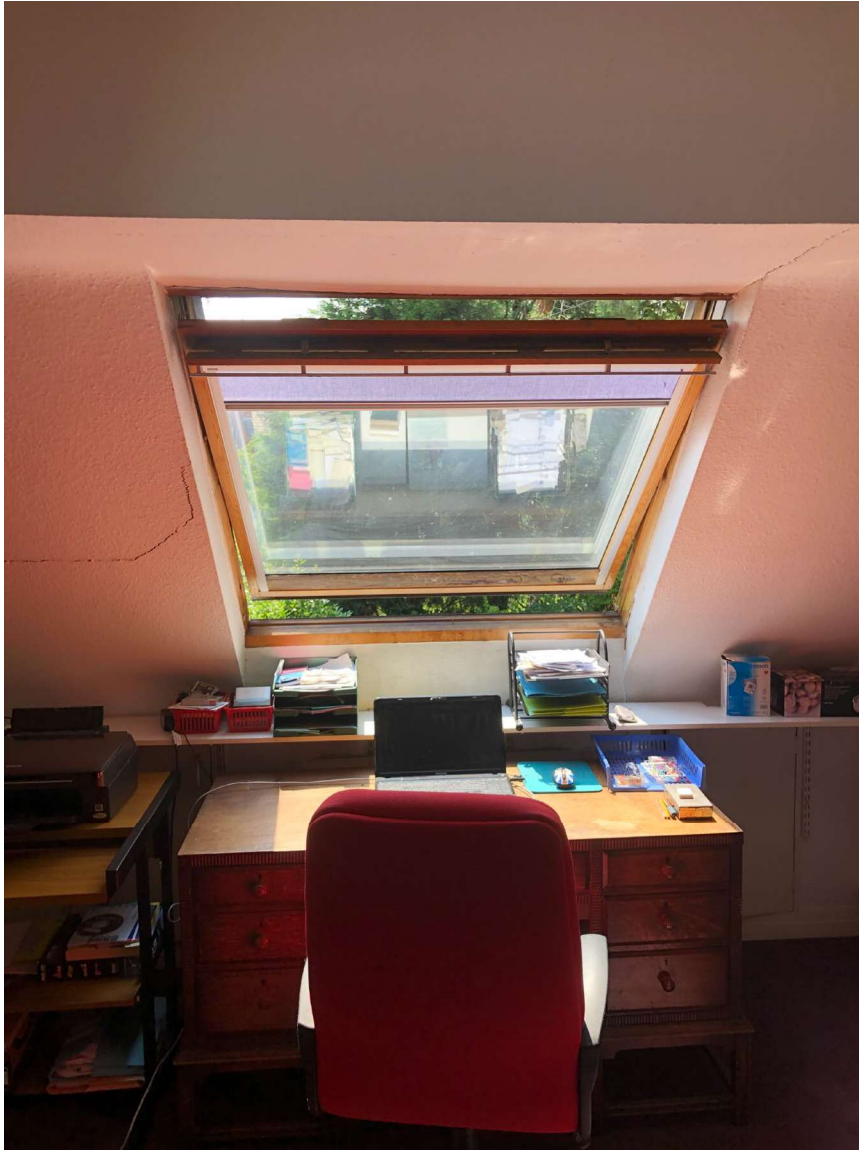
**Photo 12**

Whilst some movement has been noted around the roof lights, these are considered minor, long standing and not significant. You should allow for redecoration soon.

Historic stains around the right-hand roof light indicates a previous leak around the roof lights. Whilst functional, their age suggest that you should expect to replace the roof lights to the first-floor bedrooms soon.

Description: Movement around Velux window. Considered non structural.

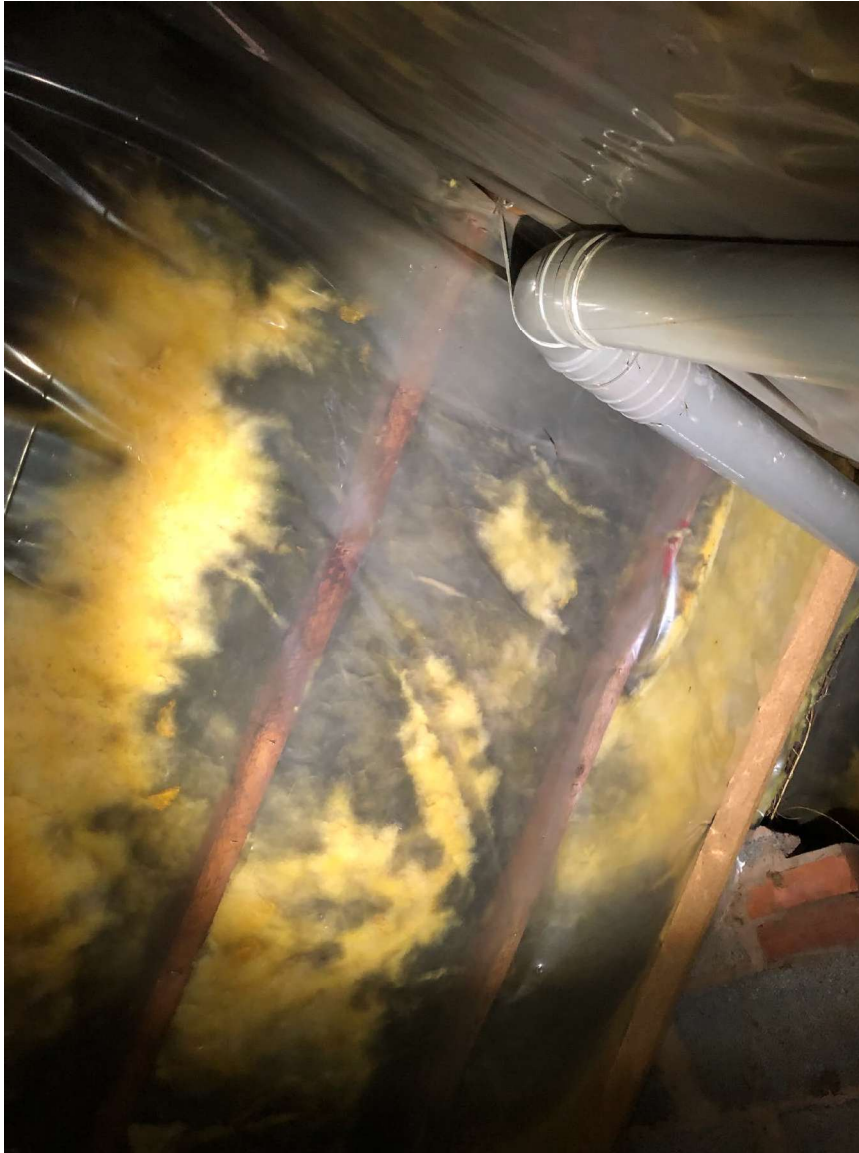
**Photo 13**

There is **poor** ventilation to the roof space and a suitable means of ventilation should be provided now. Extensive condensation and therefore risk of rot and infestation is noted to some parts of the roof structure. The extent must therefore be established through further investigation. The costs can be expensive, so should be undertaken before you commit to purchase.

Description: Extensive condensation to roof structure and fibre glass insulation – further investigations.

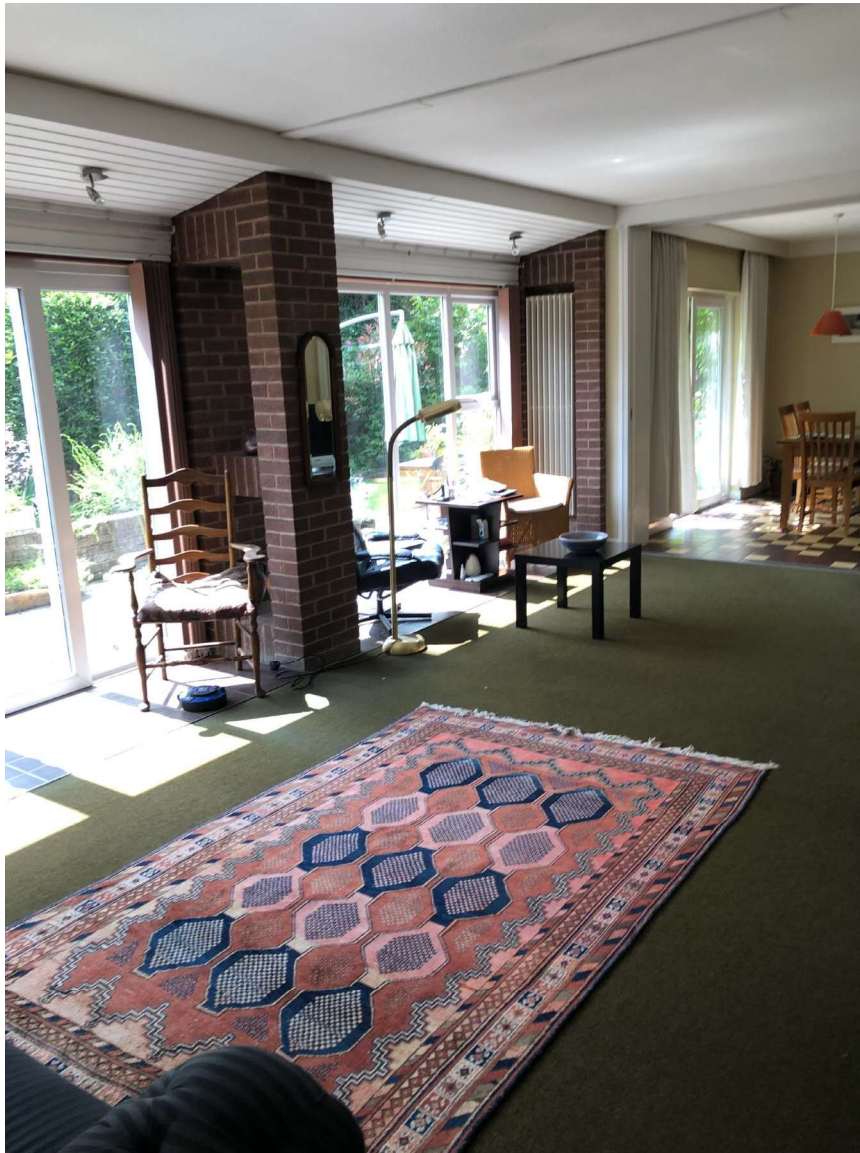
**Photo 14**

Description: Typical view of open living room and replaced upvc windows and doors.

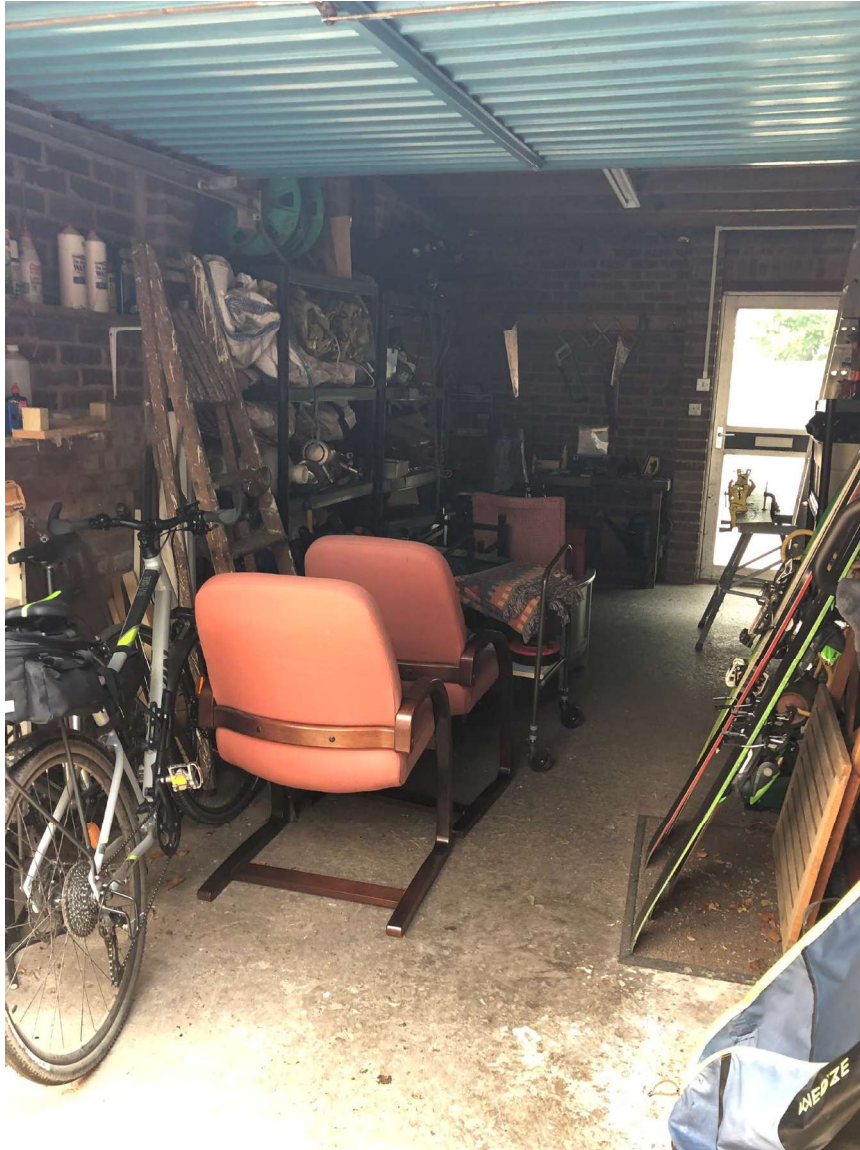
**Photo 15**

Description: Internal view of garage space.
