| <b>Project:</b> | St Anselm Building, Rear Roofs Survey | |
| <b>WML reference number:</b> | 12350-WML-XX-ZZ-RP-S0001 | 7 <sup>th</sup> October 2025 |

| <b>Survey Brief:</b> | Structural survey of visible, accessible rear roof areas following recent timber survey |

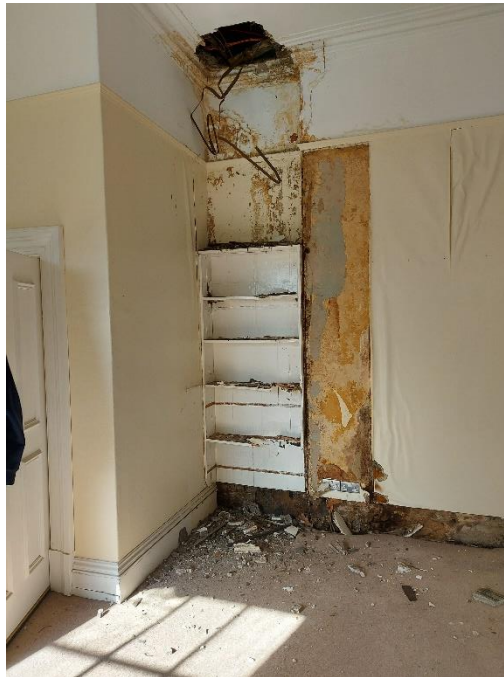
- Photographs 1 – 5 inclusive show the main area of concern. A ceiling joist showed clear signs of rot (Photograph 2) on at least one ceiling joist, close to the supporting wall. Otherwise the main timbers appeared to be intact from our limited point of inspection.

**Photograph 1**  
**Room 1.107 – rafter feet exposed**

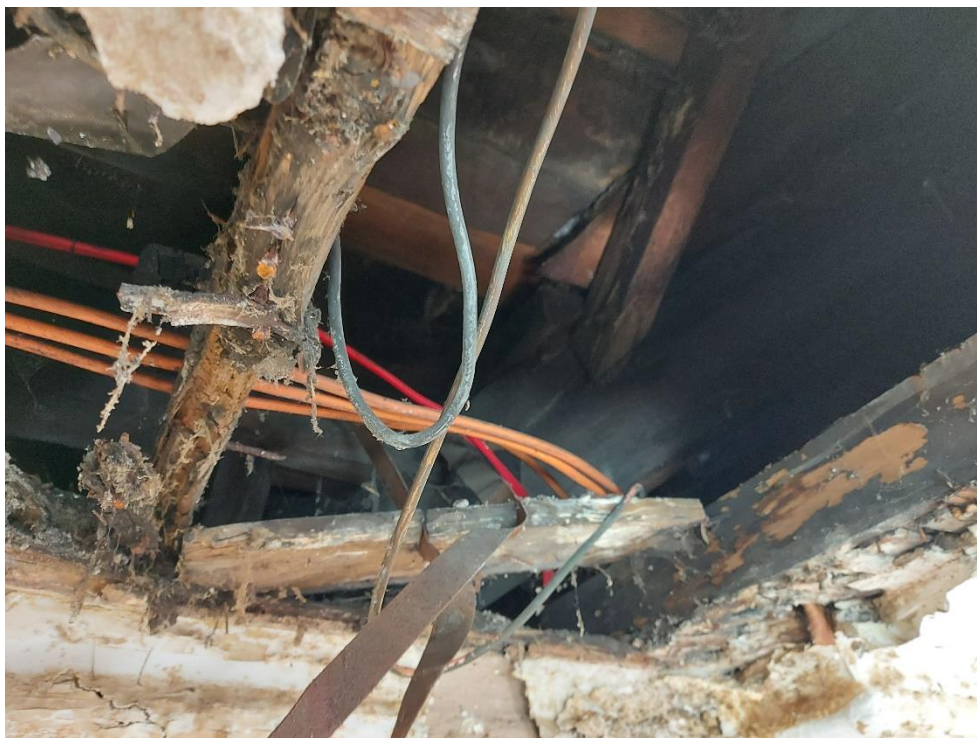
**Photograph 2**  
**Room 1.107 – ceiling joist rotted**

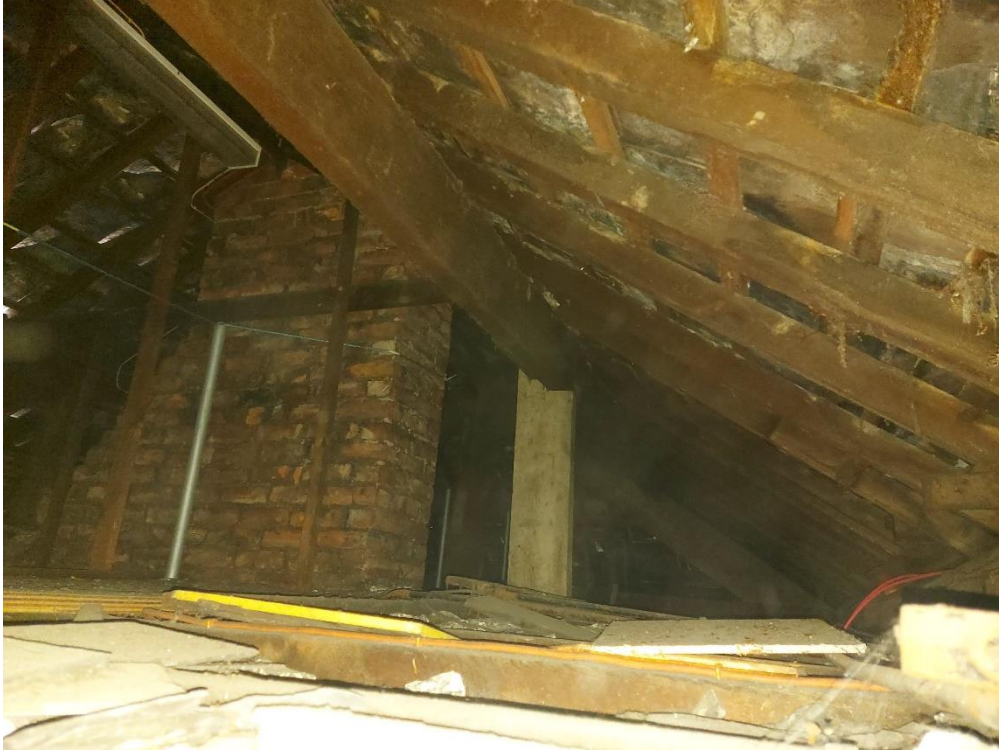
**Photograph 3**  
**Room 1.107 – main roof carcass appears intact**

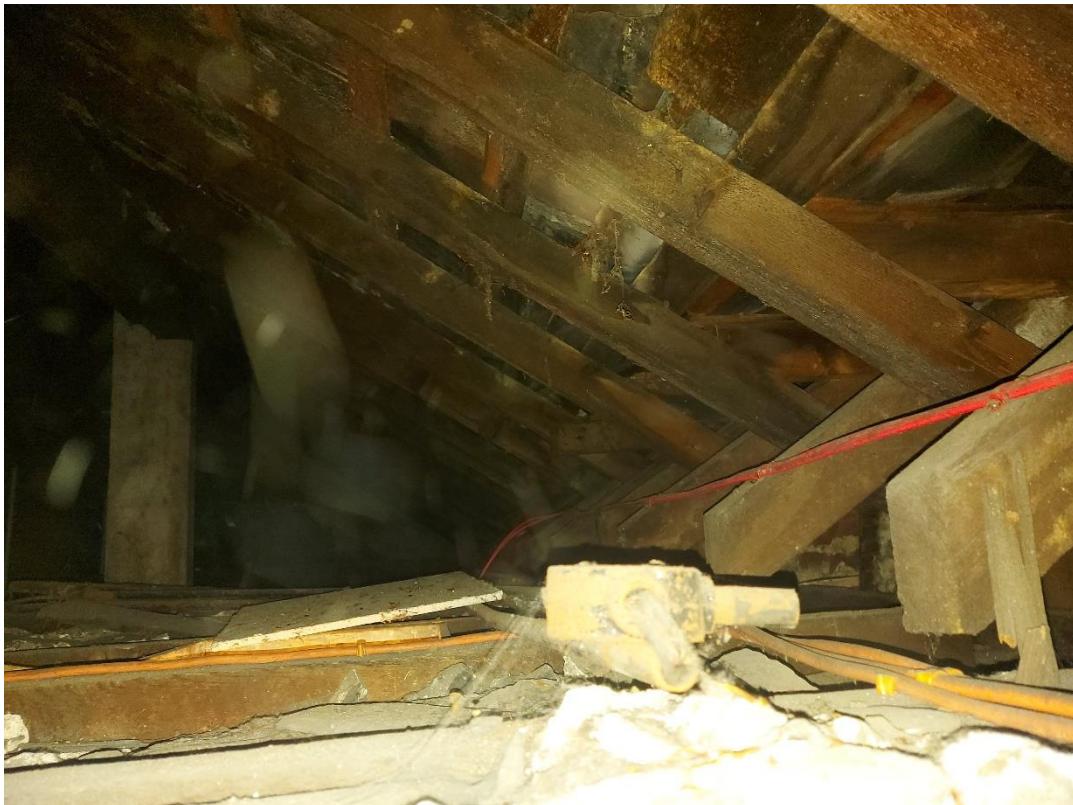
**Photograph 4**  
**Room 1.107 – rafter feet appear intact**

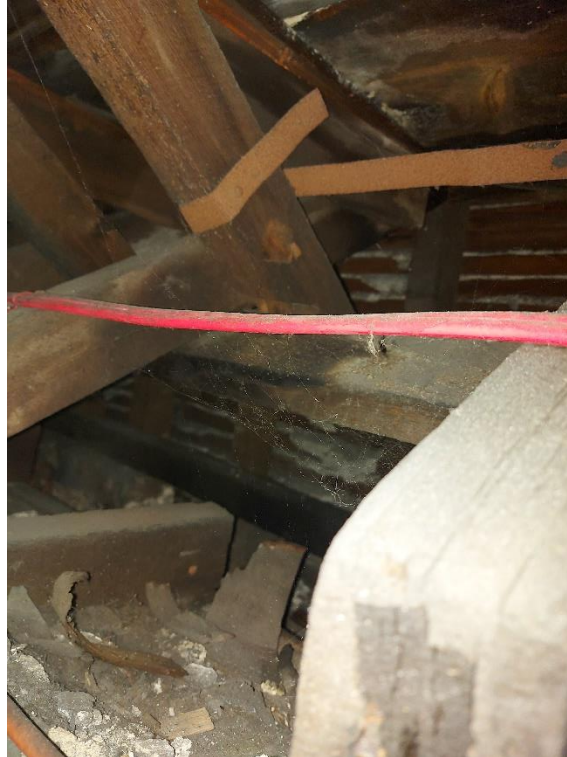
**Photograph 5**  
**Room 1.107 – rafter and hip feet appear intact**

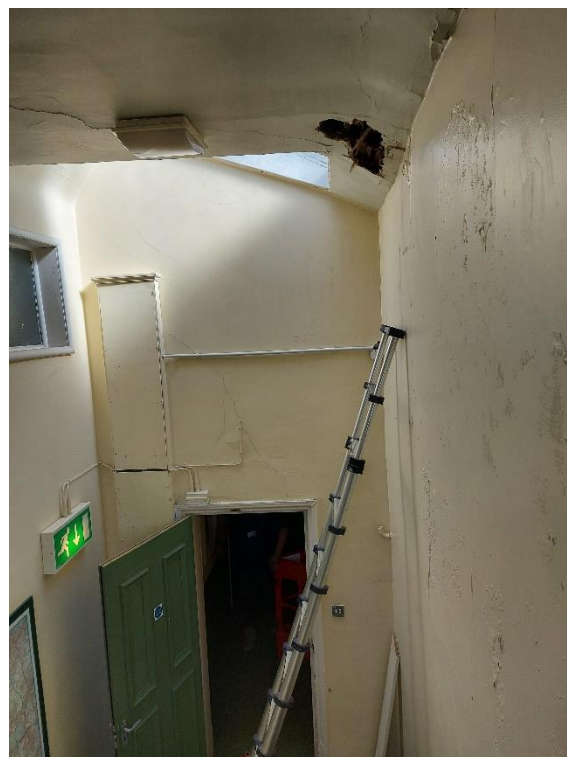
- The area above the small staircase up to some second floor offices (within the roofspace) was also exposed, and again no visible signs of rot were noted (Photographs 6 & 7).
- We also exposed an area of ceiling above the adjacent landing 1.C03 (Photographs 8 & 9), as the ceiling displayed signs of previous leakage, as elsewhere. Only ceiling joists were visible as these appeared to be boarded over, but again no signs of affected timbers were observed.
- Overall from our limited points of inspection the dry rot does not appear to have significantly spread within the roofspace, and there is currently no evidence of structural damage to the main roof timbers.

**Photograph 6**  
**Stairway 1.024 – rafter feet exposed**

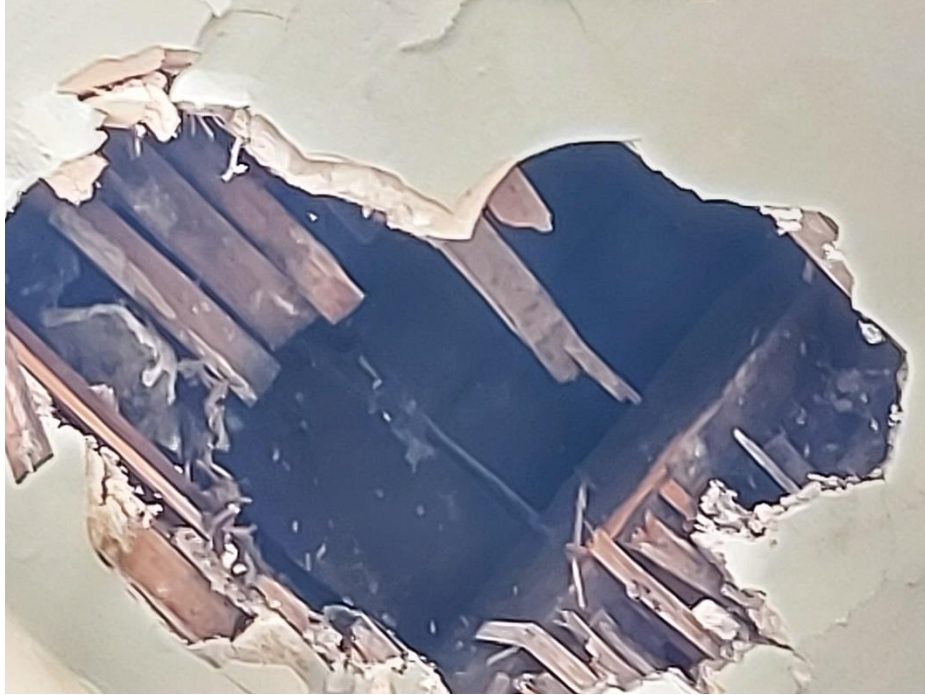
**Photograph 7**  
**Stairway 1.024 – rafter feet appear intact**

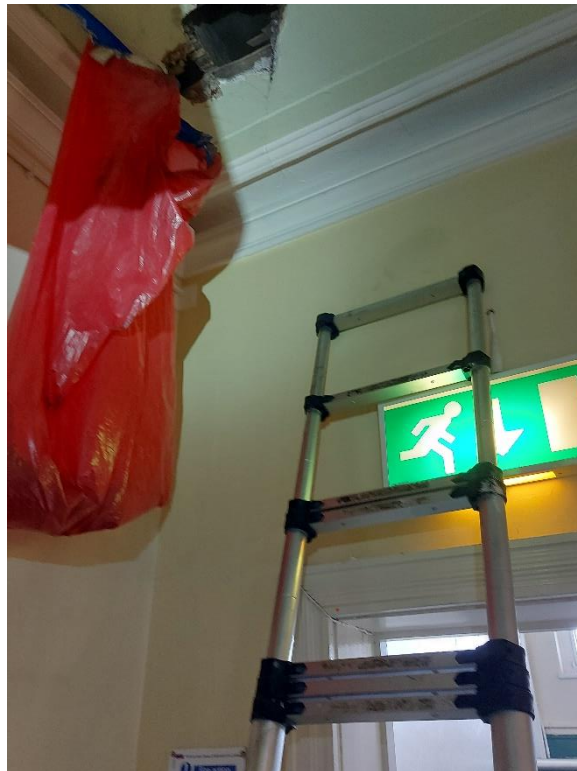
**Photograph 8**  
**Landing 1.C03 – ceiling joists exposed**

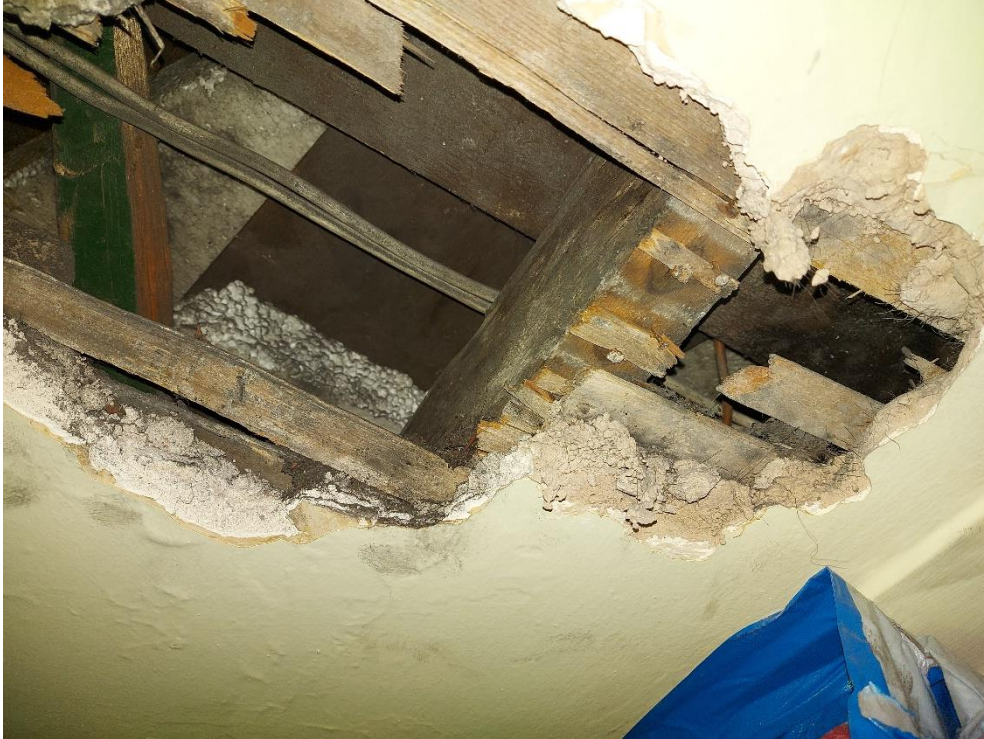
**Photograph 9**

**Landing 1.C03 – ceiling joists appear intact, boarded over so rafter feet inaccessible**
