### GAS MEMBRANE VALIDATION – BELLE VUE

**Project Name: Belle Bue Stadium****Project Number: 12-123****Client: Countryside Properties****Date: 22-08-2023****Project Manager; S. Ellis – FGS, CEnv****E3P Engineer: P. Lavelle****Gas Membrane Installers Chandos Civils****Ground Gas Risk Assessment: Amber 1****Plots: 223**

## GAS MEMBRANE VALIDATION

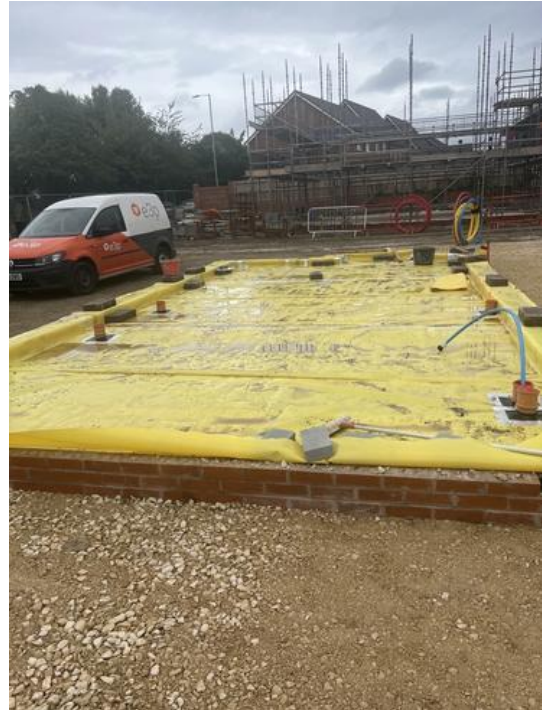
Photo 32

Type of Development: Other add note

House

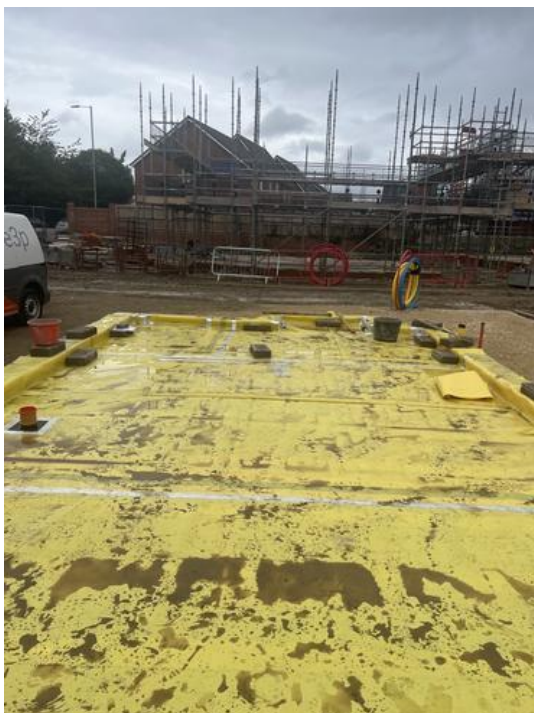
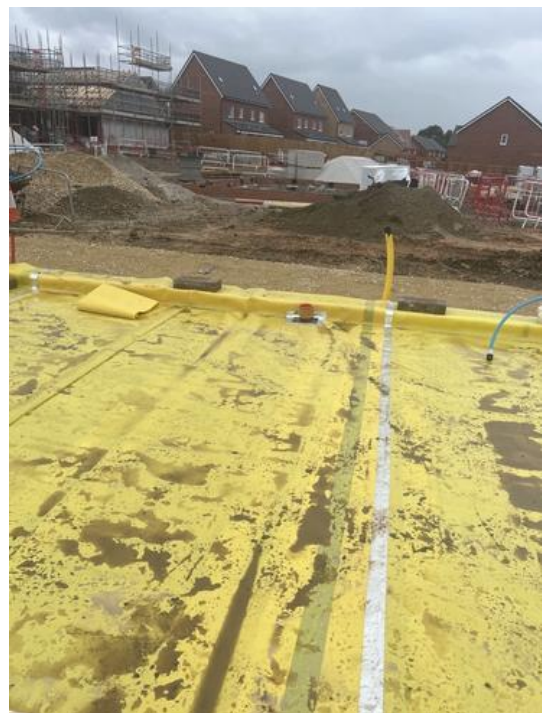
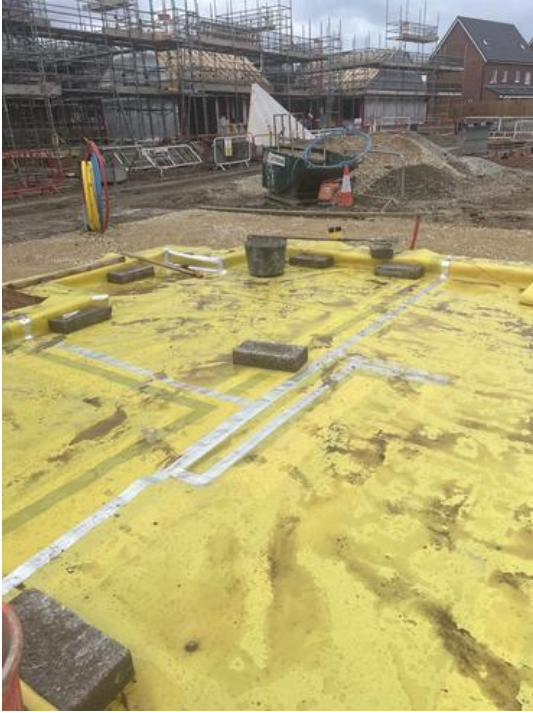
Gas Membrane Condition: Open punctures, tears, rips, stretching, Presence of debris, Repairs, Signs of weakness such as raised or sunken indentations, Protection plan in place to restrict access to lain gas membrane? IF FAIL DESCRIPTION IN ACTIONS AND PHOTOS REQUIRED

Pass

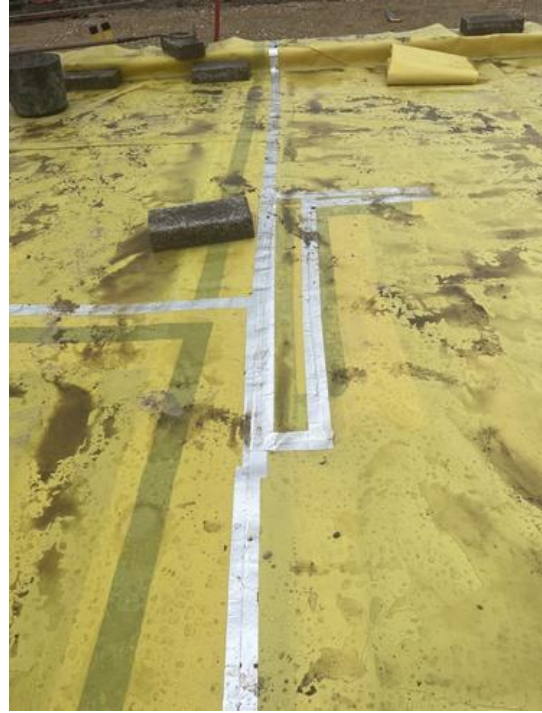
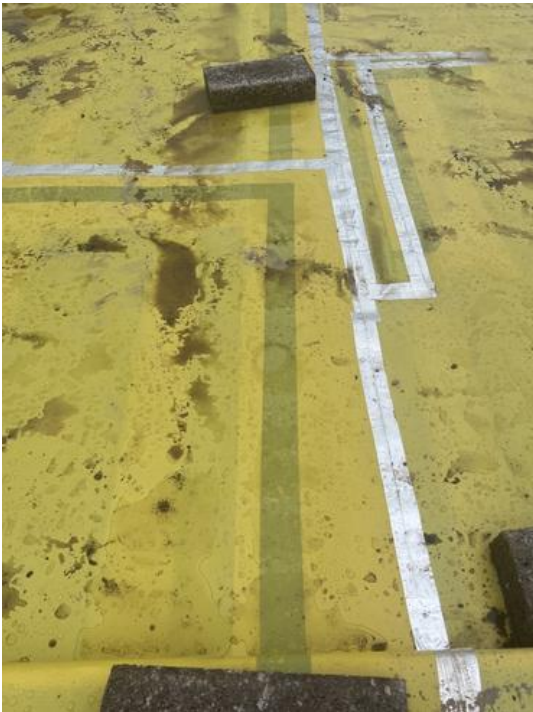
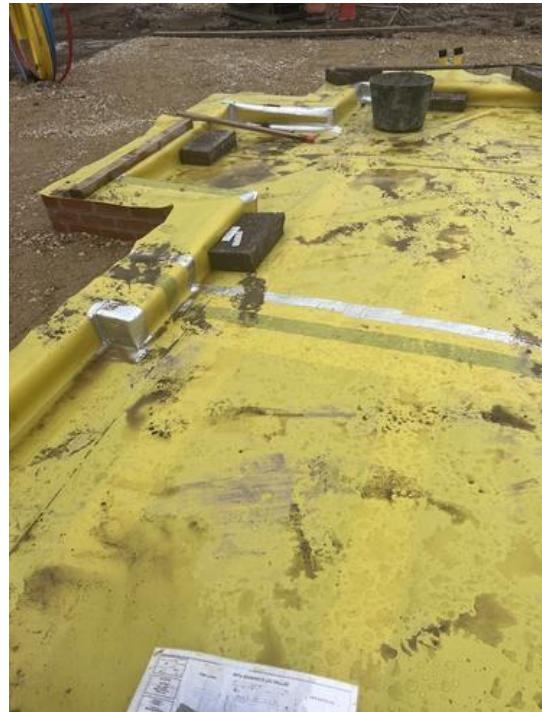
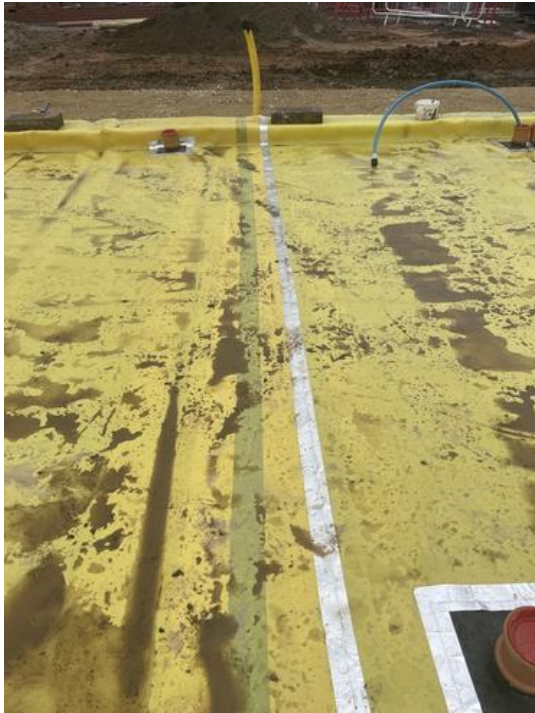
E3P inspected all external joints, and E3P can confirm that the membrane was overlapped and double-taped. The membrane was taped using double-sided jointing tape. All the overlaps were then additionally taped using foil-backed girth tape.

Laps, welds, and joints seals: Joints lapped and sealed in accordance with manufacturer's requirements/ specification? Minimum overlap insured? Sections taped twice? Are welds complete? Appropriate joining/double-sided tape used, Folds running in line with joints? (no joints cutting across folds)

Pass

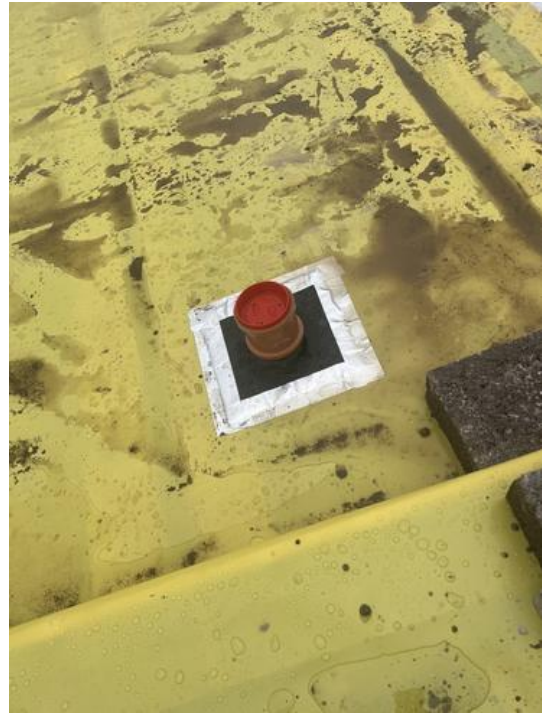
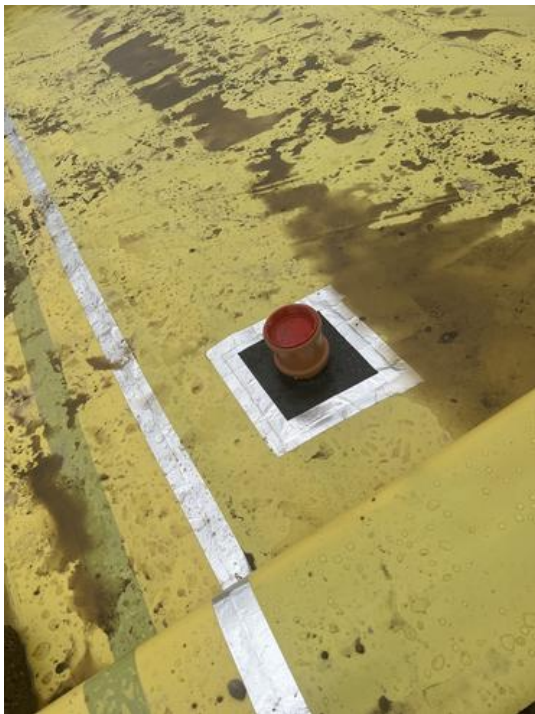
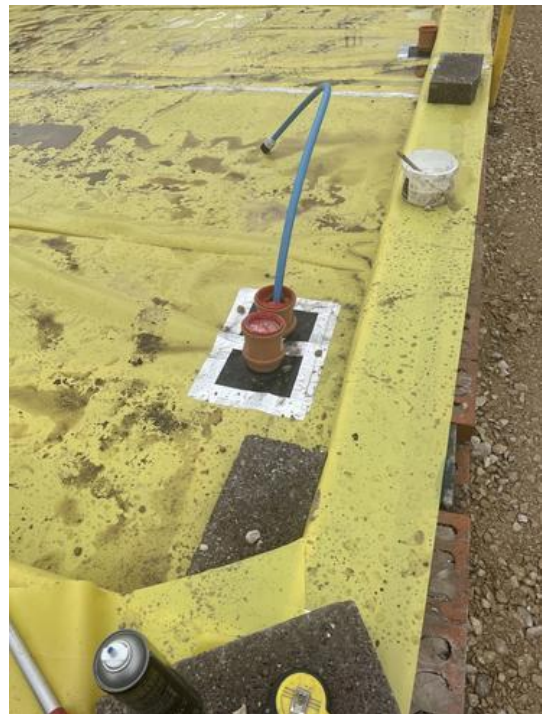
Each unit has a service duct located at the front and outer edge of the property. E3P inspected each one and can confirm that the top hats have been adequately sealed against the membrane.

Service entries seals: Top hats seal arrangements fixed around service entries? Use of Jubilee clips?

Yes

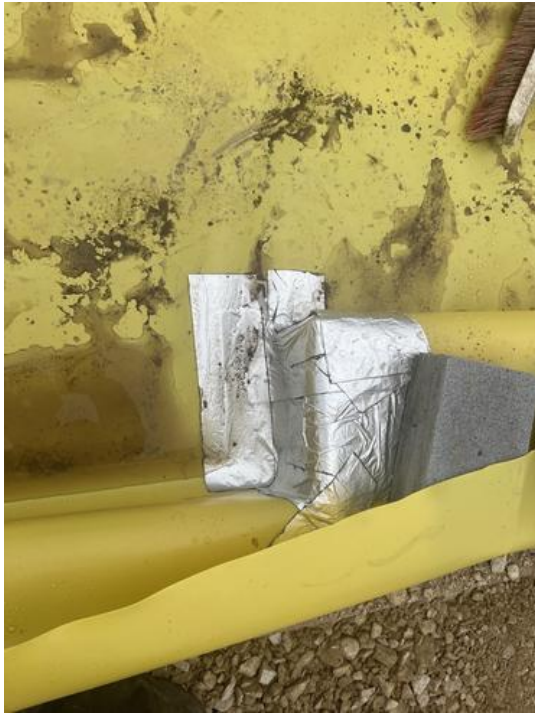
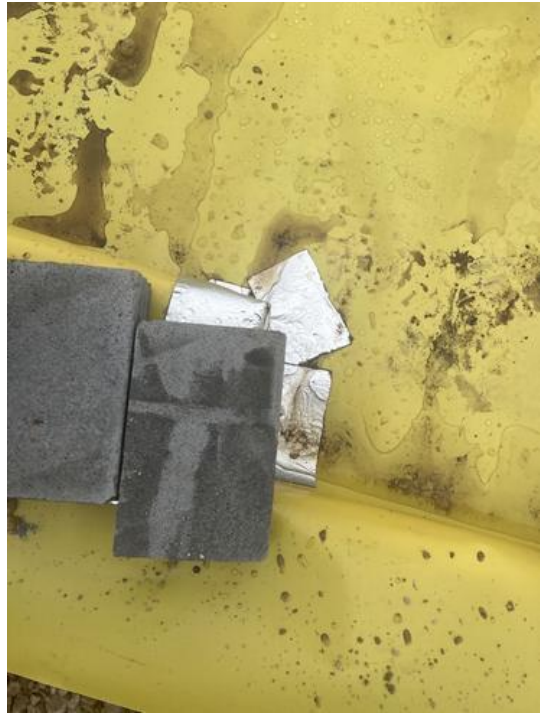
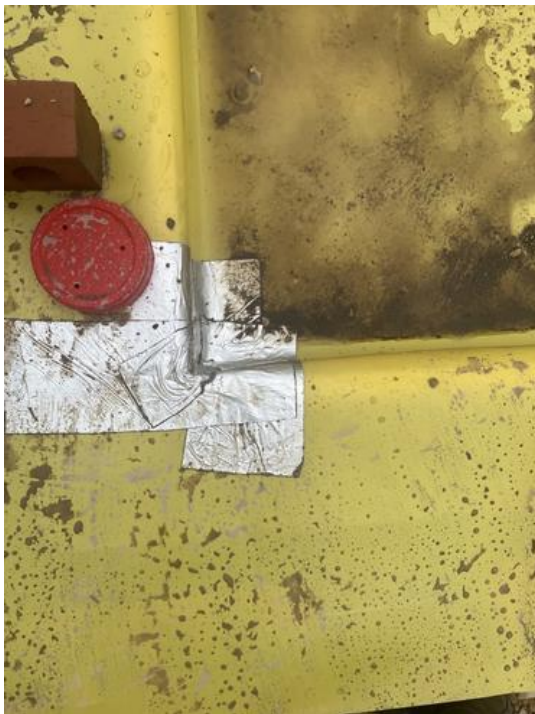
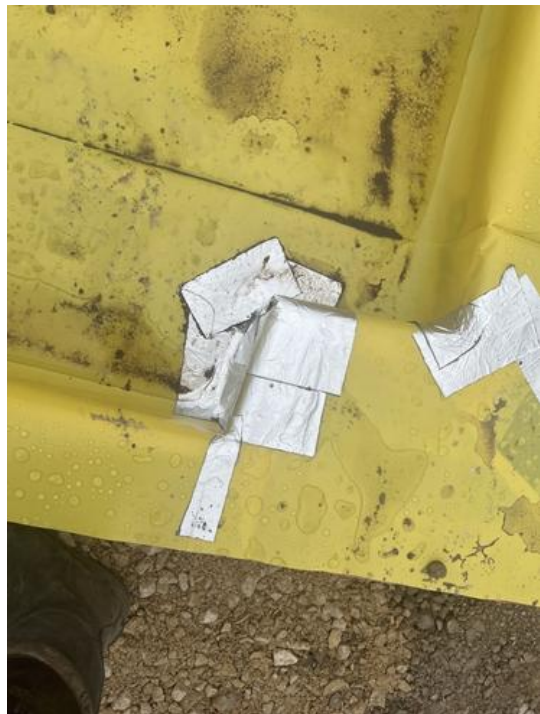
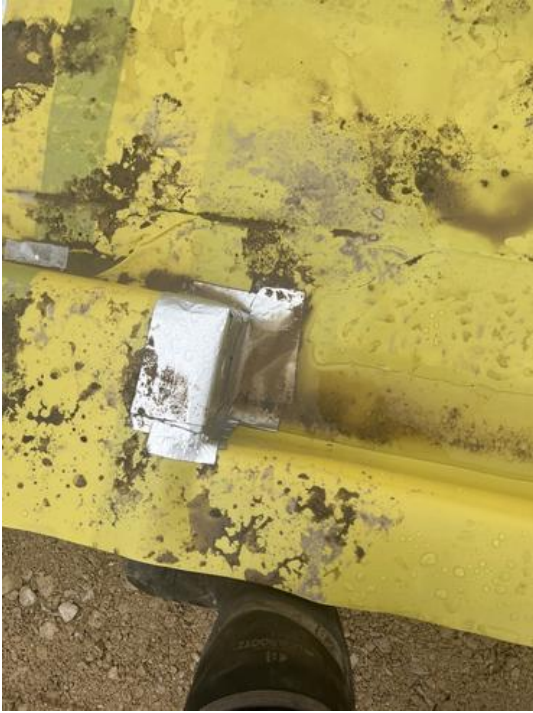
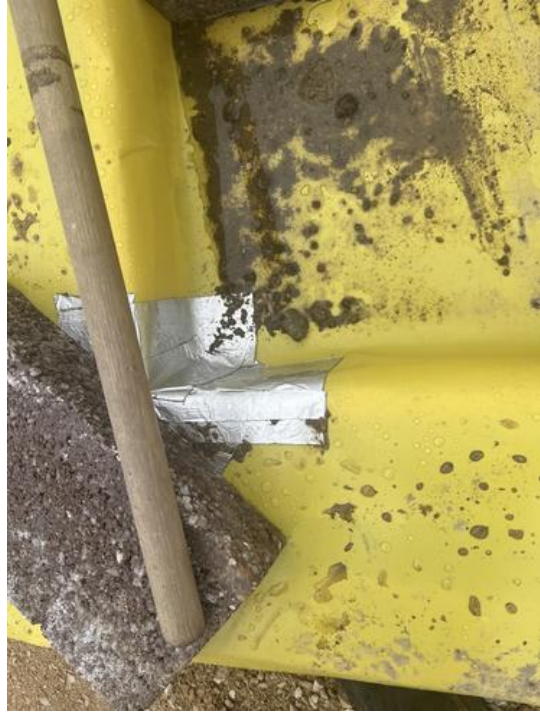
**Corners / Internal joints: Check all corners are correctly formed or contractor has used preformed corners.**

Pass

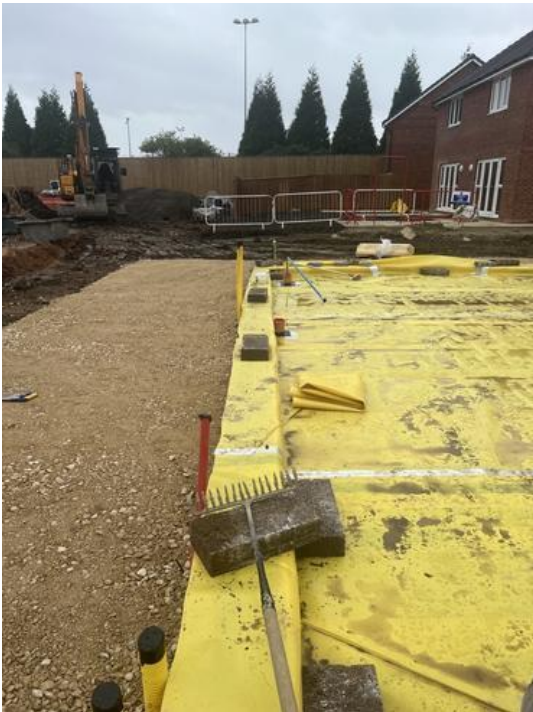
Photo 49

**Extent of Coverage: Is the membrane covering the entire plot? Does membrane span over outside walls?**

Yes

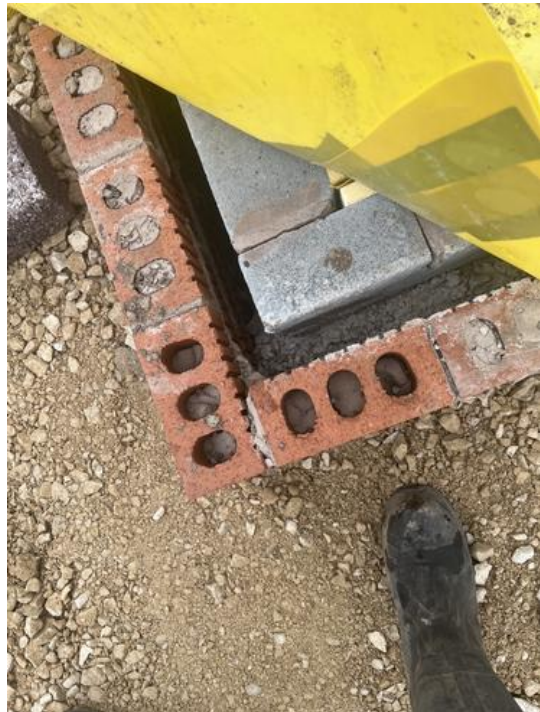
Photo 50

**Condition of sub-grade and underside of gas membrane: Check that the subgrade does not contain rough/uneven surfaces, is appropriately clean and that there are no hard/sharp objects. That protective sand blinding or geotextile (if specified) is present and meets the design criteria.**

Pass

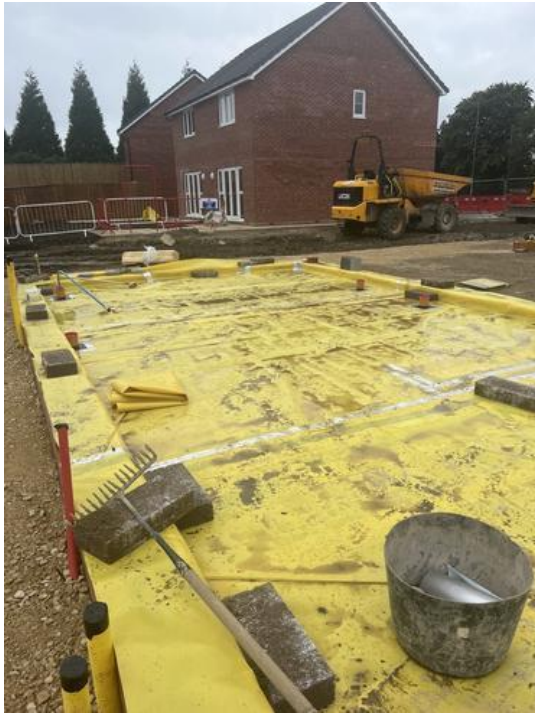
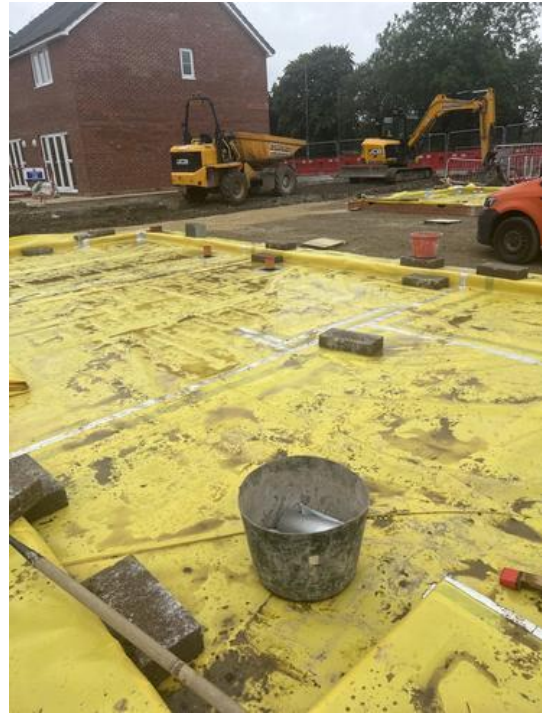
**Slab / membrane condition (is membrane clear of debris or insulation): Can membrane be fully seen and photographed – ask contractor to remove an debris so membrane can be fully seen and inspected – this is a requirement of NHBC and local authorities.**

Pass

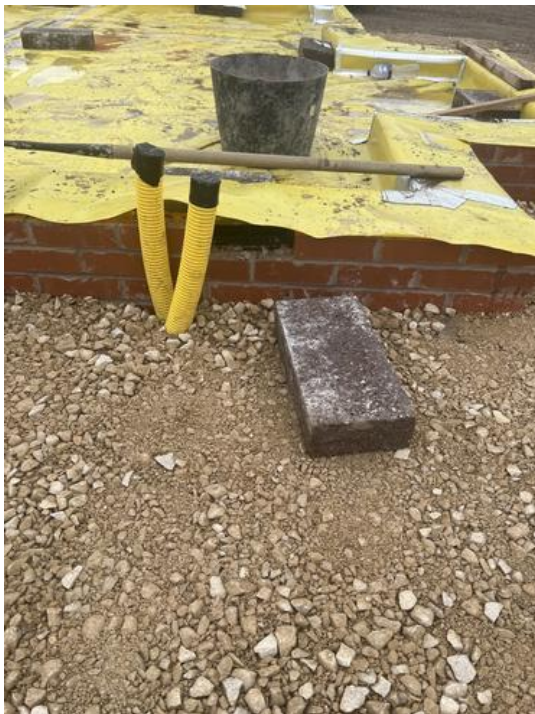
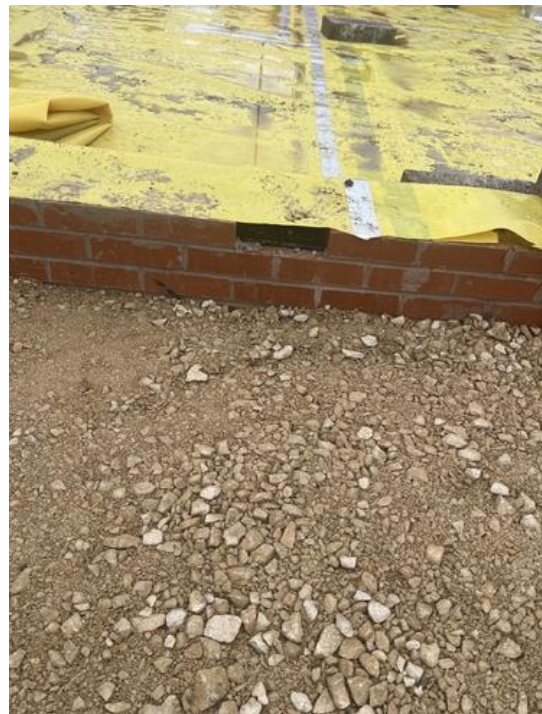
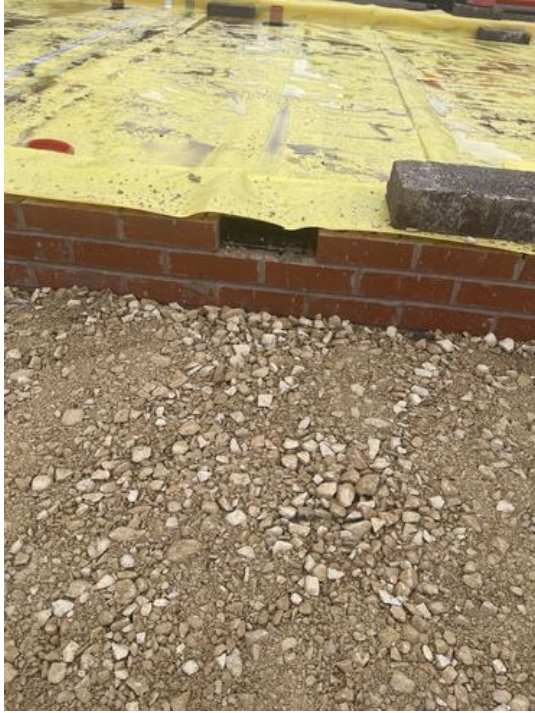
**External Wall Air bricks: Numbers, size. positions as design drawing? (Minimum of 3 walls)**

Pass
