# PHASE 2 SITE INVESTIGATION

## Freight Island Event Space

Mayfield Partnership Ltd

| DESCRIPTION | | DATE | AUTHOR | REVIEWED BY | APPROVED BY |
|---|---|---|---|---|---|
| Phase 2 Site Investigation Report<br>FINAL | | 23/02/2021 | Reece McGuinness<br> | Liam Daley<br> | Alex Smiles<br> |

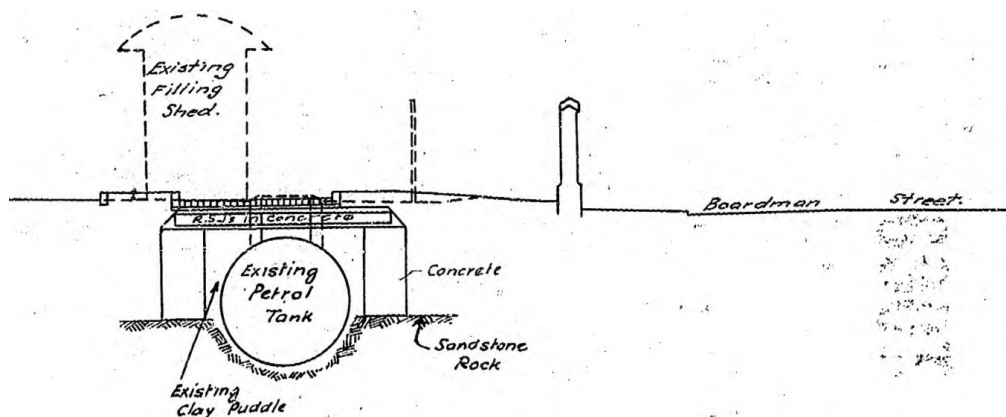
**Fig 3.0: Extract from LMSR Plan relating to Road Motor Petrol Depot improvement works**

- 3.3.4 The gantry structure in the centre of the site was a fuel office building with associated fuel pumps beneath a canopy roof, two fuel storage tanks were located below ground in this area. The structure in the east of the site was a filling shed with a tank located underneath. The plans appear to relate to planned improvement works and a schematic section of a new below ground fuel storage tank is provided (and reproduced below).

- 3.3.5 Records indicate the petrol tanks were contained below ground within a concrete trench structure partially cut into the Sandstone bedrock. The tanks themselves were enclosed within puddle clay, likely to contain any spillage or leakage. The records show tank locations from the original Road Motor depot construction as well as alterations associated with the proposed improvement works. The plans indicate the original below ground tanks were to be removed and replaced. An overlay showing current site features and proposed improvement works (drawing ES300) has been provided within Appendix A.
