# Structural Inspection Report of Northenden War Memorial Palatine Road Northenden Manchester M22 4JT

11<sup>th</sup> February 2025

Phil White Associates Limited

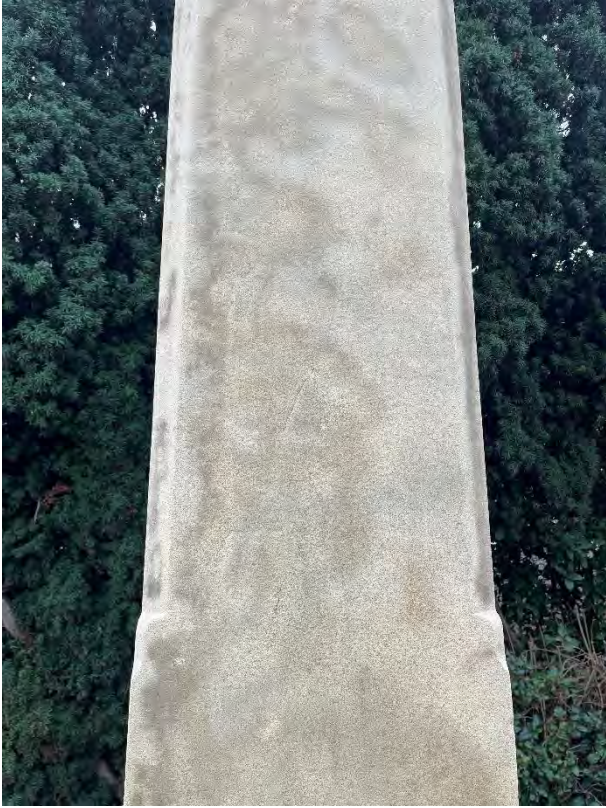
*Photo 10 shaft - front elevation showing minor weathering to surface/possible too aggressive cleaning*

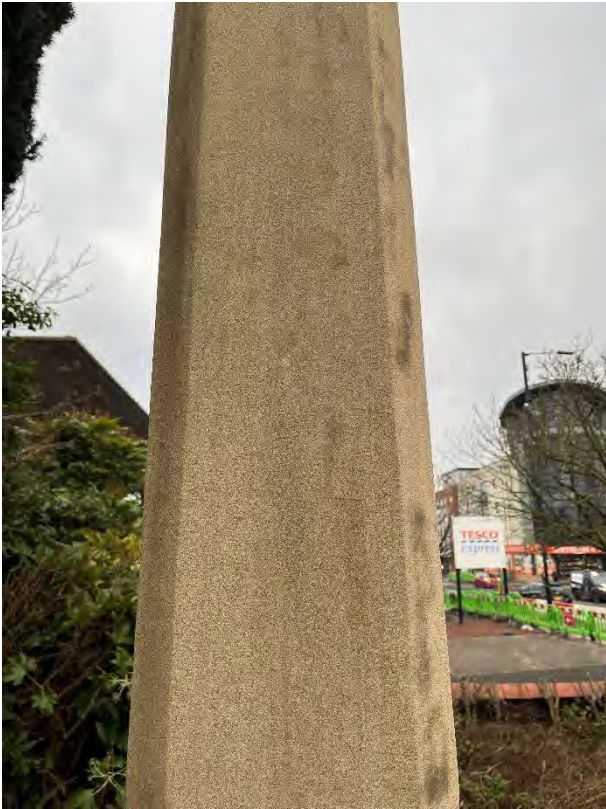
*Photo 11 The layers of the stone are visible, there are in a vertical orientation. 2 very minor areas of iron staining (horizontal - 30-40mm long x 0.5mm, with very mild rust staining running down the surface)*

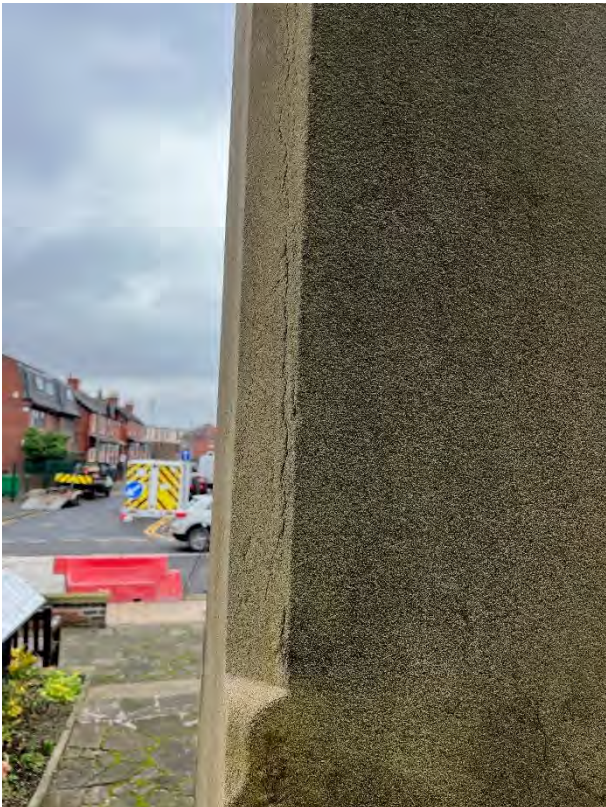
*Photo 12 Very minor cracking parallel to the vertical vertices of the chamfers*

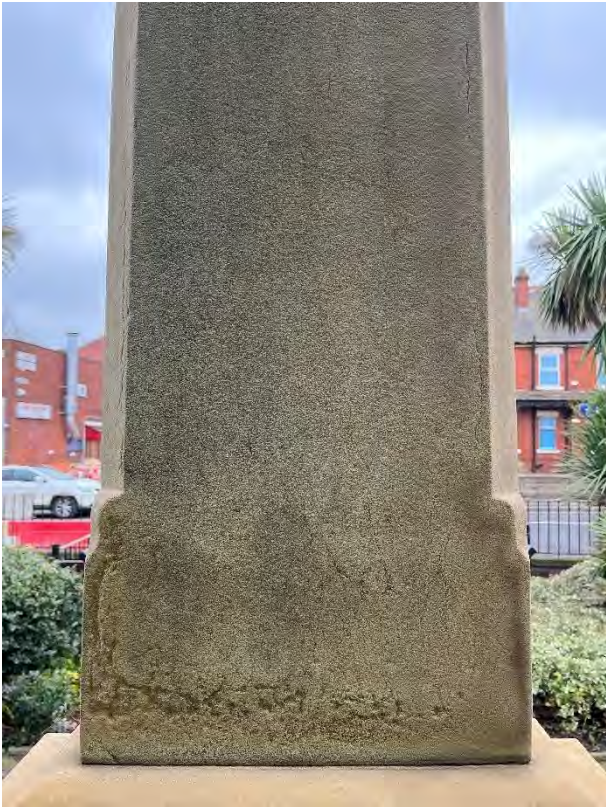
*Photo 13 Minor pitting/spalling of stone at bottom of shaft (too aggressive cleaning or natural weathering?)*

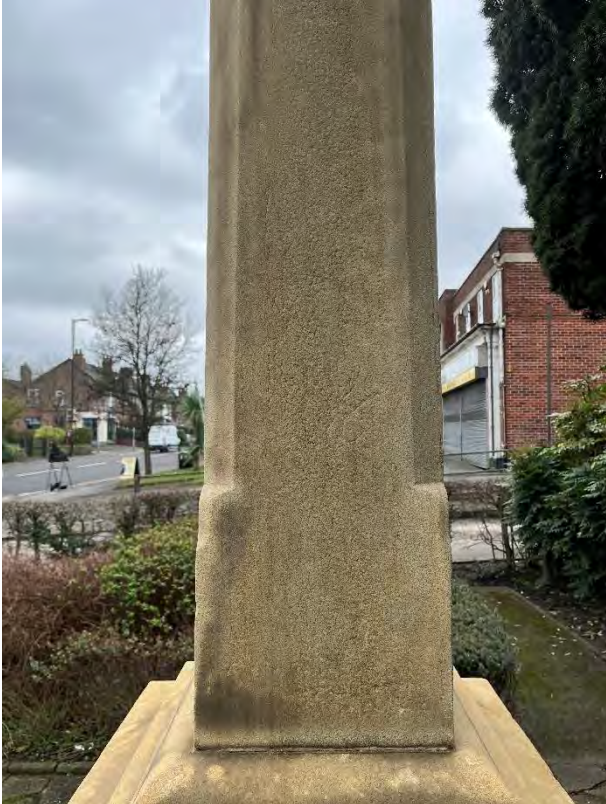
*Photo 14 The layers of the stone are visible, there are in a vertical orientation. • Minor cracking/opening up of minor fissures (too aggressive cleaning or natural weathering?)*

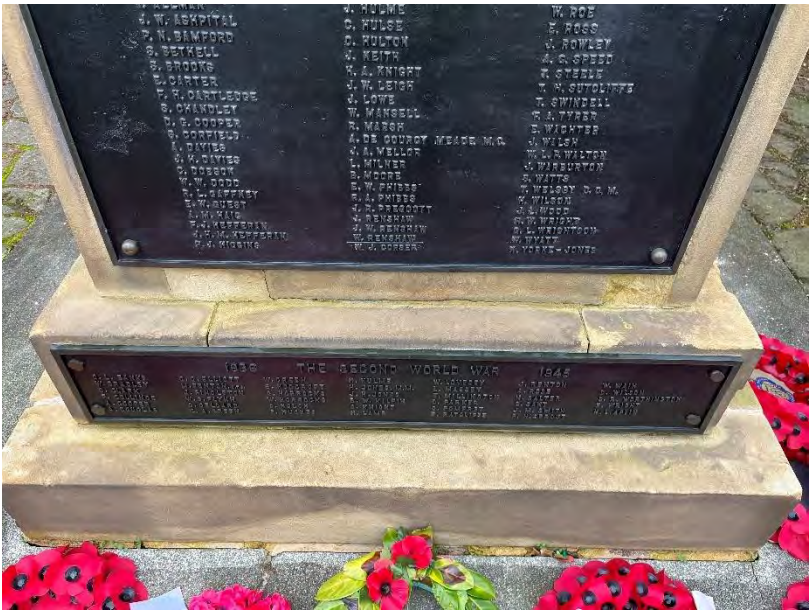
Photo 15 2 patches to lower edge.

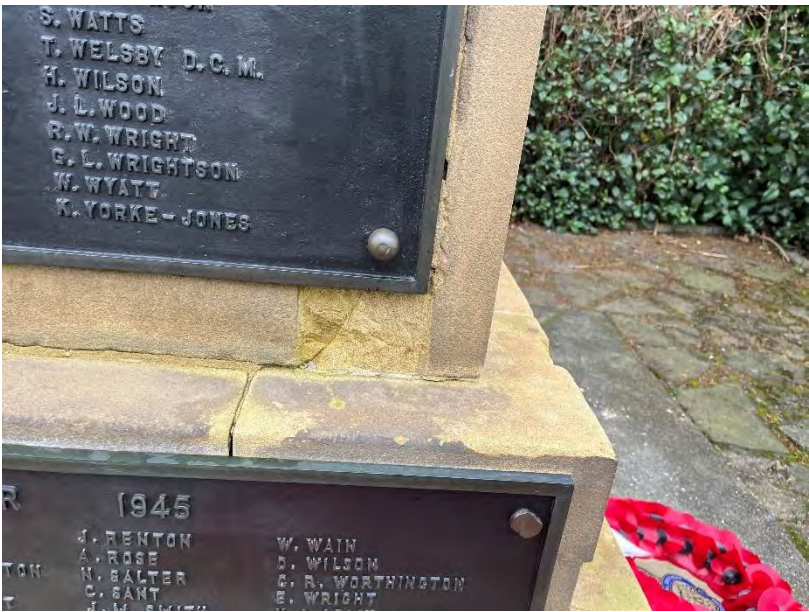
Photo 16 RHS patch has failed, showing diagonal crack

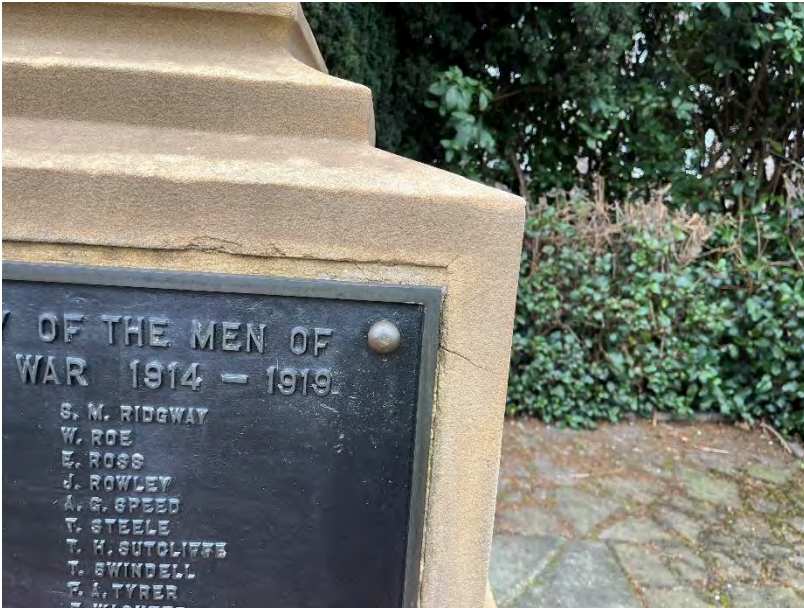
*Photo 17 crack across bolt in upper right corner of plaque*

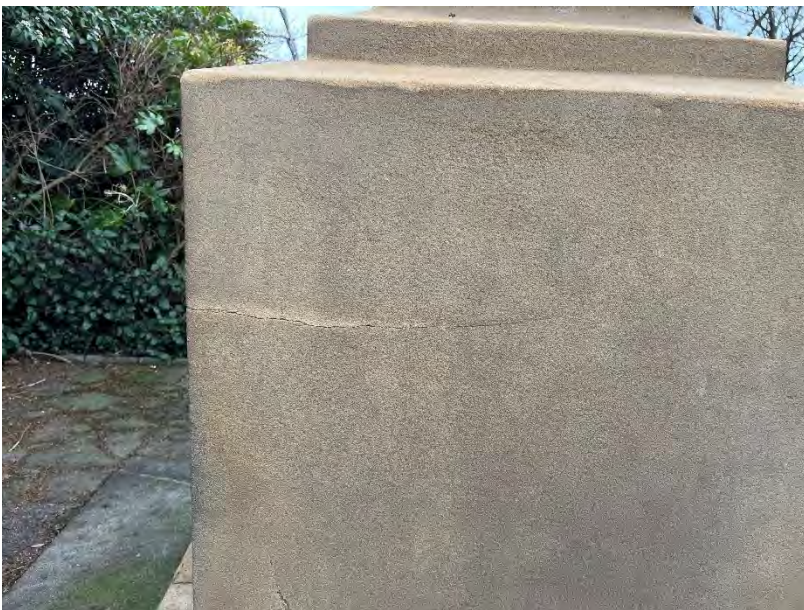
*Photo 18 Horizontal crack 2/3 way up left side, running from rear edge for ½ width*

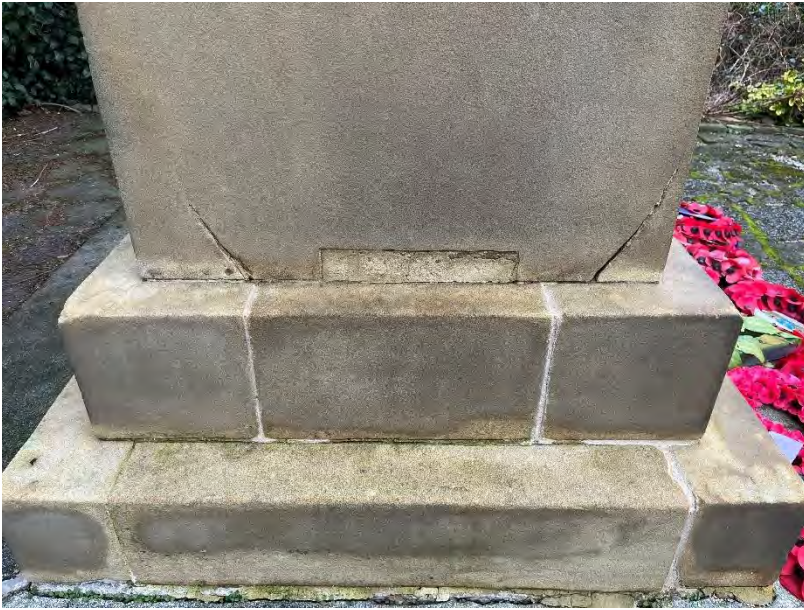
*Photo 19 Failing, poor quality repair on bottom edge. 2 diagonal cracks on bottom corners*

Over time, the plinth stone has cracked at the corners (as seen in Photo 19, Photo 20 & Photo 21) allowing the plinth to drop and active the support of the settled fill and side stones of Base 2. This has then caused the bottom left edge of the plinth to become damaged as the plinth adjusted itself to the new support, which has been repaired (as seen in Photo 19). The plinth has now come to rest, supported by the corner stones, the side stones and the infill, but with the observed movement of Base 1 & Base 2 stones and the damage to the plinth.

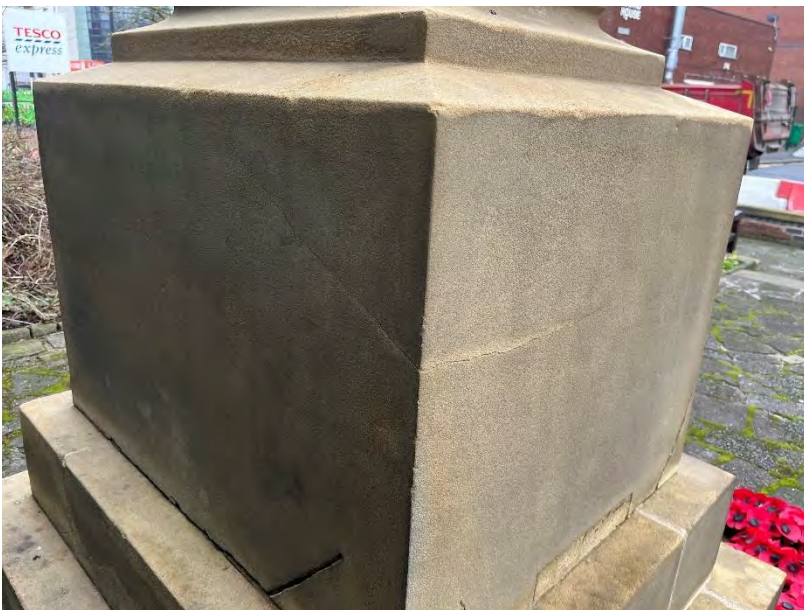
*Photo 20 Continuation of horizontal crack (see Photo 18), but heading diagonally up*

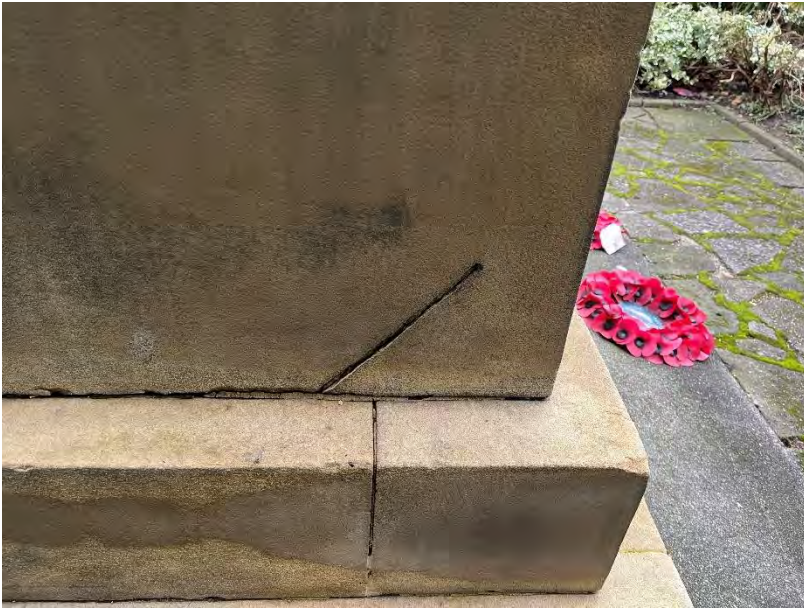
*Photo 21 Diagonal crack to lower left corner*

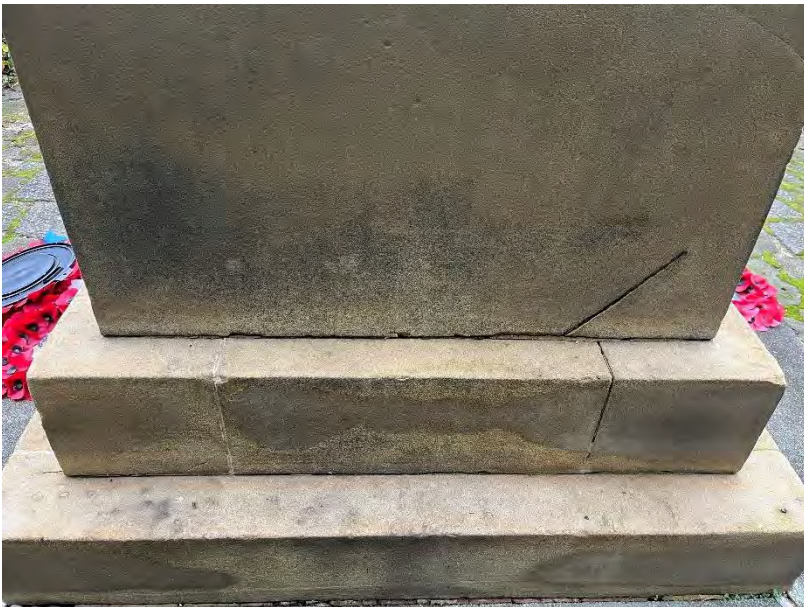
*Photo 22 Bottom edge damaged*

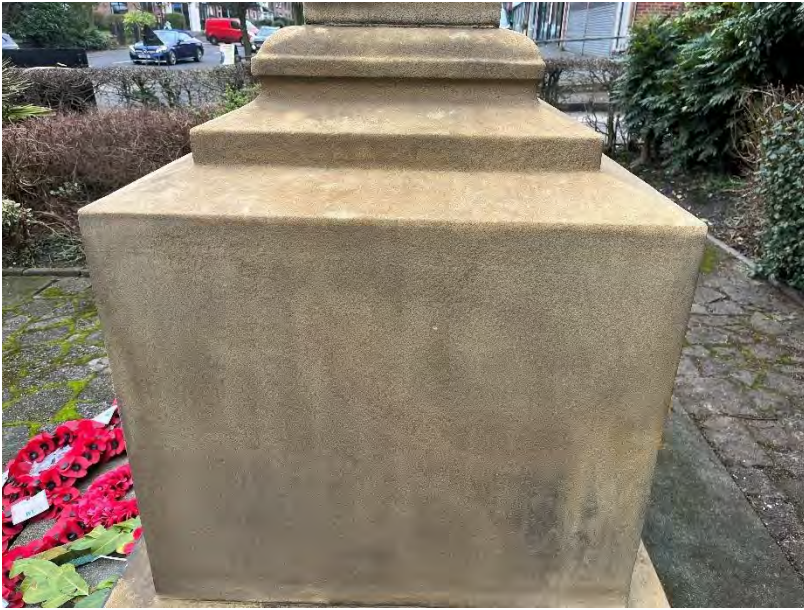
*Photo 23 Minor pitting to upper vertical surface, upper surface – very aggressively cleaned by pressure washer, slight damage to original smooth surface*

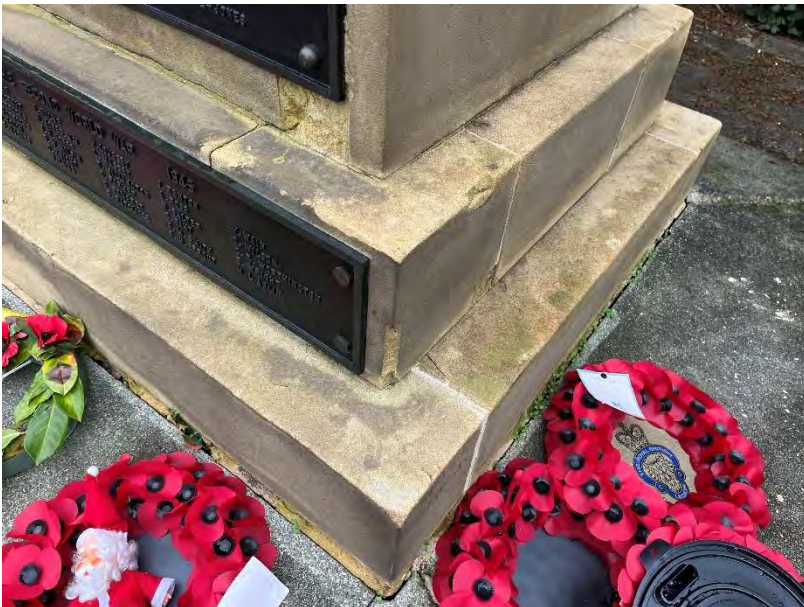
*Photo 24 Right hand block, vertical vertex damaged to lower half*

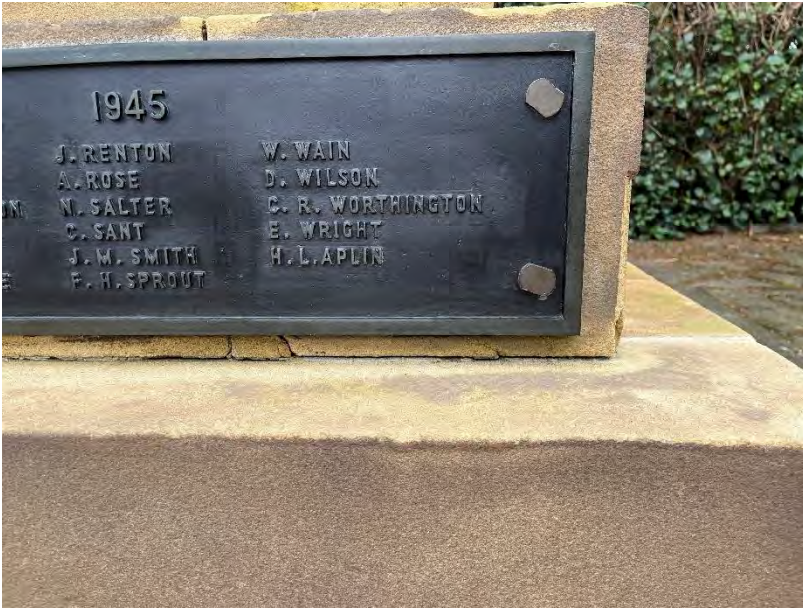
*Photo 25 Right hand block diagonal crack below plaque, LHS of block*  
**Left**

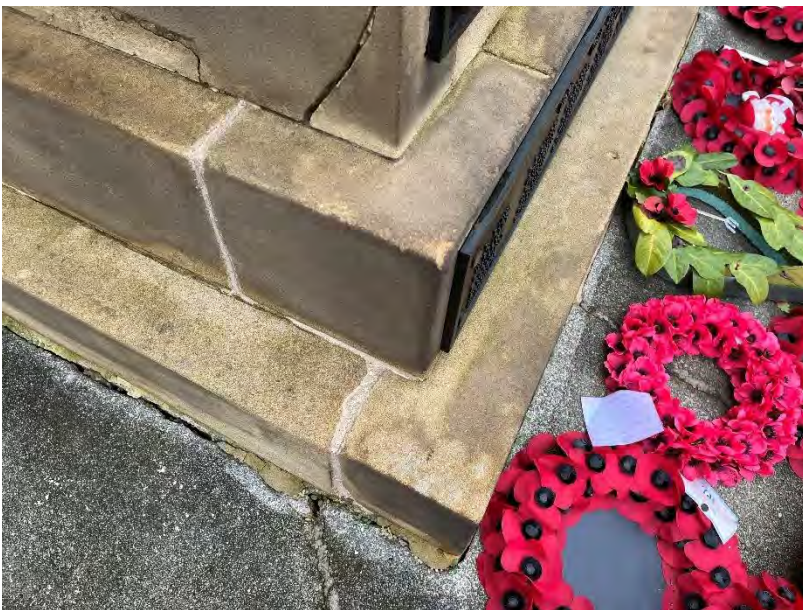
*Photo 26 minor damage to top front corner*

- The front stone of Base 1 has been displaced forwards, hence wide mortar joints to the two side stones, as seen in Photo 37 & Photo 42
- The left stone of Base 1 has been displaced sideways at the front side, as seen in Photo 38
- The effects on Base 1 stones have affected the front stones of Base 2, especially the front left stone, which had moved forward, as see Photo 26 (showing the wide mortar joint)

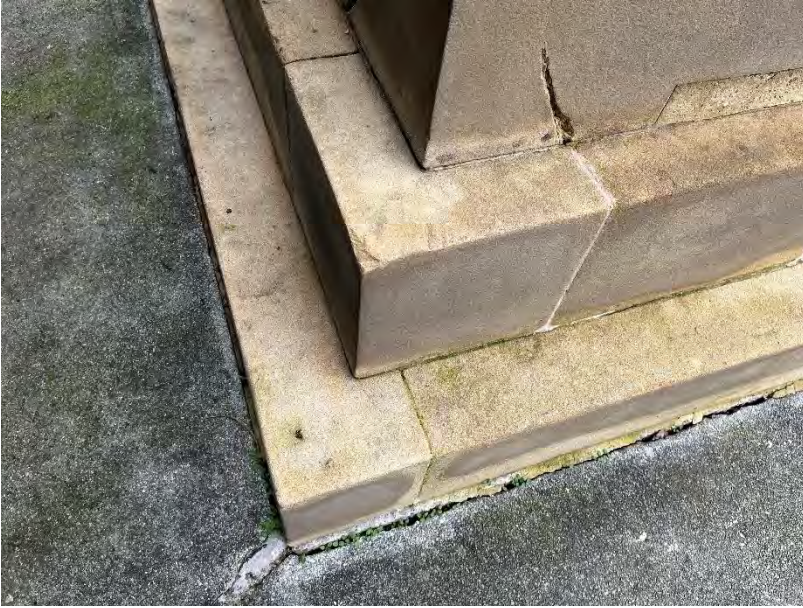
*Photo 27 damage to top rear corner*

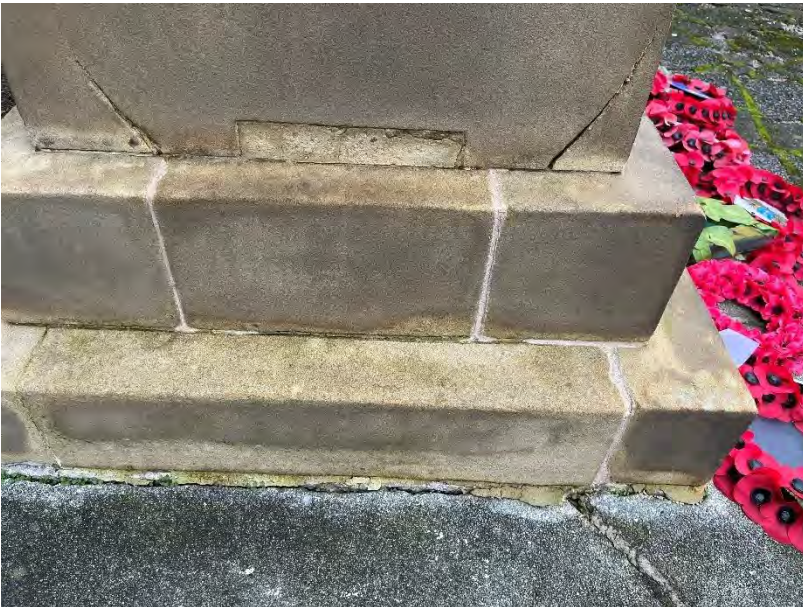
*Photo 28 Vertical joints pointed up (forward joint slightly thicker) and below front block*

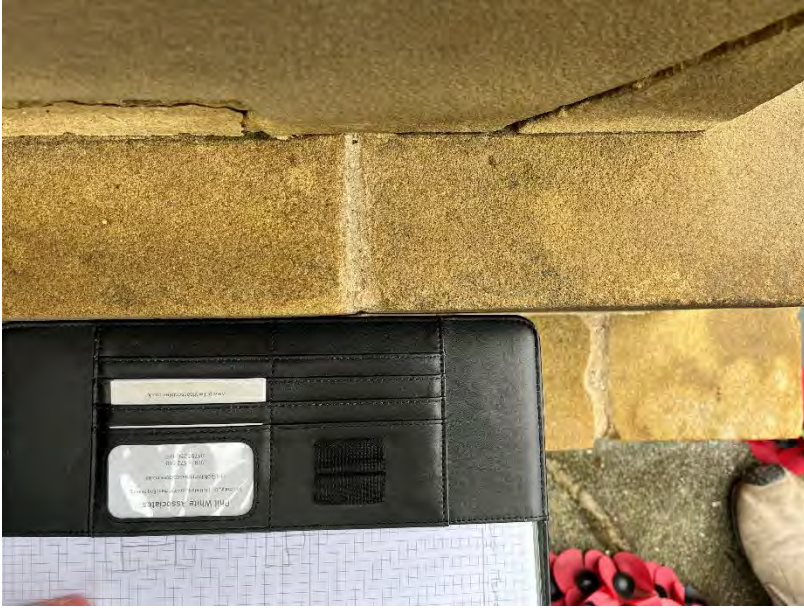
*Photo 29 Misalignment between middle and front block*

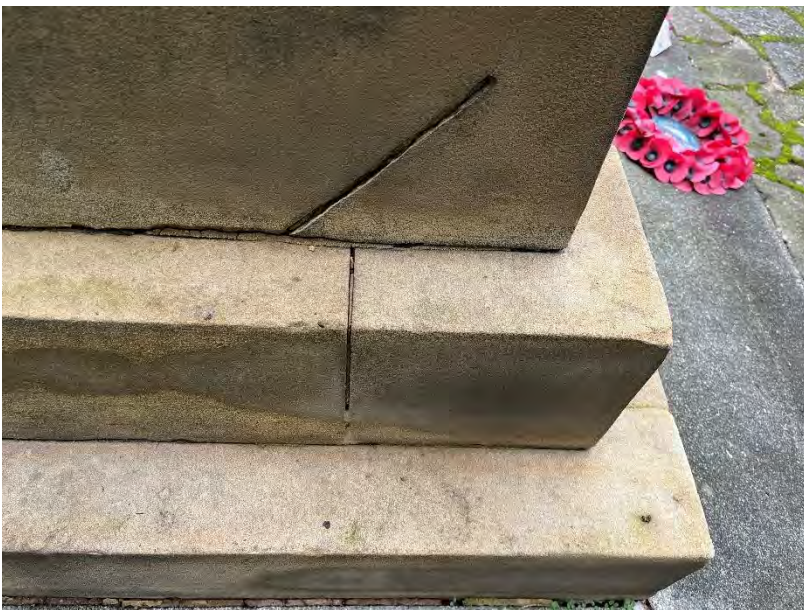
*Photo 30 joint between left rear corner stone and rear intermediate stone open-jointed*

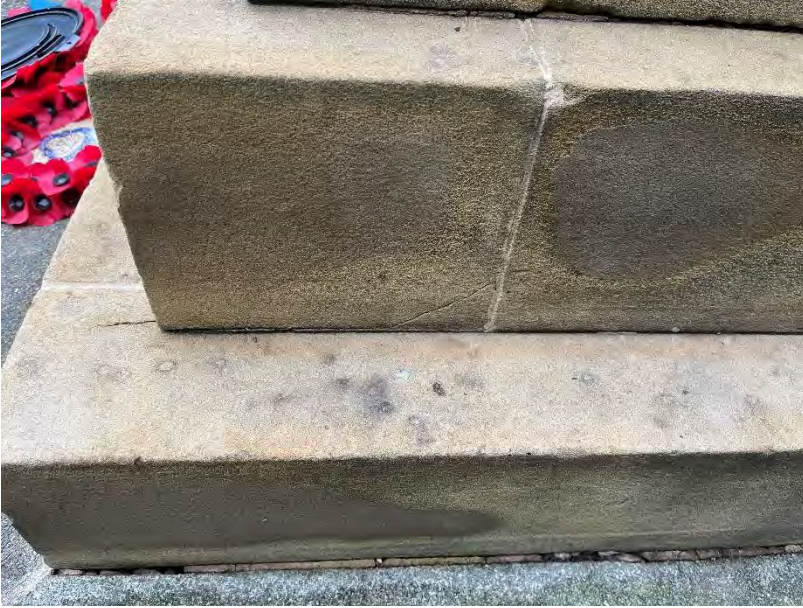
*Photo 31 Right block, small diagonal crack*

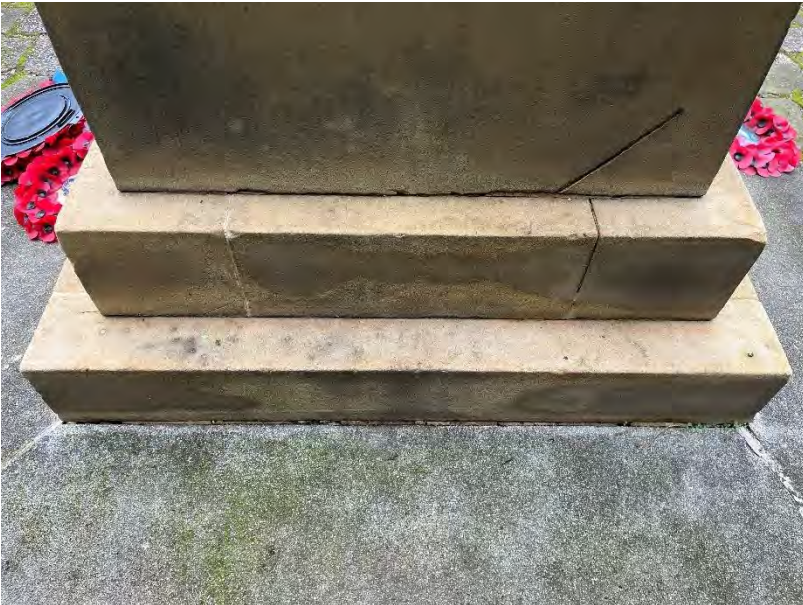
*Photo 32 Slight spalling/aggressive cleaning*

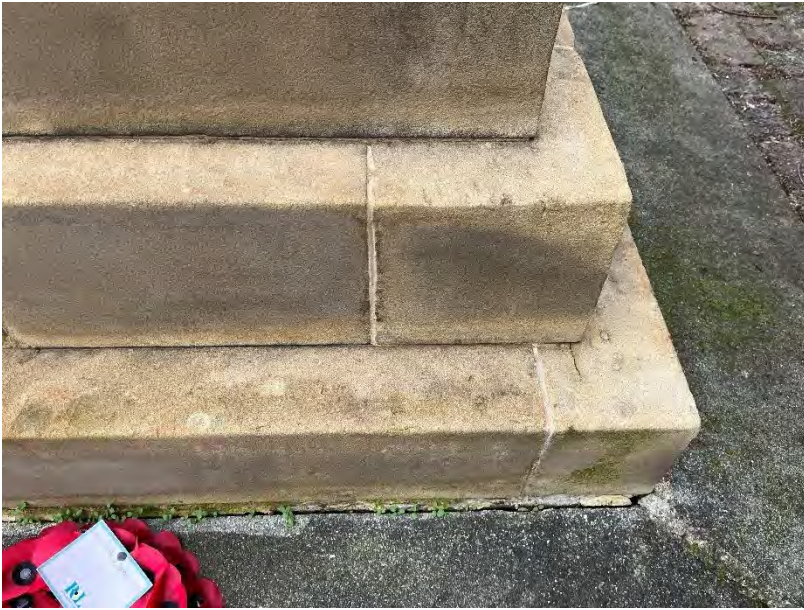
*Photo 33 Rear joint re-pointed and slightly wider*

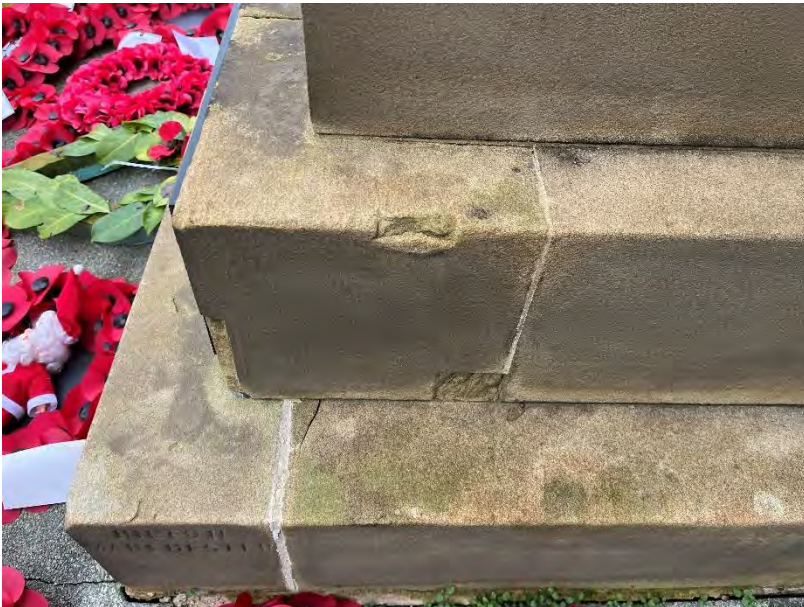
*Photo 34 Front block has 2 damaged areas with corner damage (as noted on Photo 24)*

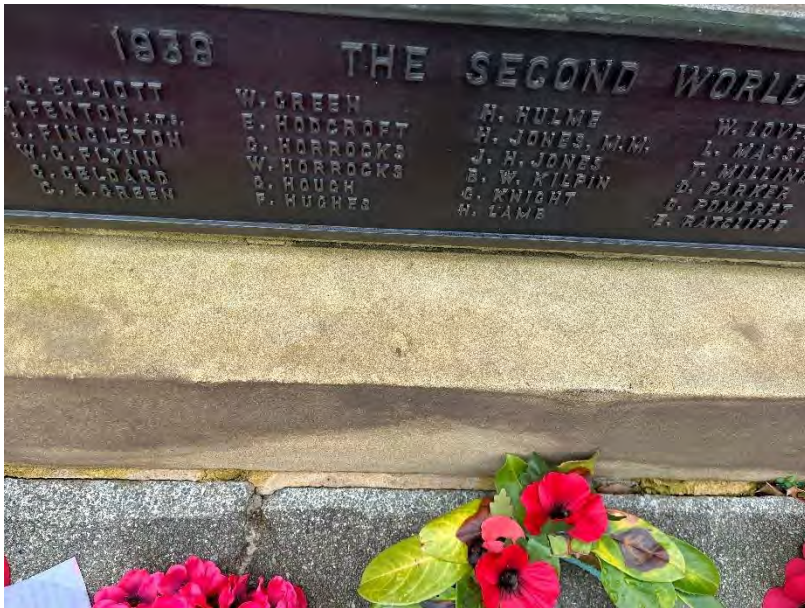
Photo 35 minor area of damage to upper surface in centre

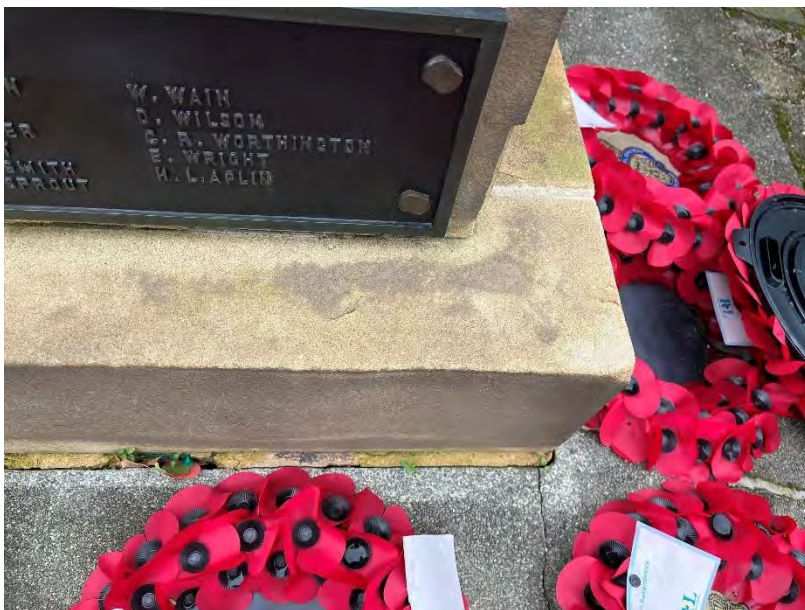
Photo 36 minor area of damage to the upper surface at RHS

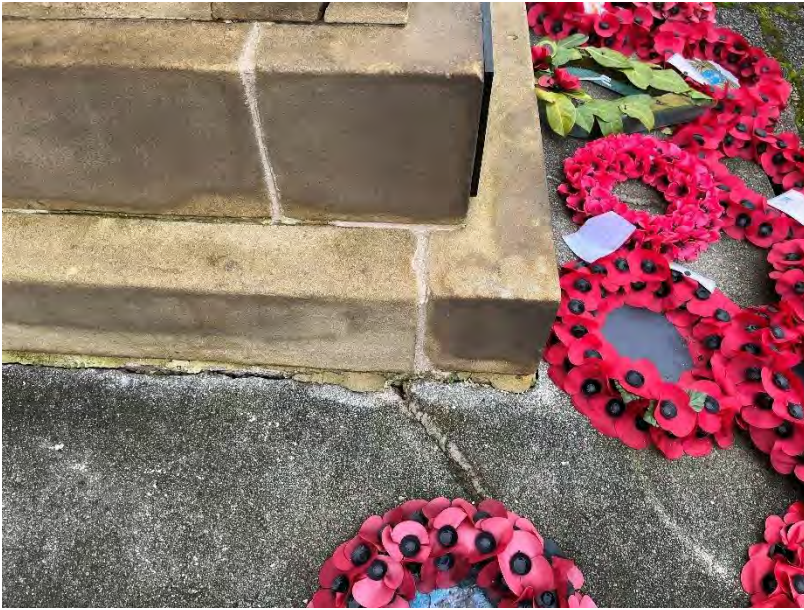
*Photo 37 Very wide front joint between front and side stones, which has been repointed*

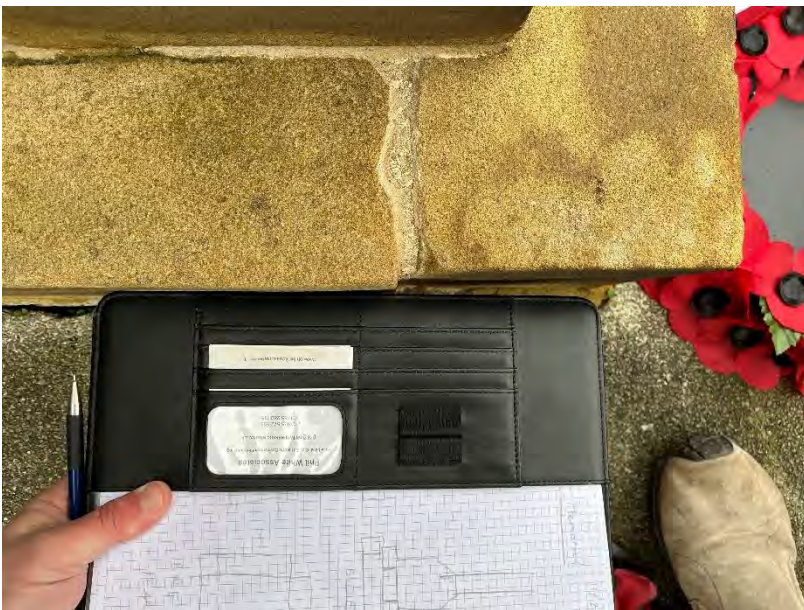
*Photo 38 The middle stone has been displaced to the left*

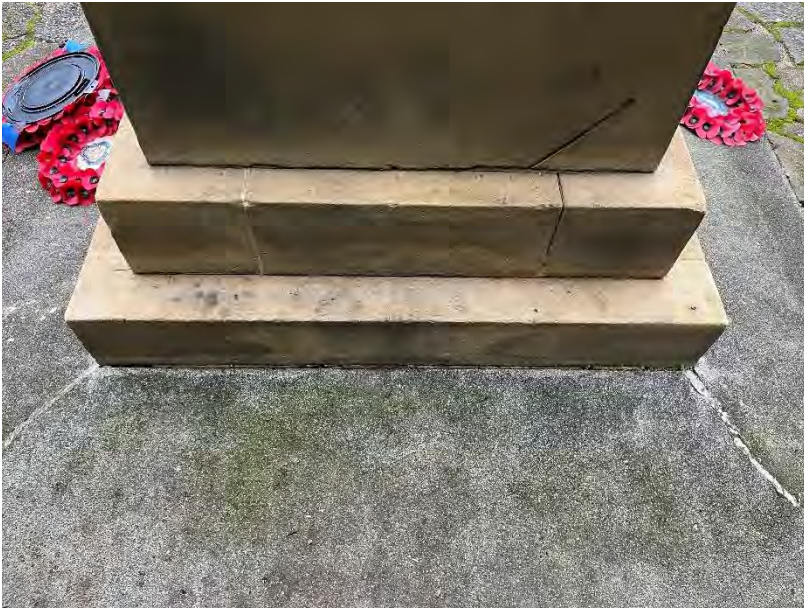
*Photo 39 some staining on upper surface*

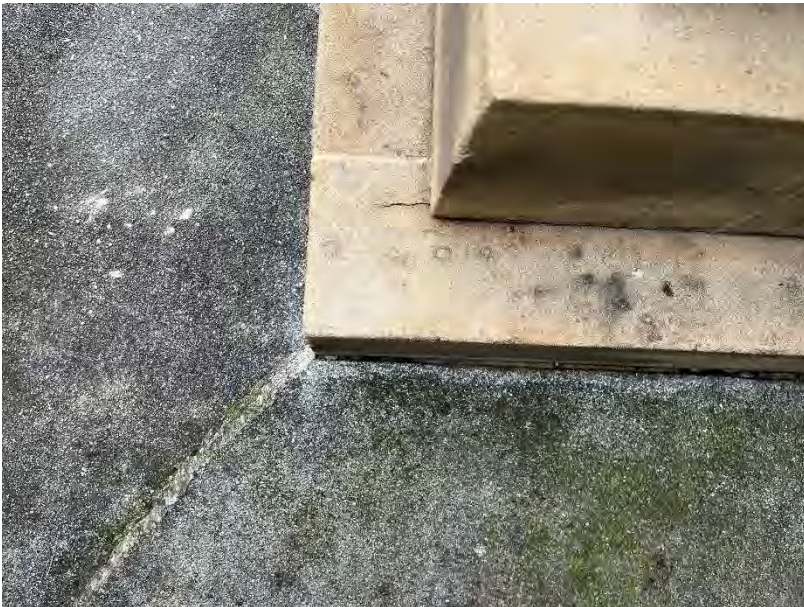
*Photo 40 minor crack on upper surface to RHS*

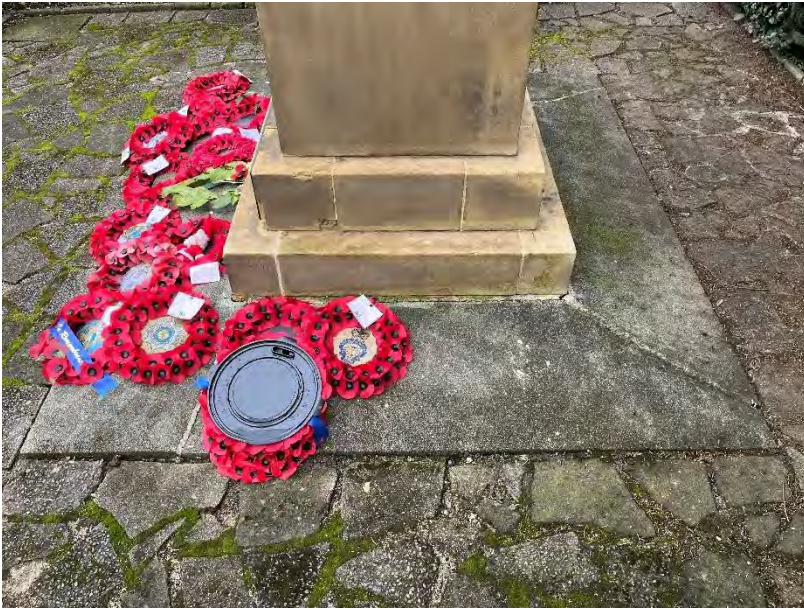
*Photo 41 both vertical joints have been repointed, both joints are wide, especially the forward vertical joint*

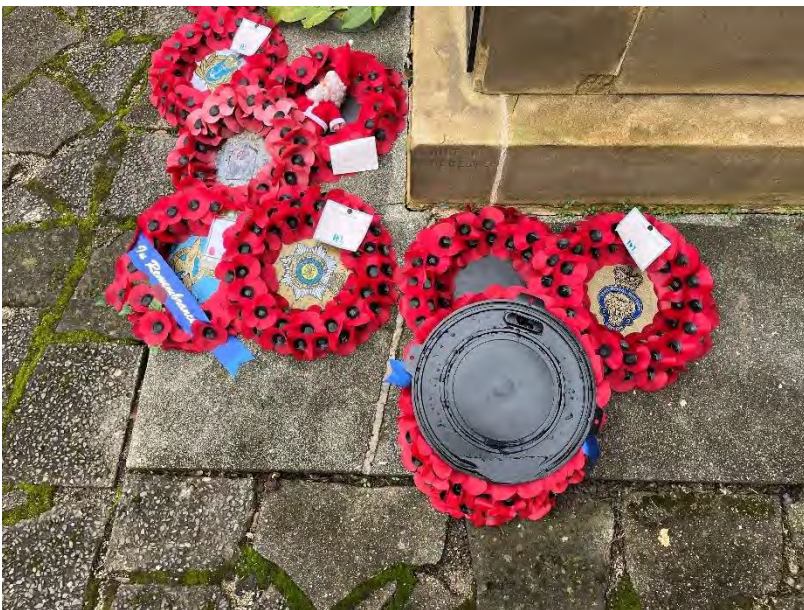
*Photo 42 minor crack on upper surface of middle stone on its front side*

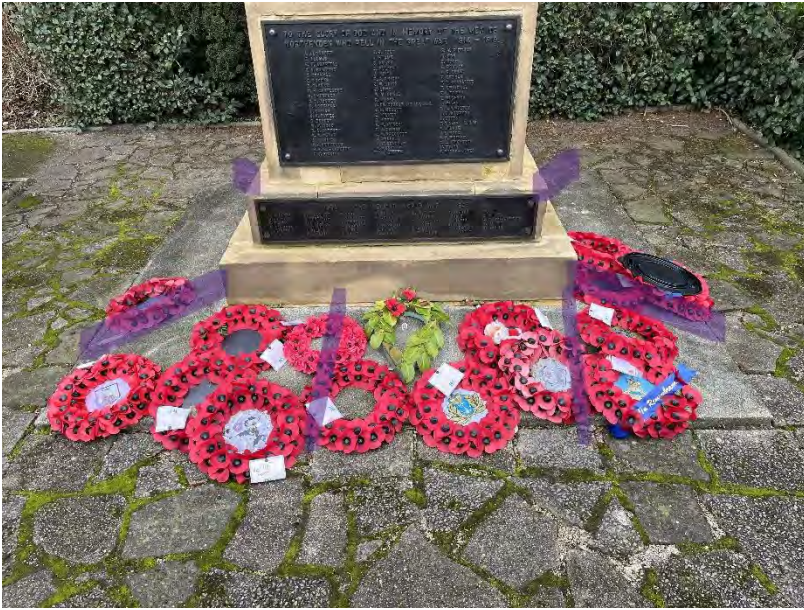
*Photo 43 front apron showing cracks (highlighted in purple)*

The cracking seen in the apron is due to the ground settlement and that it was cast monolithically without expansion gaps. Sun, weather and loading as caused it to crack.

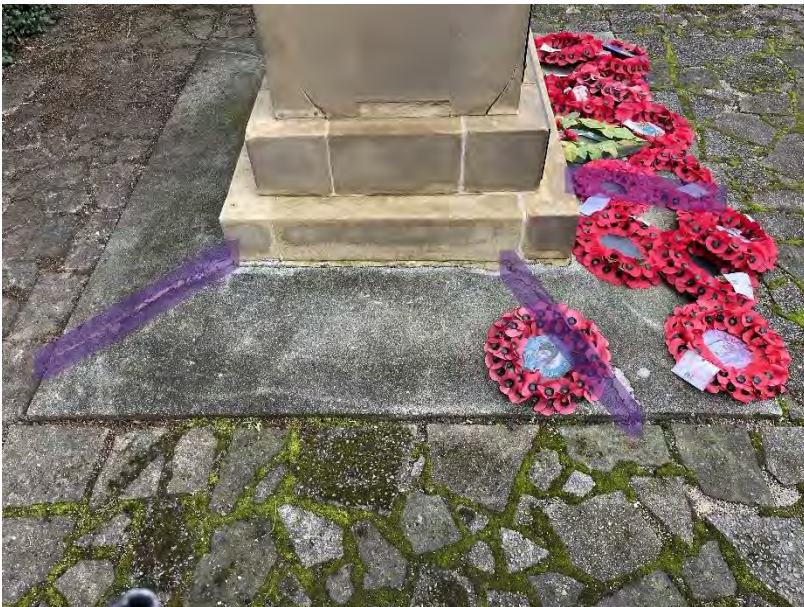
*Photo 44 left side of apron showing cracks (highlighted in purple)*

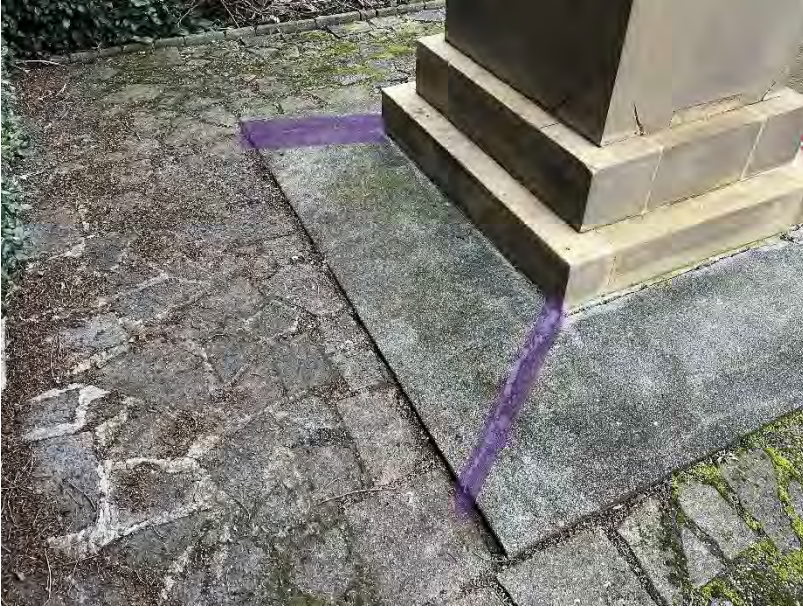
*Photo 45 rear of apron showing cracks (highlighted in purple)*

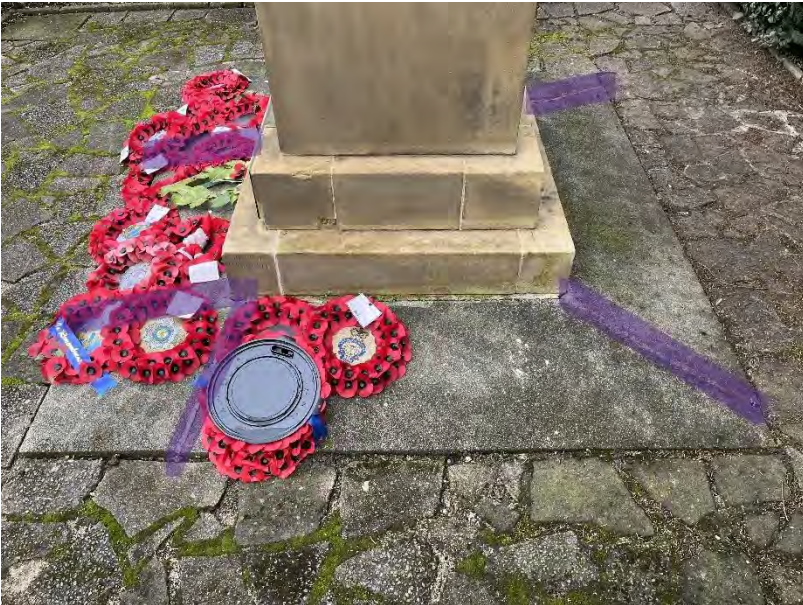
*Photo 46 right side of apron showing cracks (highlighted in purple)*
