### GAS MEMBRANE VALIDATION – BELLE VUE

**Project Name: Belle Bue Stadium**

**Plots: 226-227**

## Inspection Gas Membrane

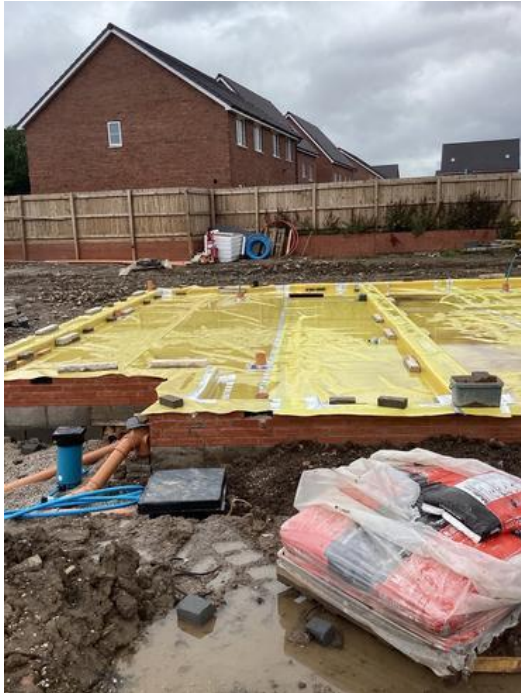
Photo 1

Gas Membrane Type: Manufacturer, gauge, and colour.

Yellow visqueen

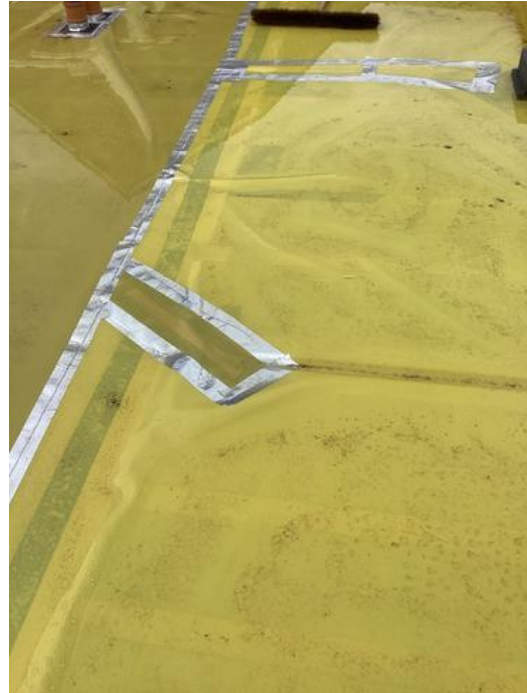
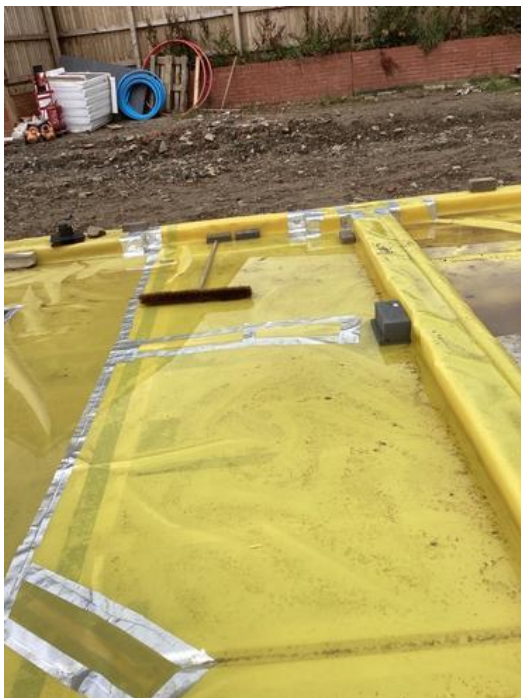
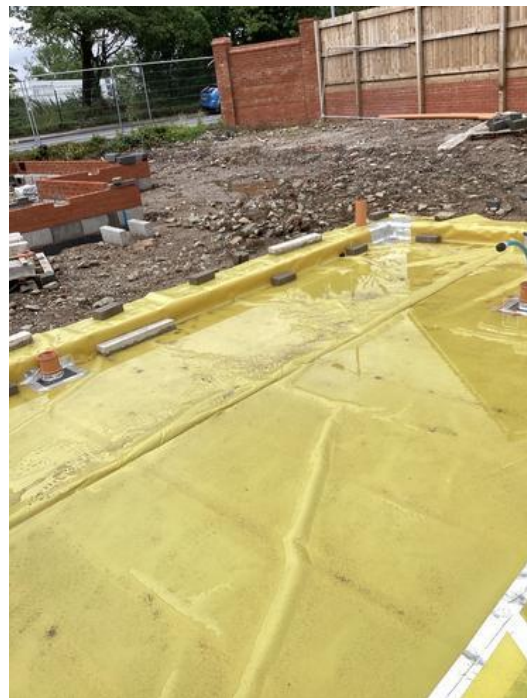
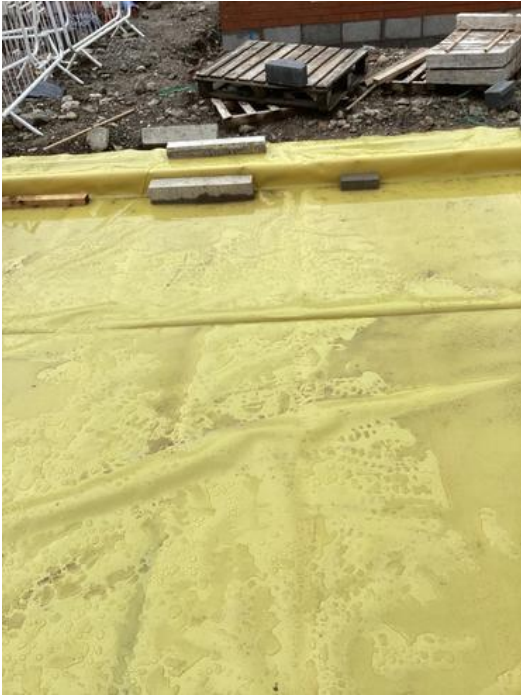
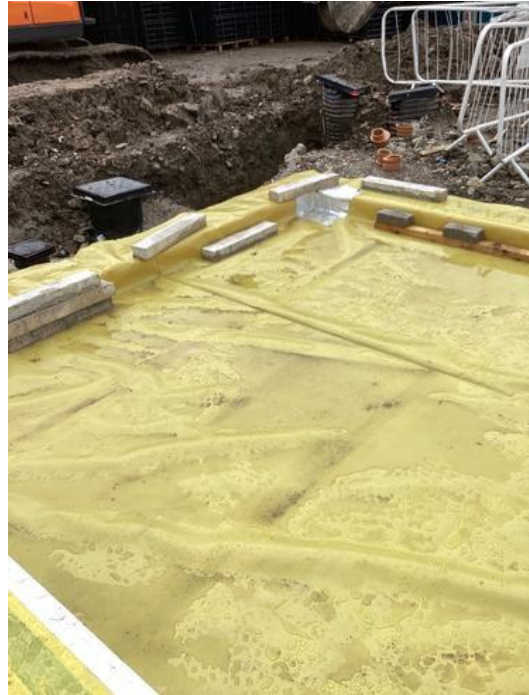
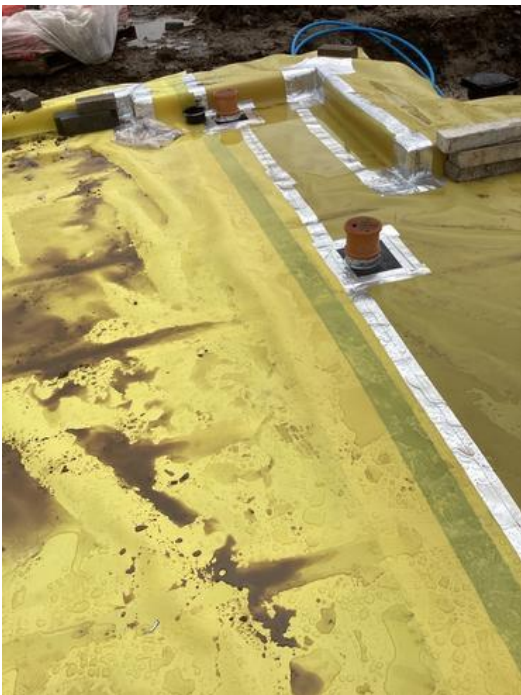
Gas Membrane Condition: Open punctures, tears, rips, stretching, Presence of debris, Repairs, Signs of weakness such as raised or sunken indentations, Protection plan in place to restrict access to lain gas membrane? IF FAIL DESCRIPTION IN ACTIONS AND PHOTOS REQUIRED

Pass

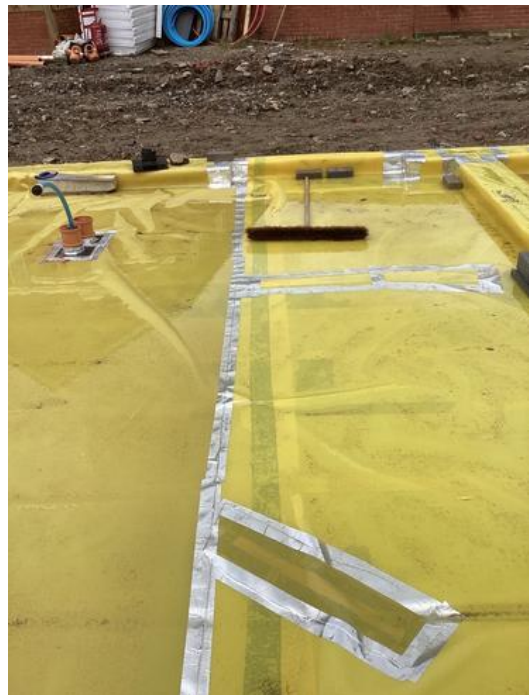
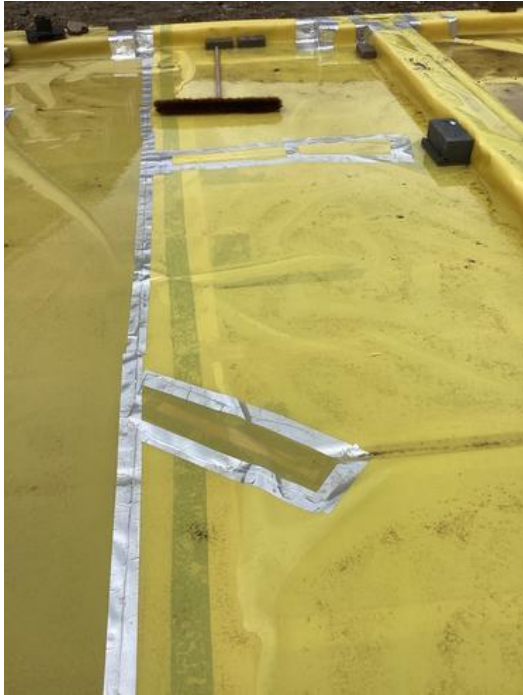
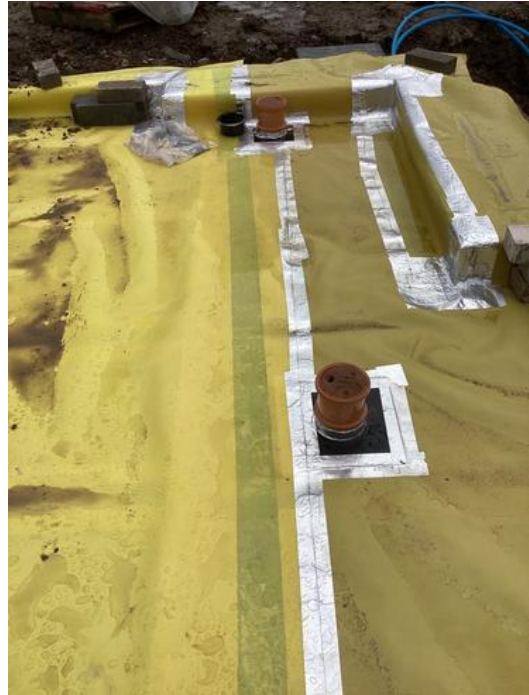
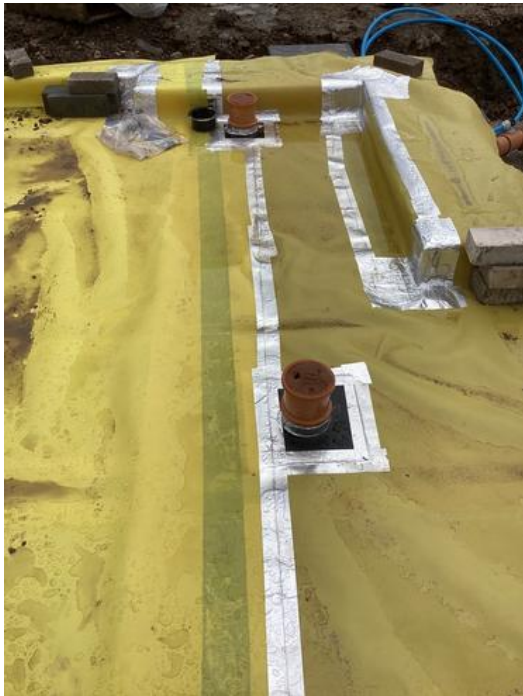
Laps, welds, and joints seals: Joints lapped and sealed in accordance with manufacturer's requirements/ specification? Minimum overlap insured? Sections taped twice? Are welds complete? Appropriate joining/double-sided tape used, Folds running in line with joints? (no joints cutting across folds)

Pass

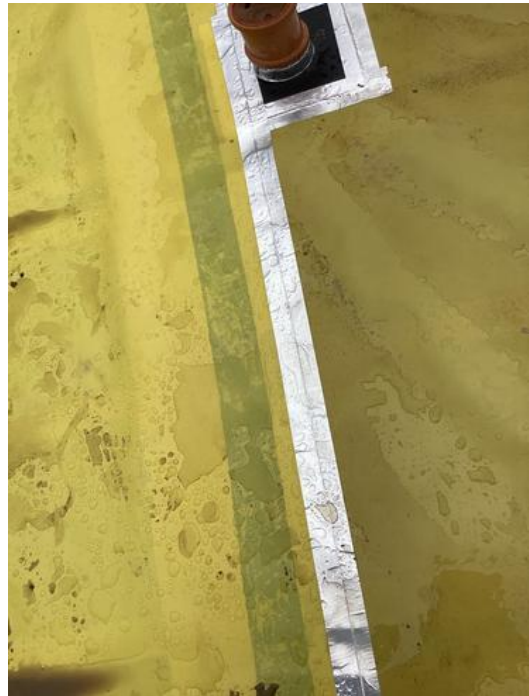
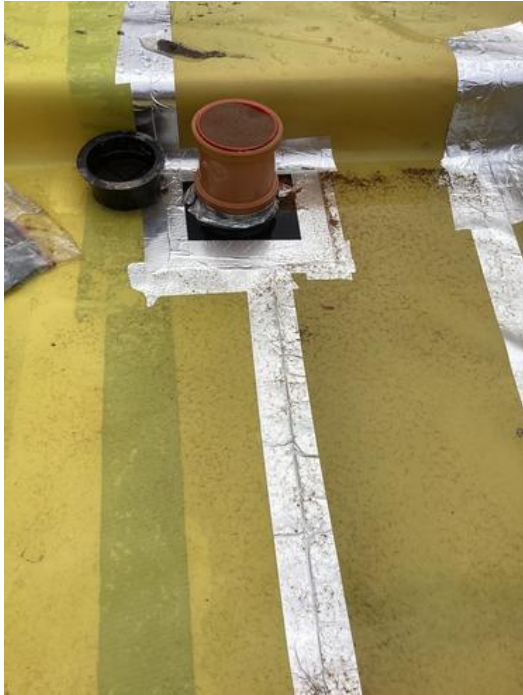
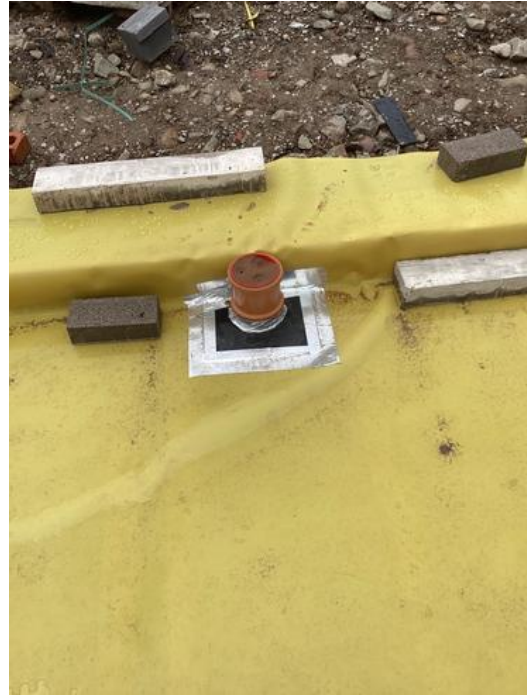
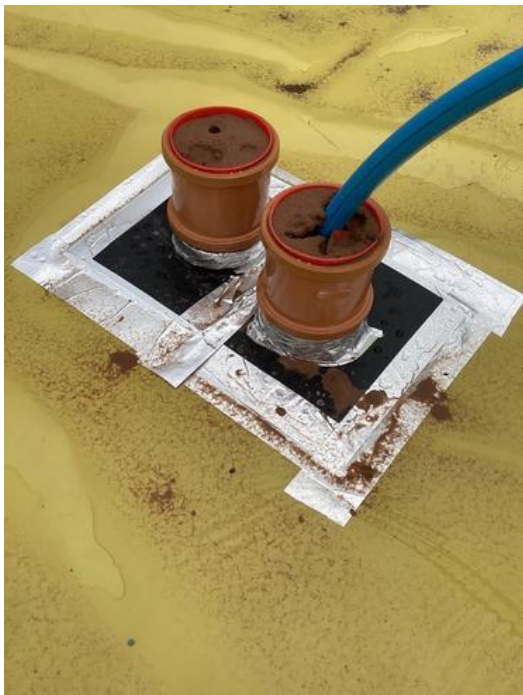
**Service entries seals: Top hats seal arrangements fixed around service entries? Use of Jubilee clips?**

Yes

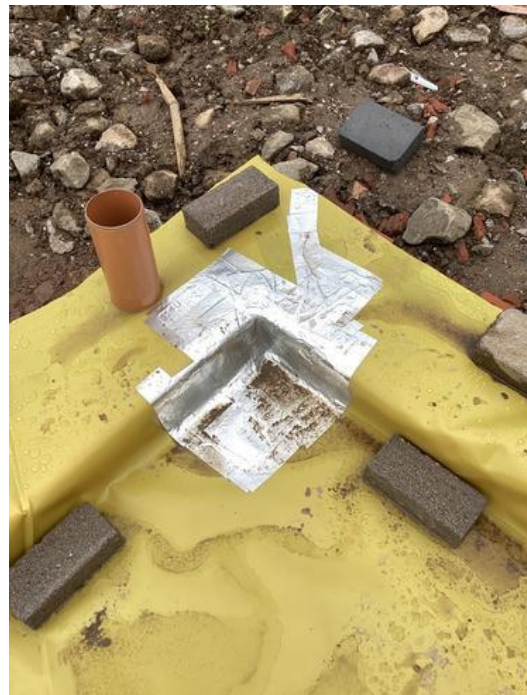
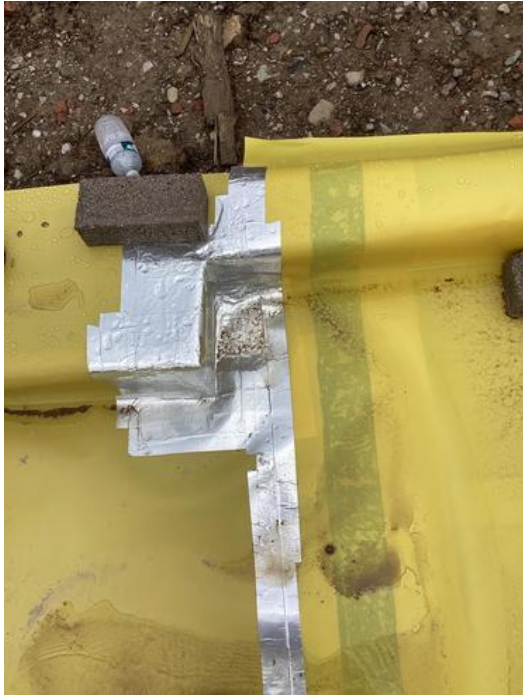
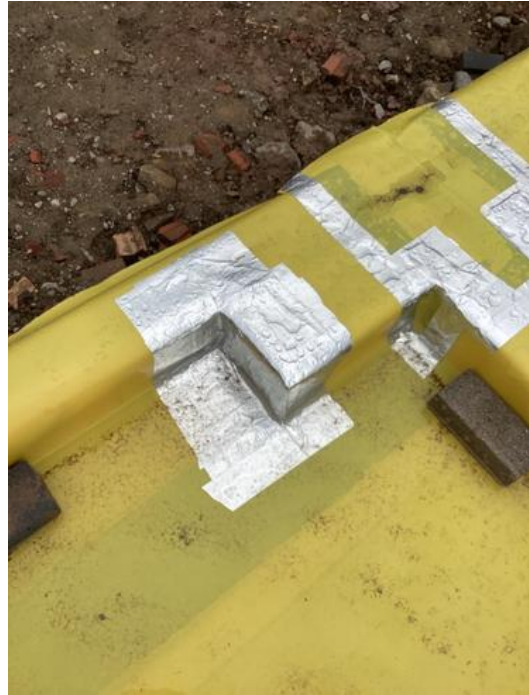
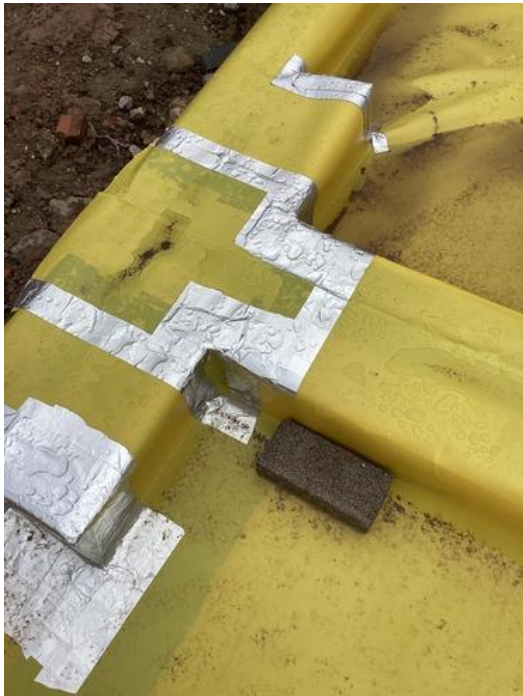
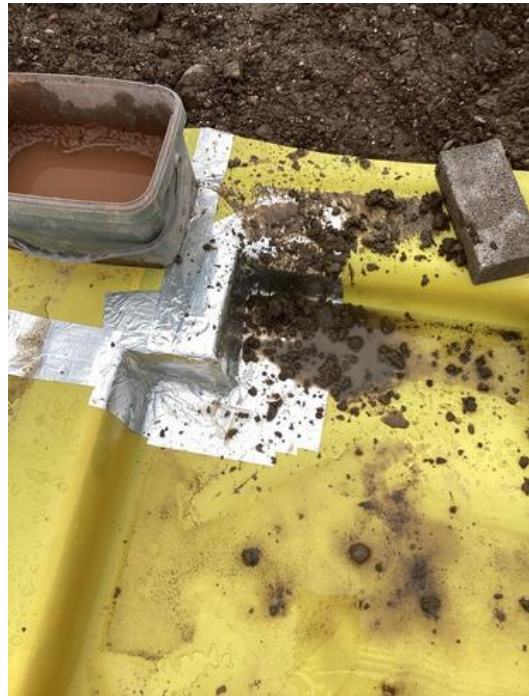
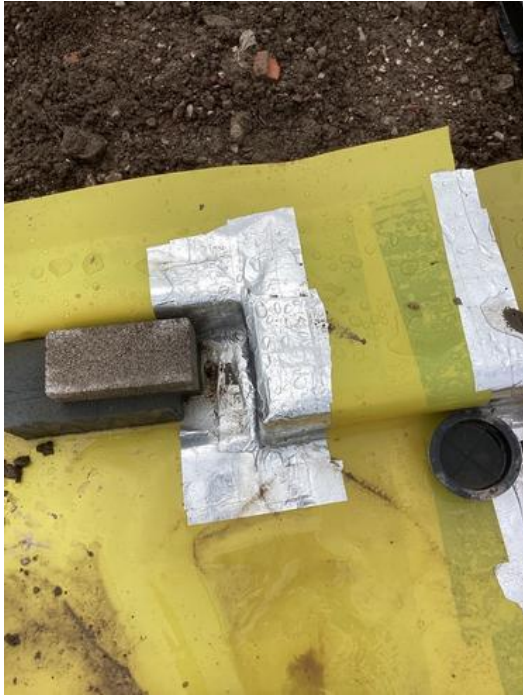
**Corners / Internal joints: Check all corners are correctly formed or contractor has used preformed corners.**

Pass

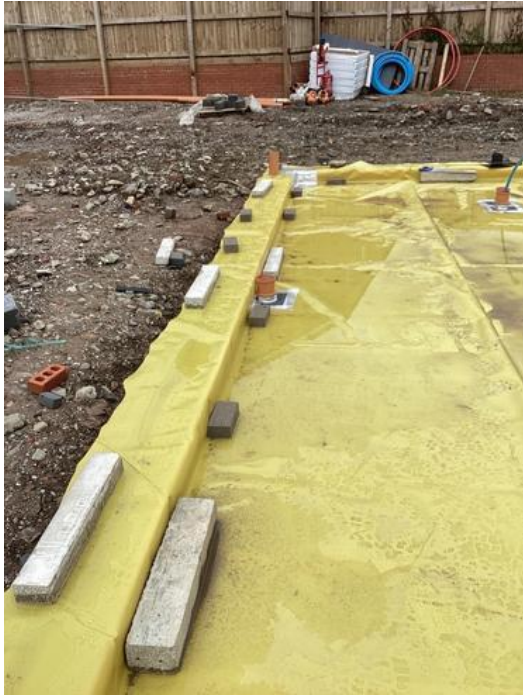
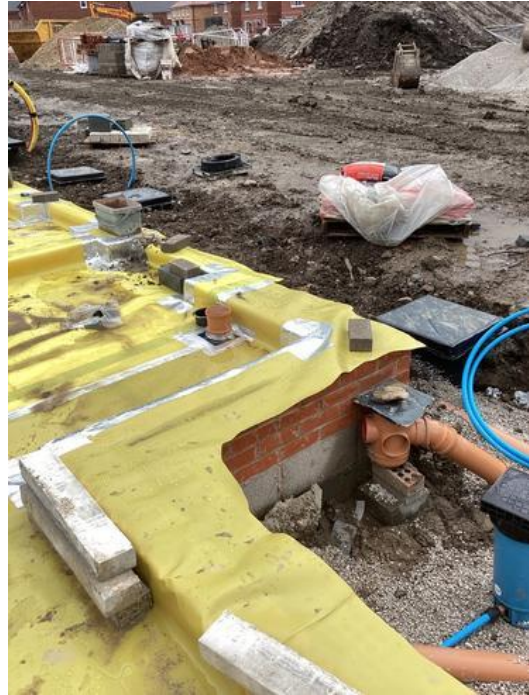
**Extent of Coverage: Is the membrane covering the entire plot? Does membrane span over outside walls?**

Yes

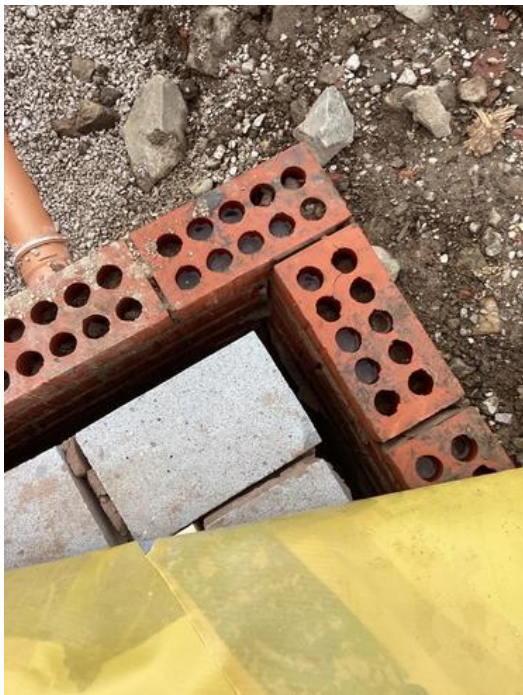
Photo 27

**Condition of sub-grade and underside of gas membrane: Check that the subgrade does not contain rough/uneven surfaces, is appropriately clean and that there are no hard/sharp objects. That protective sand blinding or geotextile (if specified) is present and meets the design criteria.**

Pass

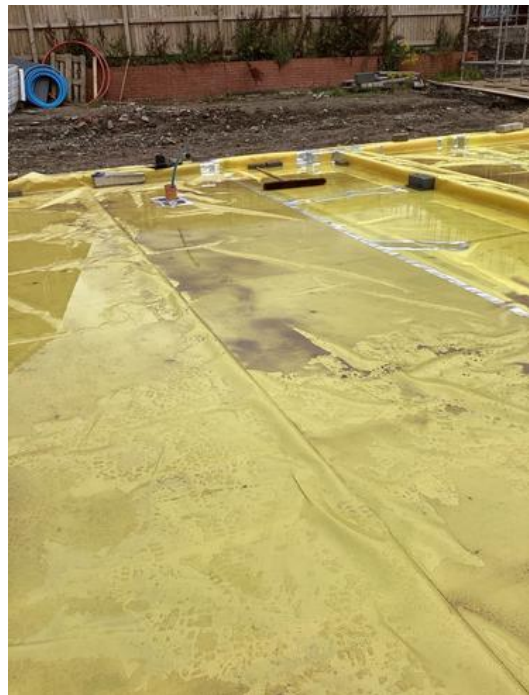
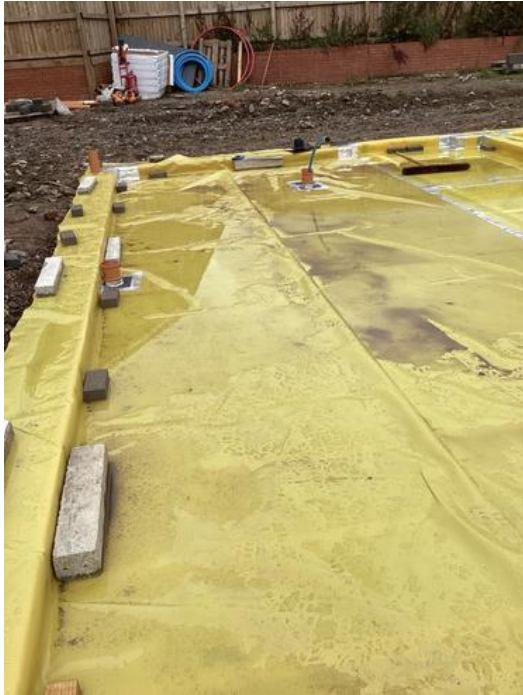
**Slab / membrane condition (is membrane clear of debris or insulation): Can membrane be fully seen and photographed – ask contractor to remove an debris so membrane can be fully seen and inspected – this is a requirement of NHBC and local authorities.**

Pass

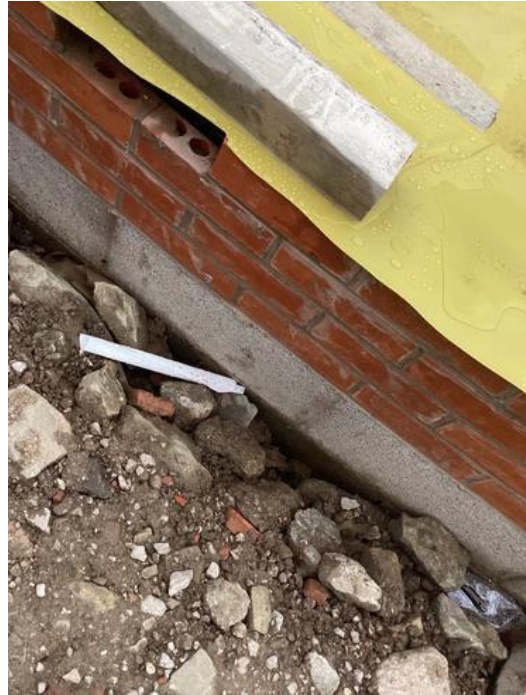
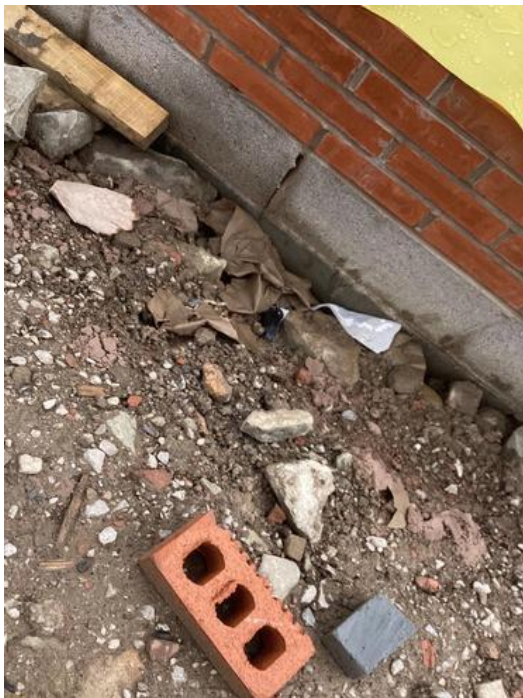
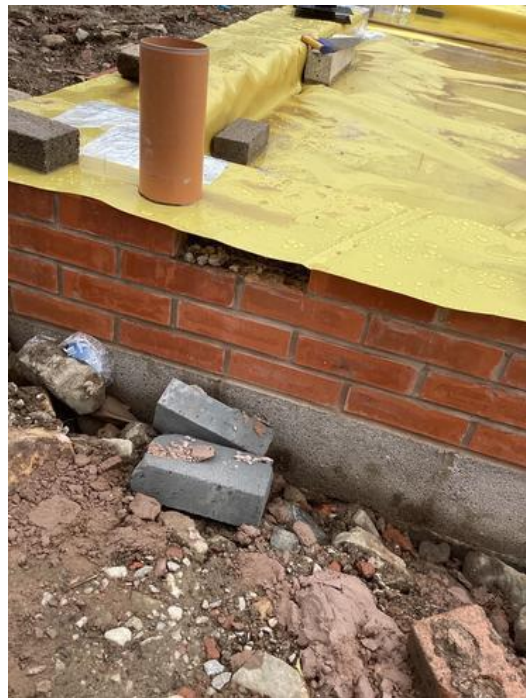
**External Wall Air bricks: Numbers, size. positions as design drawing? (Minimum of 3 walls)**

Pass

Holes left for air bricks,site didn't have any in stock

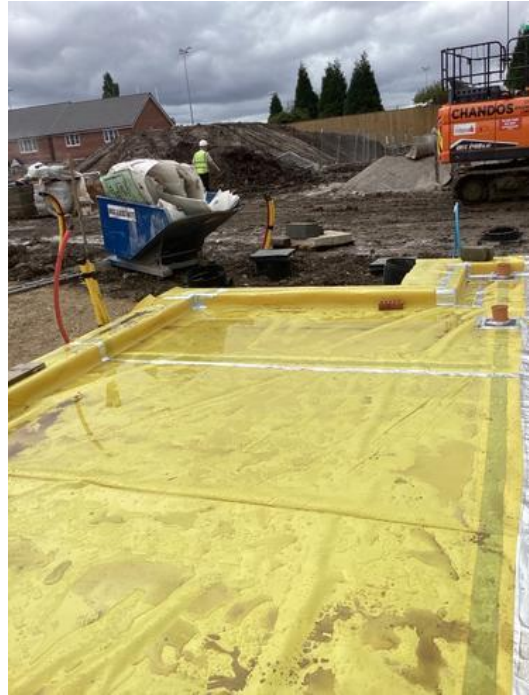
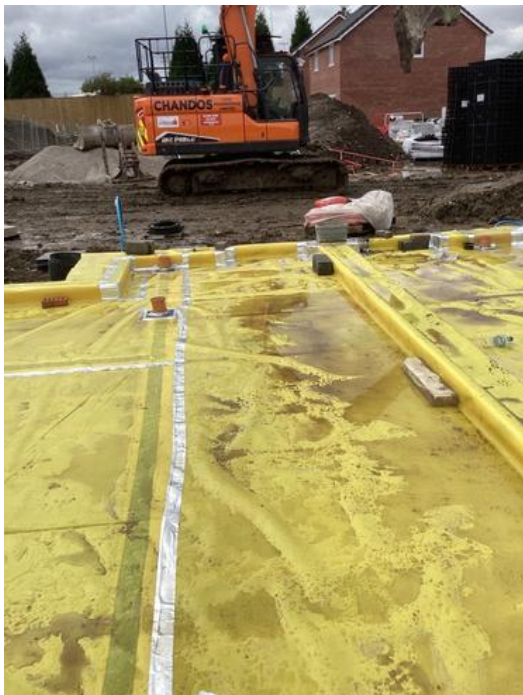
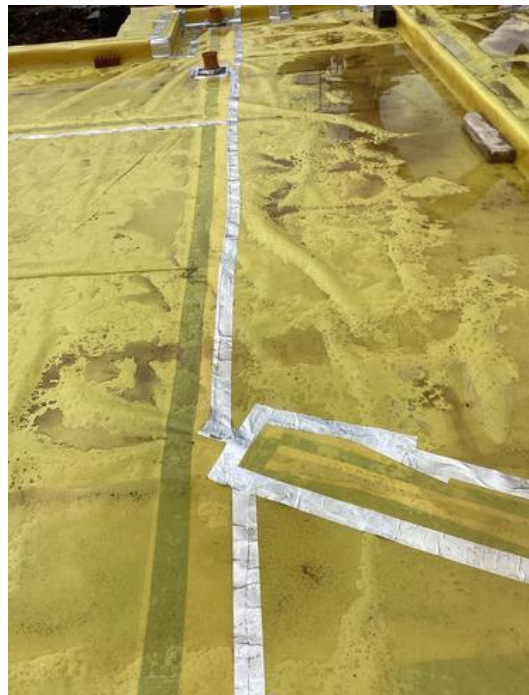
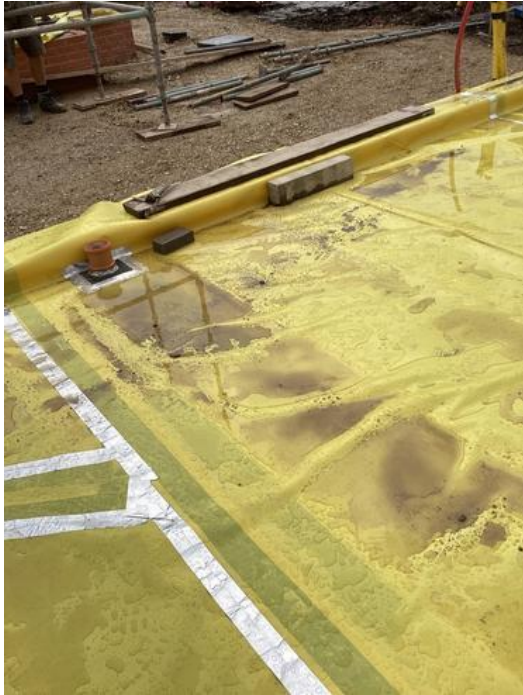
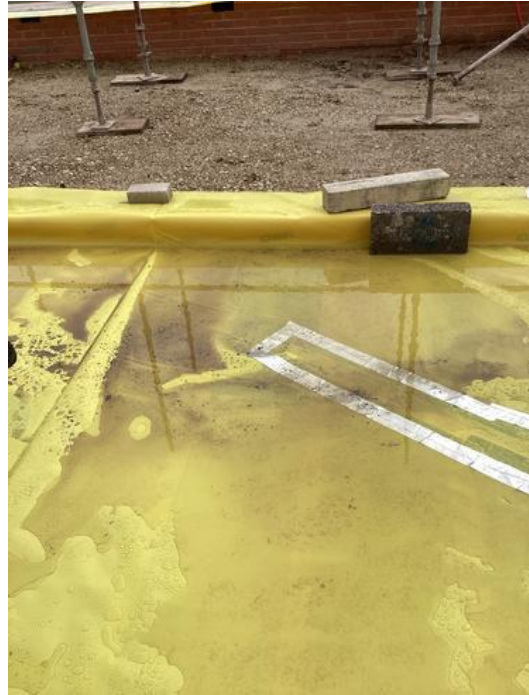
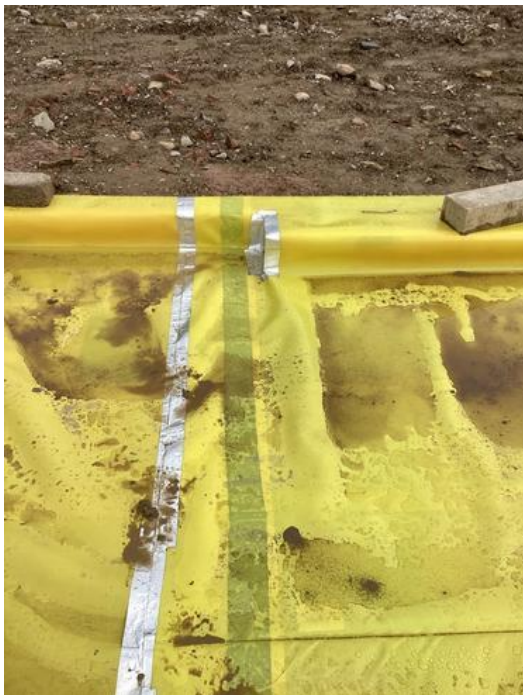
Gas Membrane Condition: Open punctures, tears, rips, stretching, Presence of debris, Repairs, Signs of weakness such as raised or sunken indentations, Protection plan in place to restrict access to lain gas membrane? IF FAIL DESCRIPTION IN ACTIONS AND PHOTOS REQUIRED

Pass

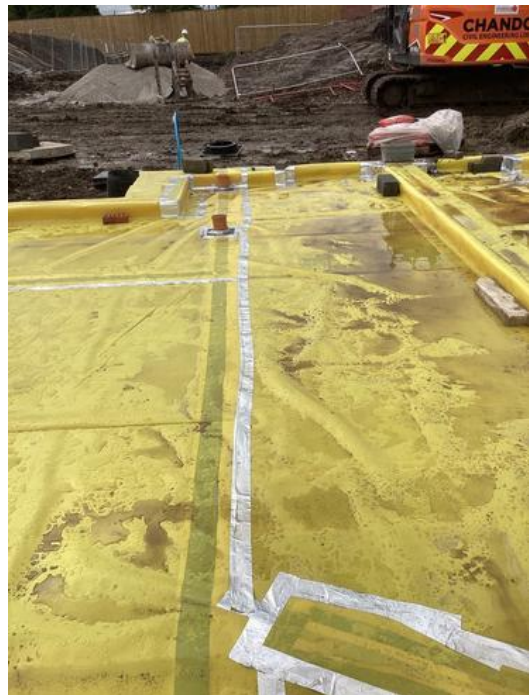
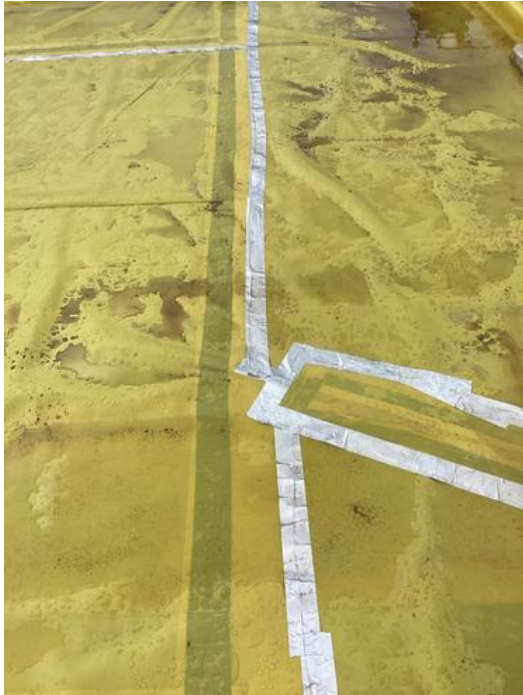
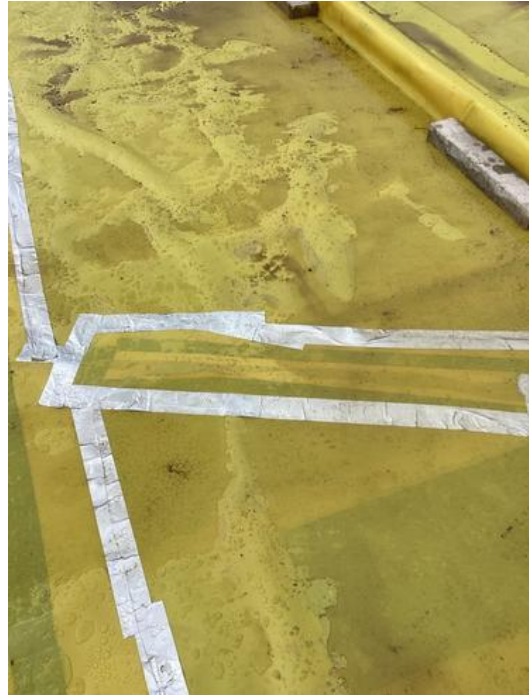
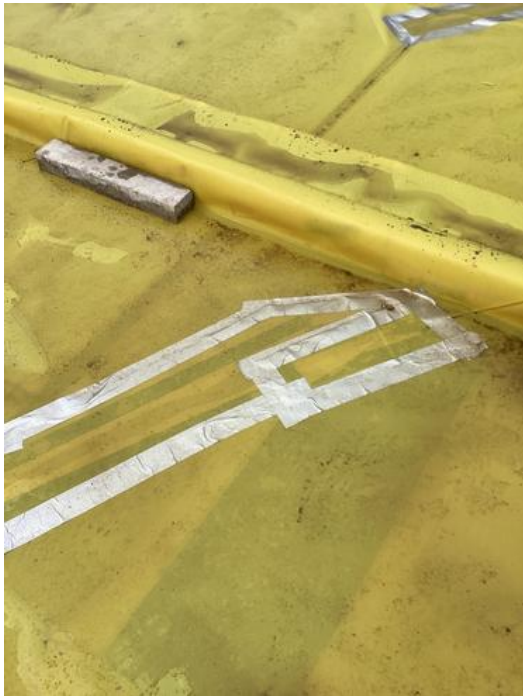
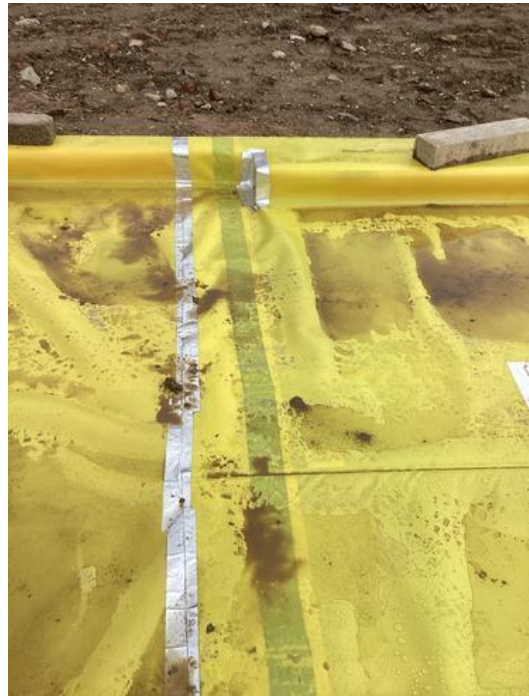
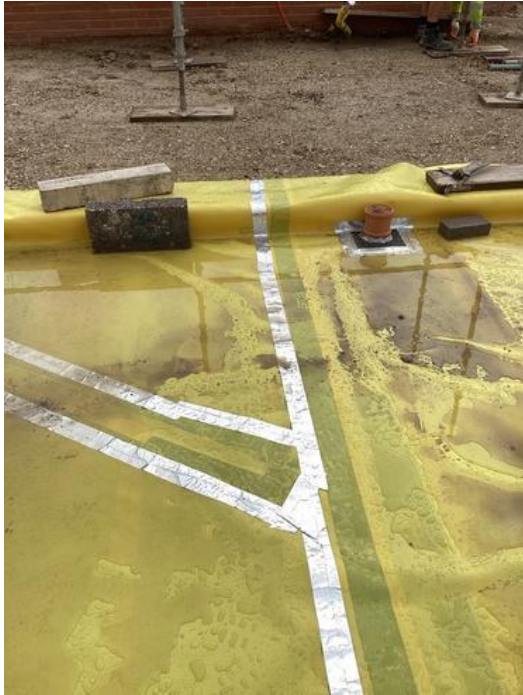
Laps, welds, and joints seals: Joints lapped and sealed in accordance with manufacturer's requirements/ specification? Minimum overlap insured? Sections taped twice? Are welds complete? Appropriate joining/double-sided tape used, Folds running in line with joints? (no joints cutting across folds)

Pass

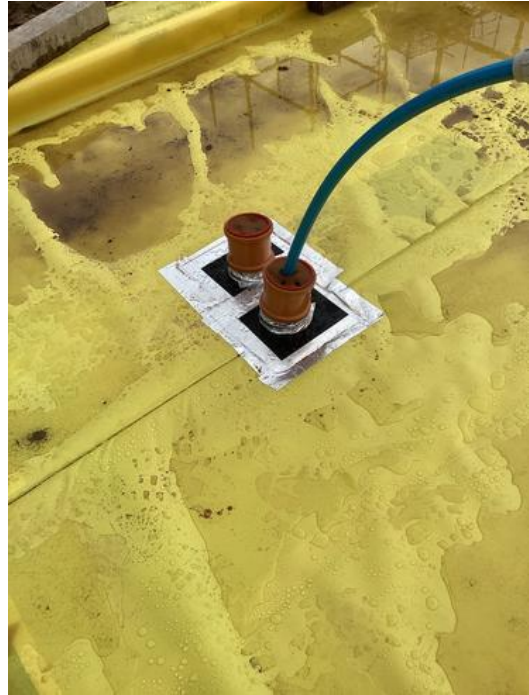
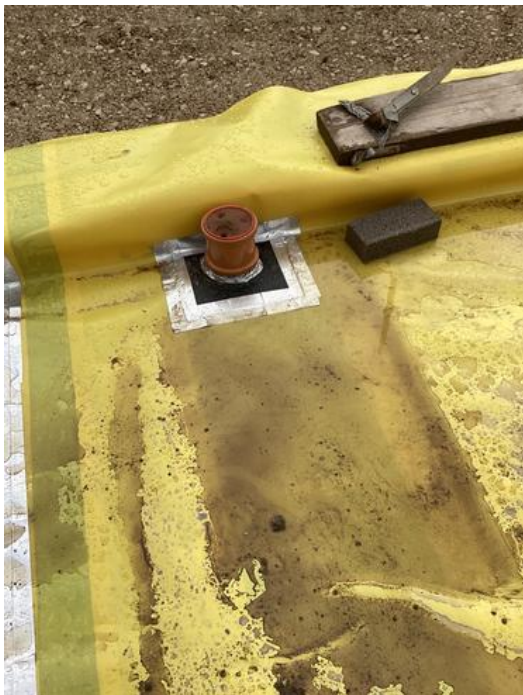
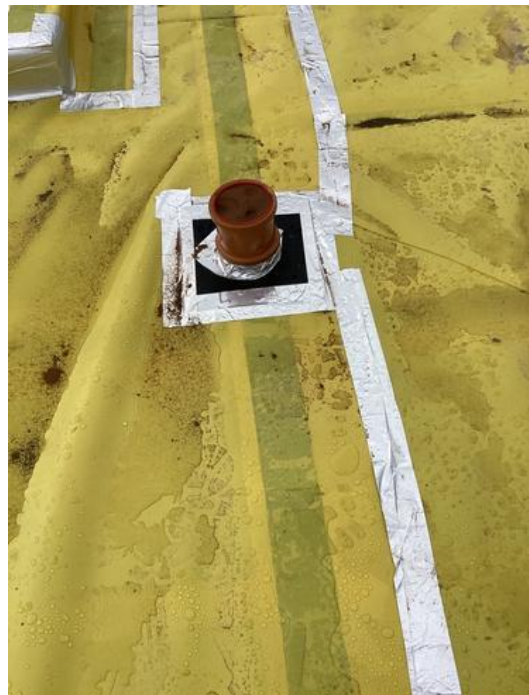
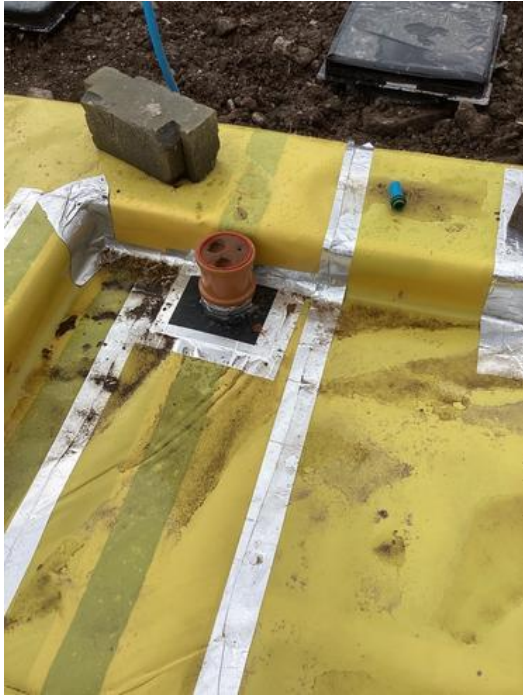
Service entries seals: Top hats seal arrangements fixed around service entries? Use of Jubilee clips?

Yes

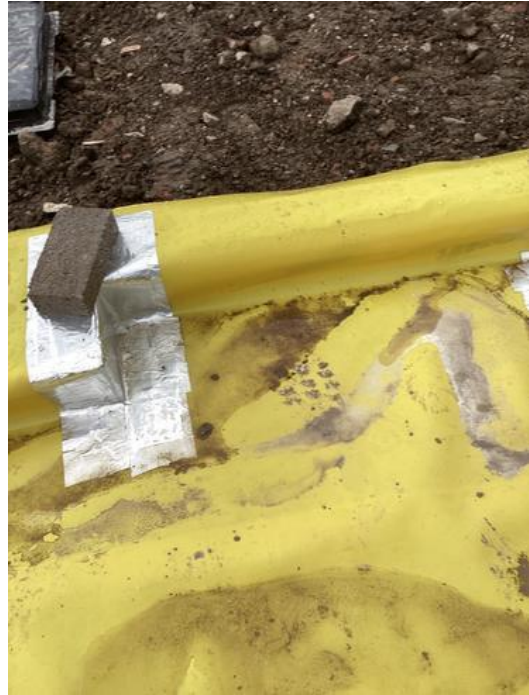
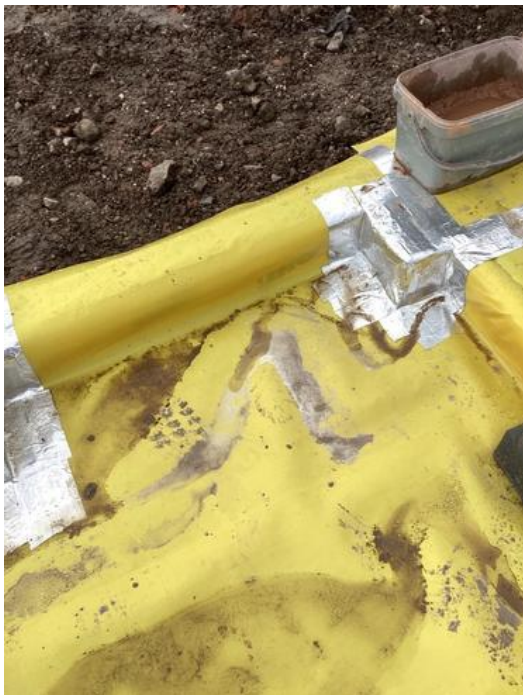
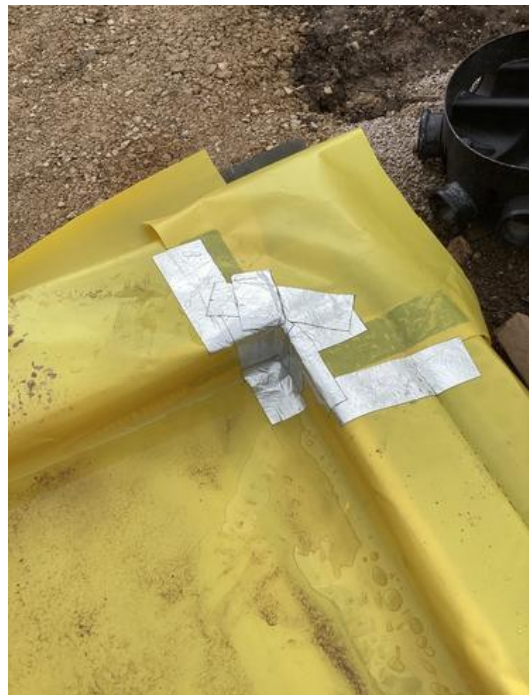
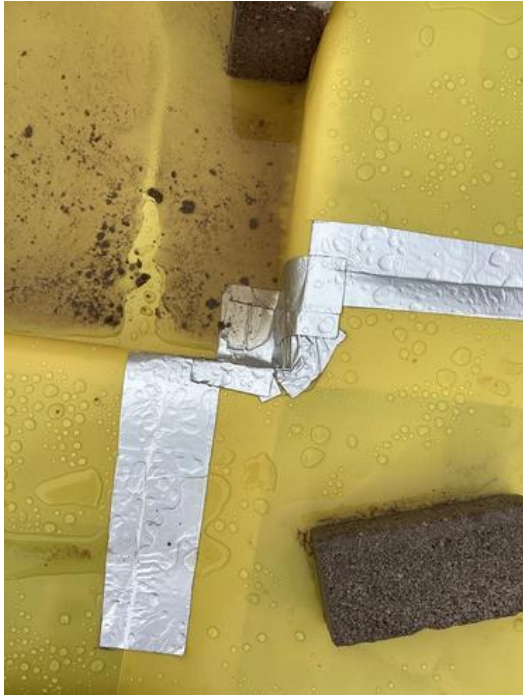
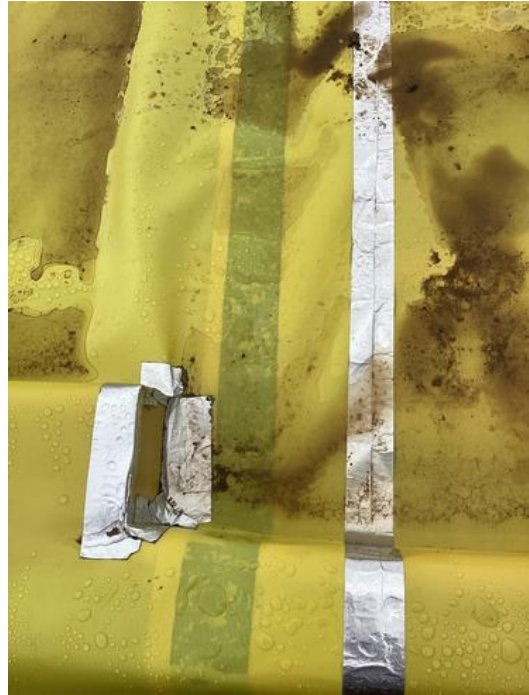
**Corners / Internal joints:** Check all corners are correctly formed or contractor has used preformed corners.

Pass

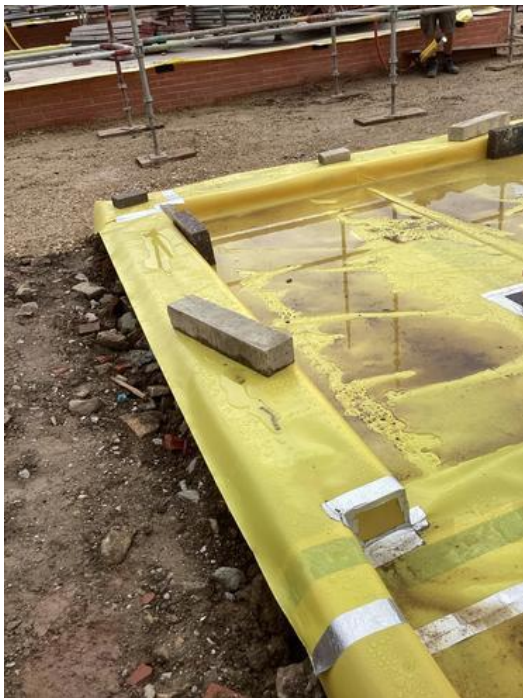
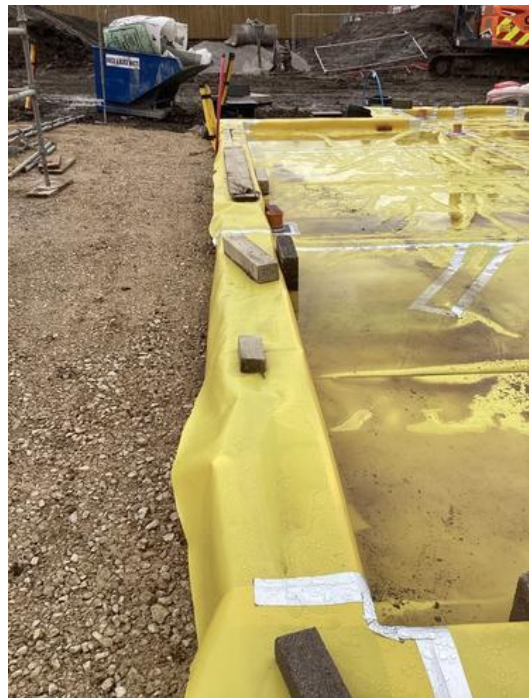
**Extent of Coverage:** Is the membrane covering the entire plot? Does membrane span over outside walls?

Yes

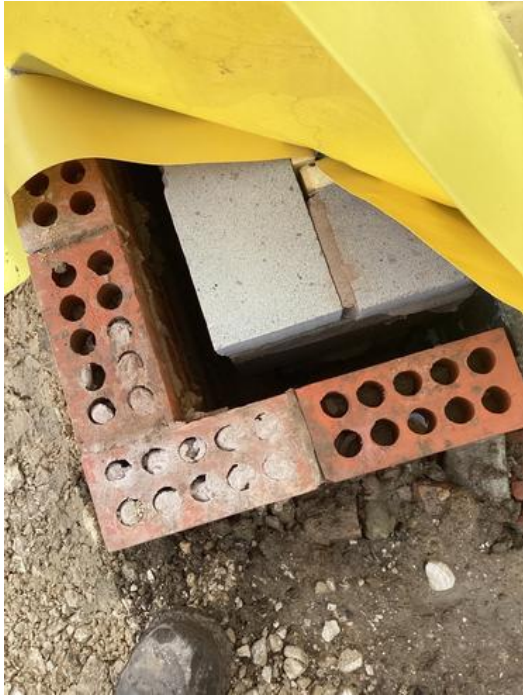
Photo 57

**Condition of sub-grade and underside of gas membrane:** Check that the subgrade does not contain rough/uneven surfaces, is appropriately clean and that there are no hard/sharp objects. That protective sand blinding or geotextile (if specified) is present and meets the design criteria.

Pass

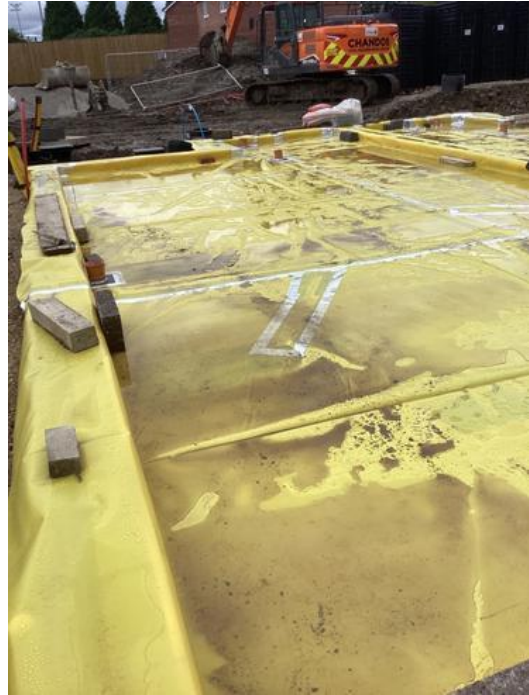
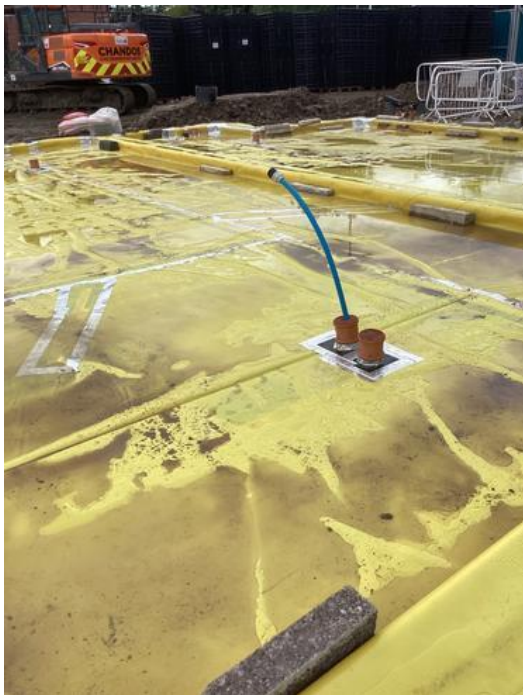
**Slab / membrane condition** (is membrane clear of debris or insulation): Can membrane be fully seen and photographed – ask contractor to remove an debris so membrane can be fully seen and inspected – this is a requirement of NHBC and local authorities.

Pass

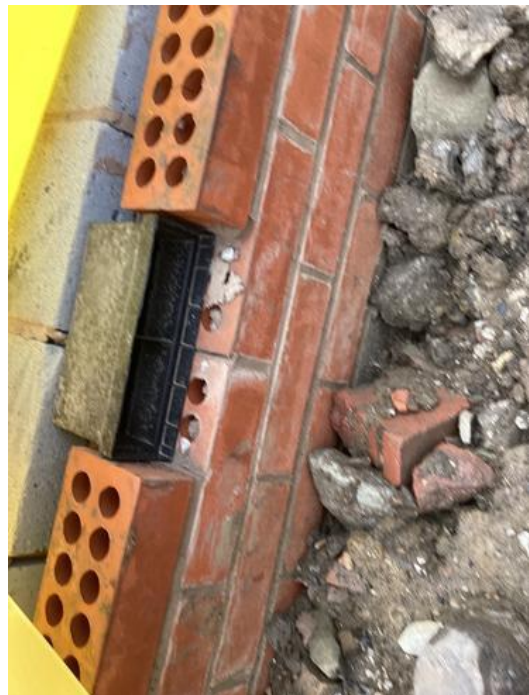
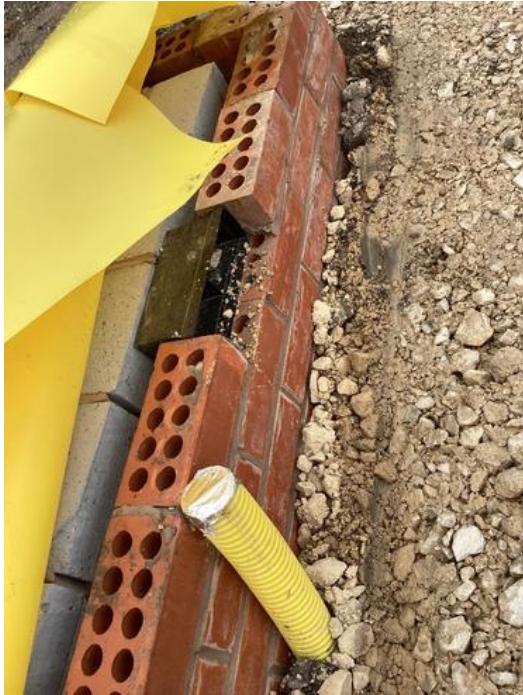
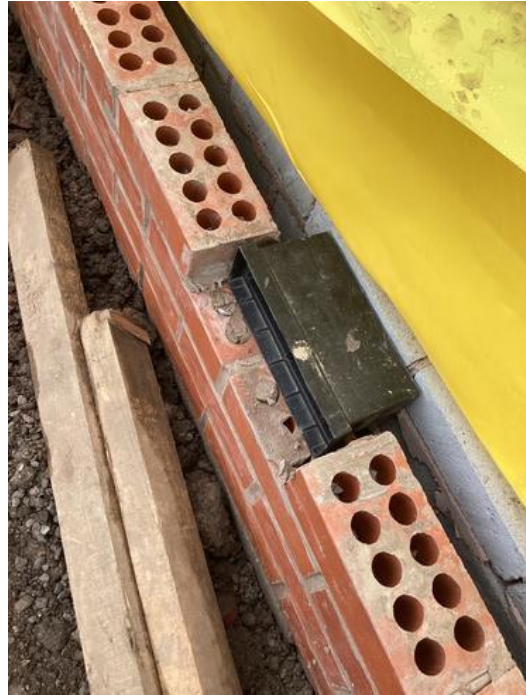
**External Wall Air bricks: Numbers, size. positions as design drawing? (Minimum of 3 walls)**

Pass
