# SIKA ROOFING ROOF CONDITION REPORT

PROJECT: Middle Warehouse Balconies, 2025  
PROJECT REF: 0536183  
DATE: 28 April 2025

# 1 0536183 MIDDLE WAREHOUSE BALCONIES, 2025 ROOF CONDITION REPORT

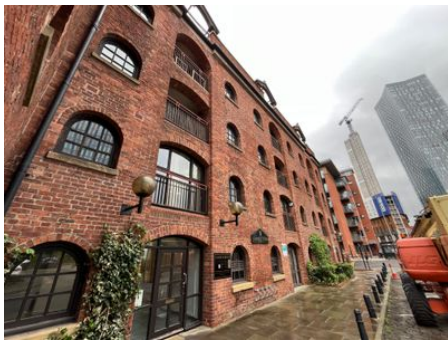
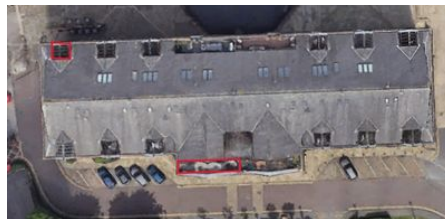
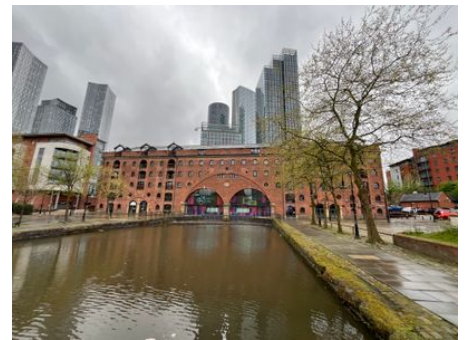
**Project Overview:** Sika were invited to site by Anstey Horne to look at the next phase of works on the residential flats at Castle Quay in Salford. Two properties were accessible at the time of visit but the scope of works will be wider than this. The balconies are all identical, and as such the recommendations of this report can be used across all roof areas.

**Roof Surfaces & Internal Gutter Runs** - The proposed **Sika Limited** roofing system is to be installed utilising the existing falls.

**Note:** *Should the existing falls not be corrected, standing water will remain following installation of the proposed system.*

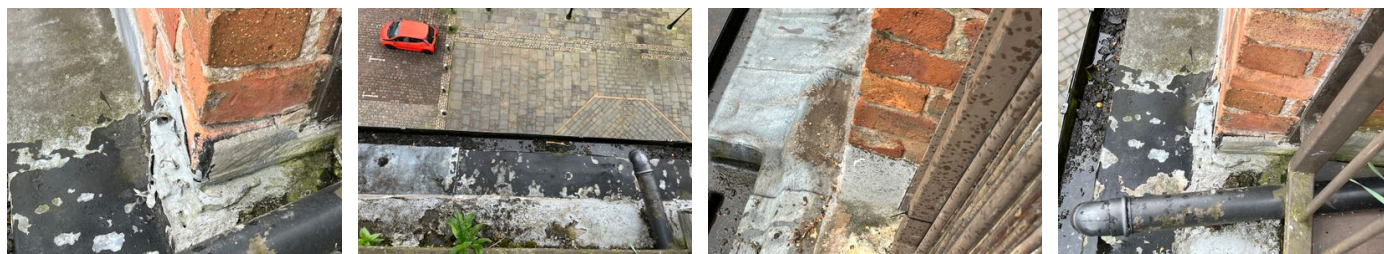
**Historical Repairs:** Local areas on both terraces show examples of patch repairs, affirming the reports that the roof has experienced leaks in the past. These will need to be suitably removed to allow the new system to be installed.

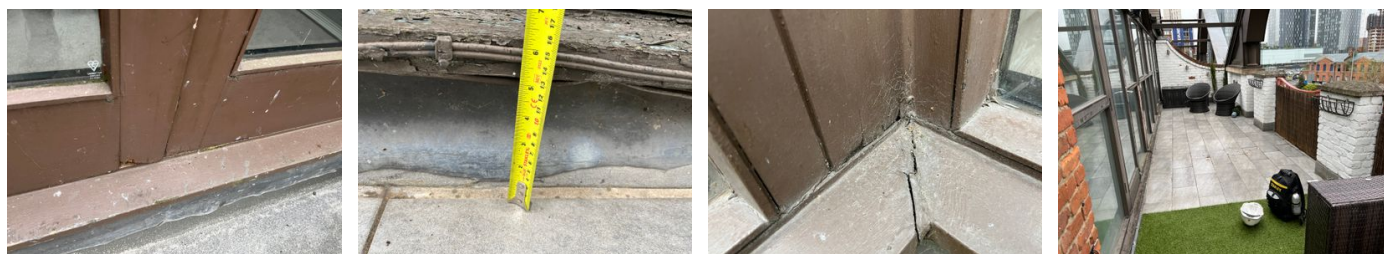
**Door Thresholds:** On each area there are, of course, doors to allow access for residents. These currently sit well above the minimum 150mm required by BS6229 and as such there is no need to raise the thresholds. It is worth noting that the doors themselves show signs of wear and may need to be replaced to prevent water ingress.

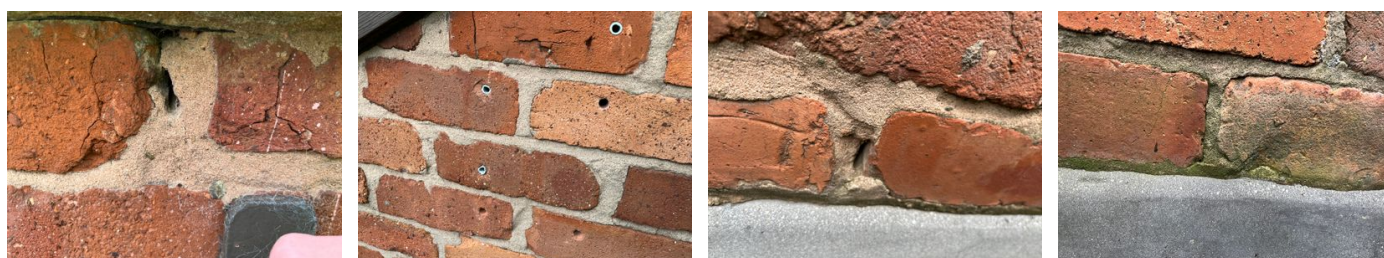
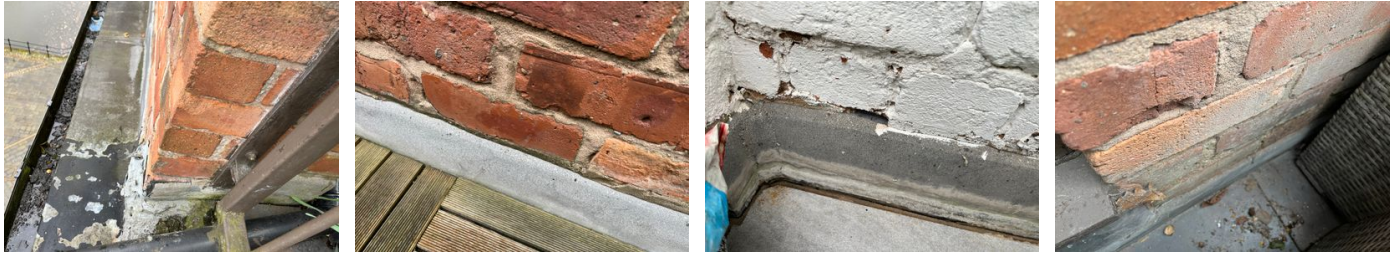
**Brickwork Upstands:** The roof is terminated into the brickwork around west and east perimeters. This has been done poorly: although the 150mm upstand threshold has been met, it has not been suitably chased into the brickwork, finished only with a mastic sealant. This could allow water track through the termination and into the building below. The new system should be chased a minimum of 25mm into the brickwork. It is also worth noting that the brickwork generally shows signs of wear and as such needs to be repointed to prevent water tracking into the spaces below, giving a false impression of a roof leak.

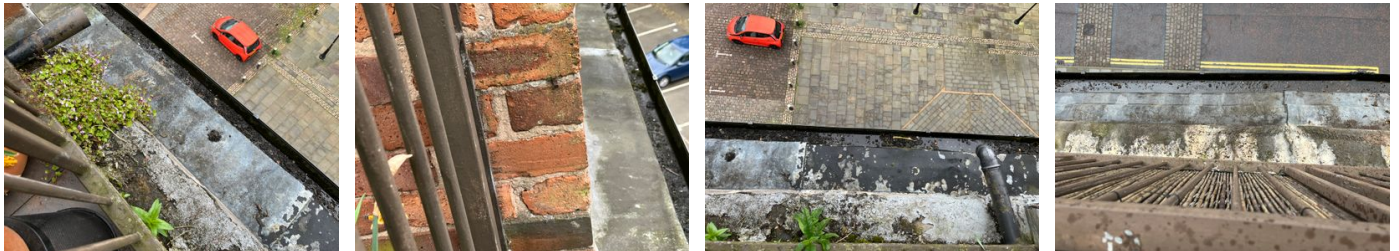
**Drainage:** The roof falls to an external gutter, over a drip edge. This detail is suitable to remain but the waterproofing of the flashings needs to be updated to prevent water tracking through this area. This should be coated in its entirety.
