# **PRELIMINARY STRUCTURAL ENGINEER'S REPORT**

**96 LADYBARN LANE - FALLOWFIELD  
MANCHESTER M14 6YH**

***Job No:* 25/0481**

***Date:* June 2025**

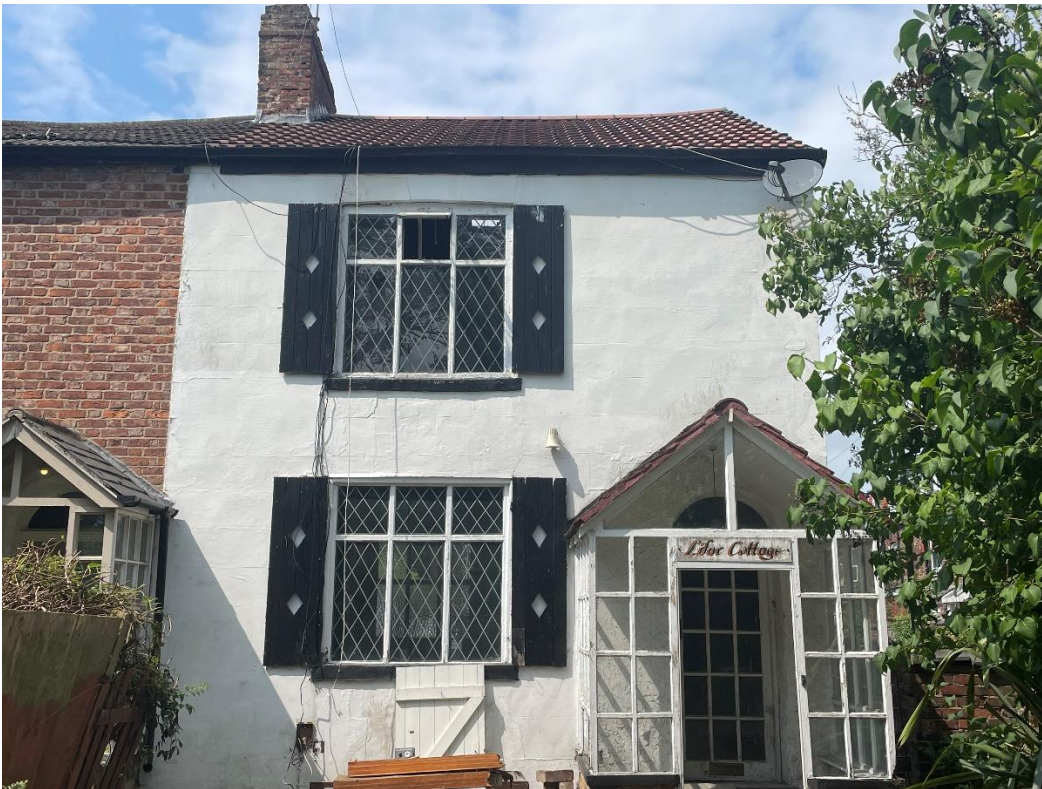
The main pitched roof, on the front elevation, was uneven (see Photo 1), probably due to vertical deflection of the roof purlins. The roof had been overhauled in the past, including the addition of additional roof purlins and the construction of a dormer (see Photo 2), on the rear roof slope and the original roof coverings had been replaced with modern roof tiles.

PHOTO 1 – FRONT ELEVATION – UNEVEN ROOF STRUCTURE

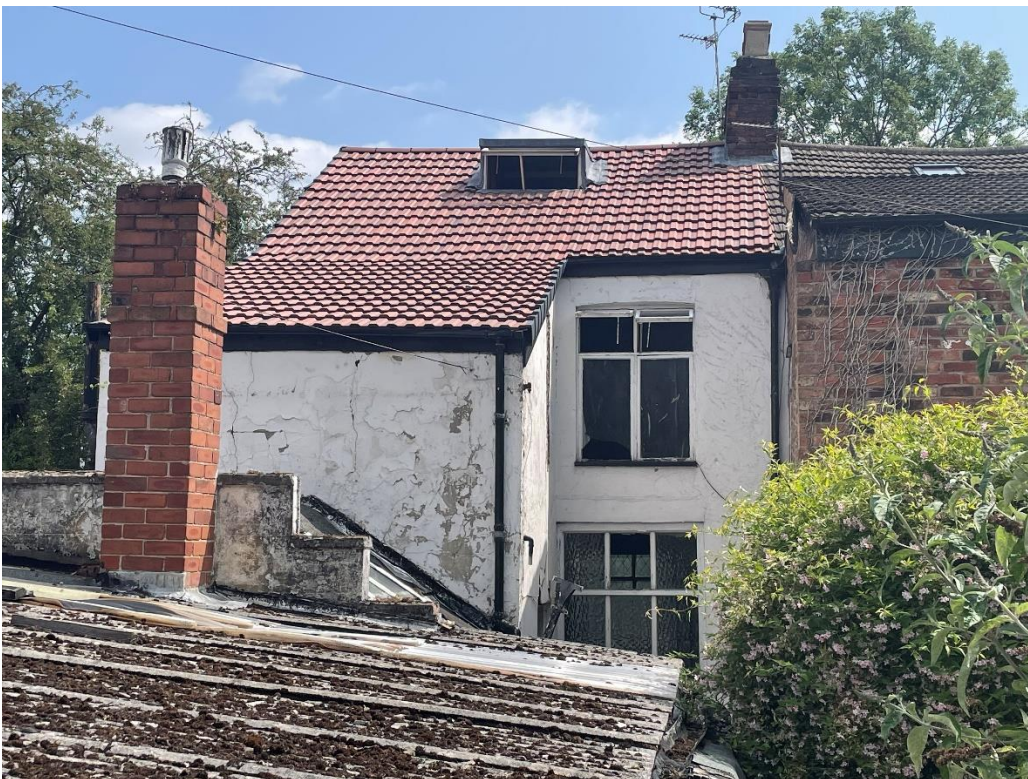
PHOTO 2 – REAR ELEVATION OF MAIN BUILDING WITH MODERN TILED ROOF COVERINGS & DORMER

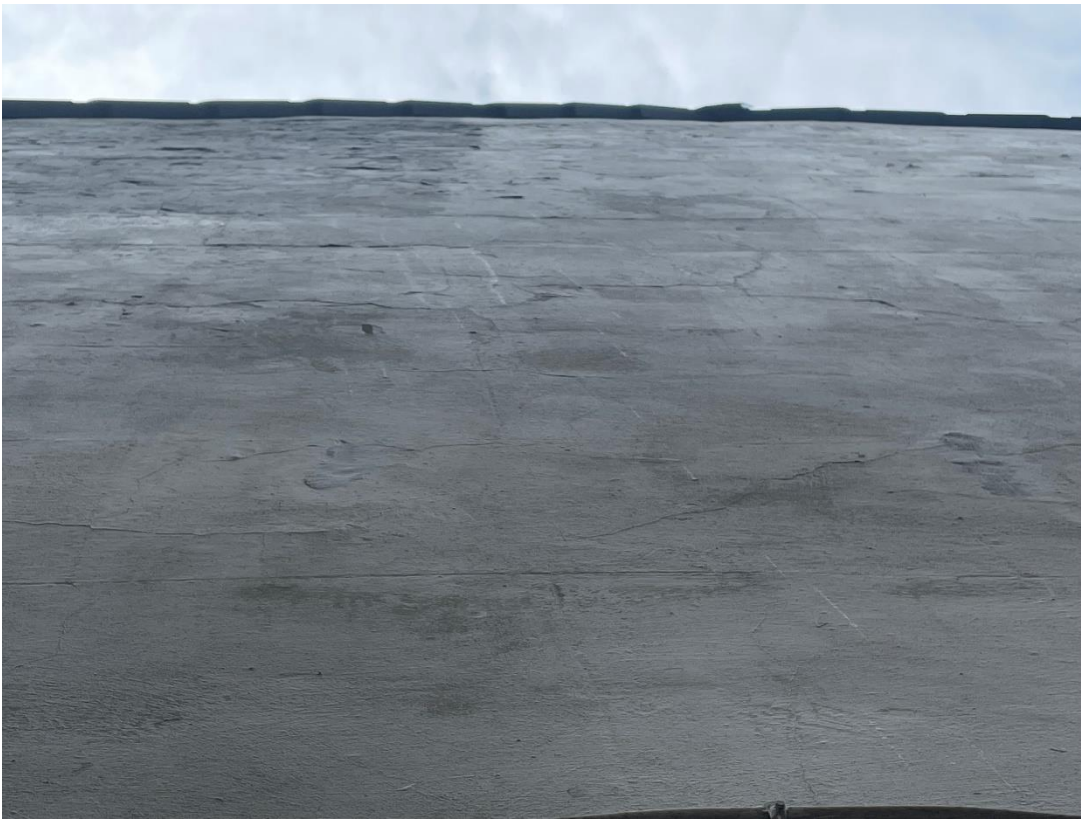
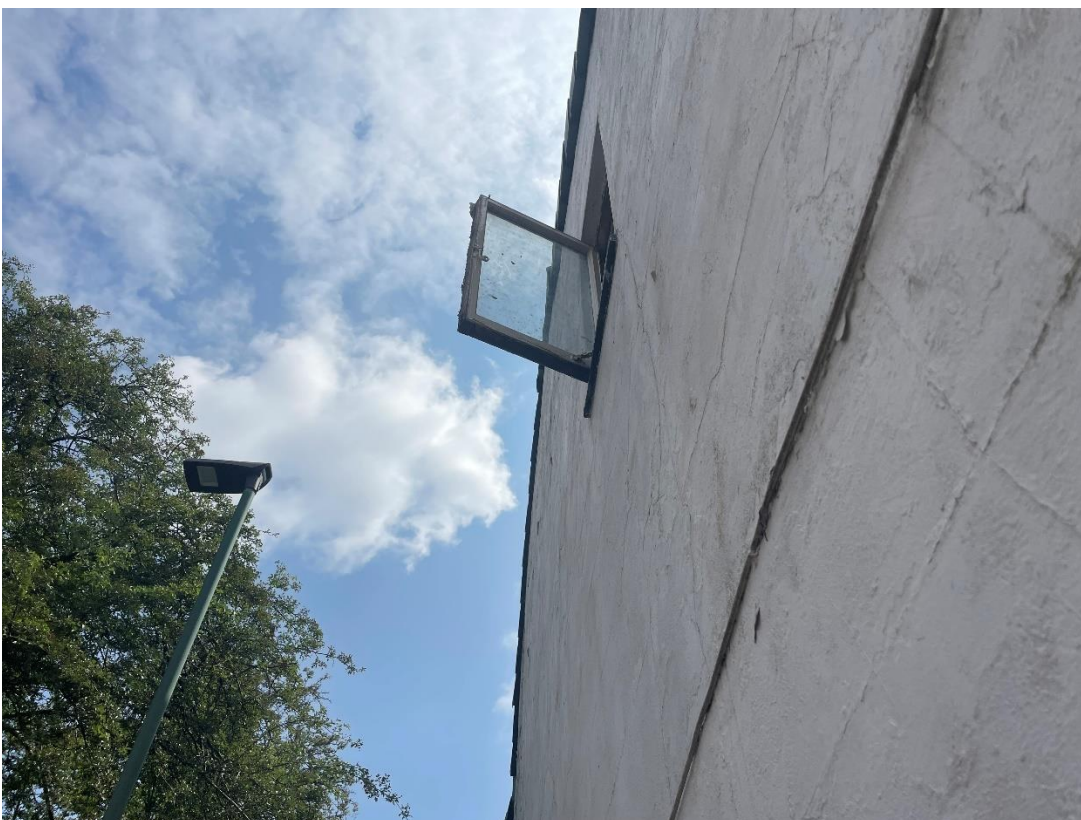
The external walls had a painted render finish, externally. The external gable wall had suffered very significant lateral movement in the past (see Photos 3 & 4). The wall had bowed outwards, above first-floor level, well beyond acceptable limits. The horizontal deflection of the wall was in both the vertical and horizontal planes.

It was difficult to accurately measure the deflections due to the extent of plaster and internal finishes etc. and lack of access externally. Where it was possible to set up a plumb line in one vertical plane, the following outward deflections were measured, relative to a fixed point approximately 250mm above Ground Floor level:

- 50mm at 200mm below Ground Floor ceiling level
- 90mm at 250mm above First Floor level
- 110mm at 150 below First Floor ceiling level.

Other sections of the gable wall had suffered greater deflections, which could not be measured at the time, due to the reasons highlighted above.

The external gable wall was the area of greatest concern. The lateral movement/deflection was well beyond acceptable limits and previous attempts to arrest the movement were unsuccessful.

PHOTOS 3 & 4 – BADLY DEFLECTED GABLE WALL

The existing wall should be;

a) carefully taken down/dismantled to external ground level and rebuilt in 225mm solid brickwork in 'Flemish Bond' and appropriate lime mortar, built off a new reinforced concrete capping beam on top of the new and existing Basement walls, subject to further investigations into the structural adequacy of the Basement walls.

b) the existing wall should be provided with a suitable lateral restraint system, e.g. steel tie rods and end plates, fixed to new internal floor beams, at First and Second floor levels (subject to further investigations into the structural integrity of the existing gable wall).

Bearing in mind the perished condition of the existing gable wall brickwork, we would anticipate that Option b) would still require some areas of the gable wall masonry to be rebuilt and would require the installation of additional steelwork beams and tie-rod arrangements, internally, which are likely to result in more extensive disturbance and intrusions into existing fabric of the building.

In addition, the existing wall should be tied/toothed-in to the existing internal walls and a strapping arrangement installed between the gable wall and the roof structure. Additional buttressing walls/piers should be constructed in the Basement, to provide additional lateral support and in the upper floors, where possible (e.g. be relocating doors from the side of the gable).

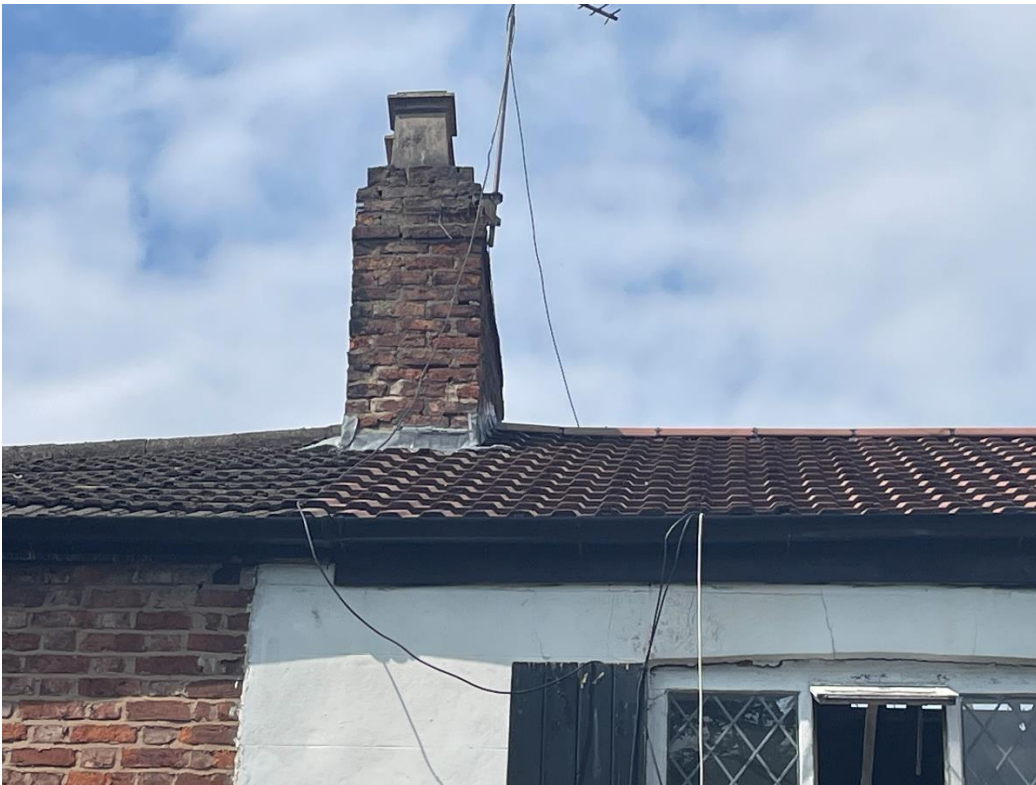
The main chimney stack, which extended above the party wall with No. 98 Ladybarn Lane, was leaning badly at the top (see Photo 5) and the exposed brickwork had an aged and weathered appearance.

**PHOTO 5 – LEANING CHIMNEY STACK**

The retained sections of the existing brickwork should be repointed, throughout, and the leaning chimney stack should be taken down.

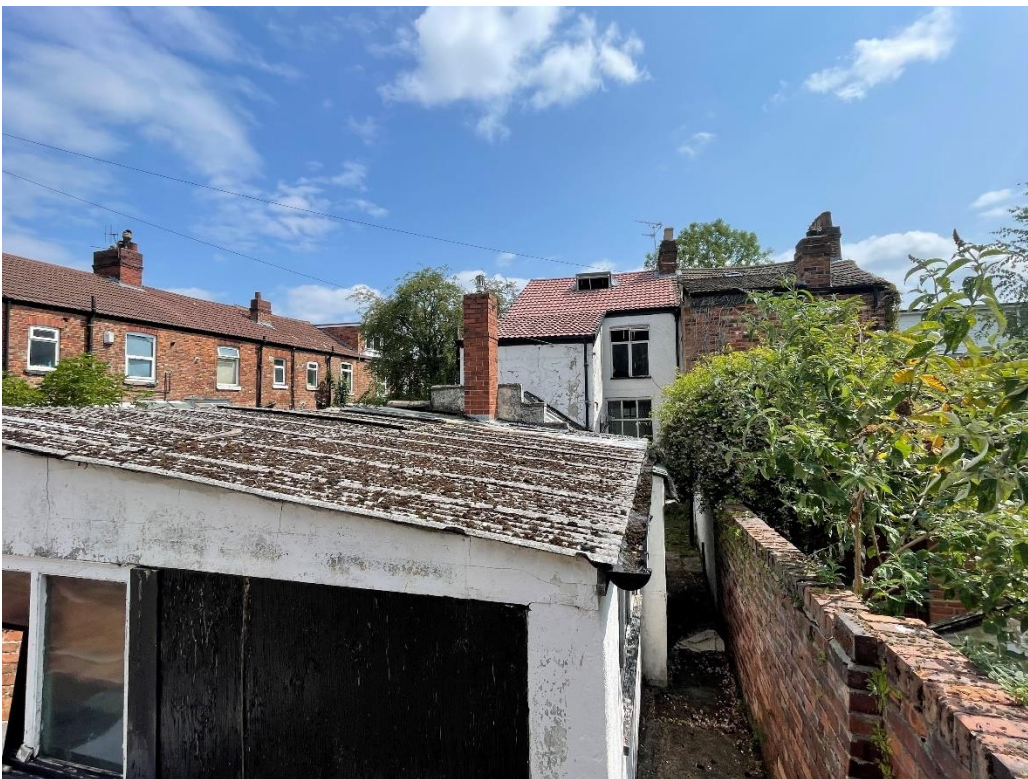
The more recent, pitched roofs, over the single-storey extensions at the rear of the property were in a dilapidated condition (Photo 6).

**PHOTO 6 – PERISHED ROOF COVERINGS OVER SINGLE STOREY REAR EXTENSIONS**

The defects noted elsewhere, e.g. defective roof coverings/flashings, blocked drainage etc. can be dealt with under a planned maintenance strategy.

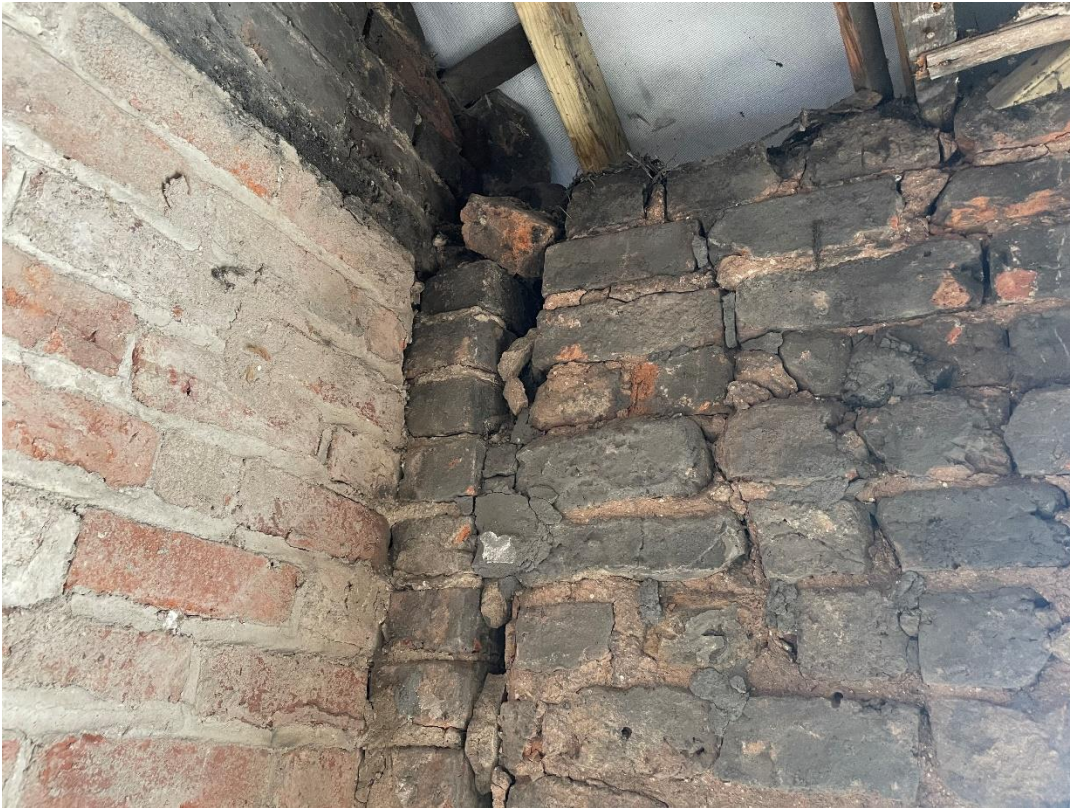
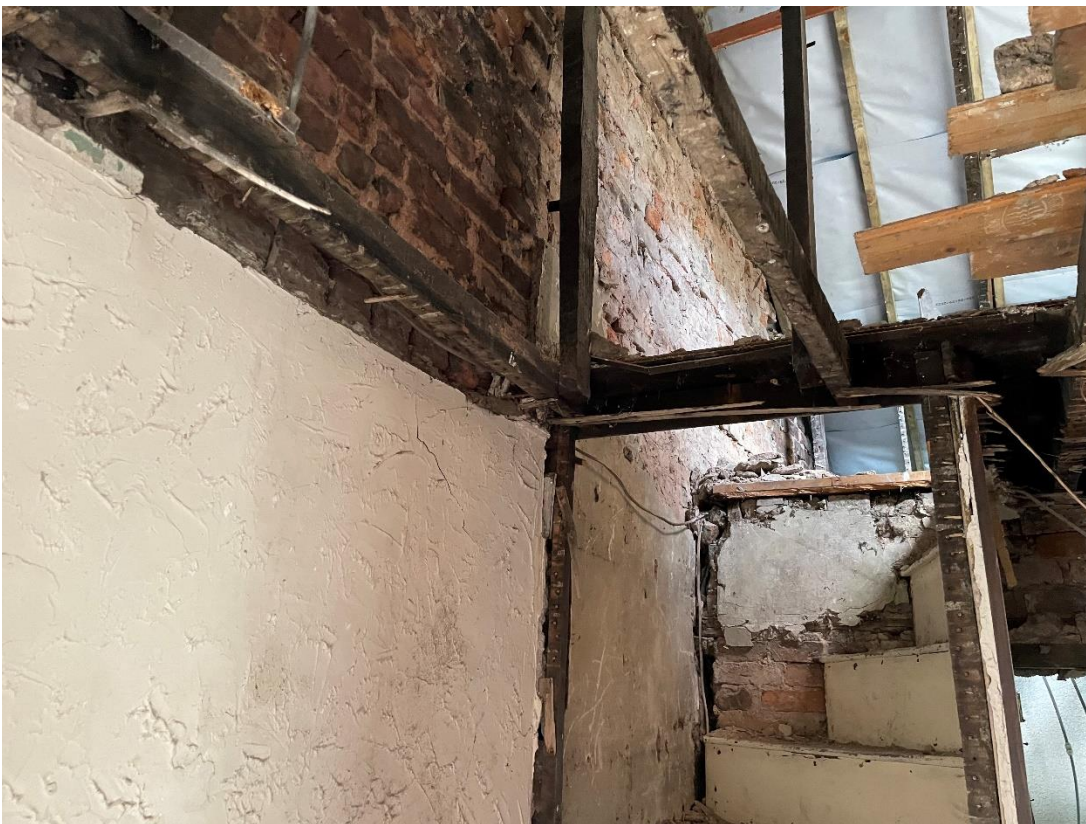
- mainly vertical, separation cracks at the junction of the internal walls and the main gable wall (see Photos 7 & 8) - (the internal walls did not appear to be tied in to the gable wall)
- mainly diagonal cracks over defective timber lintels, above openings in the masonry walls

PHOTOS 7 & 8 – VERTICAL SEPARATION CRACKS IN BRICKWORK

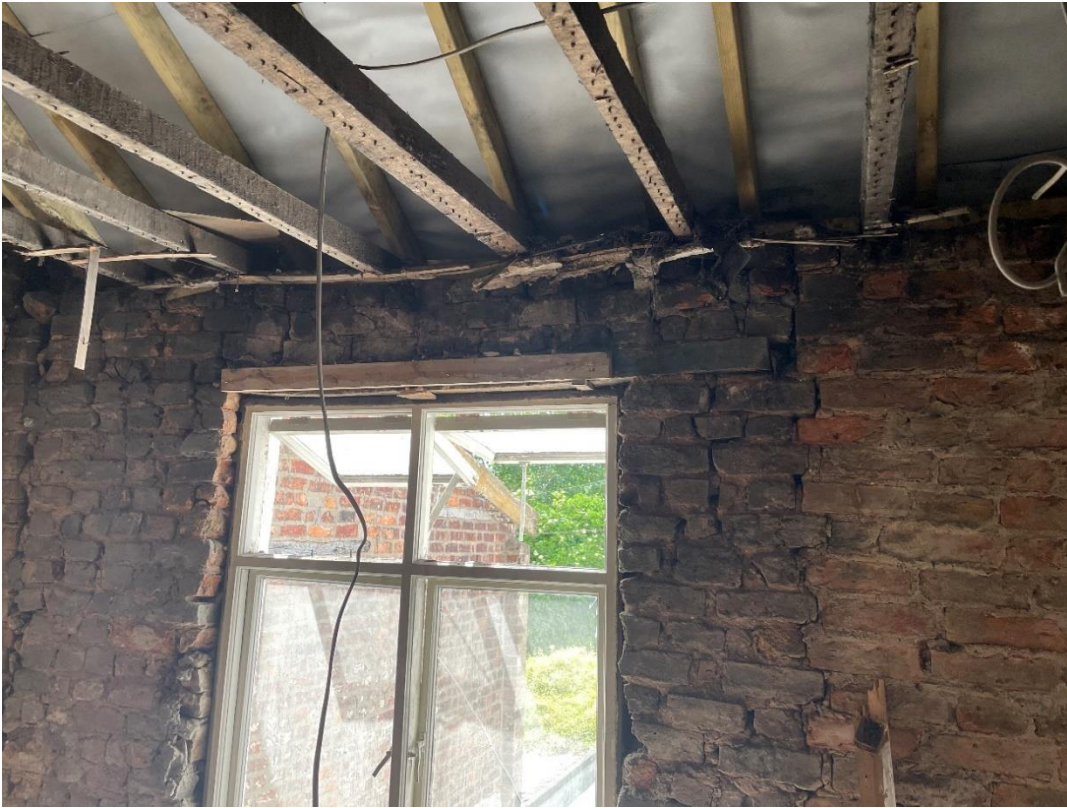
- localised cracks and displacement of the brickwork at timber, lintel beam, bearings (Photo 9).

**PHOTO 9 – LOCALLY CRACKED AND DISPLACED BRICKWORK AT LINTEL BEAM BEARING**

- the internal corridor/landing walls at Ground and First Floor levels
- locally displaced section of masonry at lintel/beam bearings.

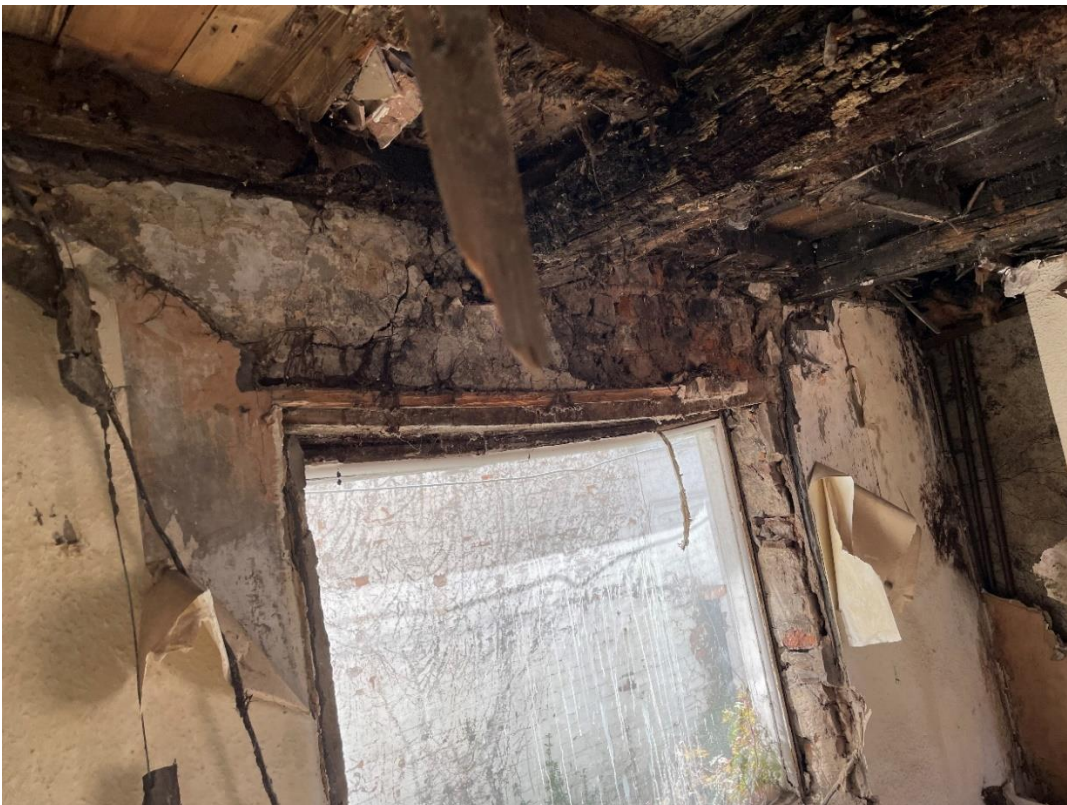
The suspended timber floors were all 'springy' (i.e. deflected badly under applied loading) and they were not level. The floors had suffered from rot and beetle infestation in the past (see Photo 10). The first floor in the rear, two-storey, outrigger was unsafe. Elsewhere, the timber floor beams had suffered significant vertical deflection. The timber floor joists and beams generally appeared undersized for the spans. An additional brickwork pier had been constructed and steel props had been installed in the Basement, to provide additional support to the ceiling beams, supporting the Ground Floor (see Photo 11). Although the props were probably originally intended to be a temporary measure, they appeared to have been in place for a considerable number of years.

**PHOTO 10 – ROT INFECTED TIMBER FLOOR BEAM AND LINTEL**

The rot infected/perished timber lintel beams should be replaced with suitable new lintels.

Areas of the existing suspended timber floors were no longer fit for purpose, in our opinion and should be replaced with new suspended timber joists, spanning between new steel beams, which can be used as part of the lateral restraint system for the gable wall. It should be possible to retain more of the existing suspended timber floors, if the rebuilding of the external gable wall was approved [i.e. Option a) above].

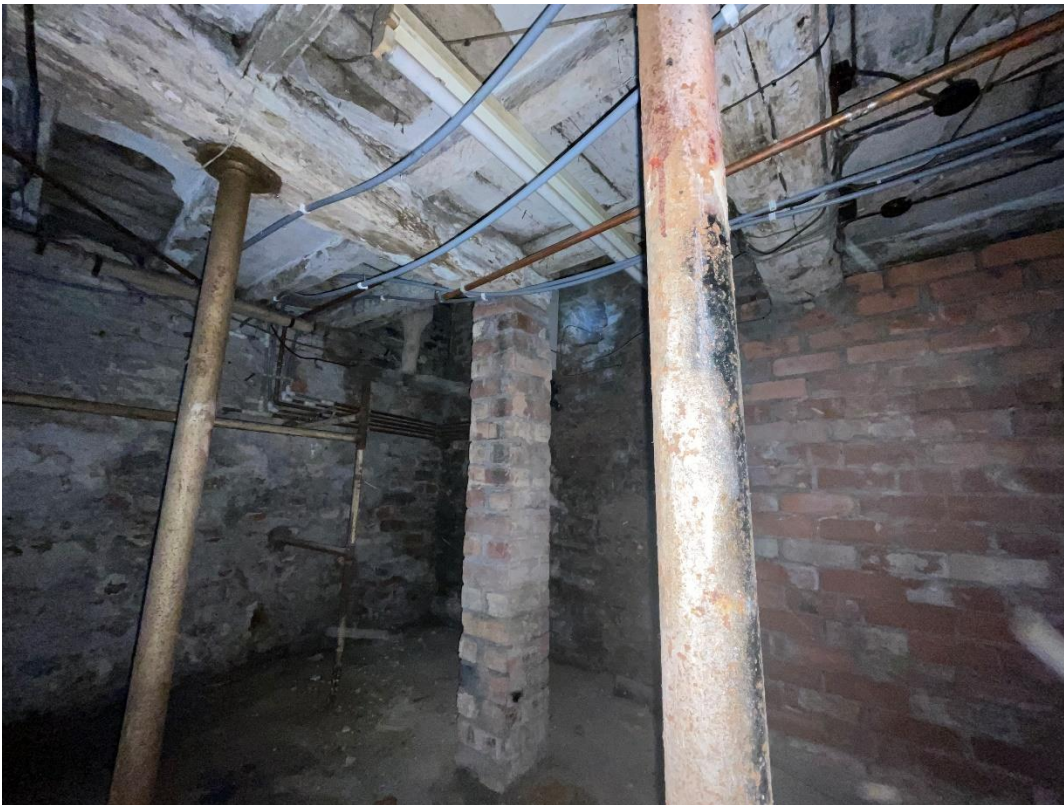
PHOTO 11 – STEEL PROPS AND MASONRY PIER SUPPORTING ORIGINAL TIMBER FLOOR BEAMS

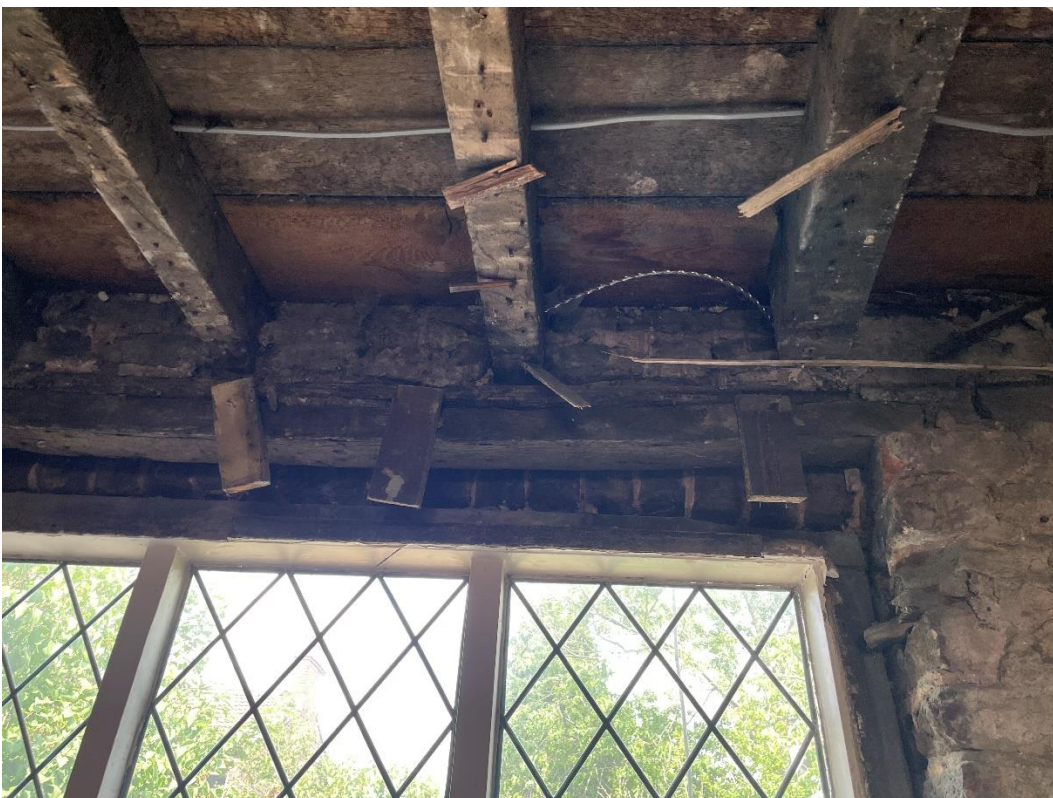
Timber lintel beams over openings in the masonry walls were no longer fit for purpose (see Photo 12). The timber lintel, over the opening in the wall between the front, Ground Floor, Reception Room and the Hallway, was unsupported at one end (see Photo 13).

PHOTO 12 – INADEQUATE TIMBER LINTEL BEAM

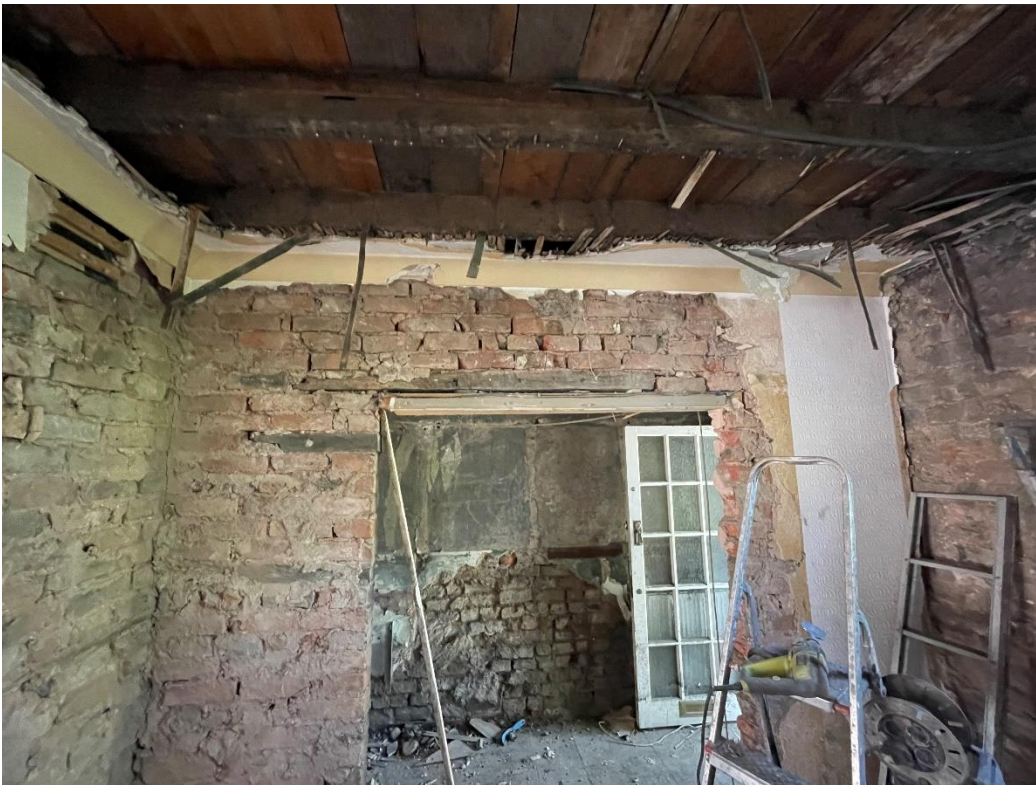
PHOTO 13 – UNSUPPORTED INTERNAL TIMBER LINTEL BEAM

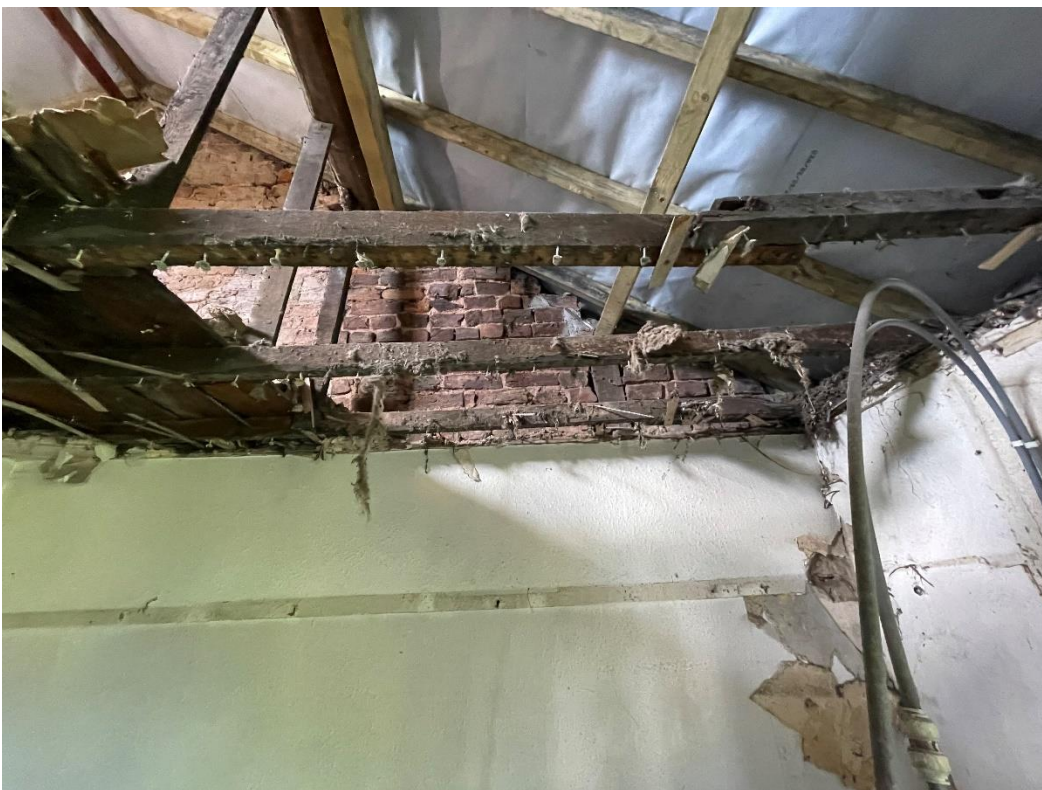
- the installation of additional timber roof purlins (see Photo 14)
- the removal of the internal between the front and rear Reception rooms at Ground Floor and the installation of a modern, galvanised steel, 'box' lintel, over
- the construction of a new 215mm brick inner skin in the Basement, along the gable wall (see Photo 15)
- the removal of the original, internal, Basement staircase from Ground Floor.

PHOTO 14 – ADDITIONAL TIMBER ROOF PURLINS INSTALLED IN THE PAST

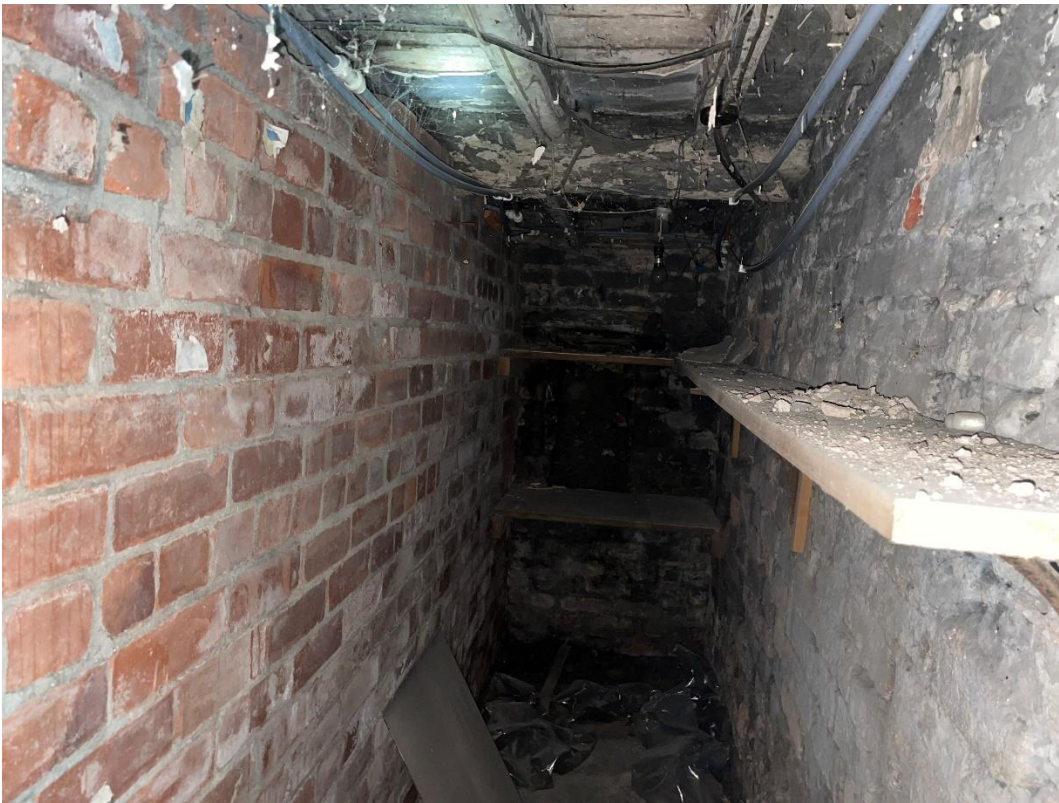
PHOTO 15 – NEW 215MM BRICKWORK SKIN CONSTRUCTED ADJACENT TO BASEMENT SIDE WALL

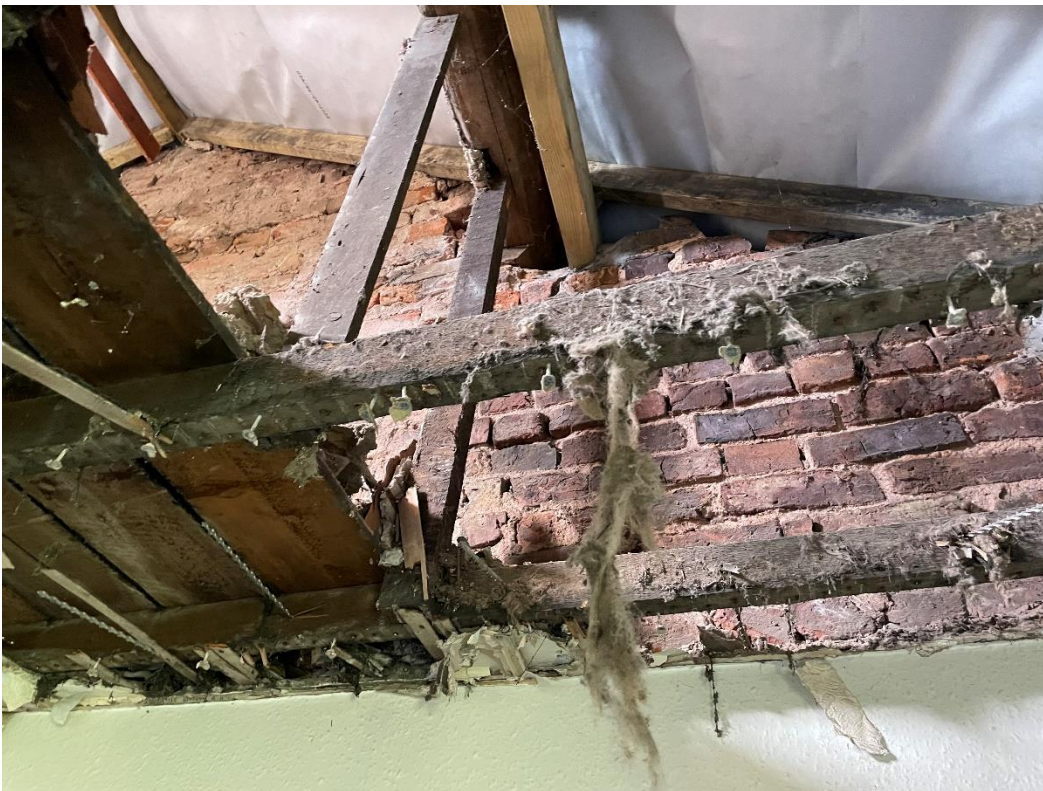
Some structural, remedial works had also been undertaken in the past, including the installation of steel, 'Heli bar', ties between the external gable wall and the internal floors (see Photo 16). The measures were probably intended to arrest the movement in the gable wall but they were not effective, in our opinion.

PHOTO 16 – STEEL HELI-BAR TIES INSTALLED THROUGH GABLE WALL IN THE PAST
