## Technical Note

### Bradford Road Wing Roof Assessment

**Project:** Brunswick Mill

**Document Number :** 23178-HWC-V1-zz-TR-S-003

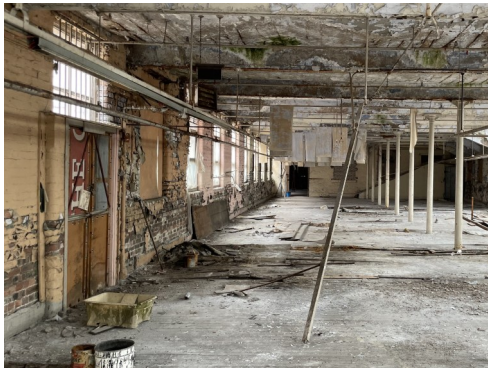
Photo 1 - North-West Roof

Examples of roof deterioration - exposed reinforcement, corroded steels concrete spalling

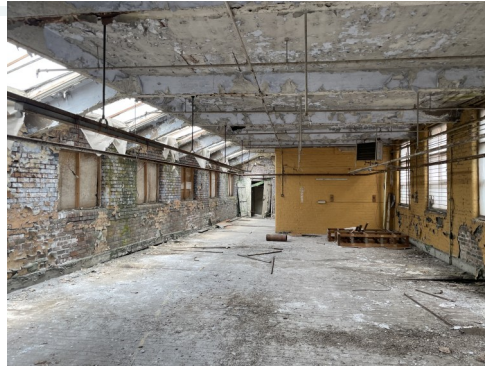
Photo 2 - North-West Roof

Examples of roof deterioration - exposed reinforcement and concrete spalling

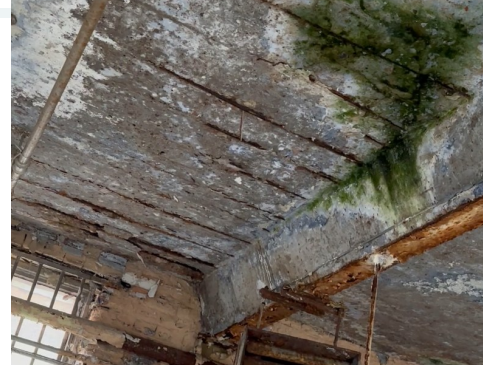
Photo 3 - North-West Roof

Water staining and moss growth evident throughout

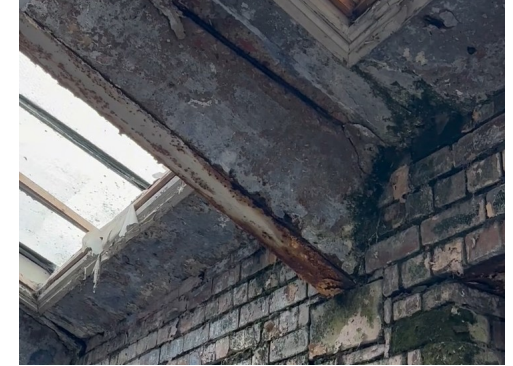
Photo 4 - North-West Roof

Heavily corroded support steels throughout

However, the original supporting steelwork appears to remain in a salvageable condition. It is therefore recommended that all surrounding concrete be carefully removed to fully expose the steel elements. Once exposed, all corroded areas should be thoroughly cleaned preferably using mechanical methods such as grit blasting—and treated with a high-performance anti-corrosion protective coating. This approach will help preserve the remaining structural steel and extend its service life, provided the surrounding concrete is reinstated using appropriate materials and detailing to prevent future moisture ingress.

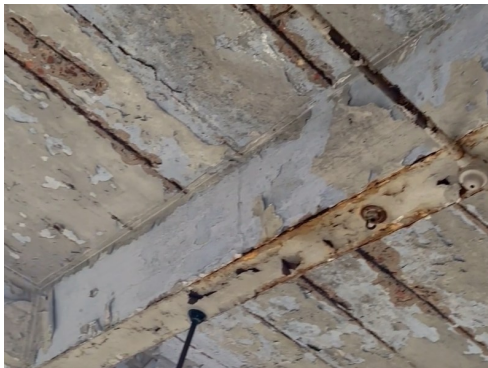
Photo 5 - North-West Roof

Examples of roof deterioration - exposed reinforcement corroded steels concrete spalling.

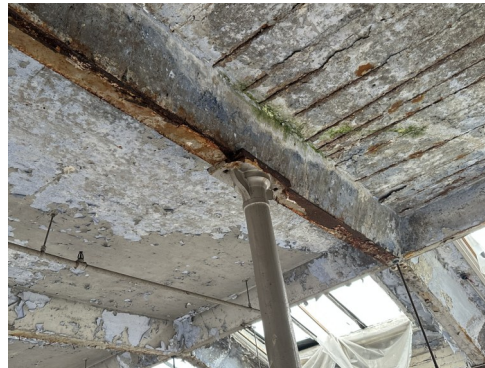
Photo 6 - North-West Roof

Examples of roof deterioration - exposed reinforcement corroded steels concrete spalling.

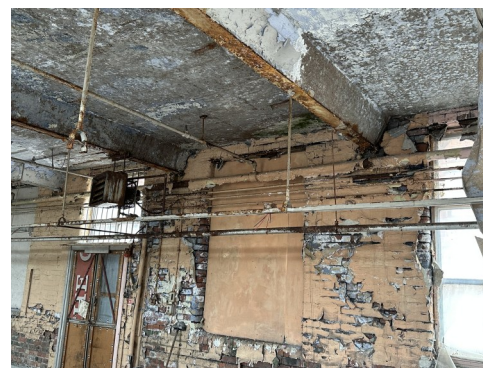
Photo 7 - North-West Roof

Examples of roof deterioration - exposed reinforcement corroded steels concrete spalling.

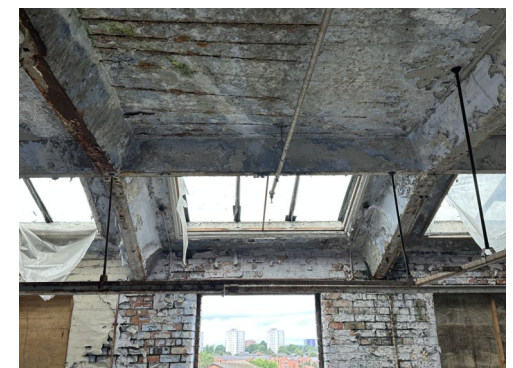
Photo 8 - North-West Roof

Examples of roof deterioration - exposed reinforcement corroded steels concrete spalling.
