**GAS MEMBRANE VALIDATION**

| Site Name: Belle Vue Stadium | Project Number: 12-123 |
| Company Name: Countryside | Date: 04-07-2022 |

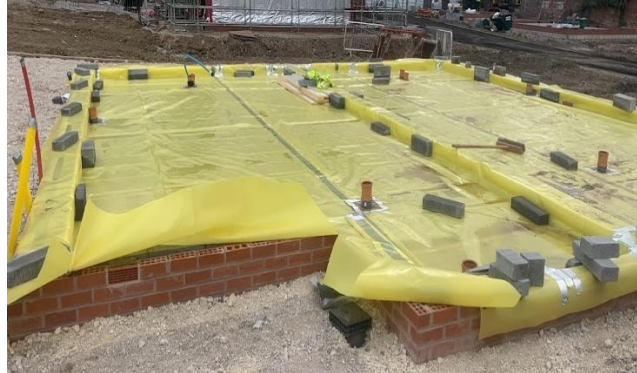
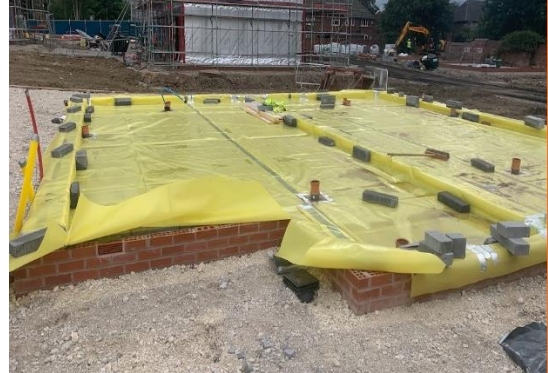
**Plot – 108**

**General Condition of Membrane-Good Condition**

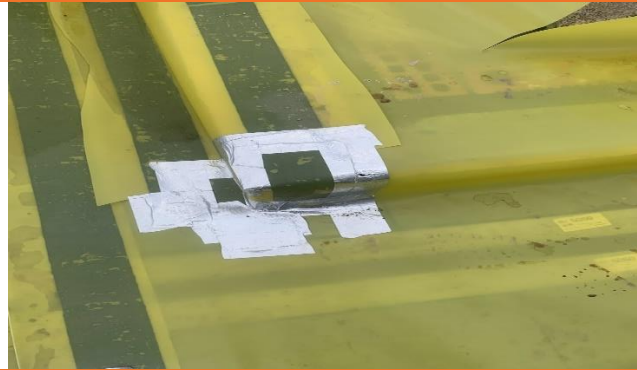
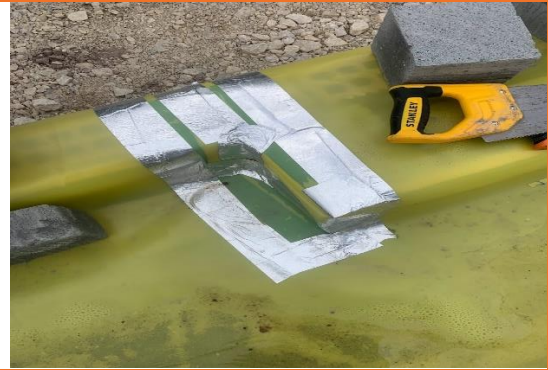
**Verification of Joints and Seals-Overlapped and sealed correctly**

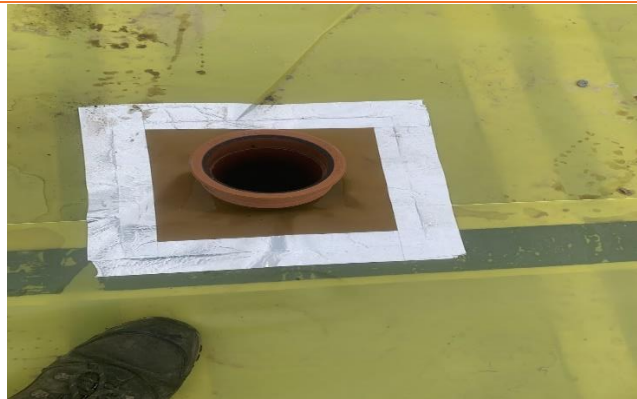
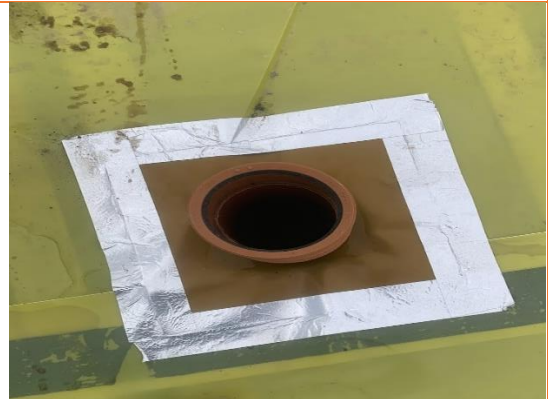
**Verification of Service Penetrations-Good Condition**

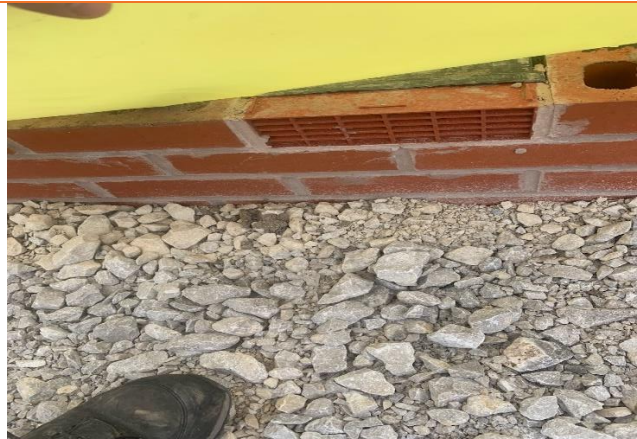
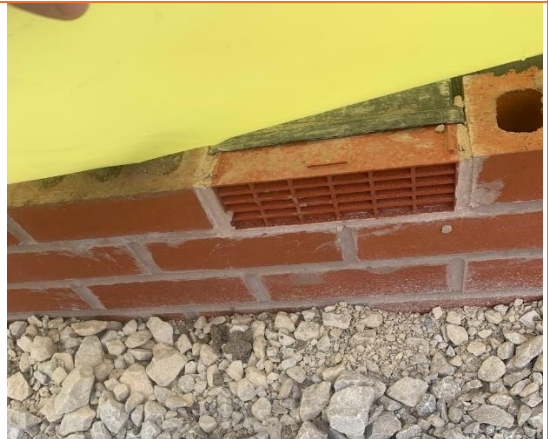
**Verification of Ventilation-Good Condition**

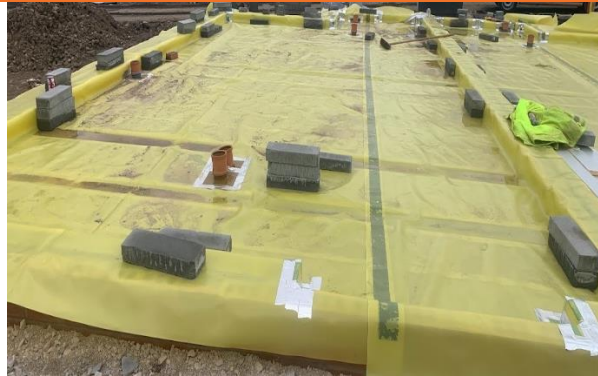
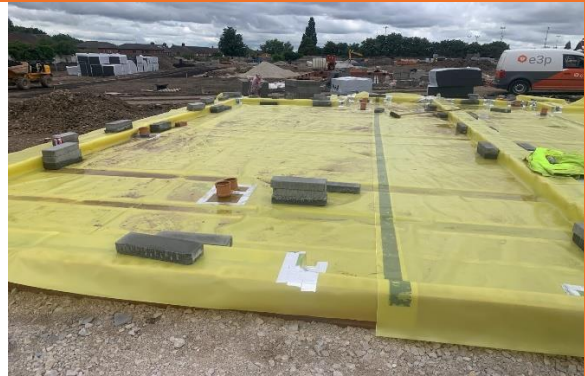
**Plot – 109**

**General Condition of Membrane-Good Condition**

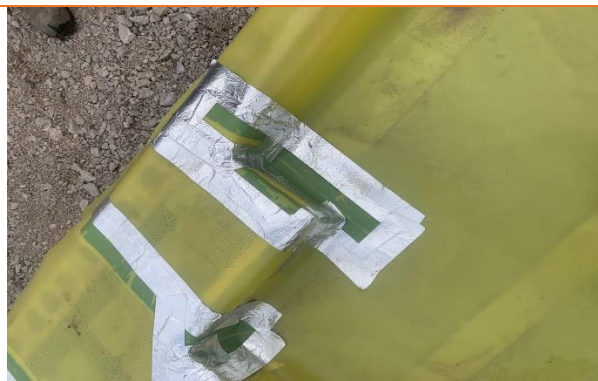
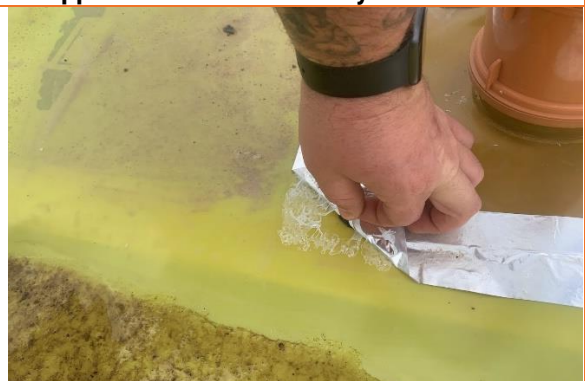
**Verification of Joints and Seals-Overlapped and sealed correctly**

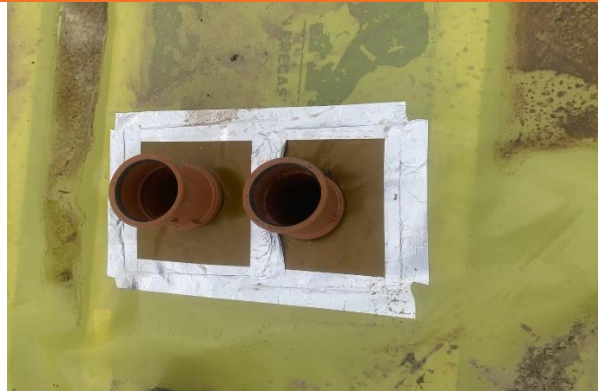
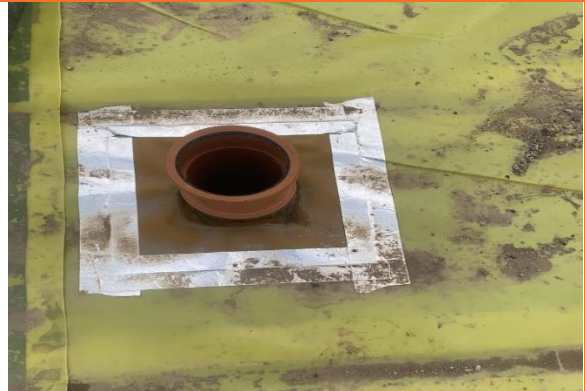
**Verification of Service Penetrations-Good Condition**

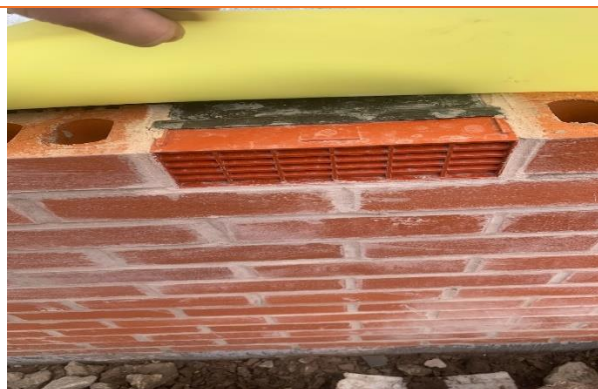
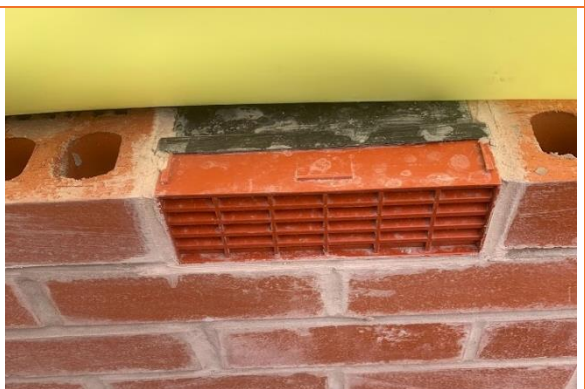
**Verification of Ventilation-Good Condition**
