Whitworth Art Gallery, Manchester  
Results of Architectural Paint  
Research

28/10/2025

| Nature of Project | Architectural Paint Research to selected exterior railings to inform redecoration as part of renovation of the boundary wall. |

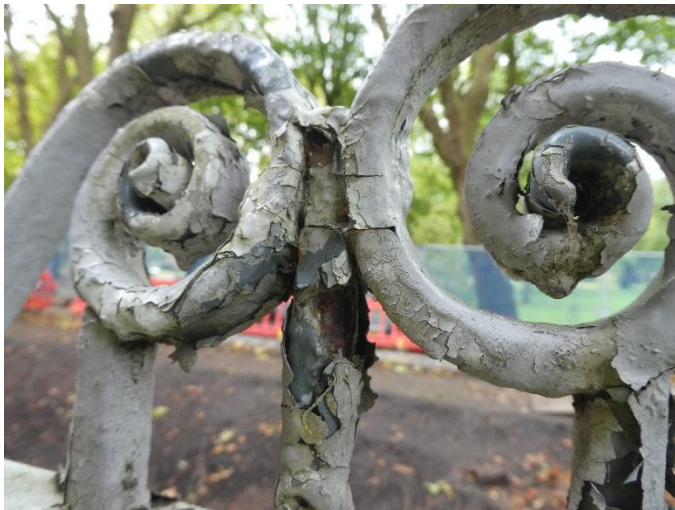
The railings are currently painted a pale grey colour and the condition of the existing paint finishes is poor as illustrated in the image below.

*Figure 9: example of the poor condition of the paint finish to the railings as seen during site survey*

A number of areas contained failing paint films and all areas of flaking paint should be removed prior to redecoration. Whilst every effort should be made to retain paint archaeology suitable preparation is required to ensure appropriate bonding of the paint films, especially given the elevated nature of the facets and any future access limitations.

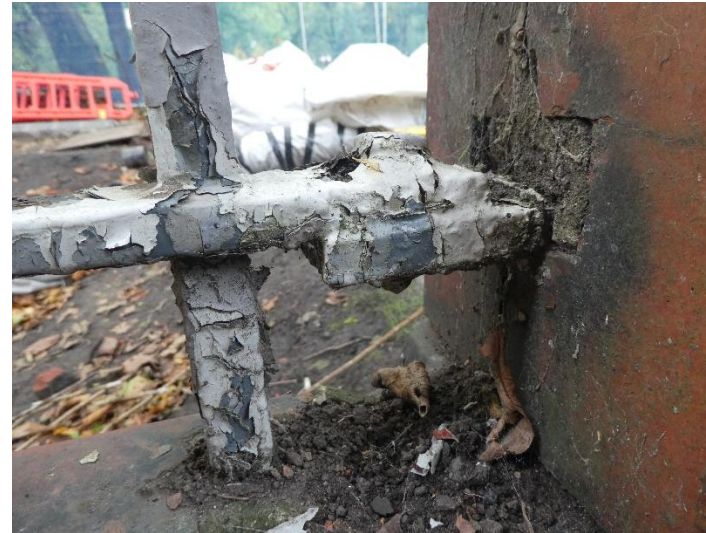
Evidence of a darker paint finish was noted to areas of failing paint and further fractures and delamination was noted.

*Figure 10: evidence of underlying darker grey paint finish*

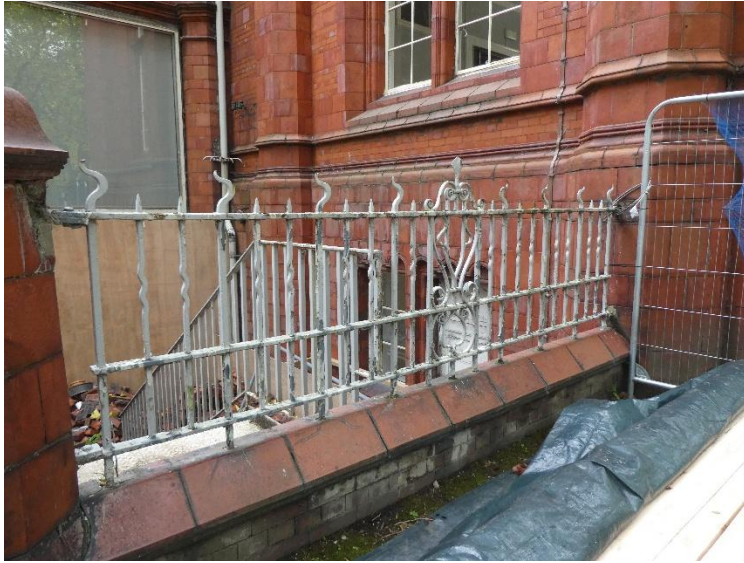
*Figure 11: image of the east end railings with later fire escape behind*

To the eastern end of the retaining wall is a second run of railings of the same design, as can be seen in Figure 11. A number of samples were taken from different facets to this area of railings and also included a limited number from the fire access railing inserted behind. These railings are plain in design but painted in the same colour as the decorative railings to the wall.

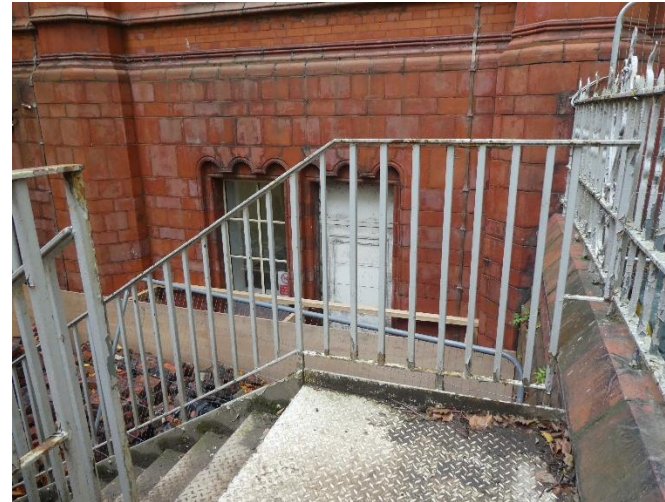
*Figure 12: detail of the fire escape staircase railings added behind the parapet wall.*

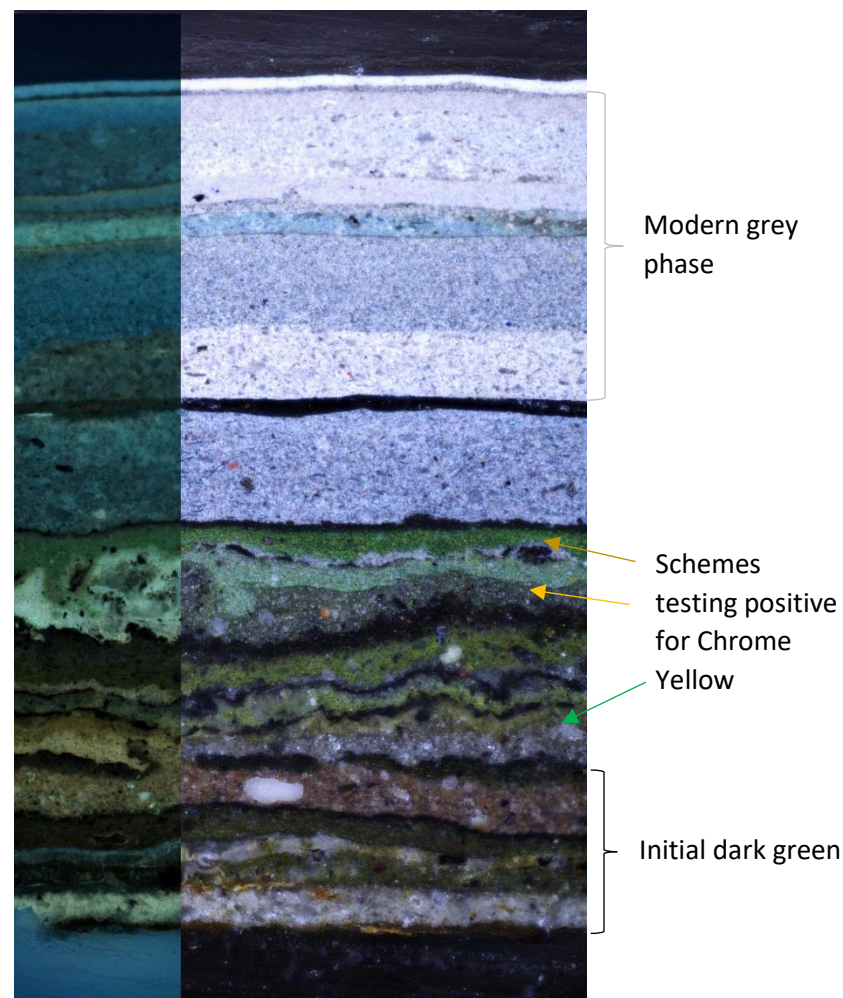
There are seven initial green colour schemes to the railings with a slight variation noted between some of the schemes. The earliest scheme would suggest the use of Invisible Green made popular in the nineteenth century by Humphrey Repton. The colour was used to railings and gates in public parks as it allowed the features to blend into the appearance of

These darker initial schemes were followed by a brighter green topcoat applied over a grey undercoat as indicated by the green arrow (right). This paint film indicated the presence of Chrome Yellow during microchemical stain tests where a reaction was also seen to two other schemes in this sample confirming the likely use of Invisible or Brunswick Green. Further tests would be required to determine the exact composition of the initial dark green schemes. These earlier topcoats were slightly affected by a dilute alkali solution but not with sufficient enough reaction to determine the combination of pigments use.

Following the initial, repeated use of green colour scheme to the railings, most of which were applied in lead paints the is a chance to the use of black. This is only seen in one scheme and, when combined with the changes in paint media when viewed under UV light, would suggest the use of modern paint film such as oil alkyd-based paint. Such paints were only commercially available from the 1950s, this change in colour may therefore also coincide with the taking over the gallery by the university following the changing use of the park.

Following the single black colour scheme, the railings have repeatedly been painted a grey colour as can be seen in the upper section of the photomicrograph shown in Figure 13.

Figure 13: sample 01B (200x mag) with inset UV image

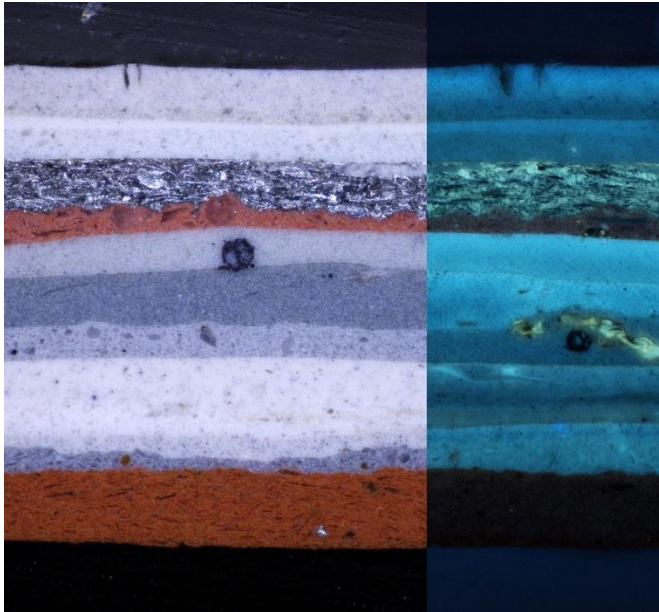
The sample taken from the fire exit access staircase can be seen over the page and also shows the repeated use of a grey colour. The two

red/orange paint films are primers and a silver metallic paint will also act as a primer. There is no lead detected in these paint films.

*Figure 14: Sample 09A (200x mag) with inset UV image*

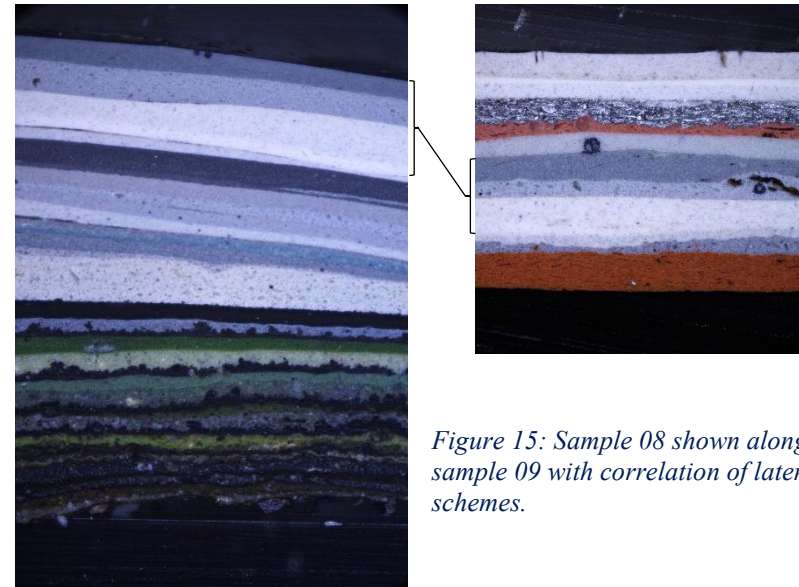
A comparison of sample 09 from the new section of railing to a sample from an older section shows the correlation between the paint films. What this comparison shows is that there is likely to have been a loss of some schemes perhaps through the failure of the paint and rubbing to a sound surface prior to redecoration. It is not known when the fire exit staircase railings were installed. The lack of later paint films in sample 08 doesn't suggest this section was not painted since the railings were installed but merely that some upper paint films are missing.

*Figure 15: Sample 08 shown alongside sample 09 with correlation of later schemes.*

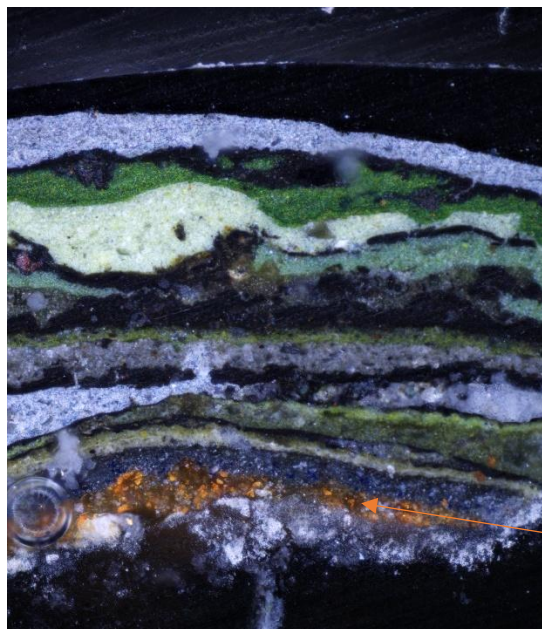
A sample taken from the eastern end of the railings contained further evidence to suggest that the railings were initially painted green and not red/terracotta to match the wall with a red lead pigmented paint film seen beneath the grey preparatory coat in sample 05 (overleaf).

*Figure 16: Sample 05B (200x mag) showing use of red lead primer beneath the grey undercoat.*

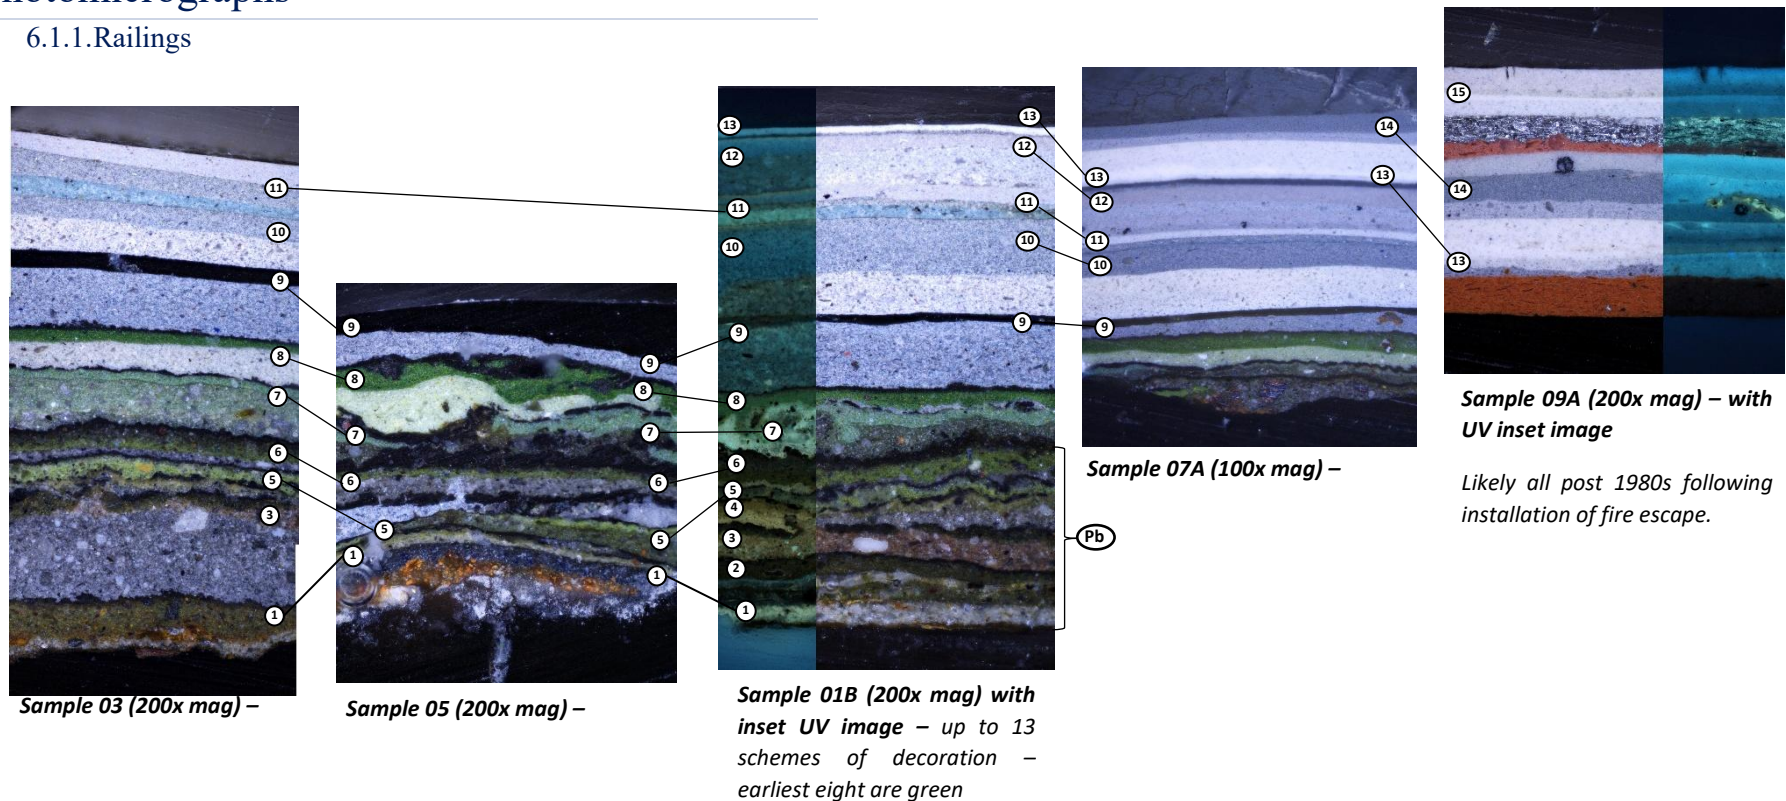
- Evidence in the region of 15 schemes of decoration with the earliest schemes applied in shades of green (schemes 01 – 08), the earliest of which have been applied in lead-based oil paints (Pb).
- Colour schemes then change from approximately scheme 9 to shades of grey, it is likely that given the changes in paint media that this will correspond to the period after the Second World War / post 1950s.
- The set of railings installed in the 1980s following the installation of the fire exit indicates in the region of three phases of decoration have been applied since this period. Due to the observed failure of the paint films in-situ then there is some disparity between the samples associated with this degradation.

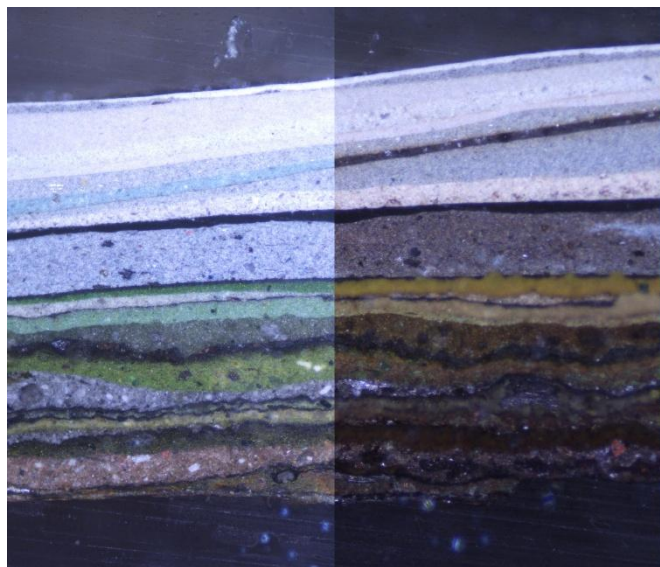
**Sample 01: railings, western end**

*Pretest image (left) following test for lead (right).  
Positive reaction shows as darkening of paint films to black/brown.*

*Change from green to yellow also confirms presence of lead based pigment.*

A proportion of paint films were found to contain lead which is toxic. Where paint removal is to be undertaken, methods should ensure safe working practice. Therefore, dry removal should be avoided to prevent the creation of air-borne, lead-containing dust, unless suitable extraction with a HEPA filter can be in place. The use of a heat gun should also not be used without the operative wearing suitable PPE and appropriate Hot Works permits in place. Any waste material from the use of paint strippers should be disposed of according to lead contaminated waste regulations.

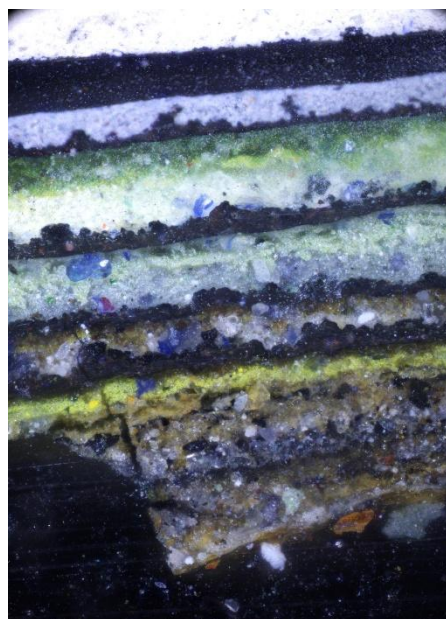
**Sample 08- east elevation railing.**

*Following application of alkali solution.*

*The tests indicate the presence of lead chromate-based pigments in the green paint films, this indicates the paint films must post-date the development of lead chromate in the early nineteenth century.*
