# Tree Condition Survey & Management Report

Hayescroft Gardens  
Didsbury  
Manchester  
M20 2AA

BE.240815.R

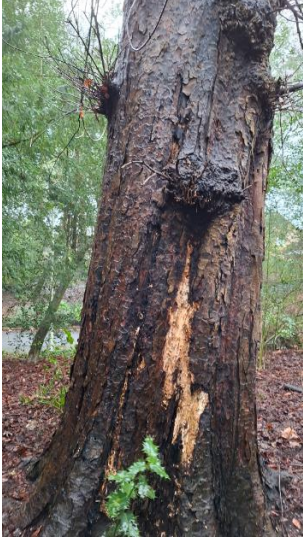
- 3.3.6 The sycamore trees T0056, T0116, T0201 and T0203 are in a poor structural condition and I have recommended reducing to monoliths or removing to ground level. Maintaining trees as monoliths will retain some ecological benefits while reducing the risk to acceptable levels. T203 is leaning over the neighbours and its structural failure is likely to cause significant damage I have recommended removing this tree to ground level (*Figure 3, 4 & 11.*)

| <p>Figure 3. Sycamore T0056</p> | <p>Figure 4. Sycamore T0116</p> | <p>Figure 5. Sycamore T0128</p> |

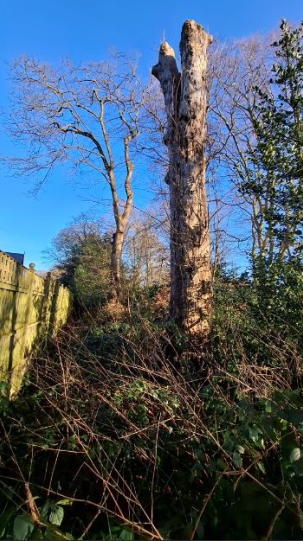
- 3.3.7 A number of trees (T0128, T0129, T0120, T0133) located to the rear of the site have been reduced into poles or high monoliths (*Figure 5.*) While I agree with the reasoning to retain standing dead wood, in my opinion these have been retained at a height where when they finally fail they could cause damage to the surrounding gardens. I have therefore recommended reducing to a lower level. While the likelihood of failure at present is very low this will increase as the trees degrade over time

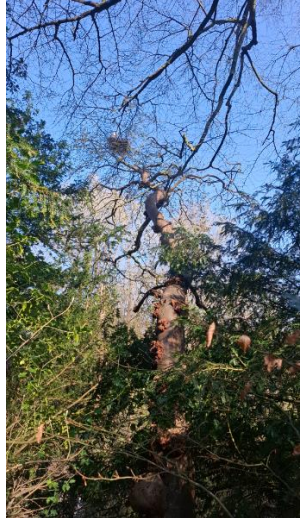
| <p>Figure 6. Horse chestnut tree T0197 with heron nest</p> | <p>Figure 7. Sycamore tree T0119 with badger set at base</p> | <p>Figure 8. Horse chestnut T250 with large cavity</p> |

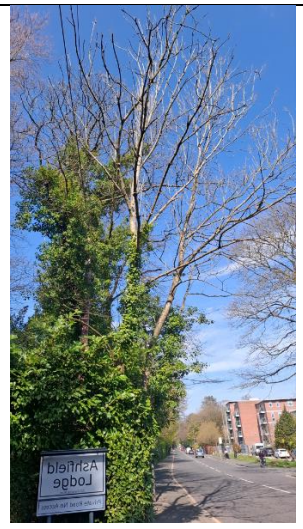
| <p>Figure 9. Ash tree T210 with signs of Ash Dieback</p> | <p>Figure 10. Trees T182-T0194 containing dead wood over car park</p> | <p>Figure 11. Sycamore Tree T0203 leaning over neighbours</p> |

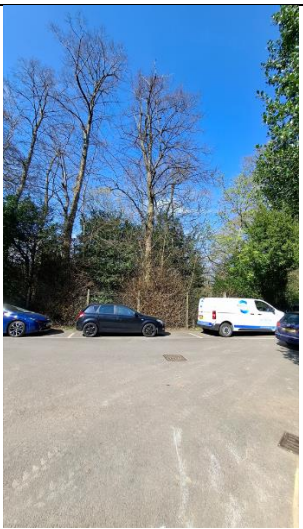
- 3.3.8 A number of trees (T0182, T0186, T0187, T0194) contain significant (over 50 millimetres diameter) deadwood which is located over the neighbouring carparking (*Figure 10.*). To prevent damage to parked cars this should be removed.

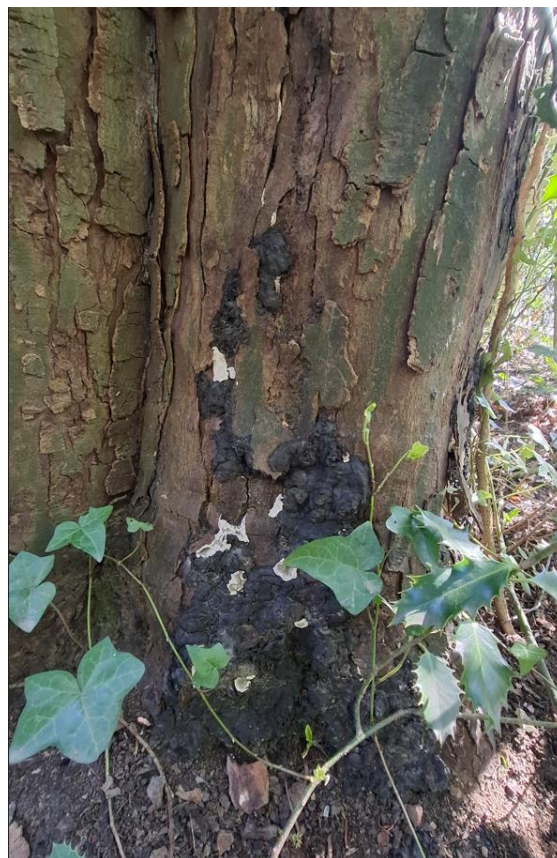
C.2.8 Consequence: Prolonged cases may lead to catastrophic failure with a ceramic like fracture surface. Able to breach reaction zones. Unlike other decay pathogens the usual warning signs of bulging or cracking are absent prior to failure.

Figure C2, showing the *Kretzschmaria deusta* fungal fruiting body attached to T0203.

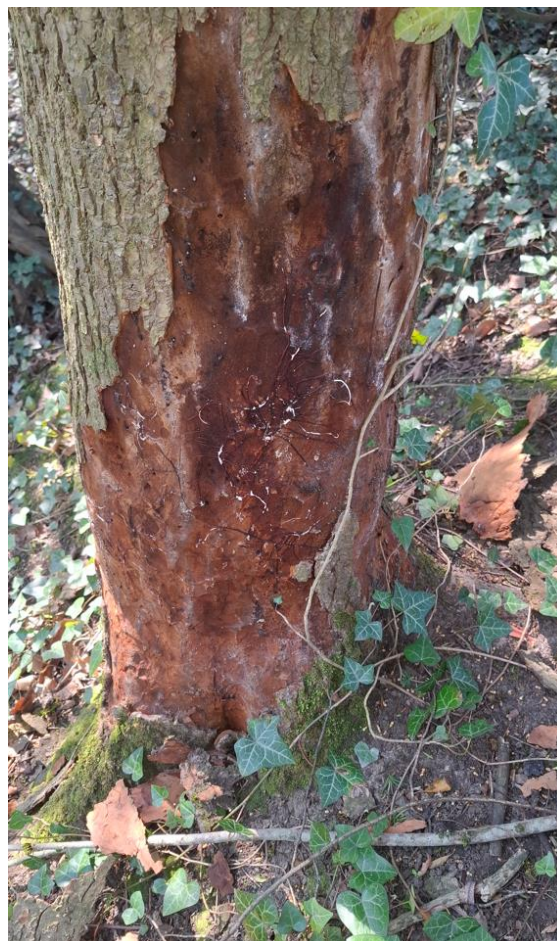
- C.3.7 Principle Species: Wide range of coniferous and broadleaf tree species affected. The Black Walnut & Box Elder have good resistance.
- C.3.8 Consequence: Rarely a primary cause of death in affected trees and often a secondary coloniser; establishing on trees irreversibly damaged/weakened by other fungal pathogens.

Figure C3, showing the Honey Fungus; fruiting bodies attached to T224.
