**Land at Hillkirk Street**

**Proposed Temporary Car Park**

**Flood Risk & Surface Water Drainage Review**

| <b>Report Reference:</b> | | <b>0177-SSC-XX-XX-RP-C-0001-P01</b> |

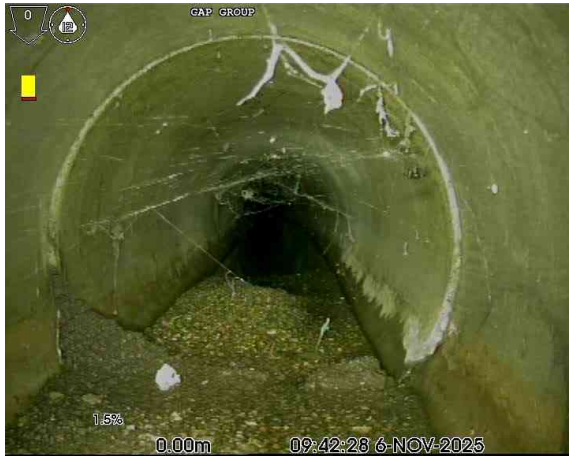
1, 00:00:04, 0.00 m

Settled deposits, fine, 20% cross-sectional area loss, start

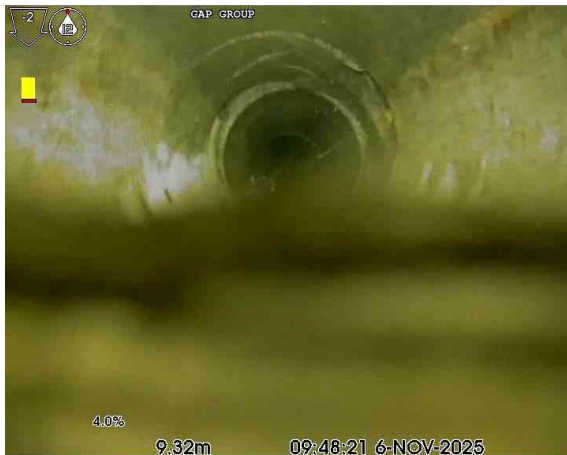
1, 00:01:35, 9.85 m  
Cracks, multiple from 12 o'clock to 12 o'clock

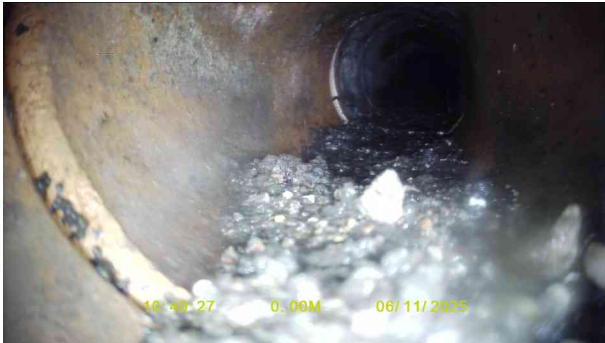
1, 00:00:05, 0.00 m  
 Settled deposits, fine, 10% cross-sectional area loss, start

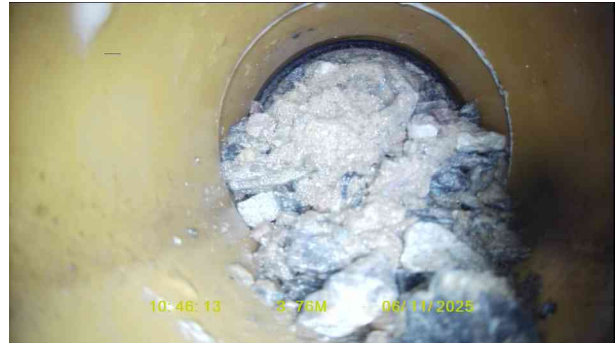
2, 00:00:18, 3.76 m  
 Settled deposits, hard or compacted, 100% cross-sectional  
 area loss, STONES

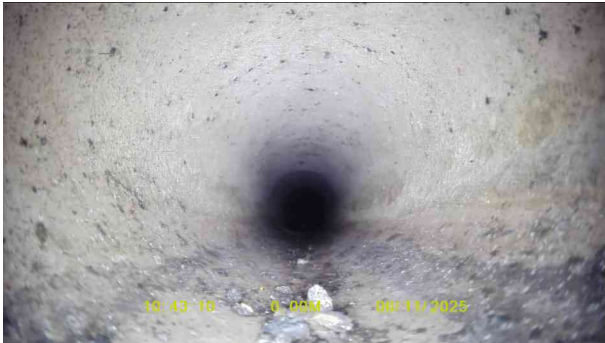
1, 00:00:04, 0.00 m  
Settled deposits, fine, 5% cross-sectional area loss, start

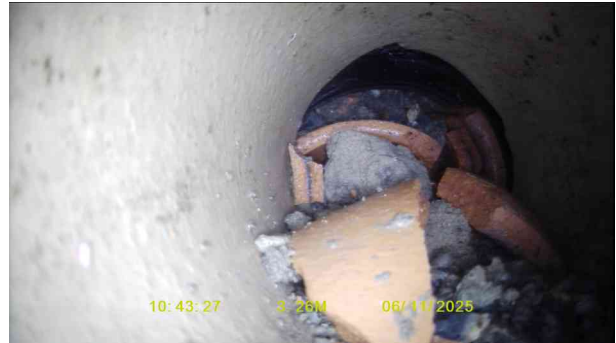
2, 00:00:21, 3.26 m  
Collapsed drain or sewer, 100% cross-sectional area loss

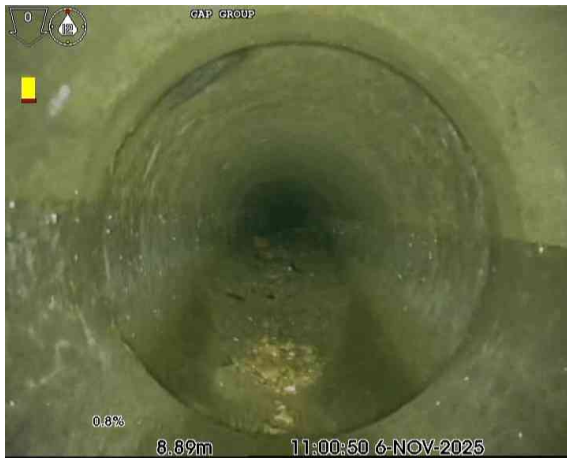
1, 00:00:57, 8.89 m  
 Joint displaced, large

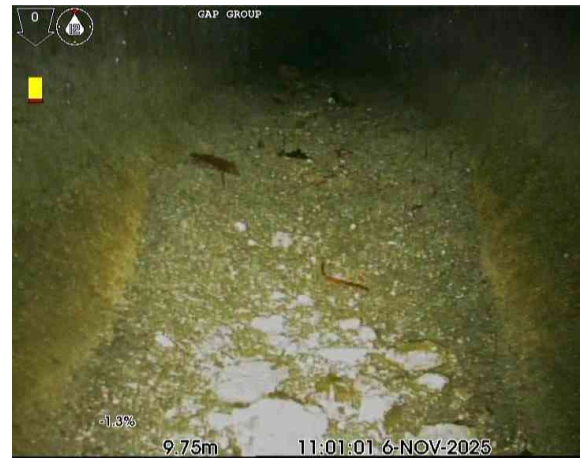
2, 00:01:08, 9.75 m  
 Settled deposits, fine, 15% cross-sectional area loss, start

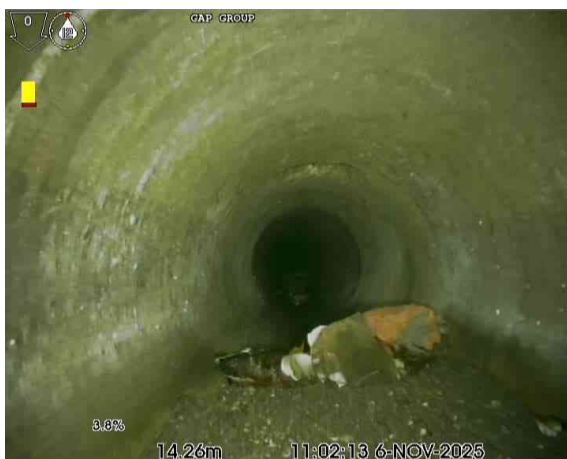
3, 00:02:21, 14.26 m  
 Other obstacles, brick or masonry in invert at 6 o'clock, 20% cross-sectional area loss

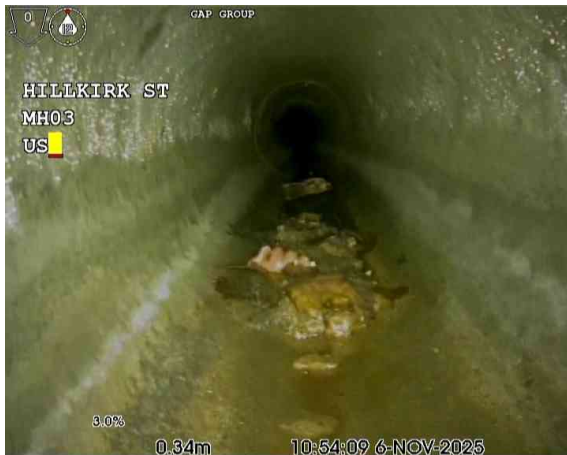
1, 00:00:06, 2.00 m  
 Other obstacles, brick or masonry in invert at 6 o'clock, 10% cross-sectional area loss

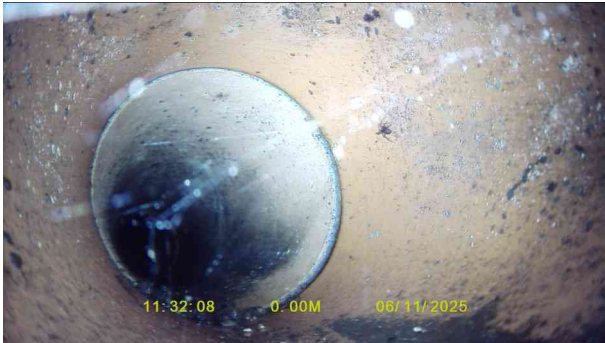
1, 00:00:05, 0.10 m  
 Line deviates left

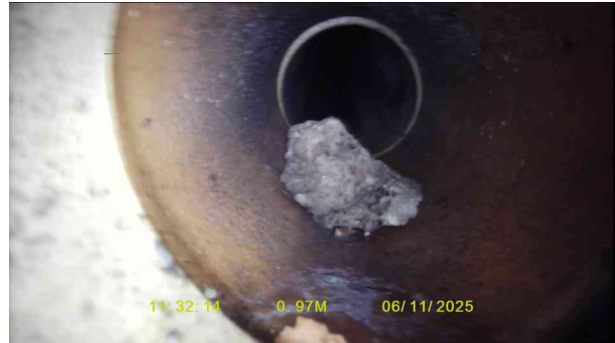
2, 00:00:10, 0.97 m  
 Other obstacles, brick or masonry in invert at 6 o'clock, 30% cross-sectional area loss

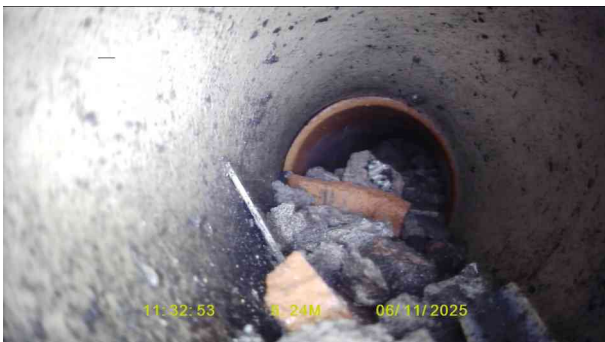
3, 00:00:50, 5.24 m  
 Other obstacles, brick or masonry in invert at 6 o'clock, 100% cross-sectional area loss

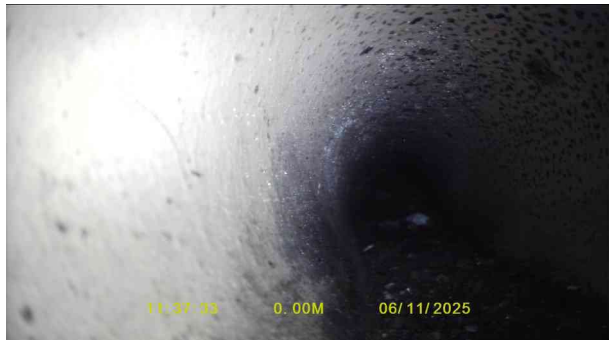
1, 00:00:05, 0.00 m  
 Settled deposits, fine, 20% cross-sectional area loss, start

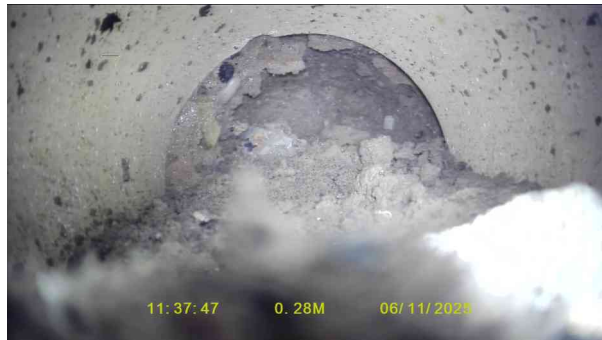
2, 00:00:19, 0.28 m  
 Settled deposits, fine, 100% cross-sectional area loss

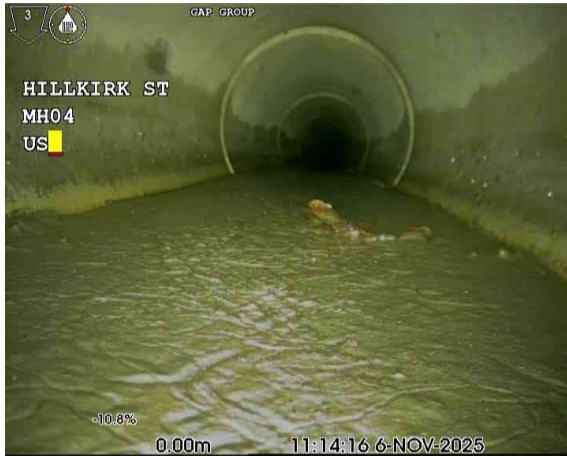
1, 00:00:03, 0.00 m

Settled deposits, fine, 25% cross-sectional area loss, start
