The National Trust

Castlefield Viaduct  
Phase 2

Remedials  
Transverse Beams  
Bearing Stiffeners

CVI-ARUP-ZZ-ZZ-DR-S-4001

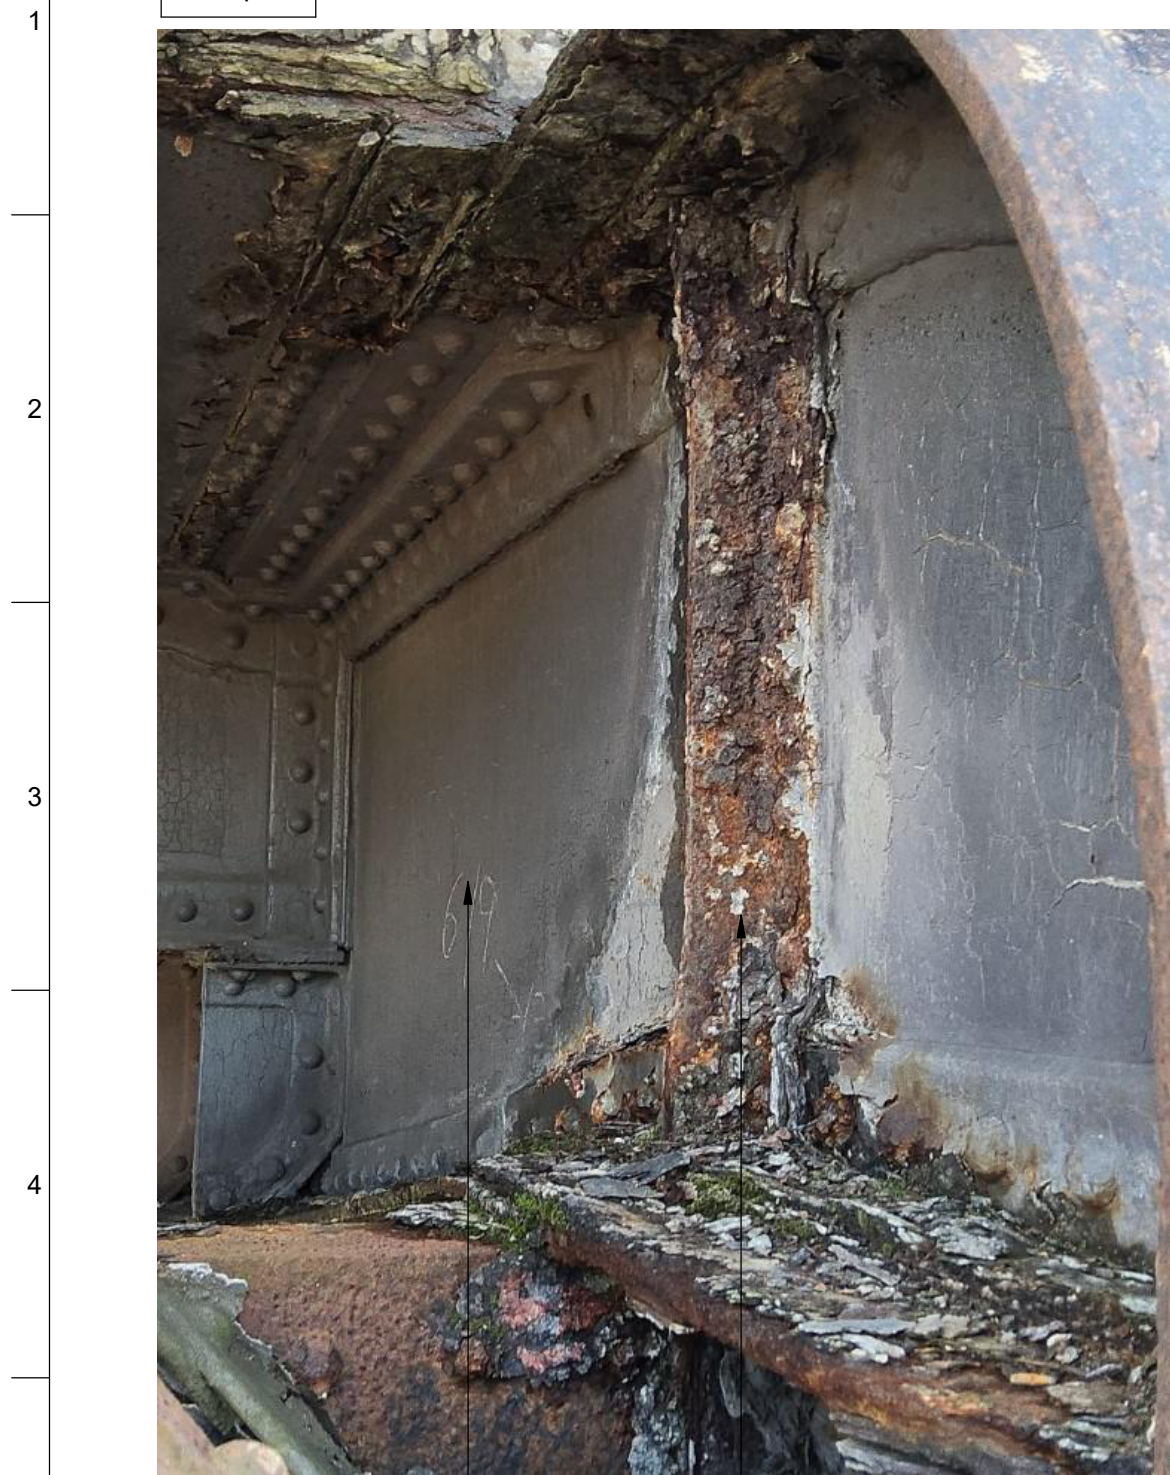
Transverse beam  
- 1/2" thick web plate

Bearing stiffener  
- 6" x 3" x 1/2" Tee  
each side of web

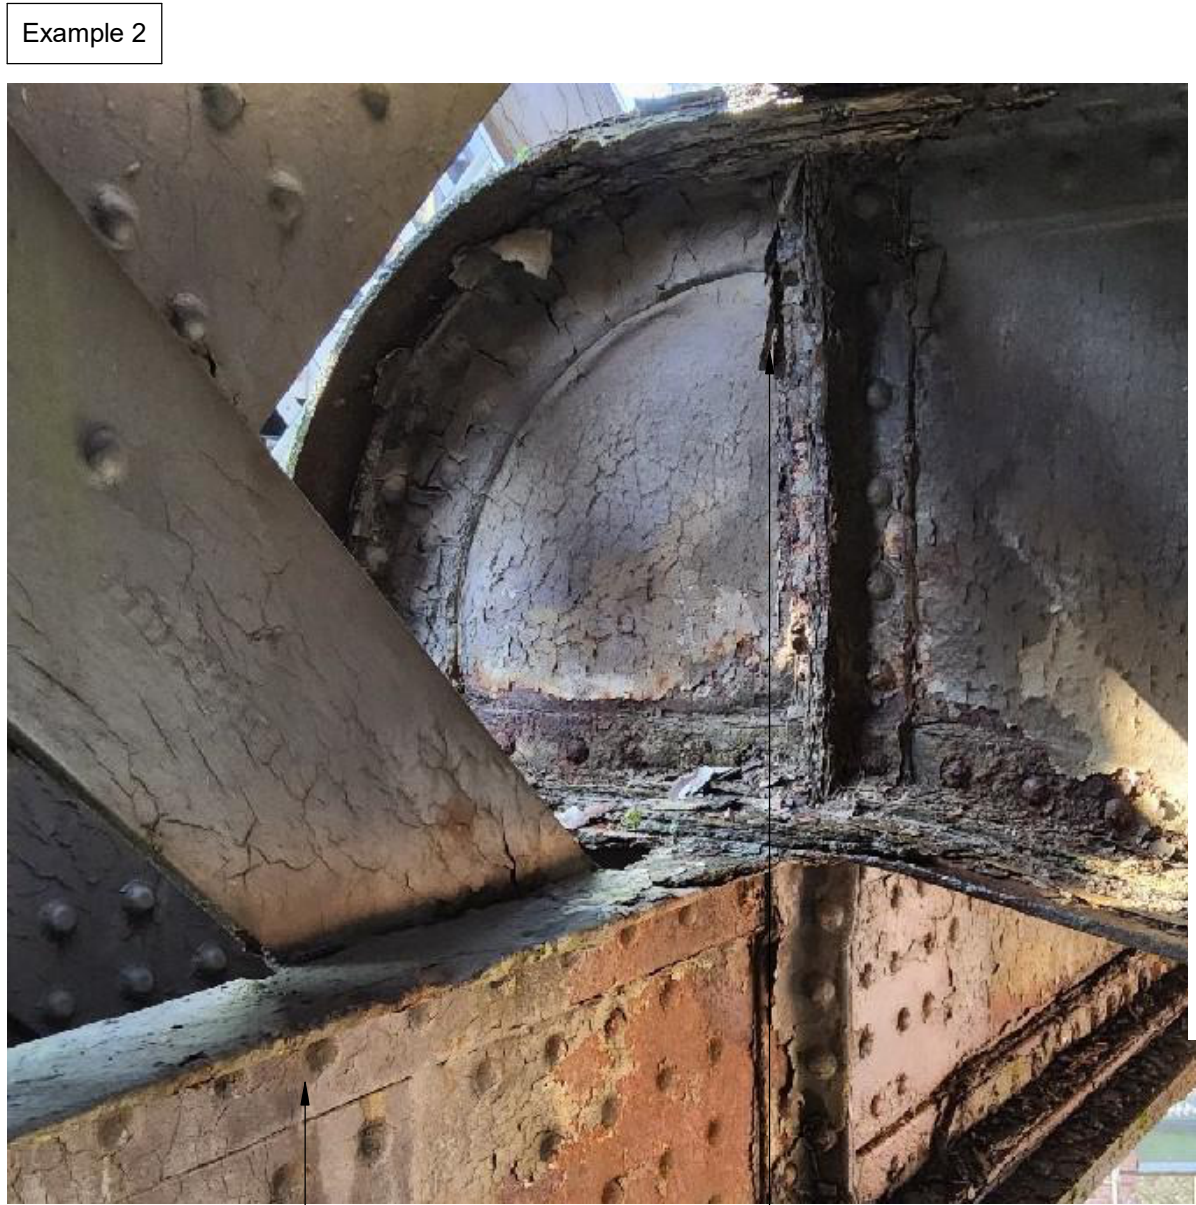
Lattice girder  
bottom chord

Corrosion typically where  
transverse beam extends  
beyond weathering  
protection of deck plate

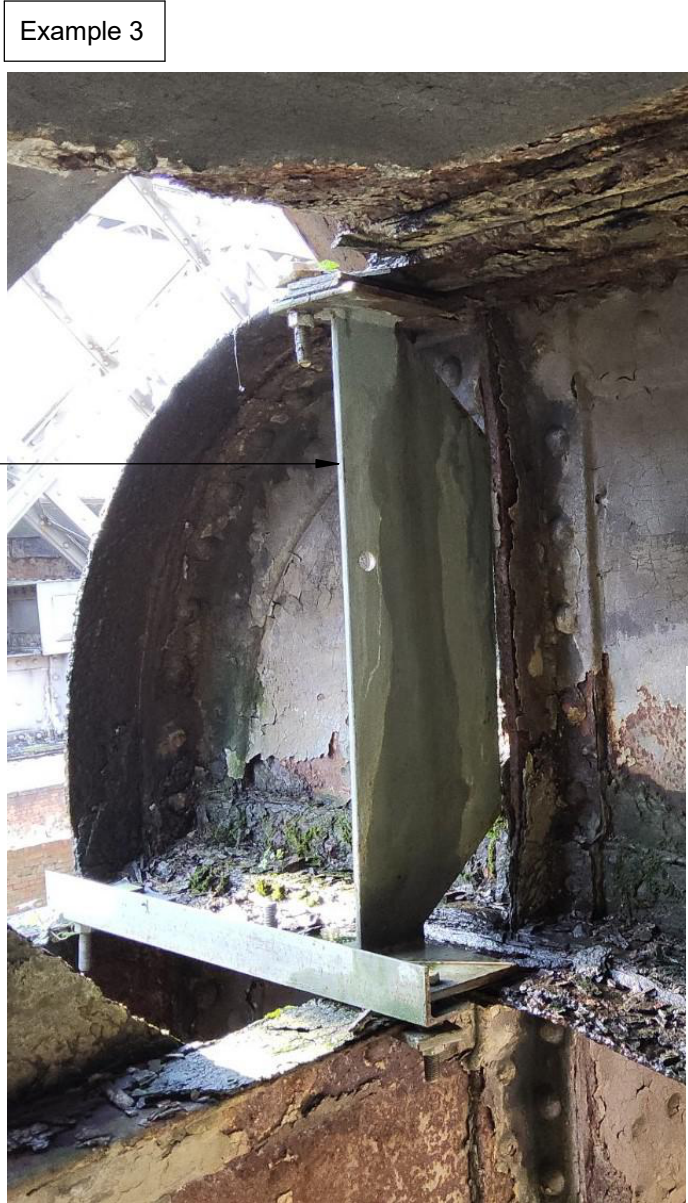
Remedial stiffeners installed  
during Ph1, to transverse  
beam (TB) ends as follows:  
- TB 25 - north and south  
- TB 27 - north and south  
- TB 29 - north  
- TB 35 - north  
- TB 36 - north  
- TB 37 - north  
- TB 38 - north  
- TB 39 - north  
- TB 40 - north  
- TB 42 - north  
(12No. total)

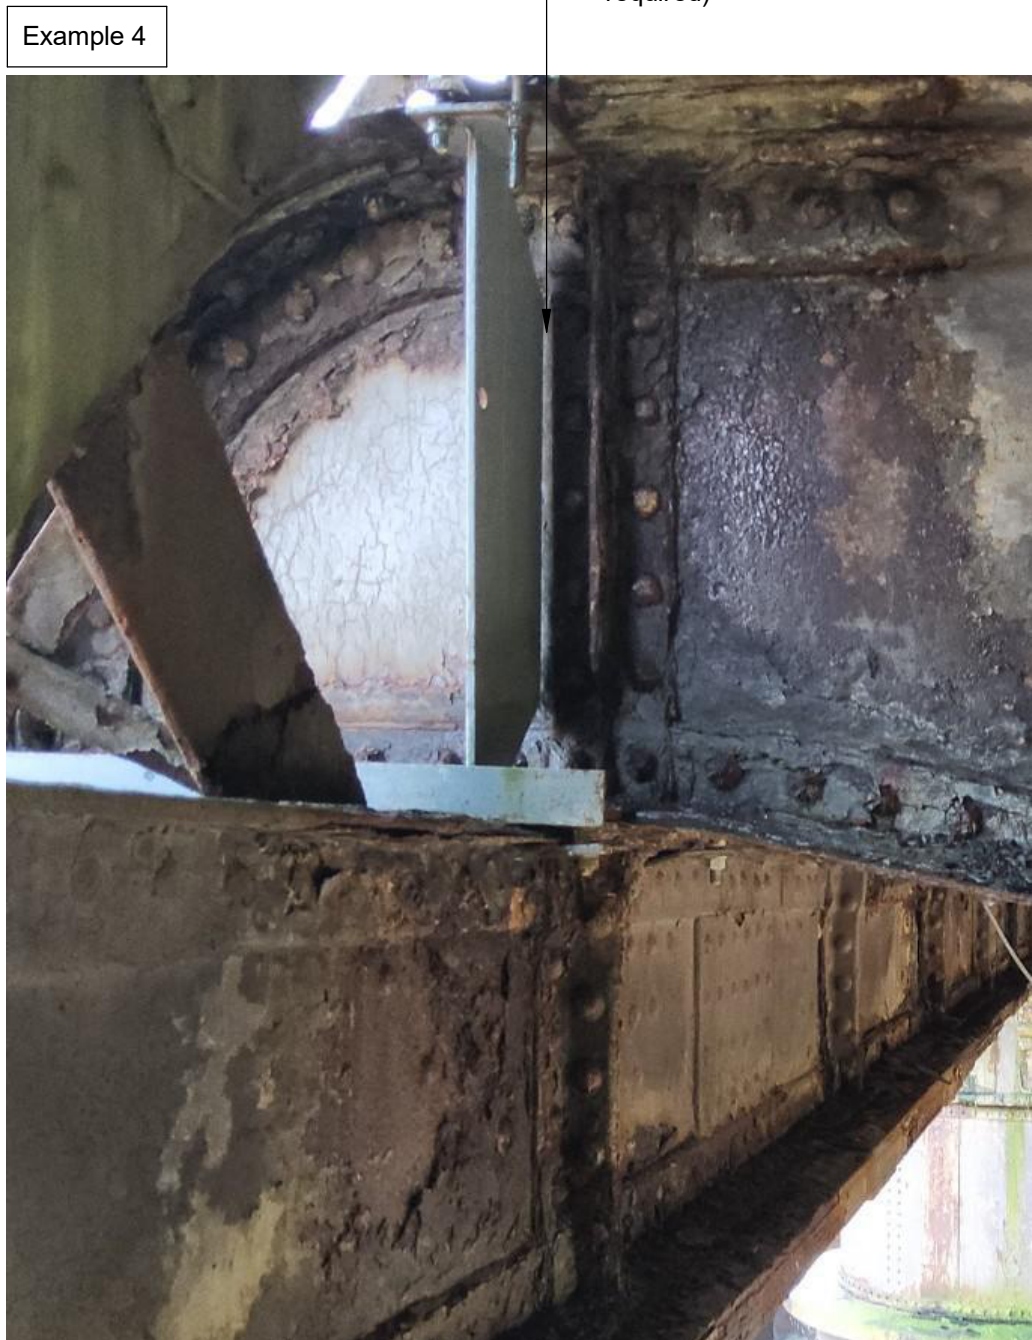
Air gap between stiffener  
and web plate  
- not as per 2022 detail  
which showed contact  
required)

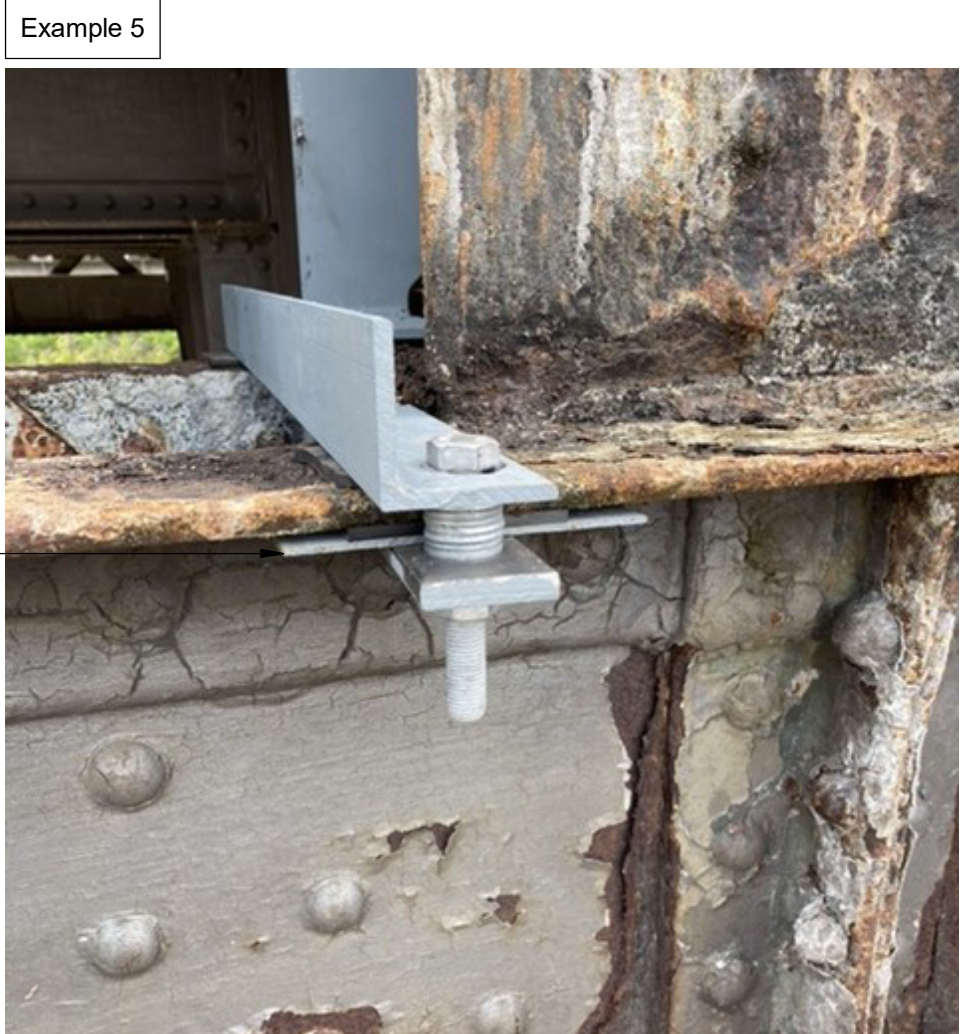
Washers as packers  
across top flange of  
bottom chord
